Environmental Team Services for Contract No.  
CV/2012/02 Construction of Sewage Pumping  
Station near Tsz Tin Road and Associated Sewerage  
Works in Area 54, Tuen Mun

Quarterly EM&A Report for August to October 2015 (Rev. A)

November 2015

Civil Engineering and Development Department

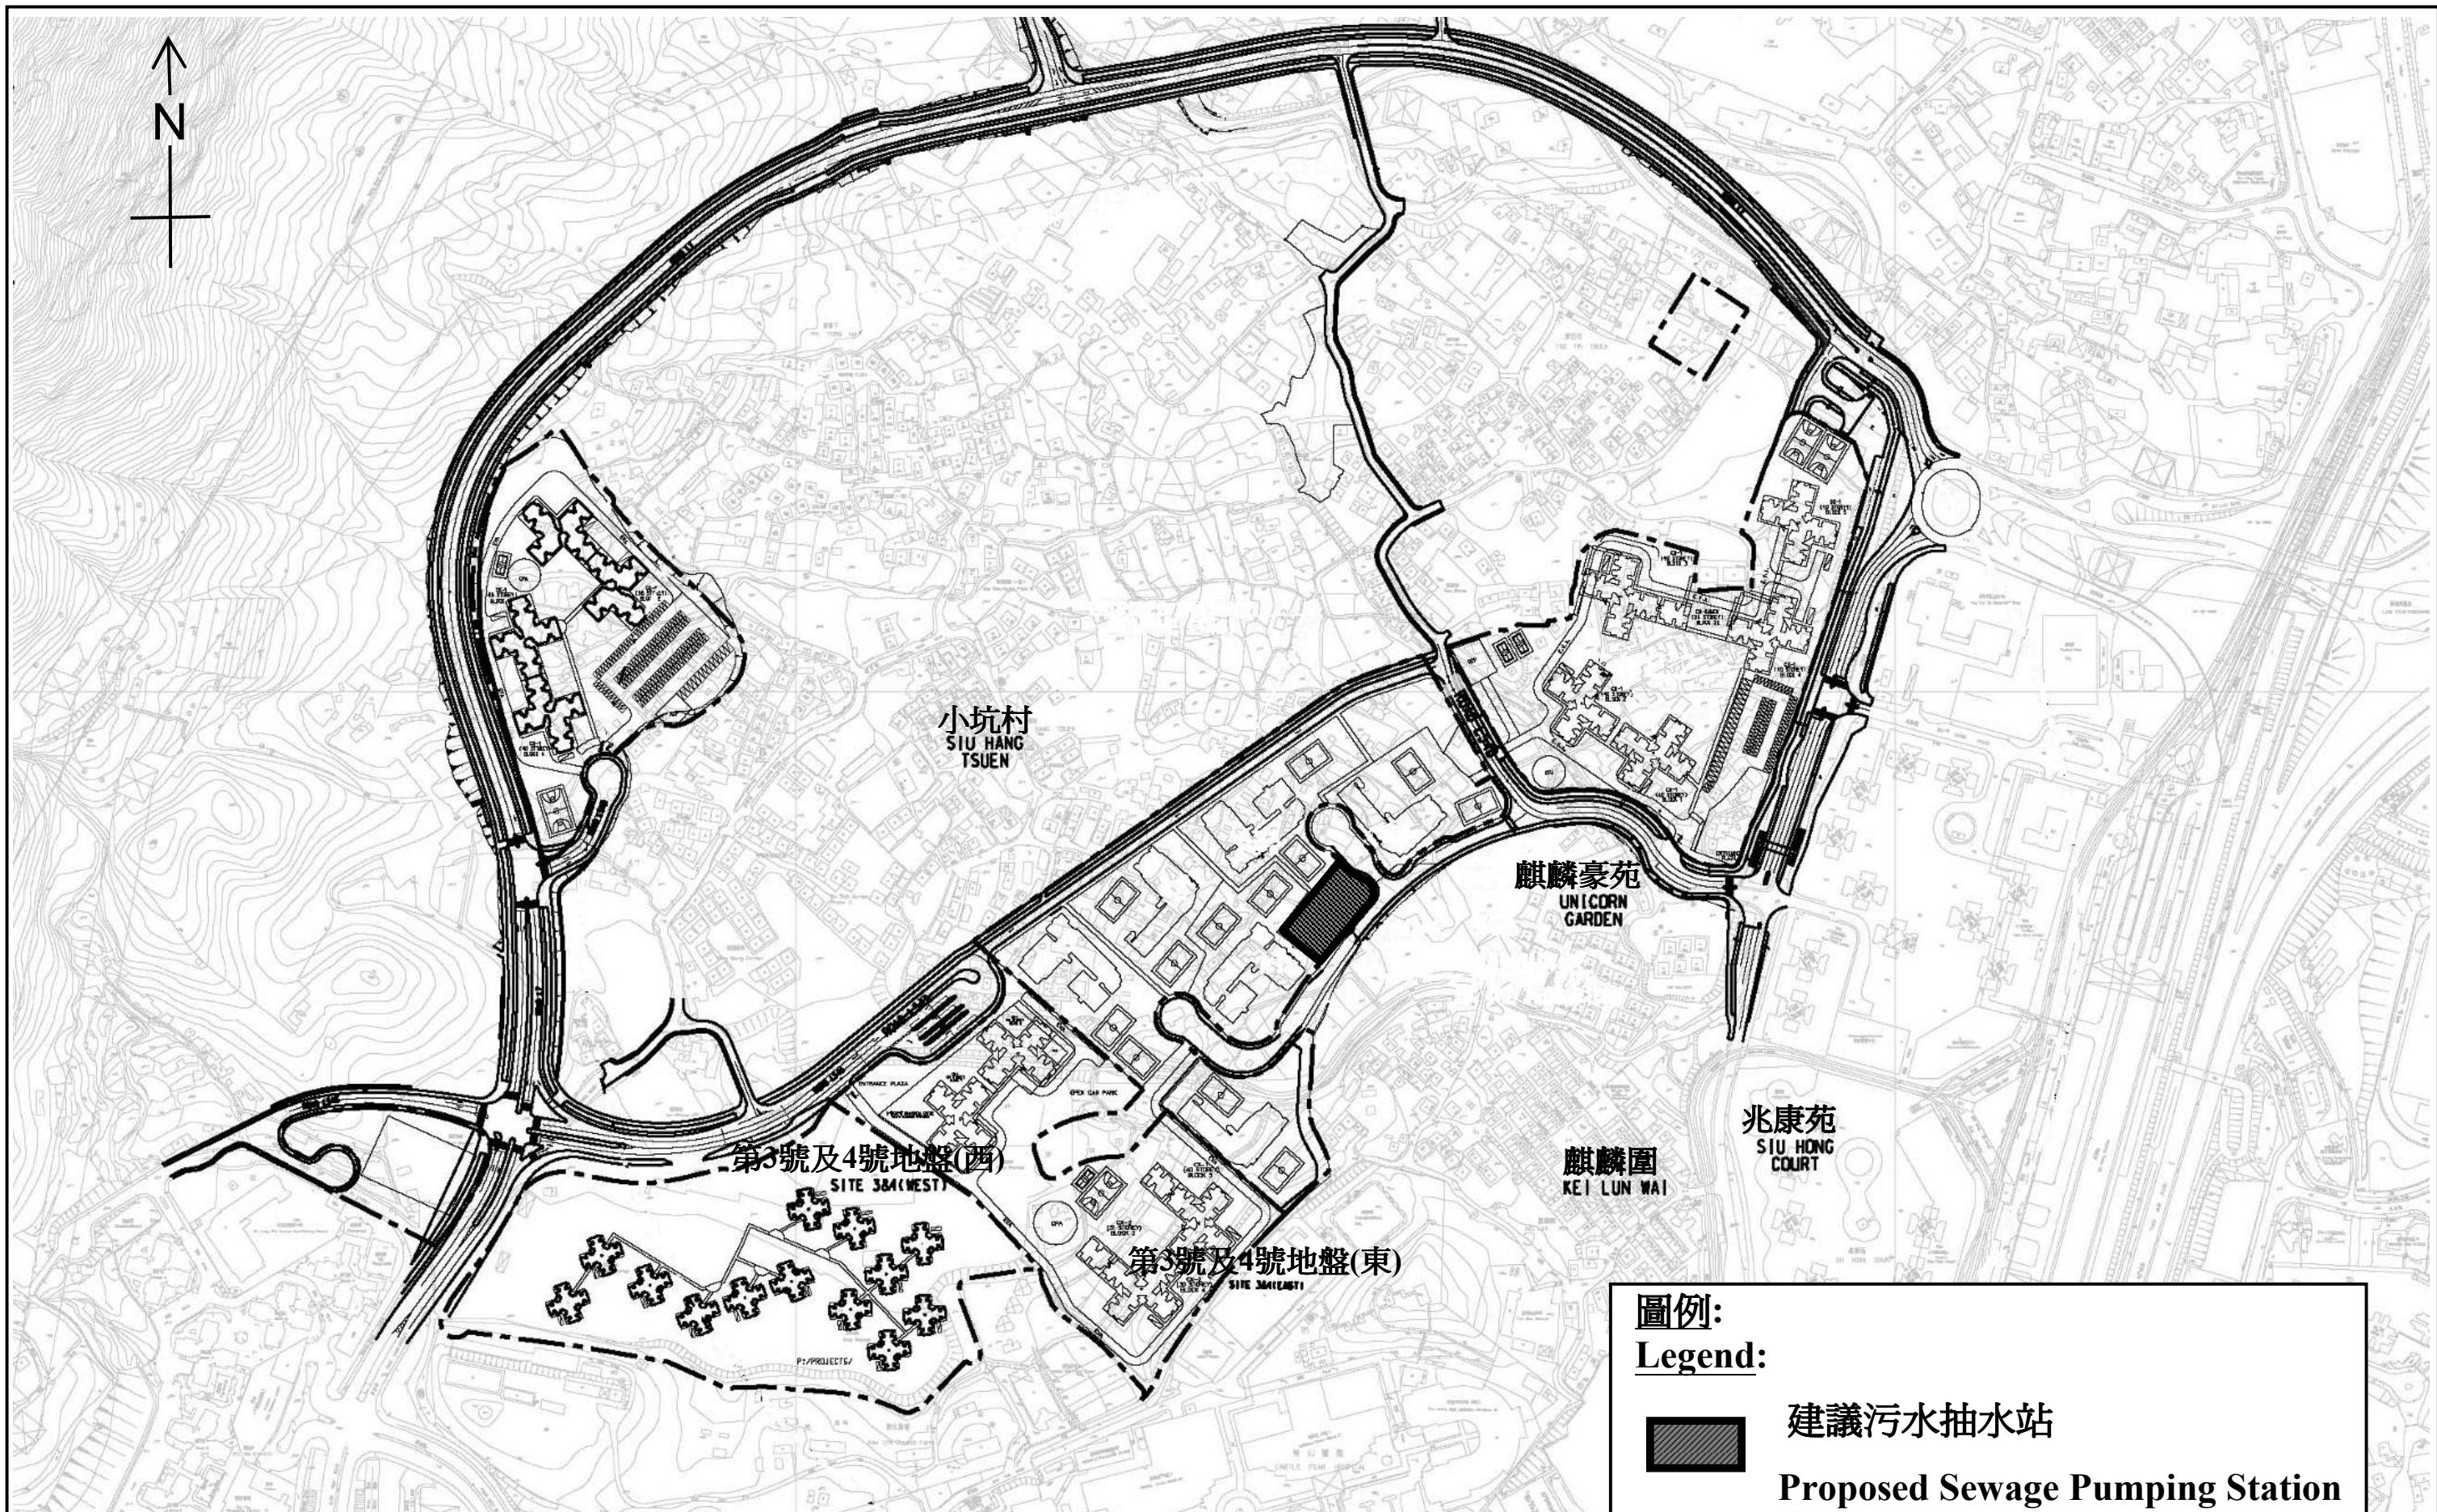
Figure 1.1

**屯門第54區污水抽水站 –**  
**Tuen Mun Area 54 Sewage Pumping Station –**  
 建議污水抽水站位置  
 Location of Proposed Sewage Pumping Station

A layout plan of the Project is provided in [Figure 1.1](#).

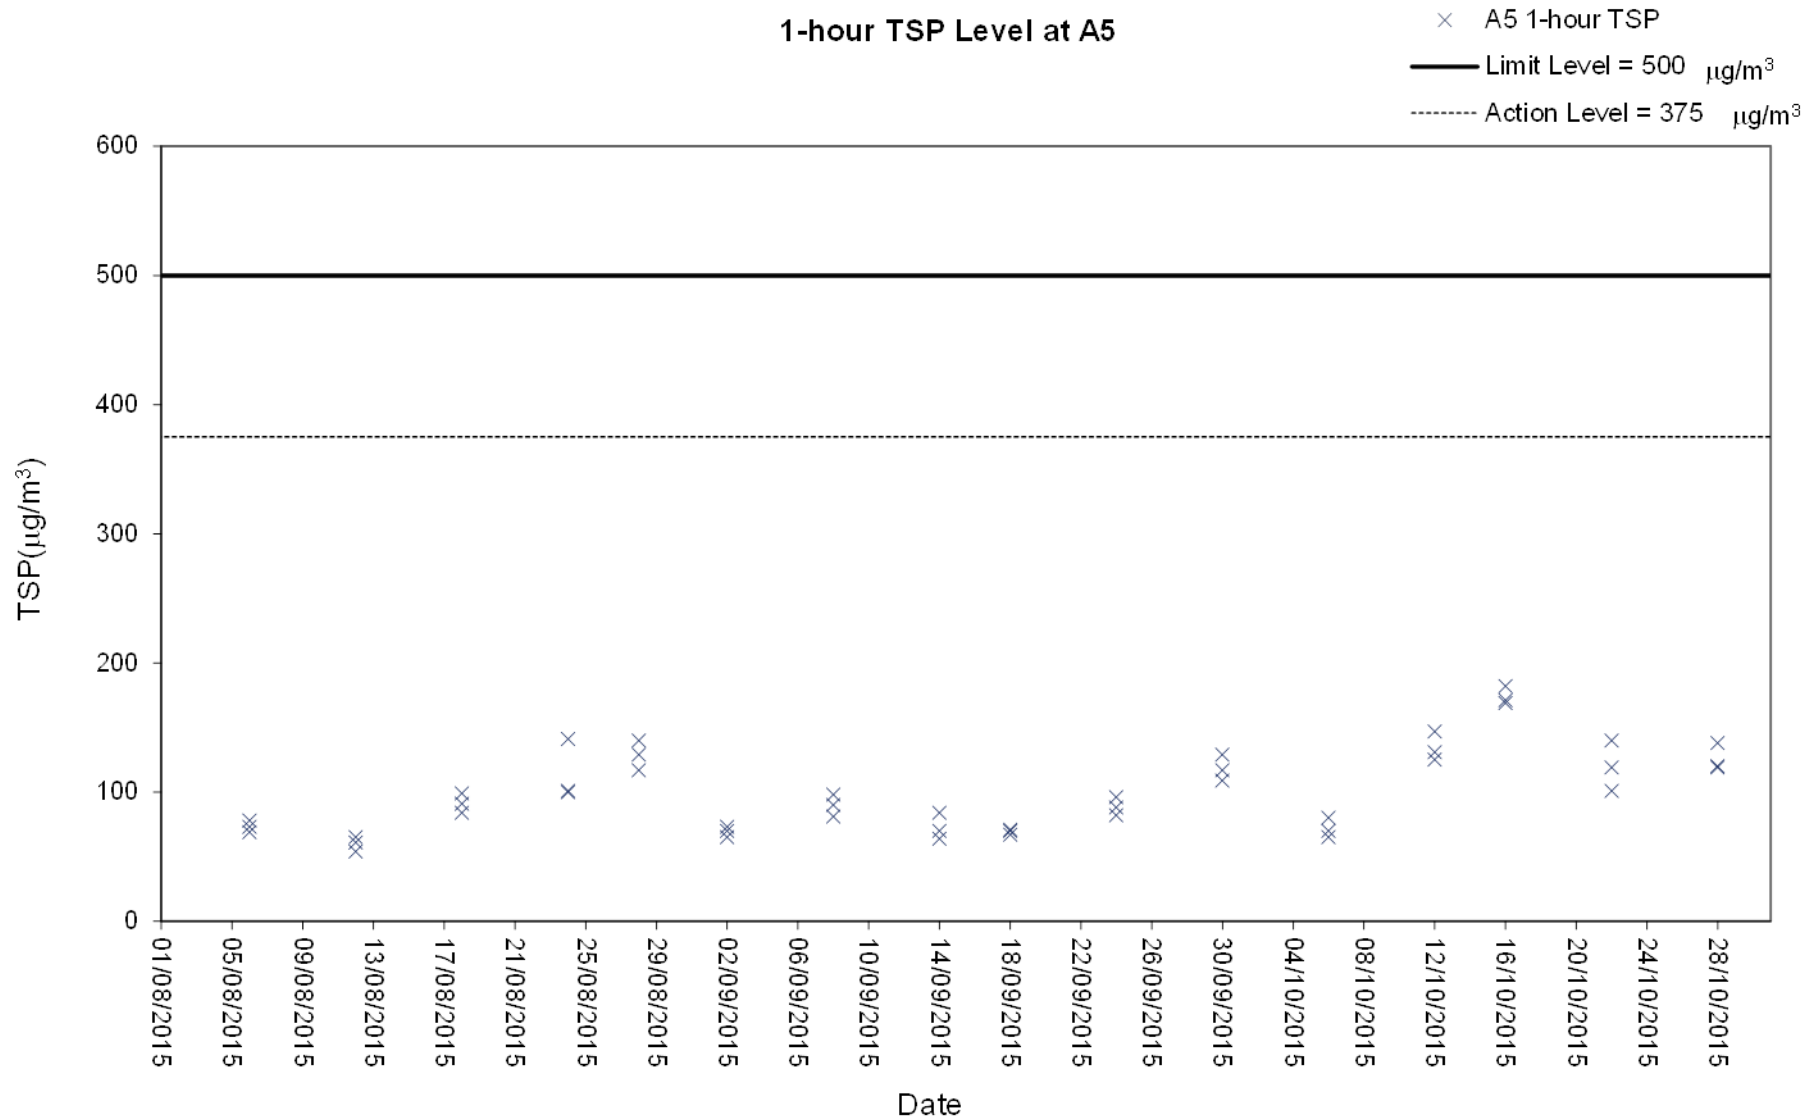
### Air quality monitoring (1-hour TSP)

The 1-hr TSP, 24-hr TSP, noise level (as L<sub>eq</sub>) under monitoring have been checked against established Action and Limit levels. There was no breach of Action and Limit Levels for 1-hr TSP, 24-hr TSP and noise in the reporting period.
