**Development of a Bathing Beach at Lung Mei, Tai Po**

**Development of a Bathing Beach at Lung Mei, Tai Po**  
**Environmental Permit No. EP-388/2010**

**REPORT**  
**1<sup>st</sup> POST-CONSTRUCTION SEAHORSE**  
**MONITORING**

**ECO-ENVIRO CONSULTANTS COMPANY**  
**January 2021**

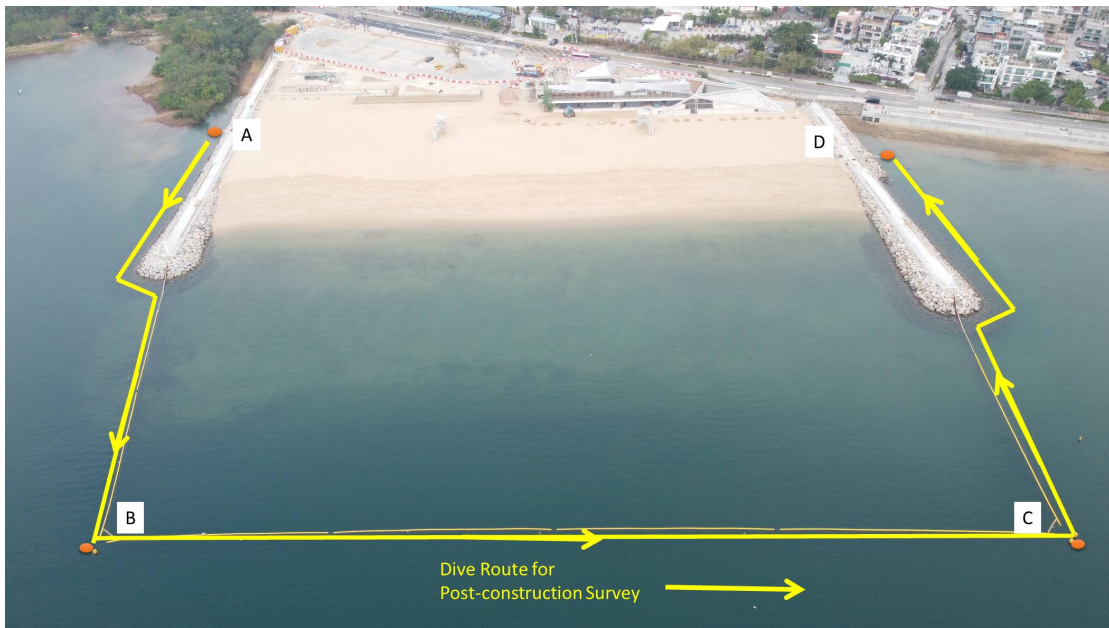
Figure 1. First Post-Construction Monitoring Survey Route at Lung Mei Beach Shark Net

2.2 Standard Underwater Visual Census (UVC) (AIMS, 1994)<sup>1</sup> surveys were conducted at the installed shark net at Lung Mei Beach at a depth range of -0.0 m CD to -6.0 m CD along survey area. Four subtidal dive surveys were conducted, two in day time and two in night time. UVC was performed on belt transects of 1 m width along the whole shark net. UVC surveys were performed at least 10 minutes after deployment of the buoys and transects. Sample survey method was also conducted for night time surveys. Similar to the baseline survey, two survey events were conducted (in two days). Each survey event included not less than four man-hours of day survey and four man-hours of night survey. At least a total of 16 man-hours would be spent over the two survey events. The actual man-hours spent during each survey was recorded. Six SCUBA divers were parallel to each other and dived along the whole shark net (Figure 1) to locate any seahorse presence next or on the shark net.

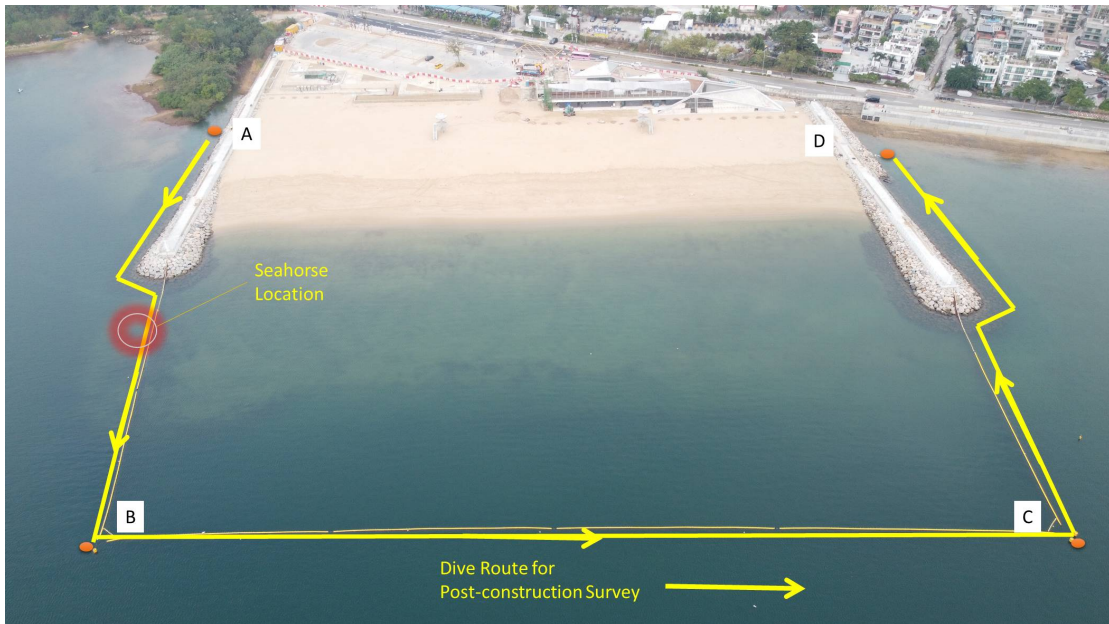
Figure 2 Seahorse Location at Lung Mei Beach Shark Net

3.4 One male seahorse *Hippocampus kuda* (Photo Plate A) was recorded next to the shark net during the second day survey (Appendix B-1) and the location of the recorded seahorse was shown in Figure 2

4.2 One male seahorse *Hippocampus kuda* was recorded during the December monitoring near the shark net (Figure 2) in which the seahorse was anchored onto the shark net.

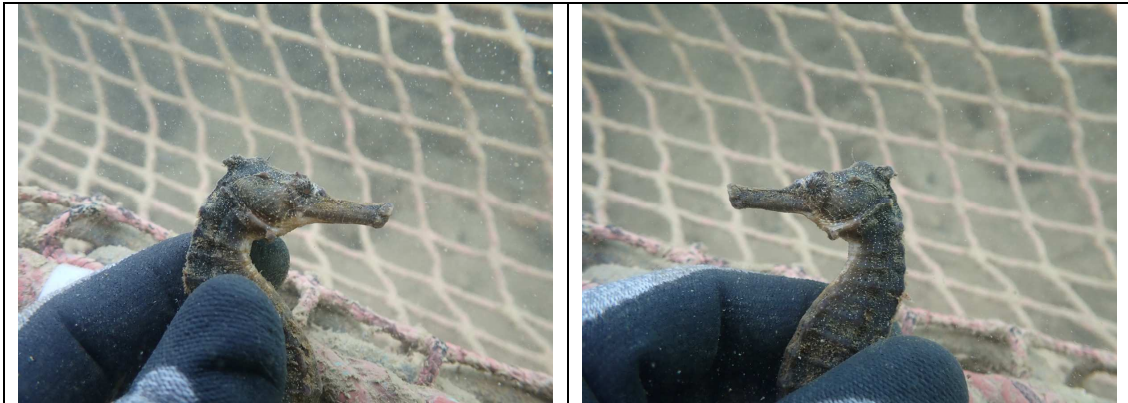
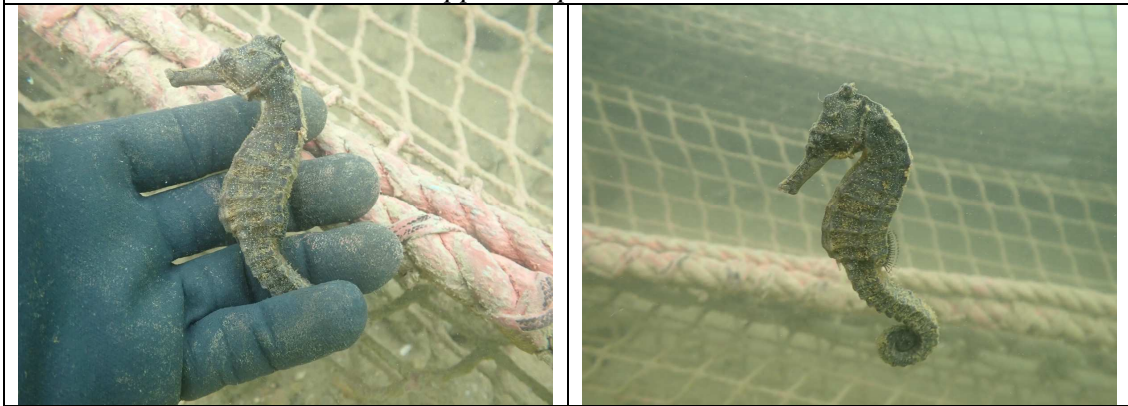
Photo Plate A

Seahorse #	Species	Sex	Reproductive Status	Torso Length (cm)	Total Length (cm) (Body + Head)	Sighting Location	Depth (m CD)	Holdfast	Proximity to the nearest seahorse	Sign of stress or injury
1	<i>Hippocampus kuda</i>	M	NA	4.5	13	Sandy Bottom	-4.5	Yes	NA	No

*Hipposcampus Kuda #1*
