**Consultancy for Environmental Monitoring on the
Major Restoration of the Residence of Ip Ting-Sz,
Lin Ma Hang Tsuen, Sha Tau Kok**

Monthly Environmental Monitoring and Audit Report

May 2011

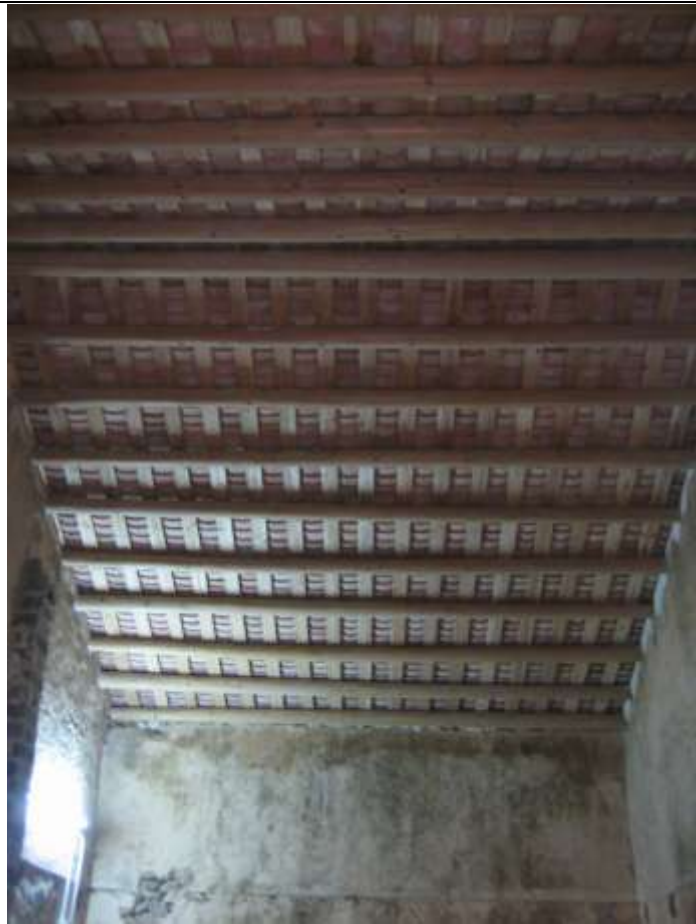
- 3.2 During AMO's visits to the site on 20 May 2011, no bat was observed in the Kitchen Annex. Photographic records showing the ceiling of the annex and the Main Building can be found in **Appendix B**.

- 3.3 As no bat was found, no bat monitoring was conducted in May.
- 3.4 Conversation with the AMO revealed that the windows of the Kitchen Annex were blocked by three security bars to match with the original design of the building by the contractors.

- 4.1 No bat was observed during AMO's site visit in May.
- 4.2 Security bars on the windows in the Kitchen Annex shall be removed to restore bat's flight path.
- 4.3 Further monitoring work shall be done to check the bat's return rate and identify the habitability of the Kitchen Annex.
