**Consultancy for Environmental Monitoring on the
Major Restoration of the Residence of Ip Ting-Sz,
Lin Ma Hang Tsuen, Sha Tau Kok**

Monthly Environmental Monitoring and Audit Report

September 2011

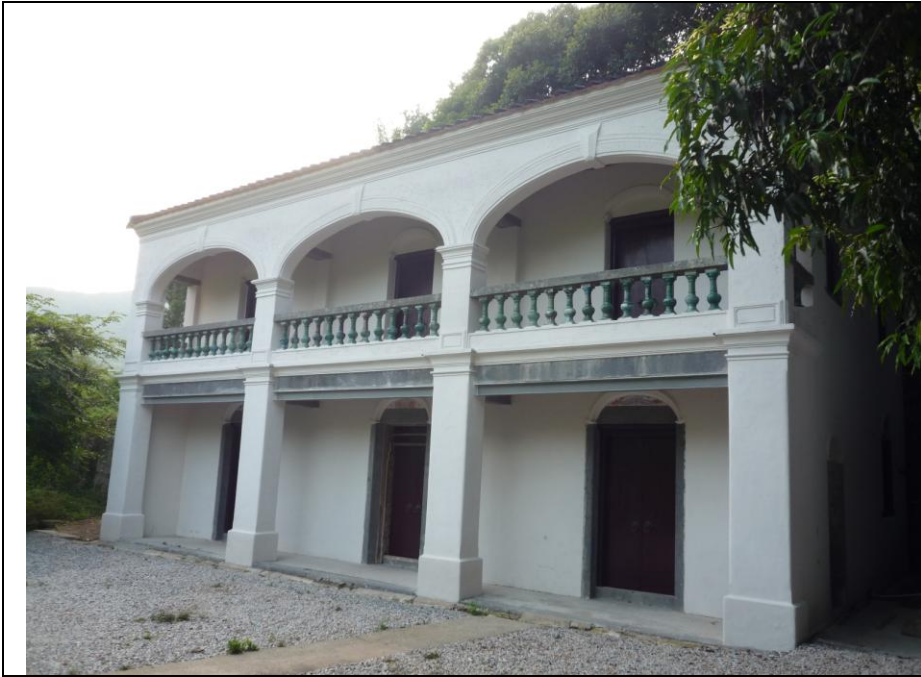
Main Building (27/9)

- 3.3 The Residence was empty. Scaffolding was removed and no rectification works was found on site. The bat friendly gate remained locked up. Some old furniture which was not used for display was placed inside the Kitchen Annex. No construction materials were stored within the Kitchen Annex.

- 4.2 Photographs showing the Residence after removal of the scaffolding can be found in **Appendix B**.
- 4.3 Since September, a security guard was employed to station at the Residence. He was remained to use the light switch inside the Residence and avoid access to the Kitchen Annex to turn on/off the main electricity control in day to day operation. The AMO noticed that he had followed this practice. Without entering or leaving the Kitchen Annex regularly, this can minimise disturbance to the roosting site.

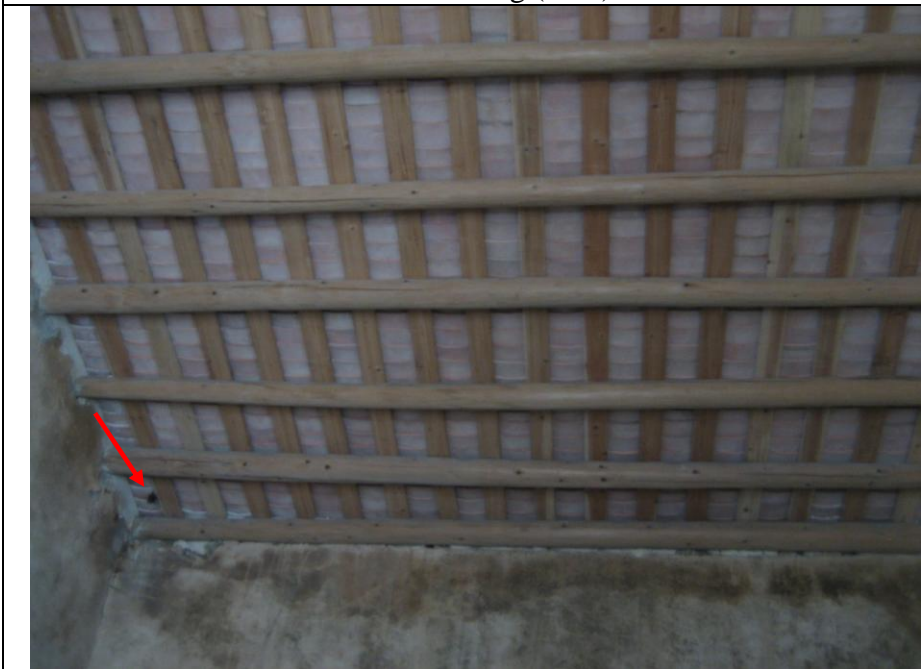
Kitchen Annex - Roof (15/9)

- 3.1 Site inspections conducted by AMO on 15 September 2011 in the daytime found one bat in the Kitchen Annex.
- 3.2 Bat monitoring was conducted in late afternoon on 27 September 2011.

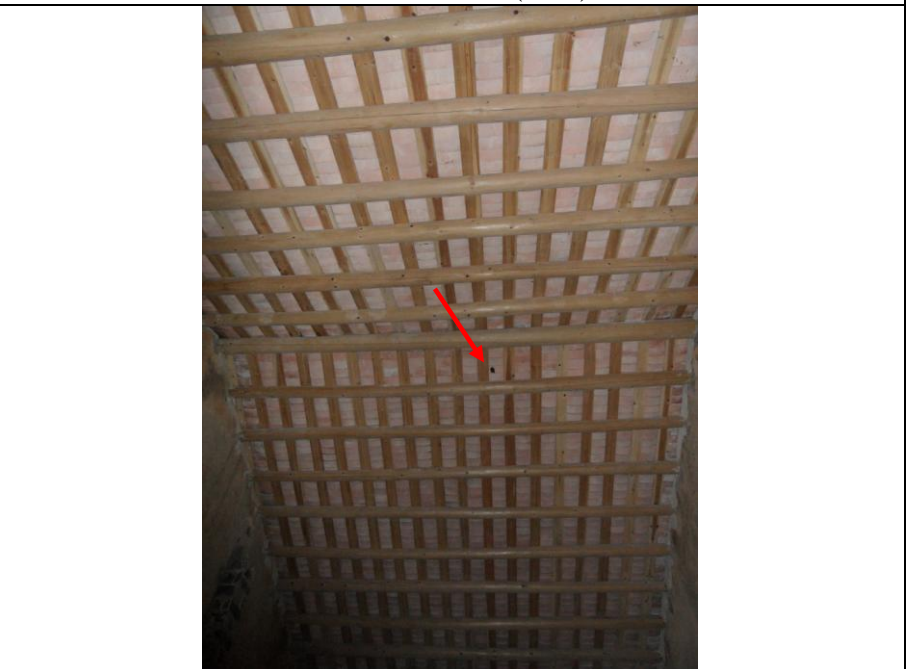
Kitchen Annex - Roof (27/9)

- 3.4 One bat was found hanging under the roof of the Kitchen Annex. Its small eyes, large ears, pointed lancet and horseshoe-shaped leaf nose were characteristics of a *Rhinolophus* species. Its body was around 5cm long and its dark brown fur suggested that it might be Intermediate Horseshoe Bat *Rhinolophus affinis*.

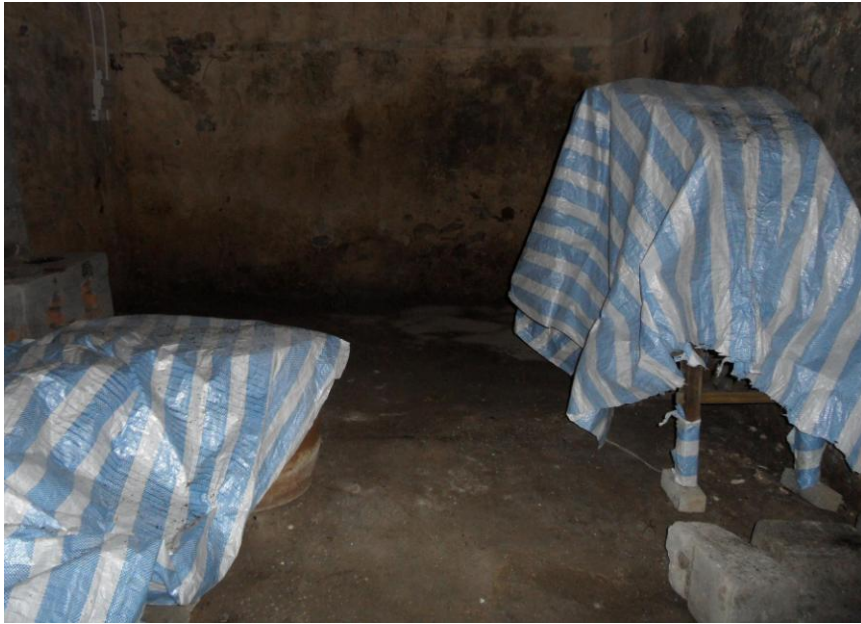
Kitchen Annex - Floor (27/9)

- 3.6 Other than direct observation of roosting bat, the presence of bat faeces and remains of eaten moths also proved that the Kitchen Annex is a suitable bat habitat. These evidences were located in the inner part of the Kitchen Annex away from the door.

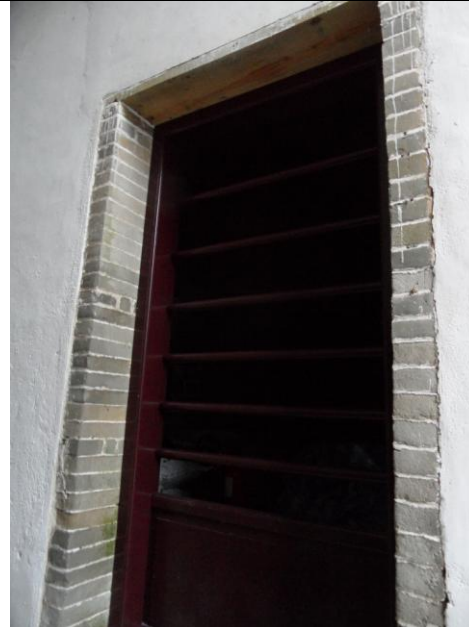
Kitchen Annex – Bat Gate (27/9)

- 3.5 At 6:10pm, this individual emerged from the Kitchen Annex through the second spacing from the top of the bat gate. It then flew towards the woodland behind the Residence.

- 3.10 On the other hand, occasional rectification work carried out by the contractor might have discouraged bats to return. Another possibility is that the spacing may not be large enough to allow Himalayan Leaf-nosed Bat to smoothly enter the Kitchen Annex. The size of Intermediate Horseshoe Bat is around half of Himalayan Leaf-nosed Bat while the uppermost is larger than the second spacing by 3cm.

- 3.11 Based on the above speculations, if Himalayan Leaf-nosed Bat does not return in the next breeding season when there is no further constructional disturbance, it is

recommended that the uppermost spacing should increase, for example to 44cm (double of the second spacing).
