**Consultancy for Environmental Monitoring on the
Major Restoration of the Residence of Ip Ting-Sz,
Lin Ma Hang Tsuen, Sha Tau Kok**

Monthly Environmental Monitoring and Audit Report

October 2011

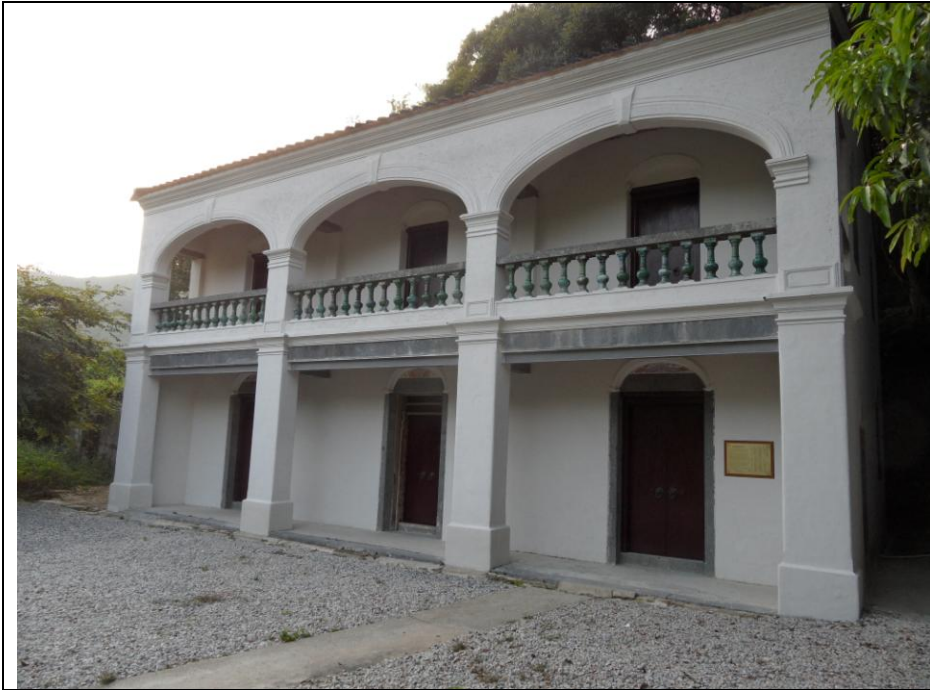
Main Building (27/10)

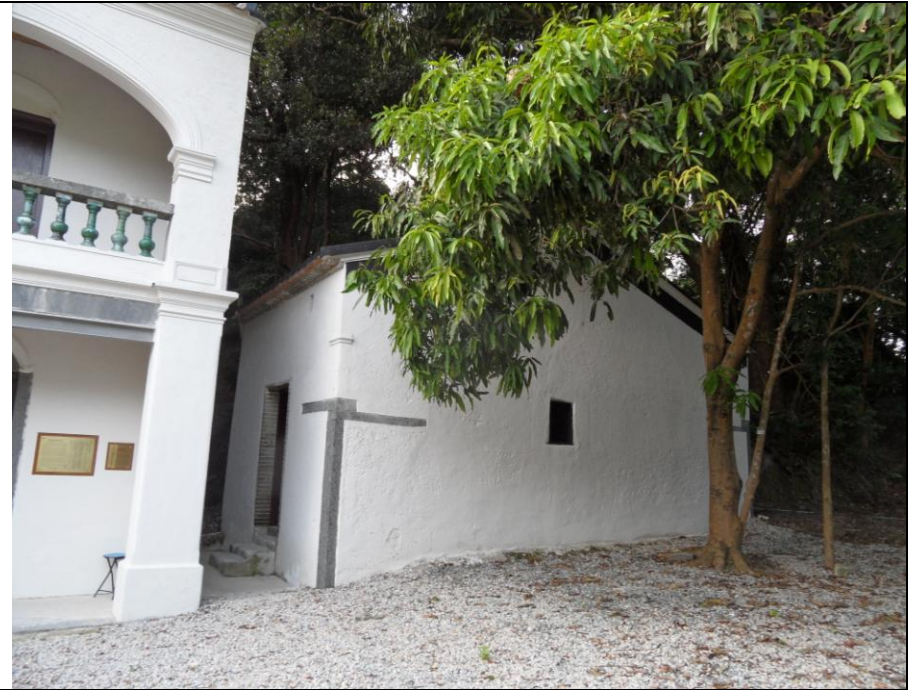
- 3.3 The Residence is now opened to public. On the monitoring date, there was no visitor and the security guard has already left. The bat friendly gate remained locked up. Some old furniture which was not used for display was placed inside the Kitchen Annex. They were covered by tarpaulin. No construction materials were stored within the Kitchen Annex.

Kitchen Annex (27/10)

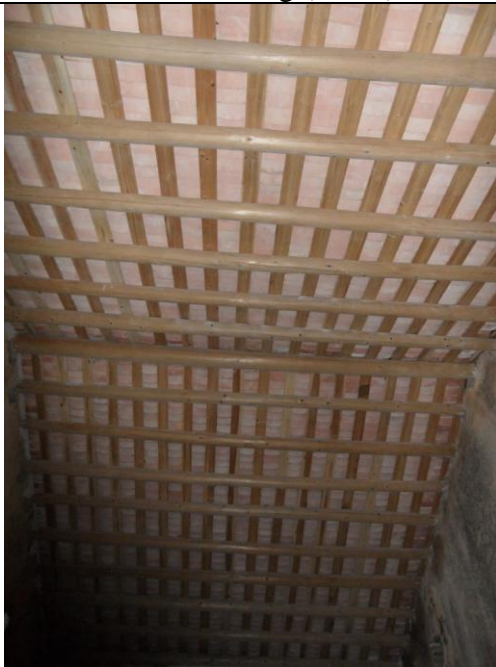
- 3.4 One bat was found hanging under the roof of the Kitchen Annex. Its small eyes, large ears, pointed lancet and horseshoe-shaped leaf nose were characteristics of a *Rhinolophus* species. Its body was around 5cm long and its dark brown fur suggested that it might be Intermediate Horseshoe Bat *Rhinolophus affinis*.

Kitchen Annex - Roof (27/10)

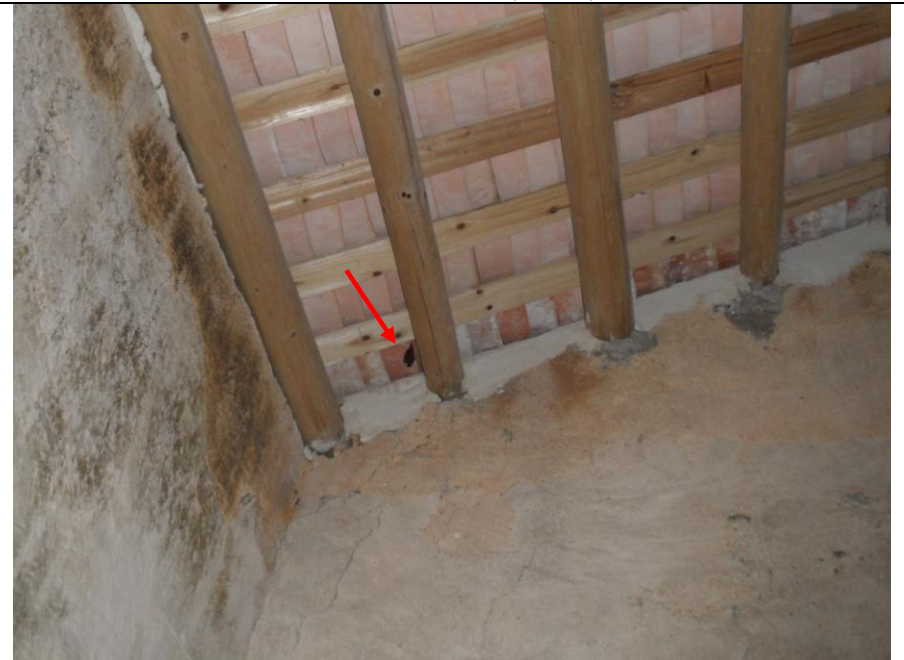
Kitchen Annex - Roof (27/10)

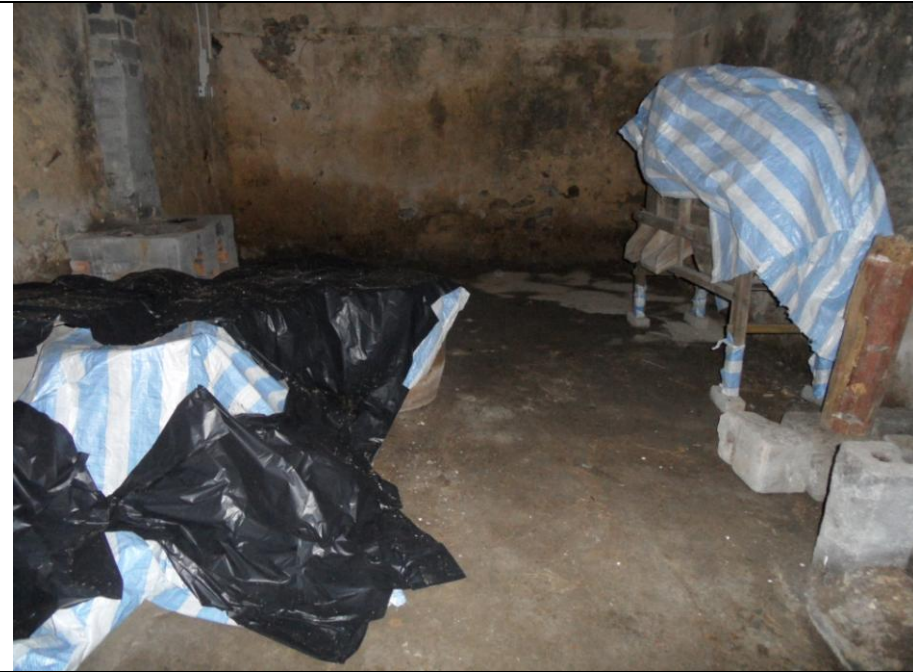
- 3.6 Other than direct observation of roosting bat, the presence of bat faeces and remains of eaten moths also proved that the Kitchen Annex is a suitable bat habitat. These evidences were located in the inner part of the Kitchen Annex away from the door.

Kitchen Annex - Floor (27/10)

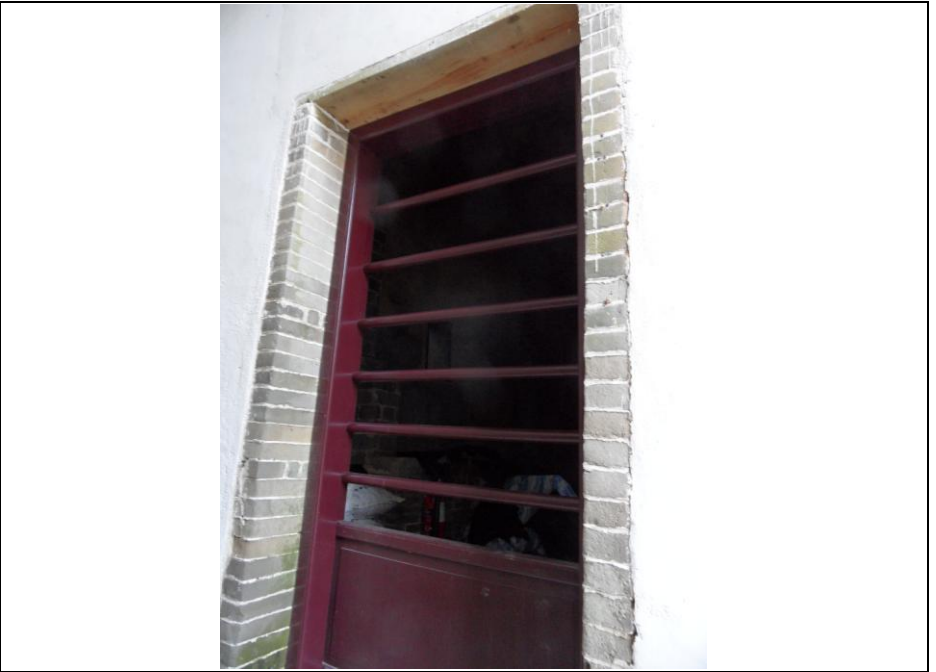
- 3.5 At 5:45pm, a bat flew from the woodland behind the Residence and entered the Kitchen Annex through the third spacing from the top of the bat gate. At 5:55pm, the Kitchen Annex was inspected but no bat was found. No bat left through the bat gate or the front window during this period. It was possible that the Intermediate Horseshoe Bat emerged from the annex through the back window (the only alternative opening) and returned through the bat gate. It then left the annex again from the back window.

- 3.10 On the other hand, occasional rectification work carried out by the contractor might have discouraged bats to return. Another possibility is that the spacing may not be

large enough to allow Himalayan Leaf-nosed Bat to smoothly enter the Kitchen Annex. The size of Intermediate Horseshoe Bat is around half of Himalayan Leaf-nosed Bat while the uppermost is larger than the third spacing by 25%.

Kitchen Annex – Bat Gate (27/10)

- 3.11 Based on the above speculations, if Himalayan Leaf-nosed Bat does not return in the next breeding season when there is no further constructional disturbance, it is recommended that the uppermost spacing should increase, for example to 40cm (double of the third spacing).

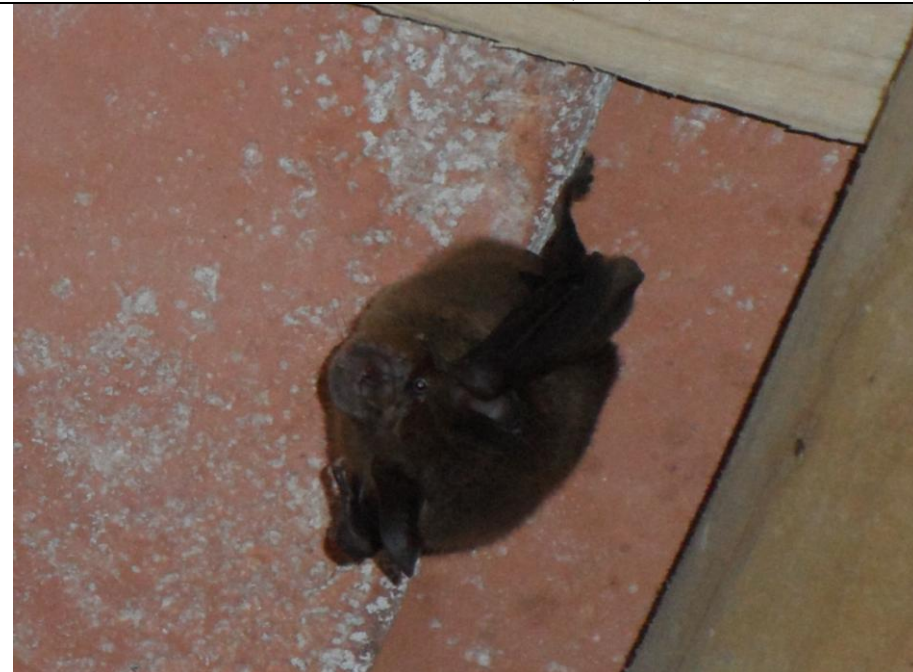
Kitchen Annex – Intermediate Horseshoe Bat (27/10)

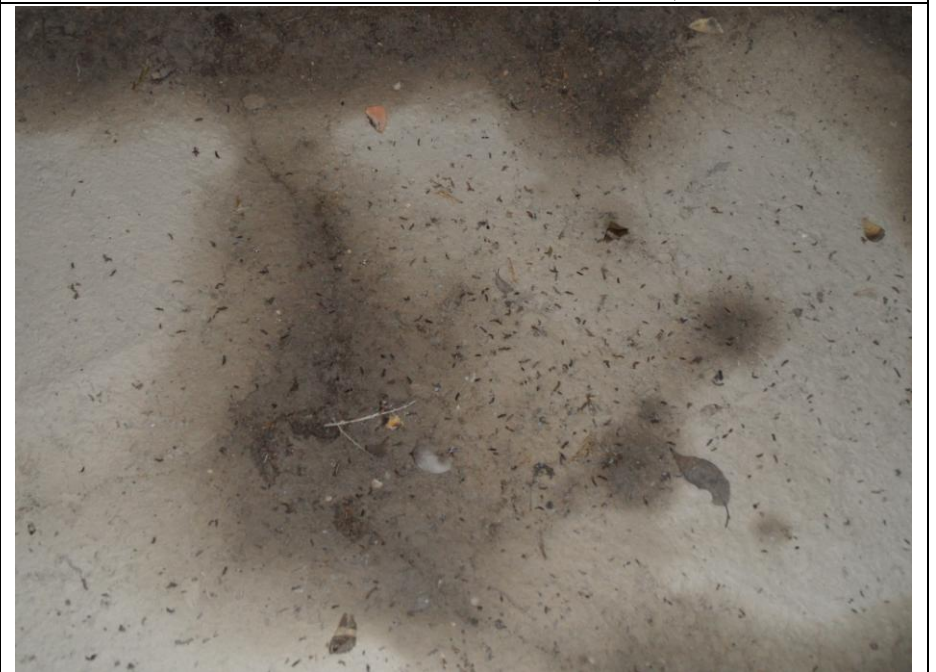
Kitchen Annex – Bat Faeces (27/10)
