**Antiquities and Monuments Office**

**Consultancy for Environmental Monitoring on the  
Major Restoration of the Residence of Ip Ting-Sz,  
Lin Ma Hang Tsuen, Sha Tau Kok**

Monthly Environmental Monitoring and Audit Report

November 2011

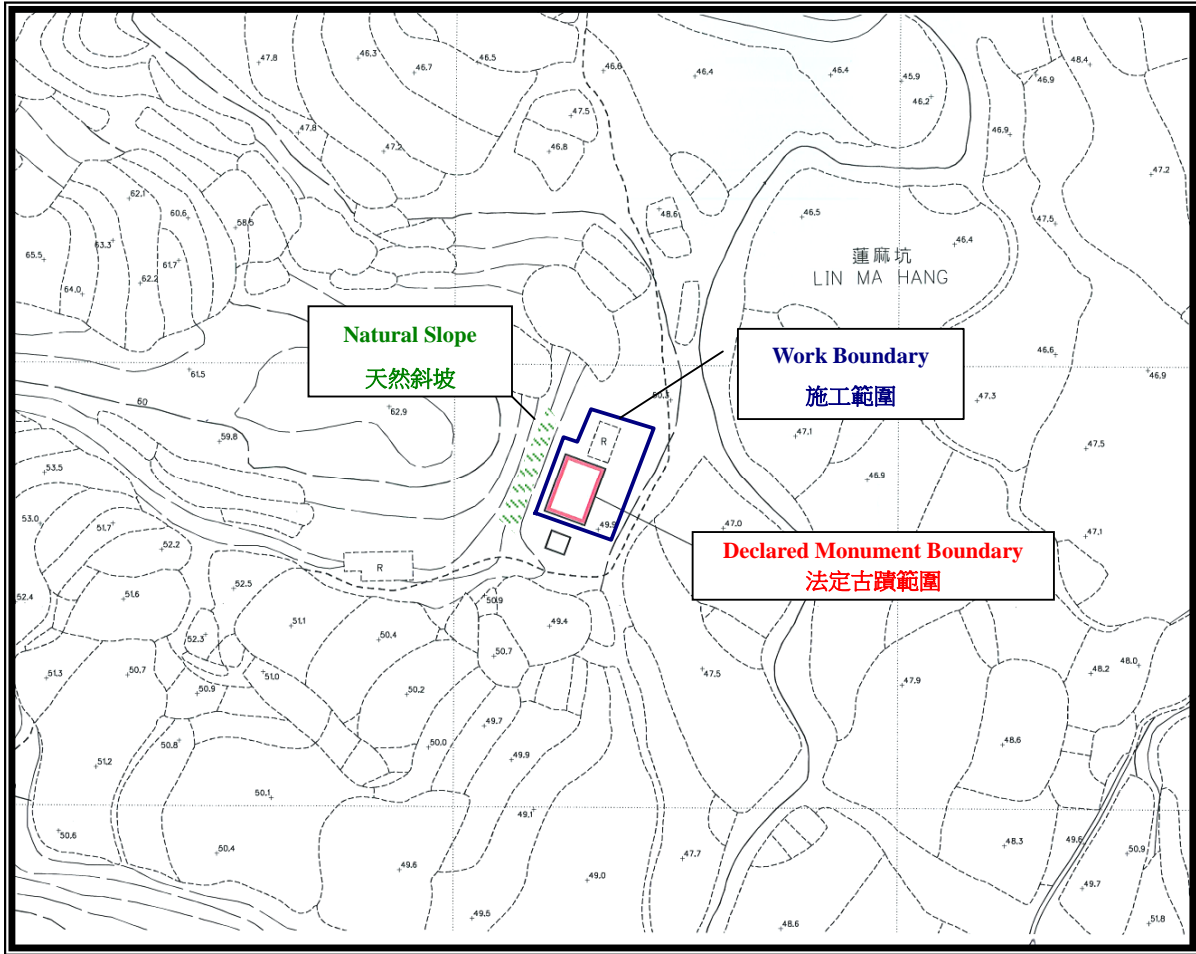
## Work Boundary of the Project 施工範圍

- 1.3 Major restoration works were carried out to the Residence from December 2010 to March 2011, which included the complete reconstruction of roof, internal and external redecorations (Location plan showing the project area and work boundary is at **Appendix A**).

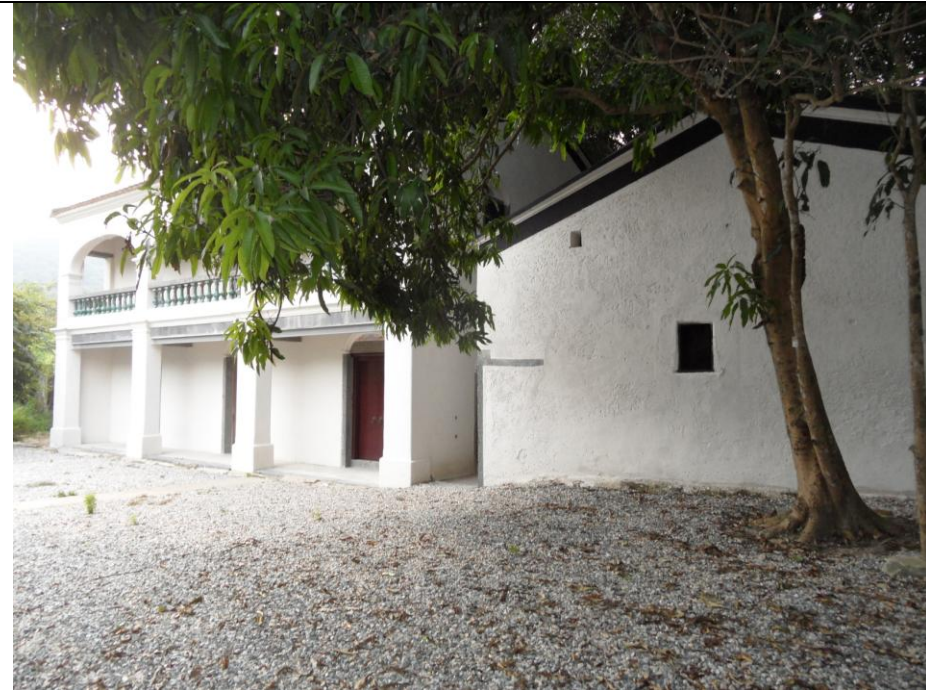
Main Building & Kitchen Annex (01/11)

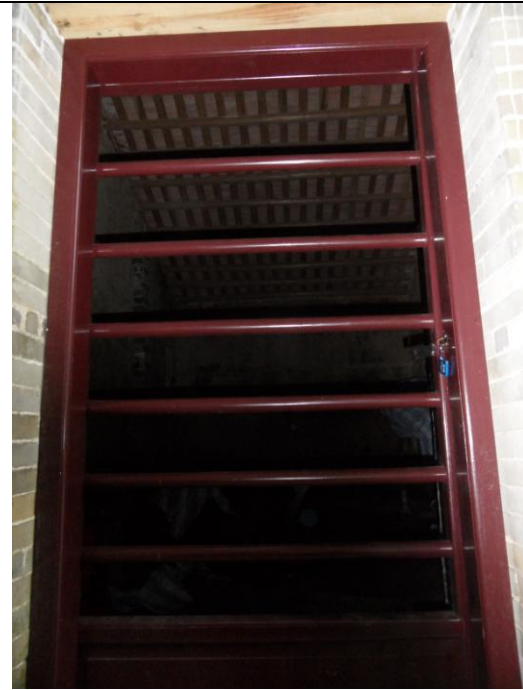
Bat Gate (01/11)

- 4.5 Effectiveness of the bat gate to Himalayan Leaf-nosed Bat's flight cannot be confirmed as this species was not observed during monitoring. Also, there is no project of similar nature carried out in Hong Kong as reference. The monitoring result in October showed that the Intermediate Horseshoe Bat utilized the third spacing from the top of the bat gate. The size of Intermediate Horseshoe Bat is around half of Himalayan Leaf-nosed Bat while the uppermost spacing is larger than the third spacing by 25%. The bat gate spacing may not be large enough to allow Himalayan Leaf-nosed Bat to smoothly enter the Kitchen Annex.

breeding season when there is little human disturbance, it is recommended that the uppermost spacing should be enlarged to about 40cm (double of the third spacing).

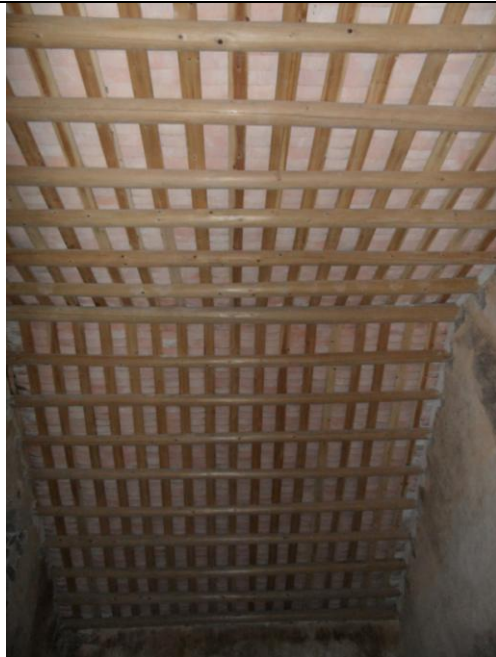
Kitchen Annex - Roof (01/11)

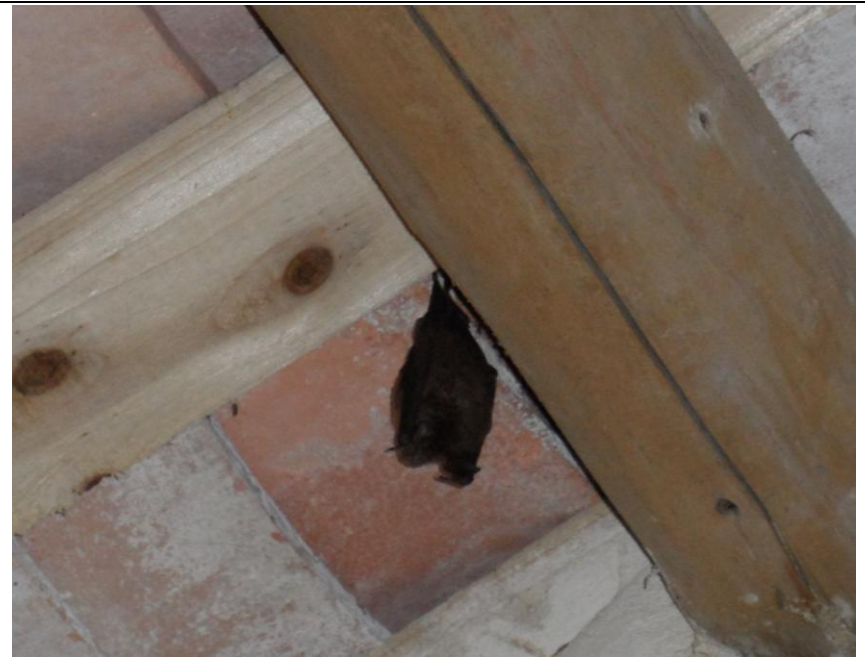
- 3.4 One bat was found hanging under the roof of the Kitchen Annex. Its small eyes, large ears, pointed lancet and horseshoe-shaped leaf nose were characteristics of a *Rhinolophus* species. Its body was around 5cm long and its dark brown fur suggested that it might be Intermediate Horseshoe Bat *Rhinolophus affinis*.

Kitchen Annex – Intermediate Horseshoe Bat (01/11)

- 3.5 After inspecting in the Kitchen Annex at around 5:00pm, bat emergence survey was followed. No bat left the annex through the bat gate or the front window. At 5:50pm, the annex was re-inspected and the Intermediate Horseshoe Bat was no longer present. It might have emerged from the annex through the back window (the only alternative opening) during the monitoring period.

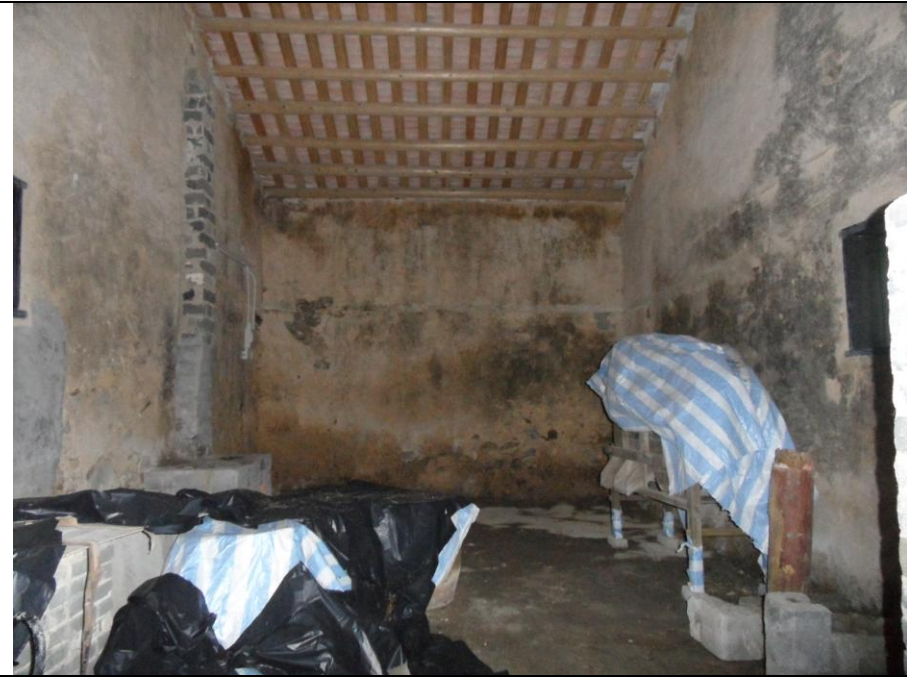
Kitchen Annex - Floor (01/11)

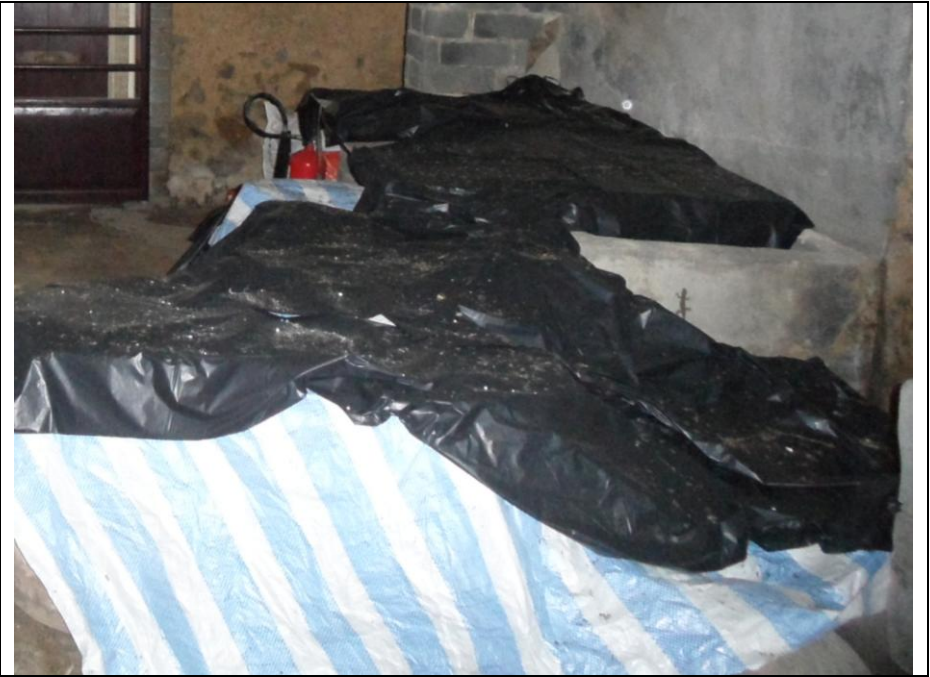
- 3.6 Other than direct observation of roosting bat, the presence of bat faeces and remains of eaten moths proved bat utilization of the annex. These were located in the inner part of the Kitchen Annex away from the door.

Kitchen Annex – Bat Faeces (01/11)
