South Island Line (East)

Transplantation Proposal  
(*Houttuynia cordata*)

September 2011

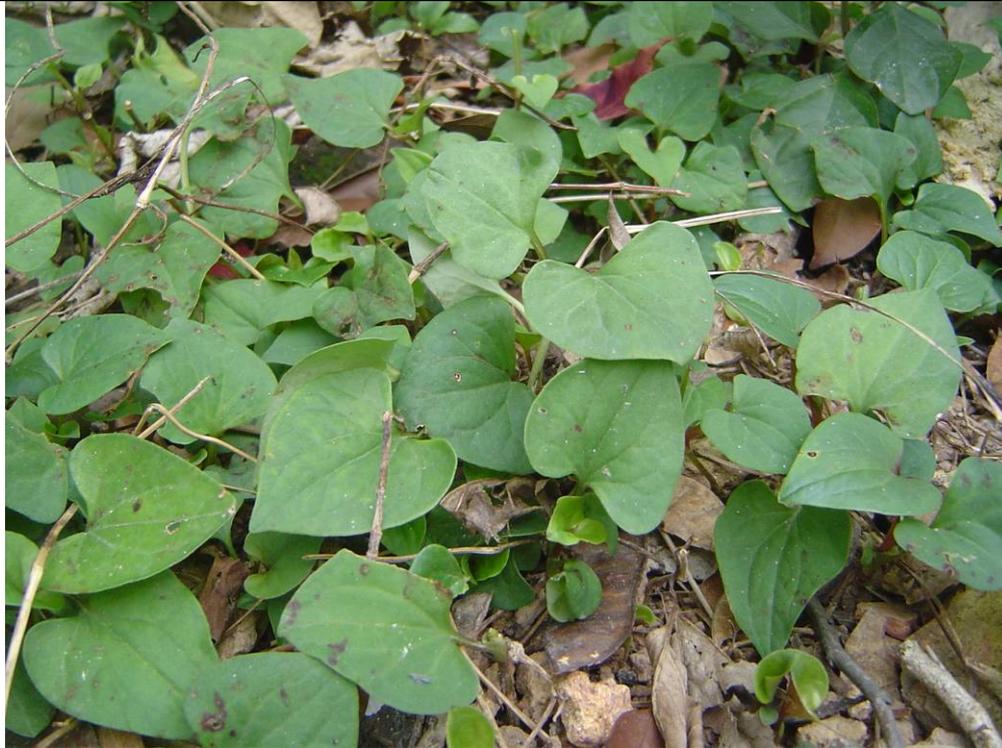
Plate 1. *Houttuynia cordata*.

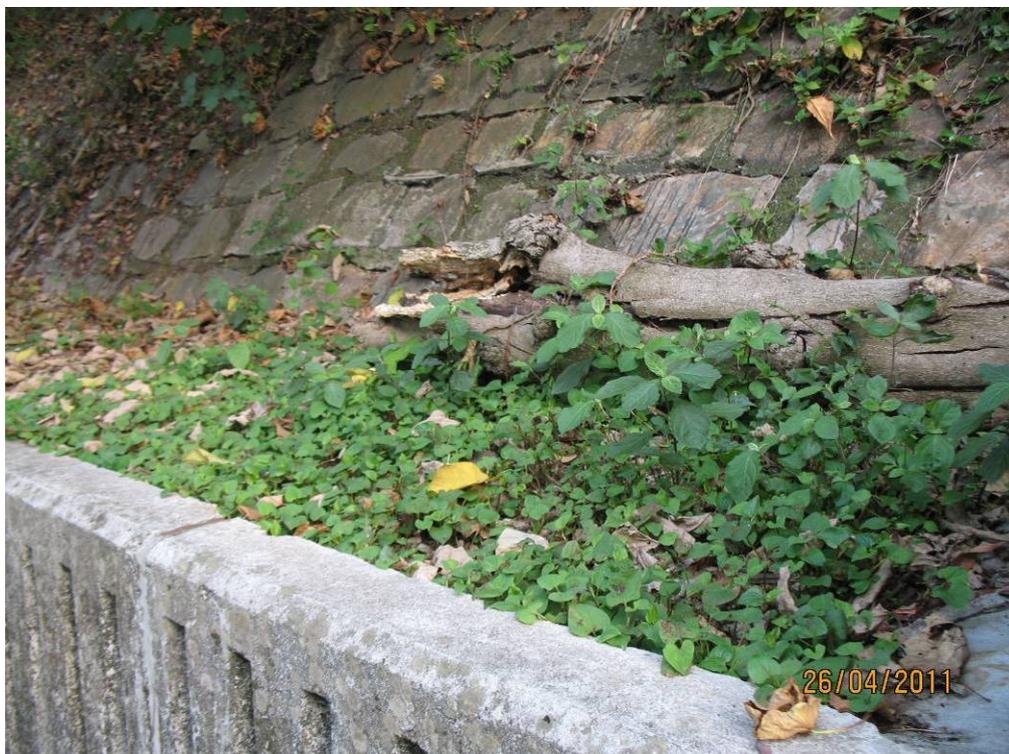
The recorded herb was in good health condition (with approximately 0.1m in height) and grew on a flat, semi-shady ground that can retain moisture on the top of the retaining wall (**Plates 1 & 2**). The overstorey trees on the adjacent man-made slope provide shade to favor the growth and establishment of this herbaceous species.

Plate 2. The identified *Houttuynia cordata* on top of a concreted retaining wall, with decayed wood debris and other herbs colonized the area.

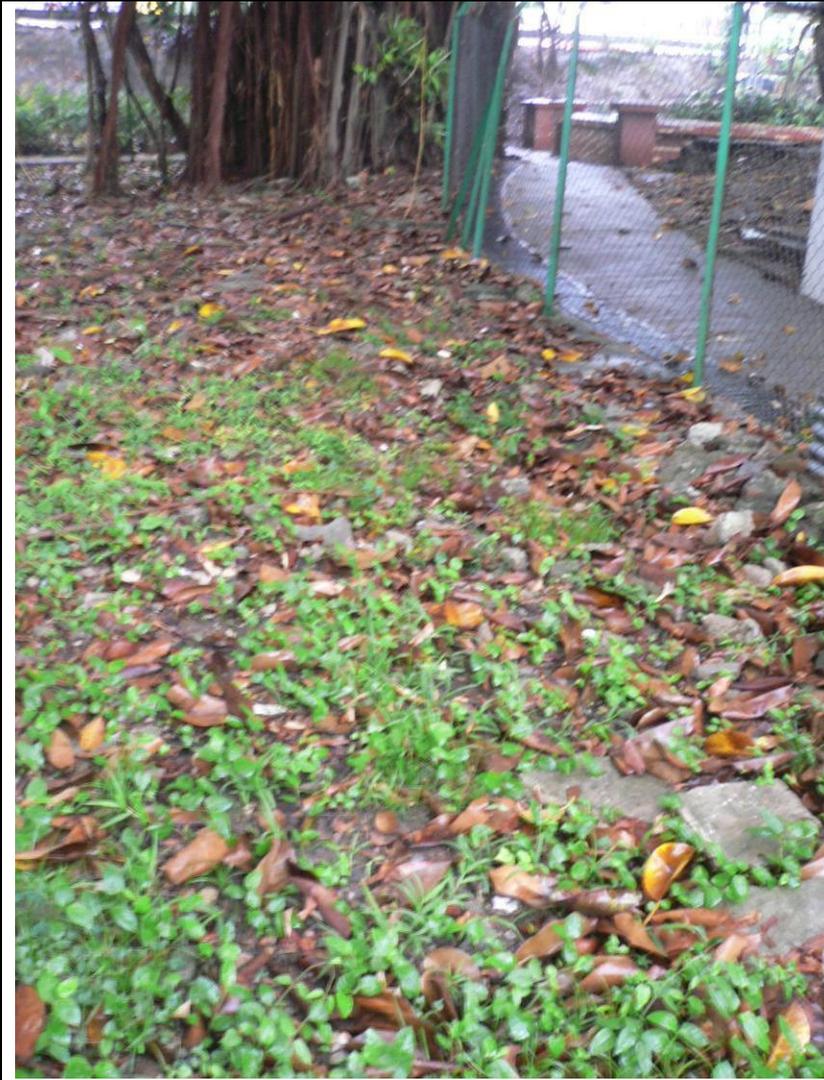
A small receptor site, with an area of about 2.0m x 2.6m, is proposed in **Section 5 (Figure 2)**. The selected receptor site is a flat, soil ground with a small stones and some paved structure (**Plate 3**). The receptor site is dominated by fertile topsoil which is similar to farmland soil rich in organic matter. Soil in the receptor site would facilitate the herb establishment with its farmland-type soil condition. It is underneath a spreading canopy of a retained tree *Ficus elastica*, which would provide a semi-shady environ favoring the establishment of *H. cordata*.

Plate 3. The proposed receptor site for the transplanted *Houttuynia cordata*. Stones and paved structures will be removed during site preparation stage for the transplant.

A small area located within an existing fenced area to the northeast of Wong Chuk Hang Road Garden is selected as a receptor site (**Figure 2, Plate 3**). Site clearance and preparation will be undertaken to facilitate the transplantation of *H. cordata*, but without causing any adverse damage to the roots of the retained *Ficus elastica*. After the transplant, the receptor site should be fenced and protected to prevent any damage resulting from the adjacent construction works (if any) during the

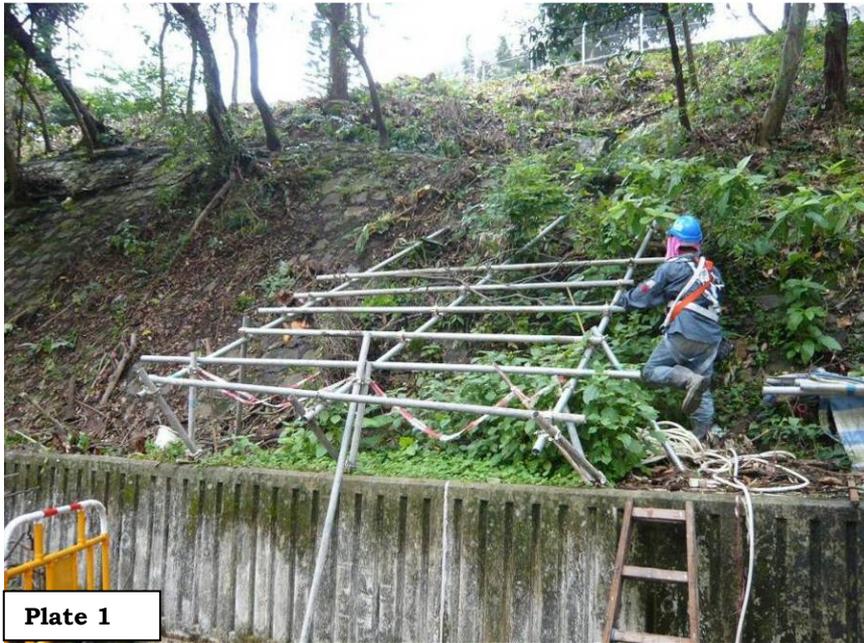
Before the transplantation, a temporary steel scaffold, which was established to protect the herb from the adjacent vegetation clearance work, was removed (**Plate 1**).

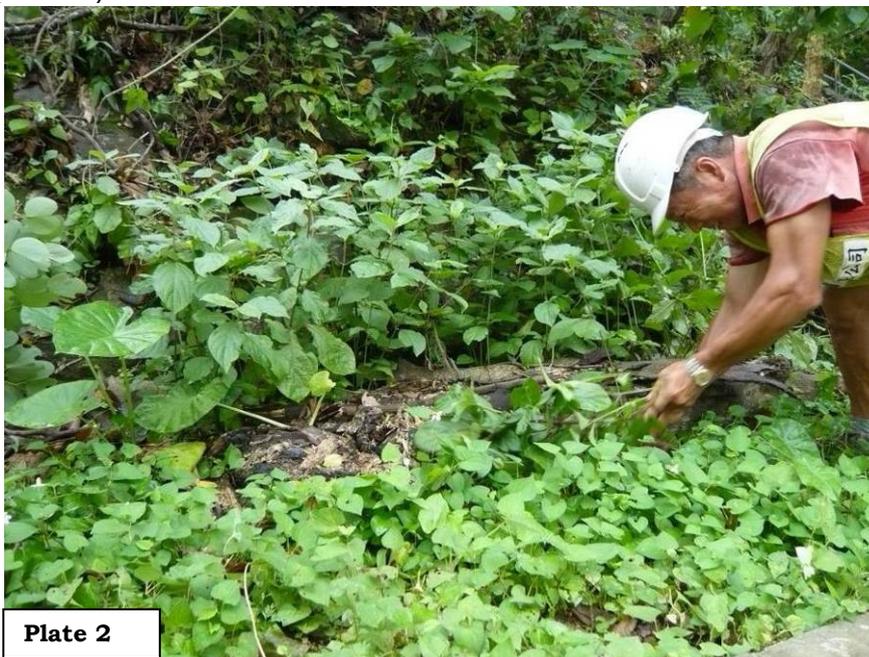
Dimensions of the area to be transplanted were marked. Manual removal of weedy herbs, grass, tree seedlings and wood debris was carried out by the Transplantation Contractor (**Plate 2**).

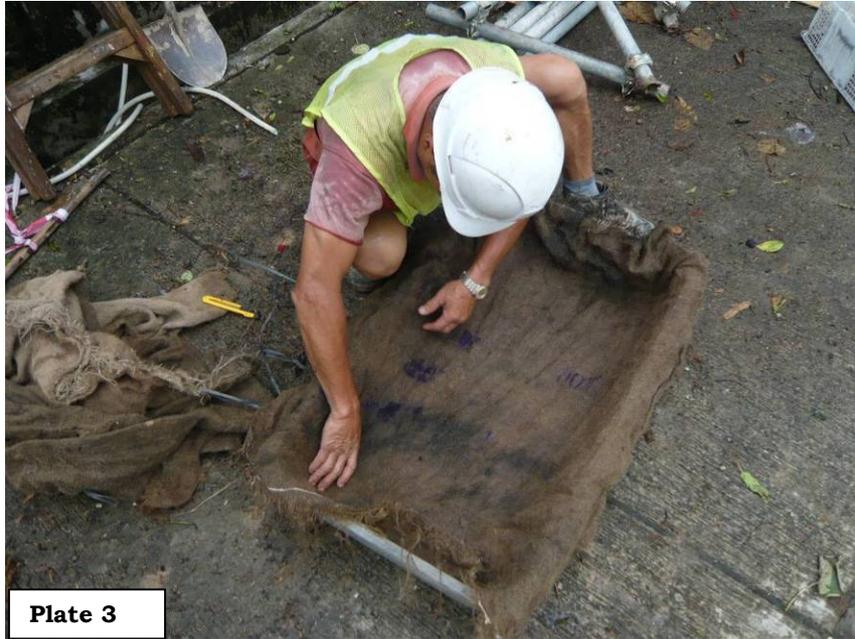
**Plate 3**

Numerous pieces of dug herbs were transferred to either a plastic box or wooden plate with a burlap sheet overlay for temporary storage before transplanting to the final receptor site (**Plate 3**) as a single complete turf of herb could not be dug with a spade due to the large area to be transplanted. Special care was taken to dig up the herbs with intact soil (about 5 cm soil depths) and undisturbed rhizomes (**Plates 3 – 5**).

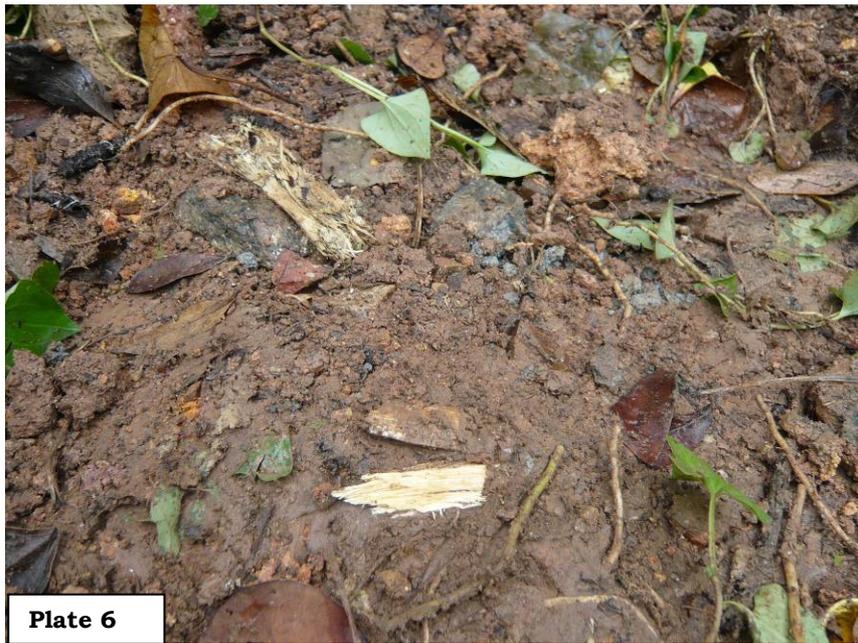
**Plate 6**

Soil found in the original site of *H. cordata* was dominated by clay soil, which is similar to the typical soil type and texture found in natural hillside area (**Plate 6**).

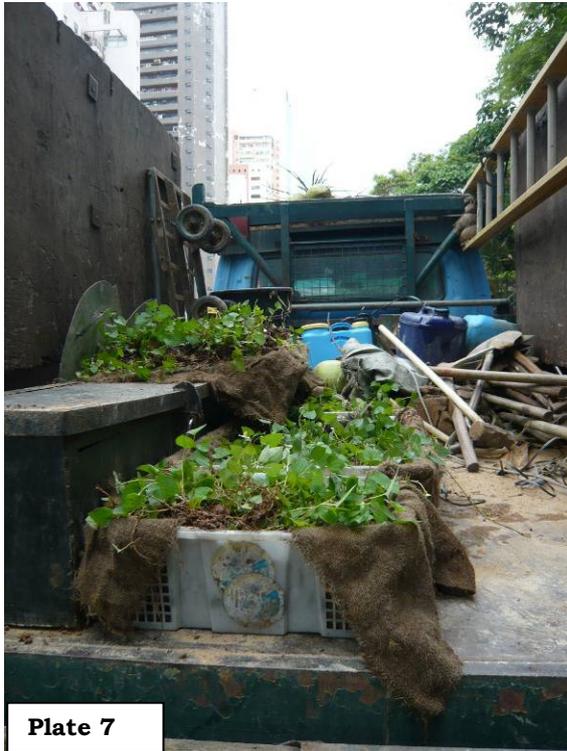
**Plate 7**

All dug herbs were transported directly to the final receptor site at Wong Chuk Hang San Wai on the same day (**Plate 7**). No stacking of dug herbs was observed during the transportation.

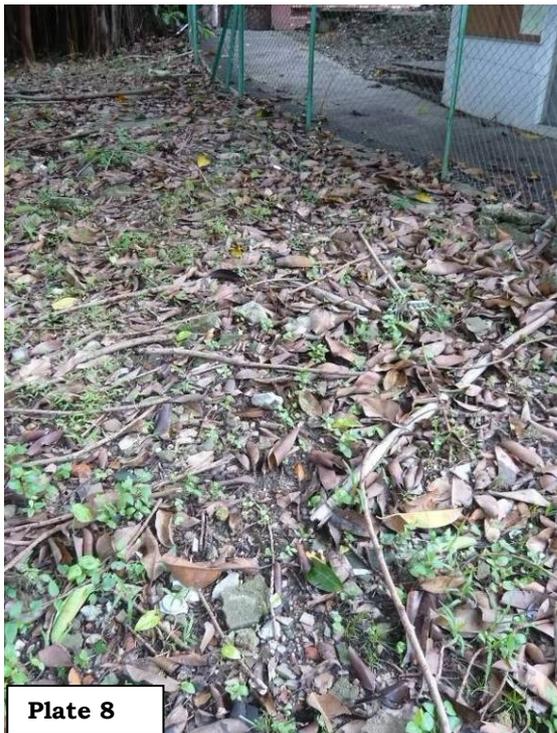
**Plate 8**

Before planting the herbs, all vegetation and stones at the selected area (about 2.0m x 2.5m) were removed, exposing the fertile topsoil of the selected receptor site (**Plates 8 – 10**). The receptor site was dominated by black-coloured soil, which is similar to farmland soil rich in organic matter (**Plate 10**).

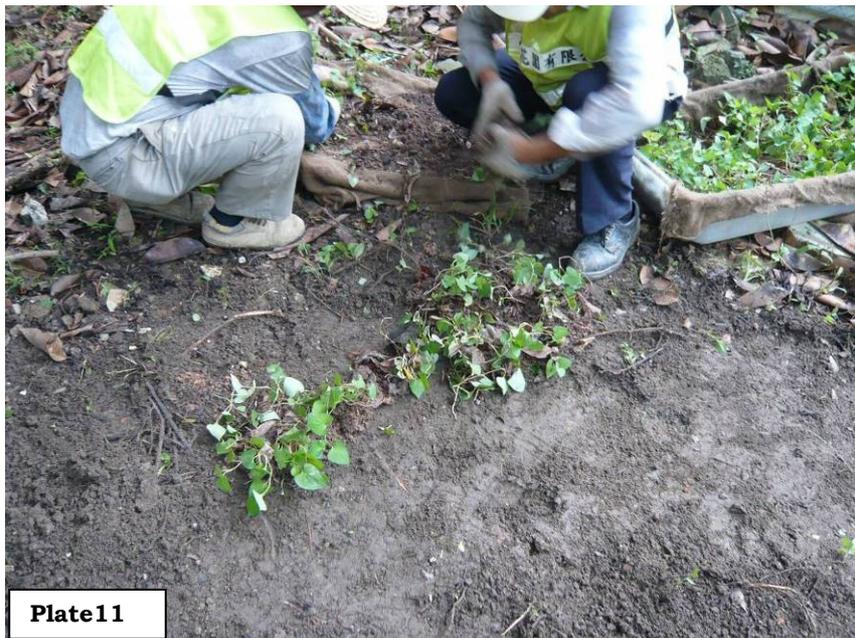
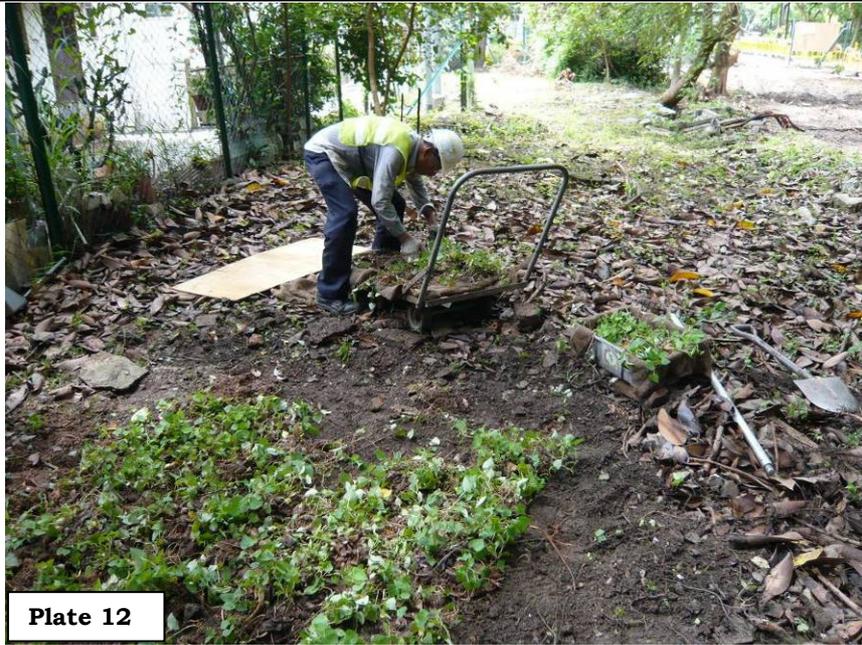
**Plate 12**

As only a relatively thin soil layer (about 5cm) with herbs was dug from the original plant location, a thin layer of topsoil was ploughed at the receptor site. The dug herbs were carefully planted and laid on the ploughed topsoil (Plates 11 – 12).

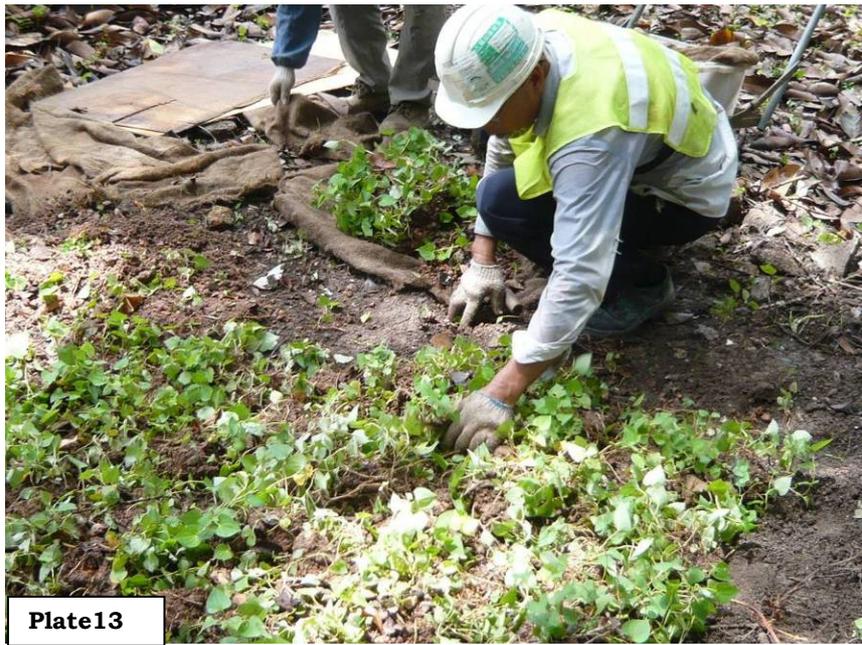
**Plate13**

Special care to spread the rhizomes and position the upright plant parts was observed. No excess soil was backfilled around the transplanted herbs (**Plate 13**).

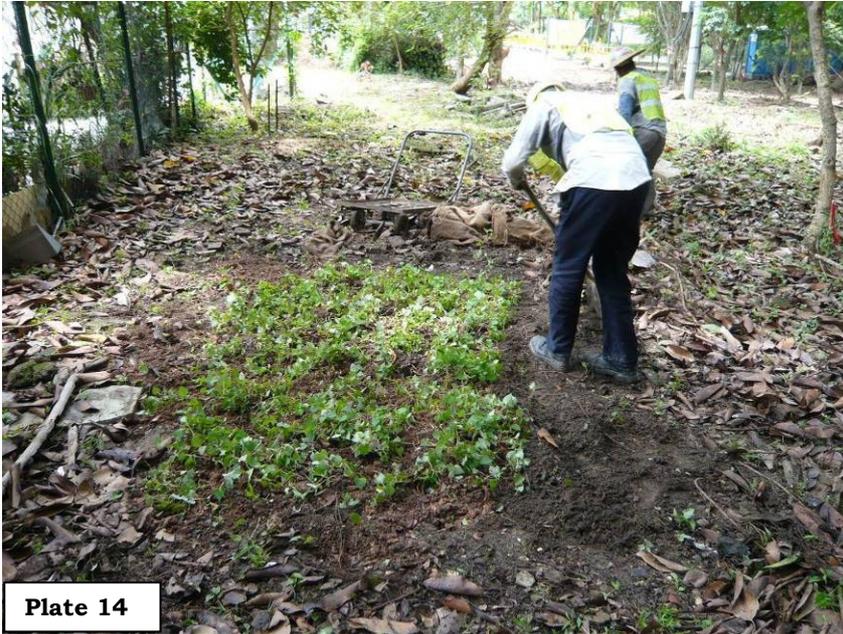
**Plate 14**

All dug herbs were transplanted to the final receptor area of 1.4m x 2.2m, with simple banks constructed around this area to retain water (**Plates 14 – 15**). The receptor site is under the shade of a *Ficus elastica* (OCP-T2128(R)). The transplanted herb was wetted by rain after the planting.

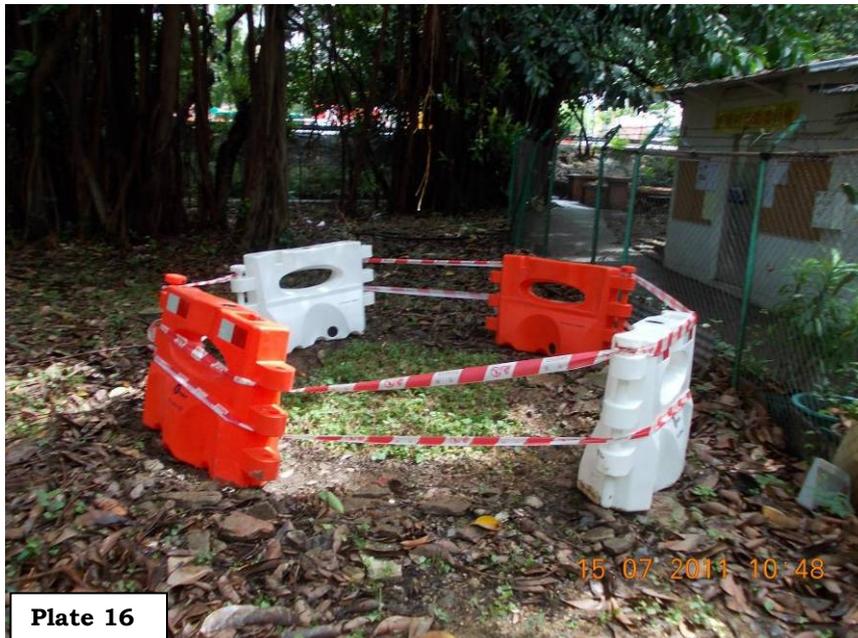
A protection fence was established around the final receptor site (**Plate 16**). The on-site construction workers were notified as to the presence of this transplanted rare herb and no collection of this herb and unauthorized entry to the fenced receptor site is allowed.

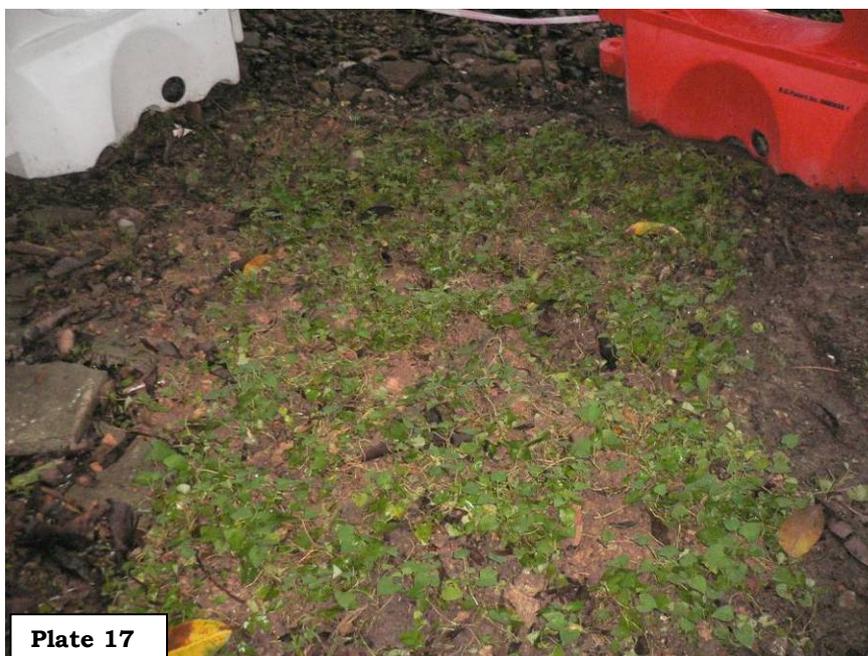
An inspection of the transplanted *H. cordata* was carried out on 20<sup>th</sup> July 2011 (monitoring will be conducted once per week in the first month and once in each following month in the remaining monitoring period as stated in the Transplantation Proposal). The transplanted herb has remained in fair condition (**Plate 17**).

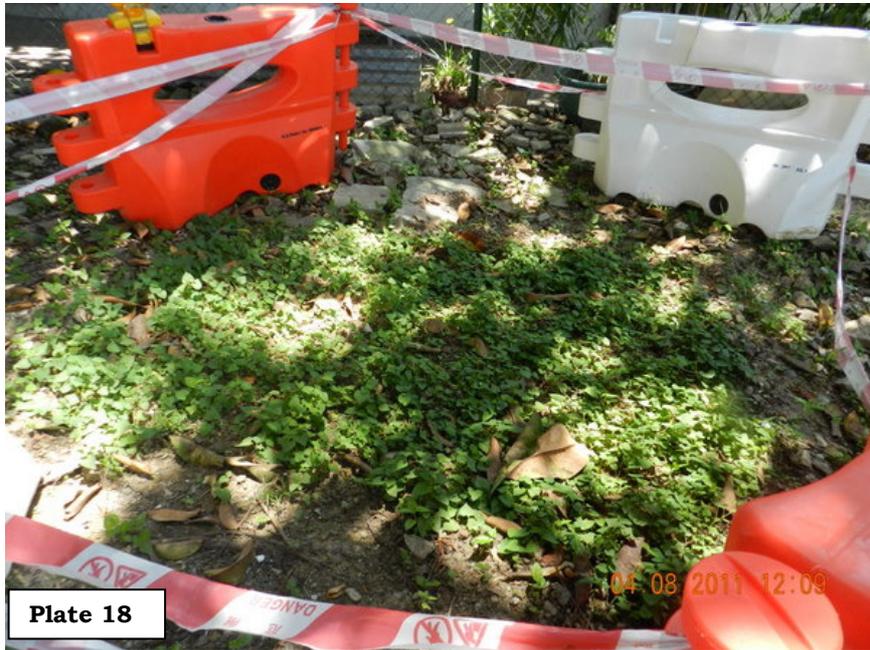
The transplanted herb has remained in good condition as shown in the inspections on 27 July and 4 August 2011. No significant dieback or wilt leaves was observed from the transplanted patches. The protection fence has been maintained properly surrounding the receptor site (**Plate 18**).
