**Shatin to Central Link –
Tai Wai to Hung Hom Section and
Mong Kok East to Hung Hom Section**

Monthly EM&A Report No. 25

[Period from 1 to 30 September 2014]

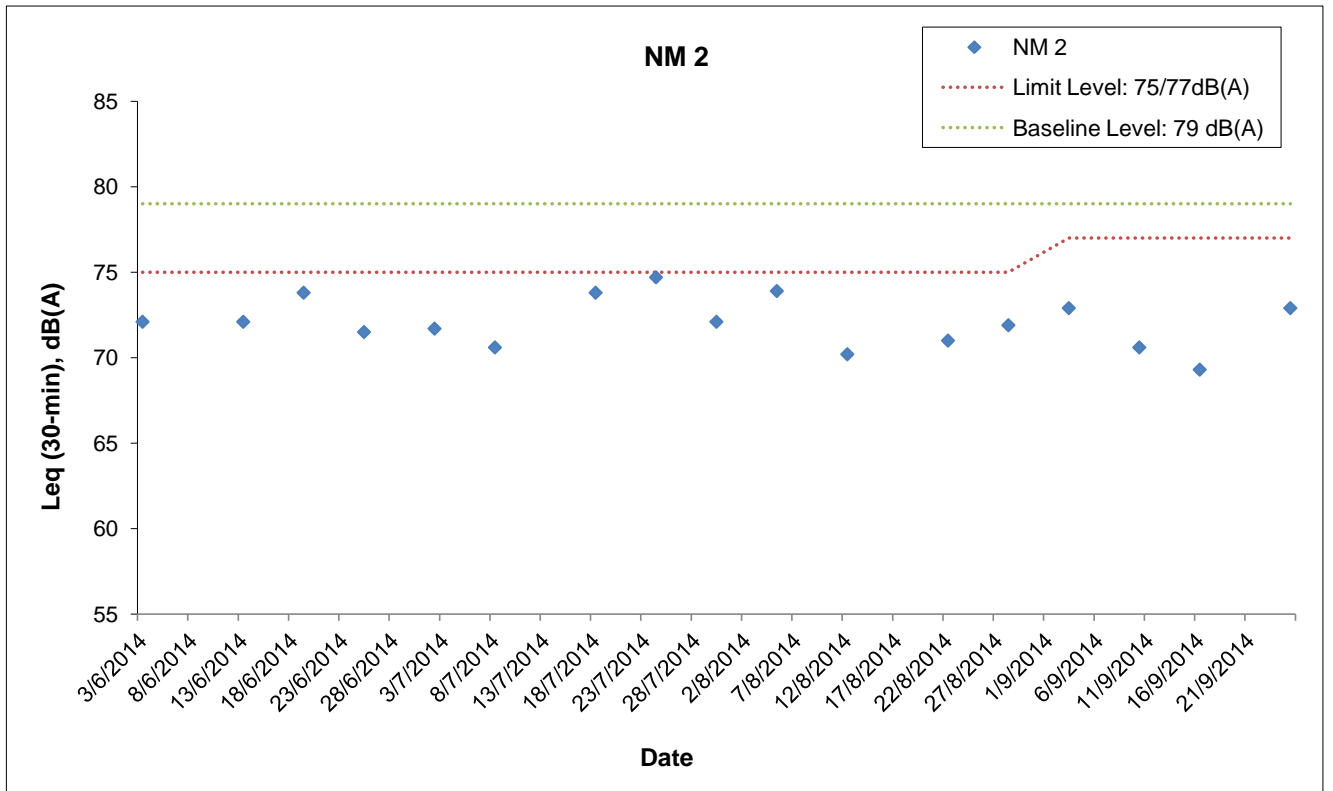
Appendix H Regular Construction Noise Monitoring Results

* - The noise monitoring results of the measurements are higher than the daytime construction noise criterion. However, the results are not considered as exceedance if they are either below the baseline level or below the limit level after deducting the baseline noise level.
