Shatin to Central Link – Tai Wai to Hung Hom Section and Mong Kok East to Hung Hom Section

Monthly EM&A Report No. 41

[Period from 1 to 31 January 2016]

Consultancy Agreements No. C11033 & C11033B

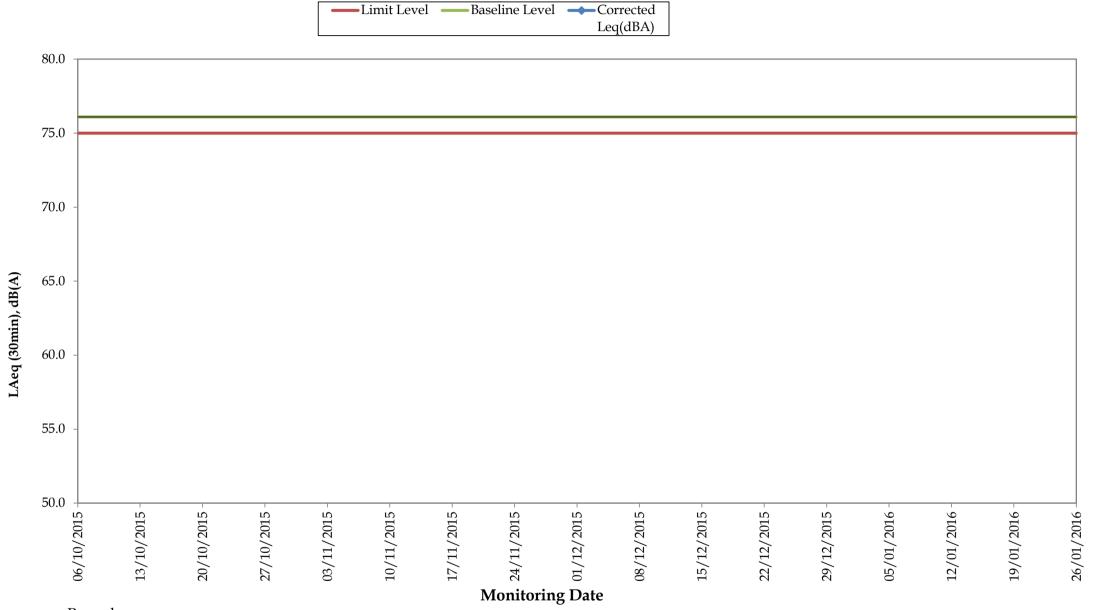
Regular Noise Monitoring Results at NMS-CA-6 (No. 16-23 Nam Kok Road) (LAeq, 30min) for the Past 4 Months

Remarks:

- For those corrected noise levels that are not shown in this graph, the measured noise level s are below baseline level.

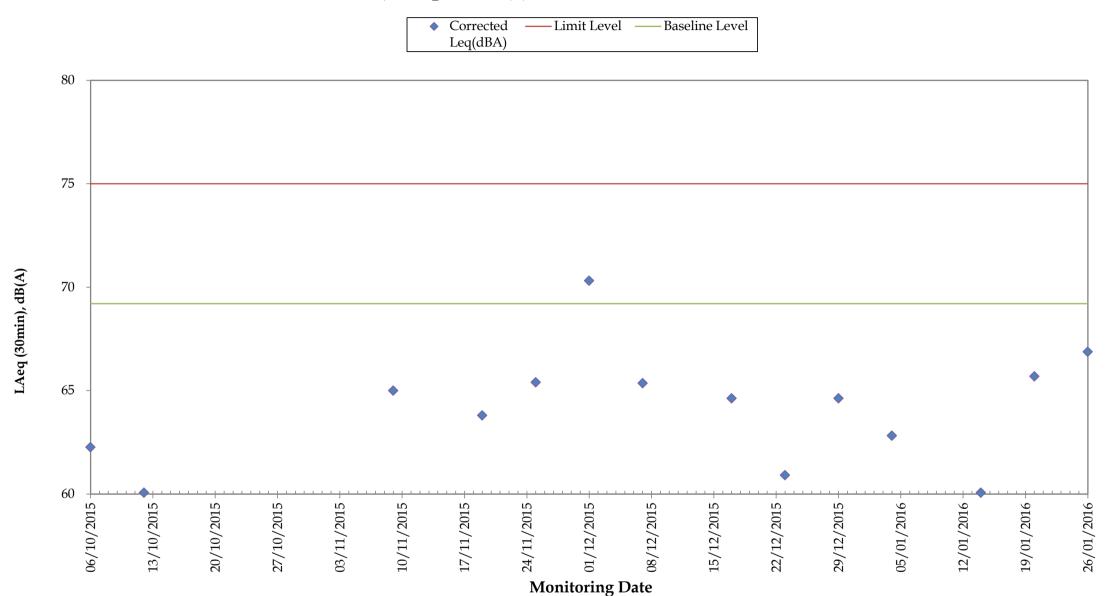
Regular Noise Monitoring Results at NMS-CA-9 (Kong Yiu Mansion) (LAeq, 30min)) for the Past 4 Months

Remarks:
- For those corrected noise levels that are not shown in this graph, the measured noise level s are below baseline level.

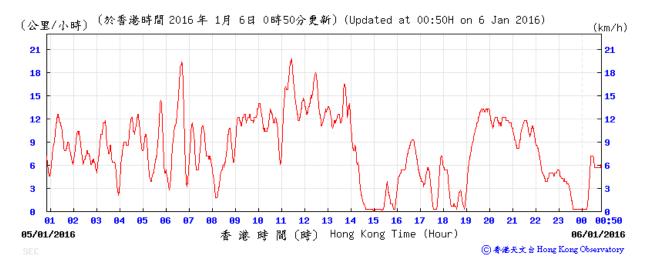
5-6 January 2016

| Shatin to Central Link – Contract 1106 Diamond Hill Station | Scale | | Project No. | MA12051 | CINOTECH |
|---|---|---|---|---|---|
| Graphical Presentation of 24-hour TSP Monitoring Results | Date | Jan 16 | Appendi | ix E | |
