MTRCL Contract C3840-13C Tsim Sha Tsui
Station Carnarvon Road Subway and Entrances
Modification Works

Monthly EM&A Report (October 2014)

Report No EB001340R00121

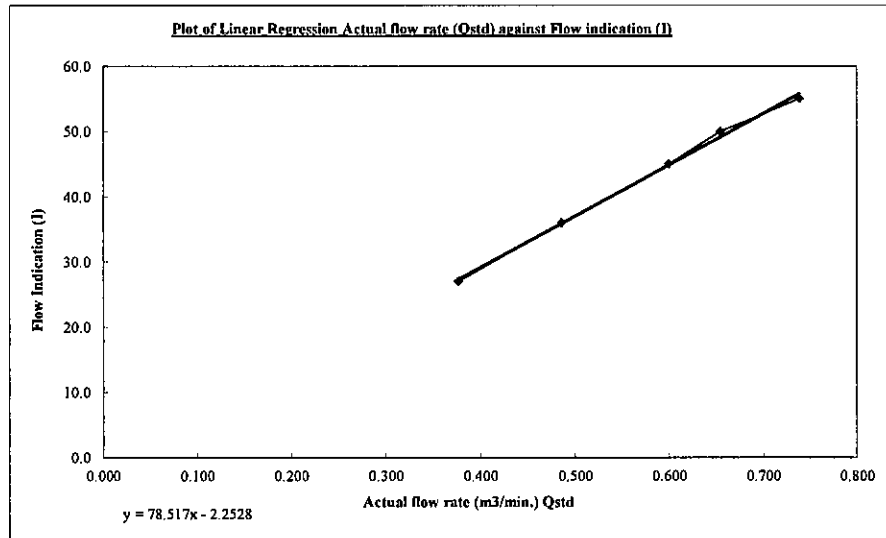
High Volume Air Sampler Calibration Worksheet

Project Title: MTR Tsim Sha Tsui Station Carnarvon Road Subway and Entrances Modification Works
 Monitoring Location: K11 Commercial Complex
 Calibration Date: 11-Sep-14
 Calibration Due Date: 11-Nov-14
 Time: 14:40

Sample no.	Pressure Drop (H), inch	Flow (corrected), m ³ /min	Actual flow rate (Qstd), m ³ /min	Flow indication (I), arbitrary
1	12.8	1.470	0.739	55.0
2	7.0	1.300	0.655	50.0
3	5.4	1.190	0.600	45.0
4	2.4	0.960	0.486	36.0
5	2.3	0.740	0.377	27.0

Correlation Coefficient : 0.9985

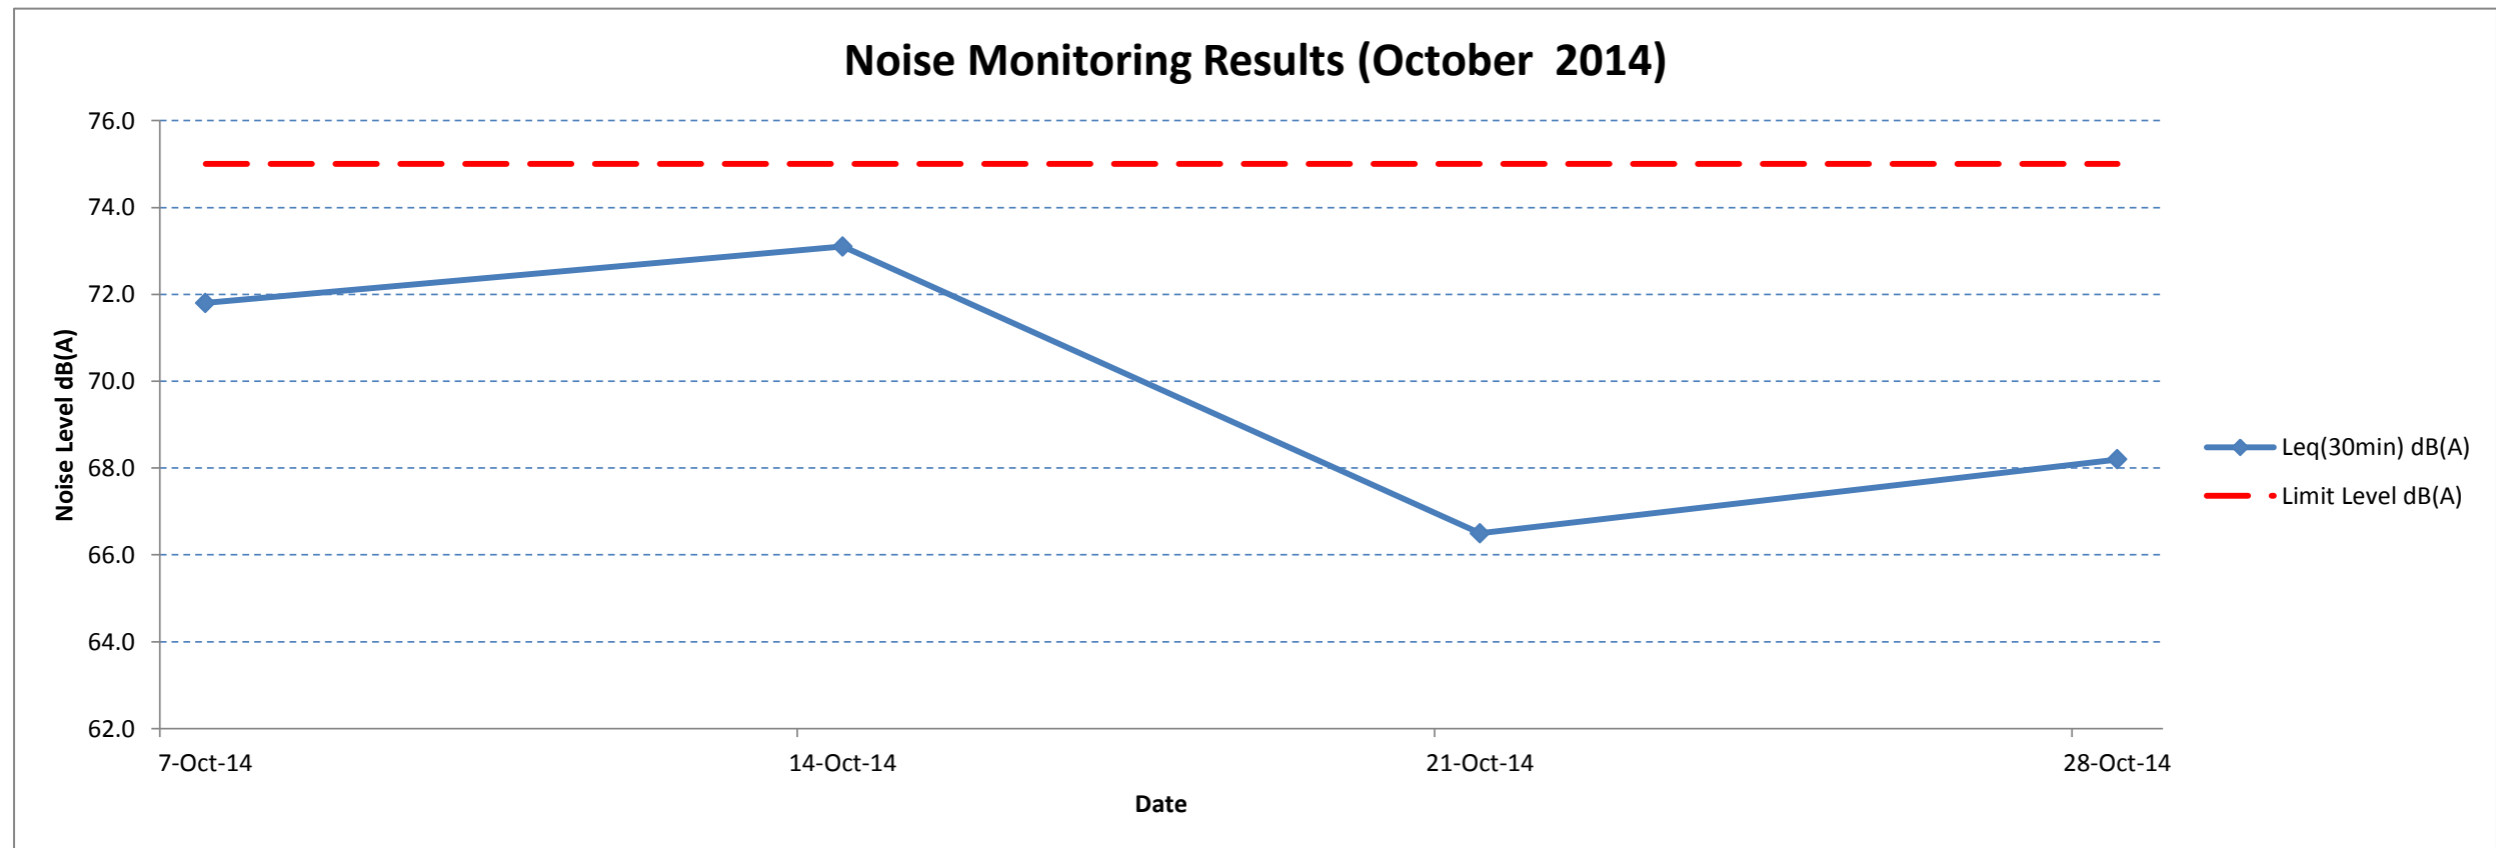
Monitoring Locations	Date	Weather Conditions	Wind Speed (m/s)	Start Time	End Time	Background Level dB(A)	Limit Level dB(A)	Leq(30min) dB(A)	L10(30min) dB(A)	L90(30min) dB(A)
K11 Art Mall	7-Oct-14	Sunny	1.1	9:44	10:14	65.3	75	71.8	74.5	68.0
	14-Oct-14	Sunny	0.9	13:10	13:40	65.3	75	73.1	76.5	69.5
	21-Oct-14	Overcast	0.7	10:48	11:18	65.3	75	66.5	67.5	64.5
	28-Oct-14	Sunny	1.4	10:59	11:29	65.3	75	68.2	69.0	66.5

Red Bold indicates an exceedance of Limit Level

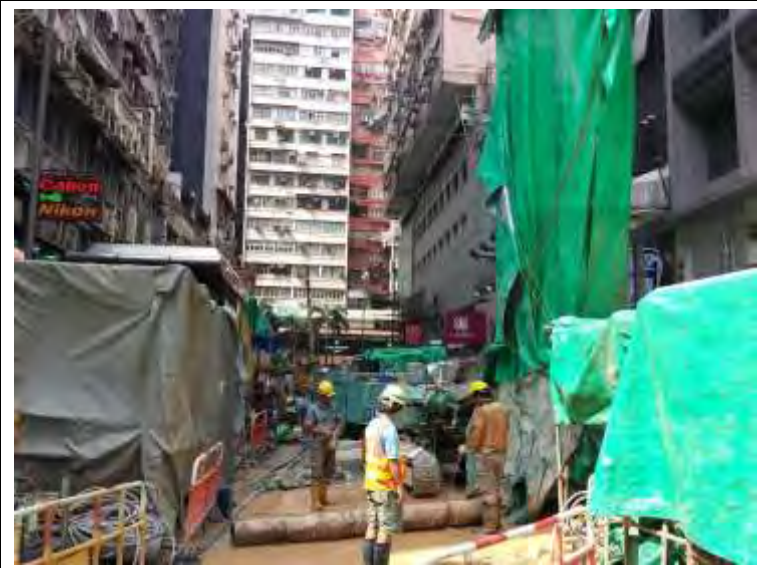
Photo(s) taken at the construction site on 14 October 2014

Air compressor (left) and drill rig (right) located near the main entrance was fully enclosed by multi layers noise insulation mat and tarpaulin respectively.

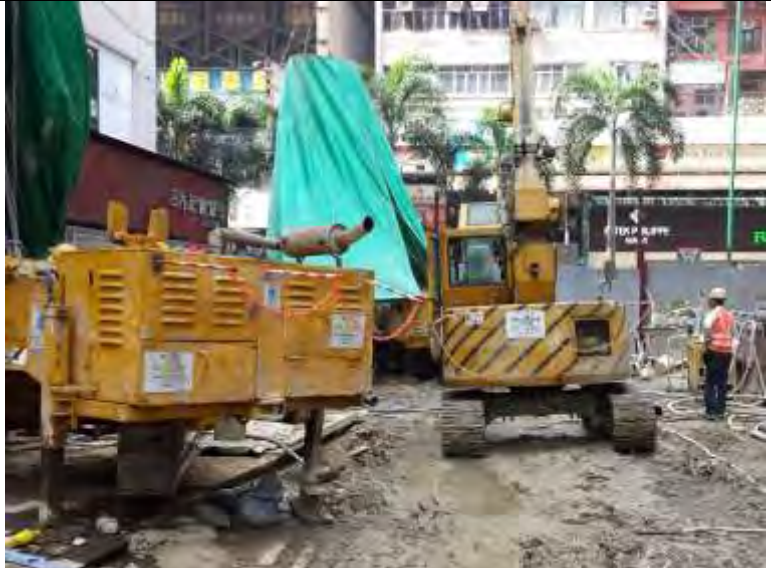
Drill rig located near Nathan Road was fully enclosed by tarpaulin.

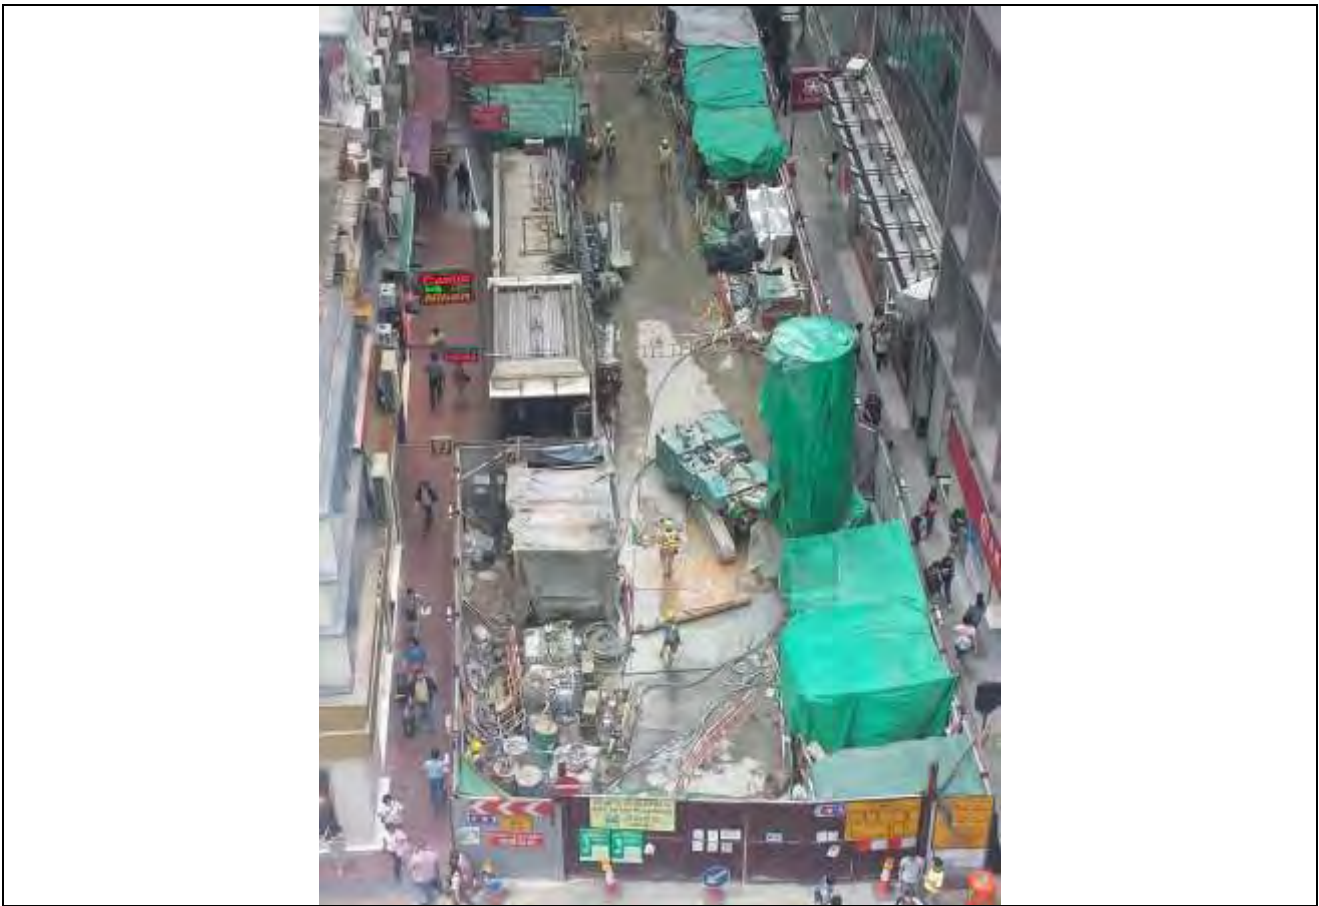
Photo(s) taken at the monitoring station (K11) on 14 October 2014

Site hoarding had been laid with noise insulation mat along the site boundary.
