MTRCL Contract C3840-13C Tsim Sha Tsui
Station Carnarvon Road Subway and Entrances
Modification Works

Quarterly EM&A Report (December 2014 to February 2015)

Report No EB001340R0182

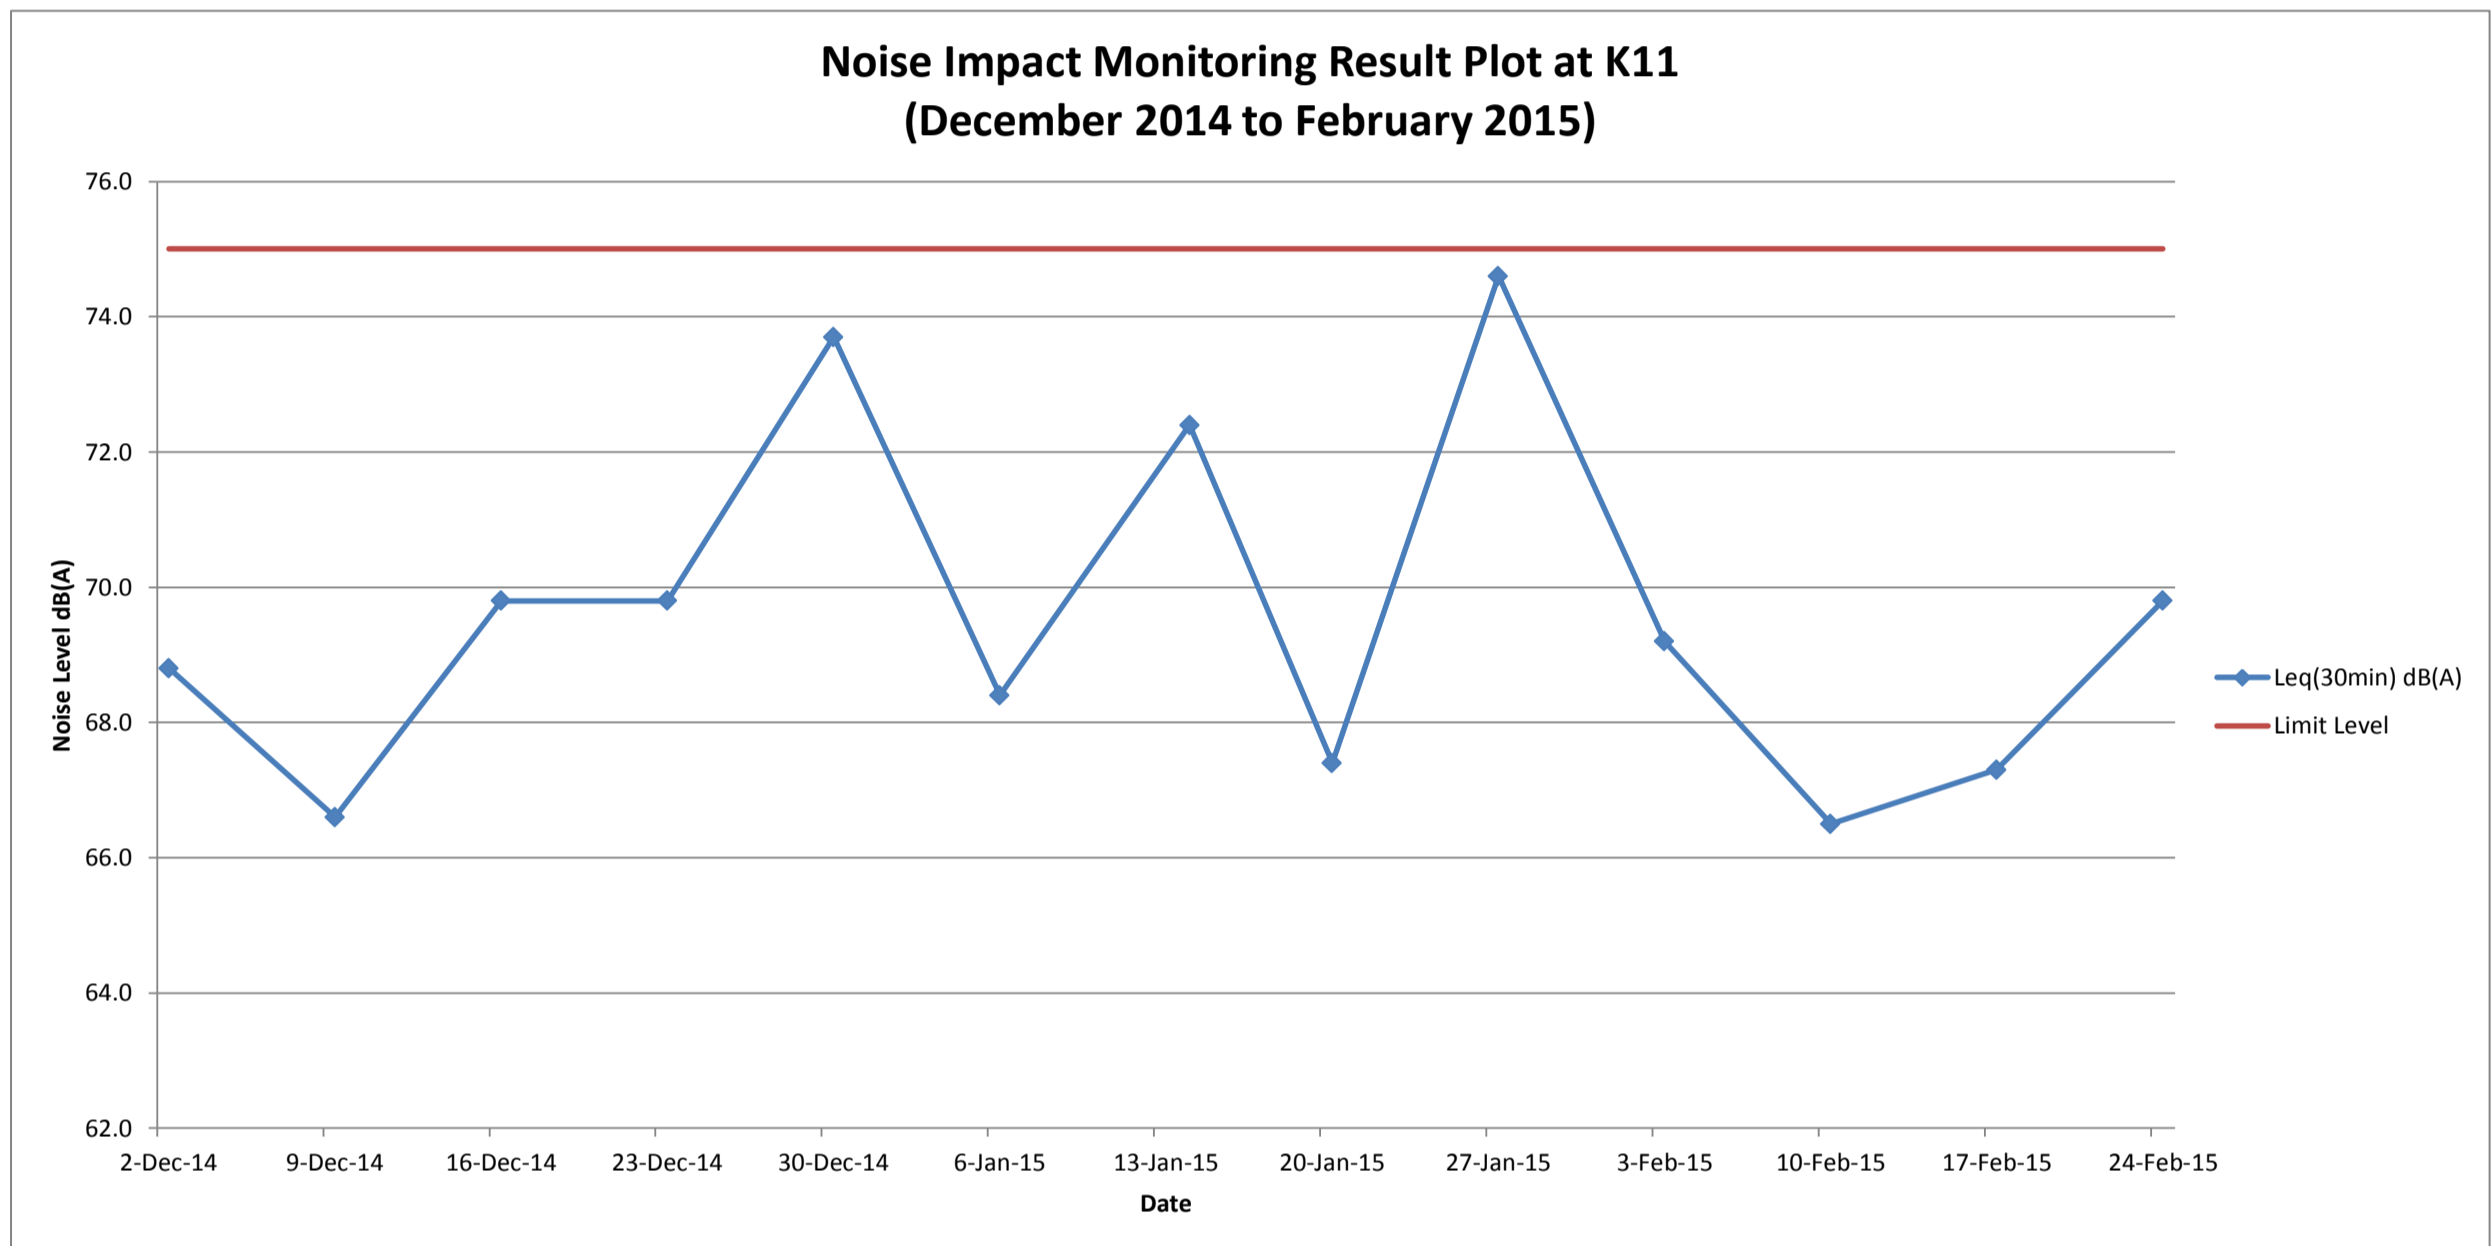
C3840-13C MTRCL Tsim Sha Tsui Station Carnarvon Road Subway and Entrances Modification Works
 Noise Impact Monitoring Results at K11 (December 2014 to February 2015)

Monitoring Locations	Date	Weather Conditions	Temperature	Wind Speed (m/s)	Start Time	End Time	Background Level dB(A)	Limit Level dB(A)	Leq(30min) dB(A)	L10(30min) dB(A)	L90(30min) dB(A)
K11 Art Mall	2-Dec-14	Cloudy	16.5	2.5	11:02	11:32	65.3	75	68.8	70.0	66.5
	9-Dec-14	Cloudy	21.0	0.7	10:56	11:26	65.3	75	66.6	68.0	64.5
	16-Dec-14	Sunny	17.0	2.4	11:03	11:33	65.3	75	69.8	72.5	66.0
	23-Dec-14	Cloudy	14.9	1.3	11:00	11:30	65.3	75	69.8	71.0	66.0
	30-Dec-14	Sunny	19.0	0.8	13:08	13:38	65.3	75	73.7	77.5	69.0
	6-Jan-15	Sunny	23.0	0.5	10:58	11:28	65.3	75	68.4	70.0	66.5
	14-Jan-15	Sunny	13.0	1.2	10:00	10:30	65.3	75	72.4	73.5	63.5
	20-Jan-15	Sunny	18.0	0.8	14:11	14:41	65.3	75	67.4	68.5	65.0
	27-Jan-15	Sunny	19.0	1.2	11:21	11:51	65.3	75	74.6	76.5	69.5
	3-Feb-15	Sunny	19.6	0.5	11:11	11:41	65.3	75	69.2	70.5	67.0
	10-Feb-15	Sunny	14.8	1.2	11:01	11:31	65.3	75	66.5	67.5	63.0
	17-Feb-15	Cloudy	18.5	0.8	11:08	11:38	65.3	75	67.3	70.0	63.0

The limit level of NSR1 is 65dB(A) during school examination period.

Red Bold indicates an exceedance of Limit Level

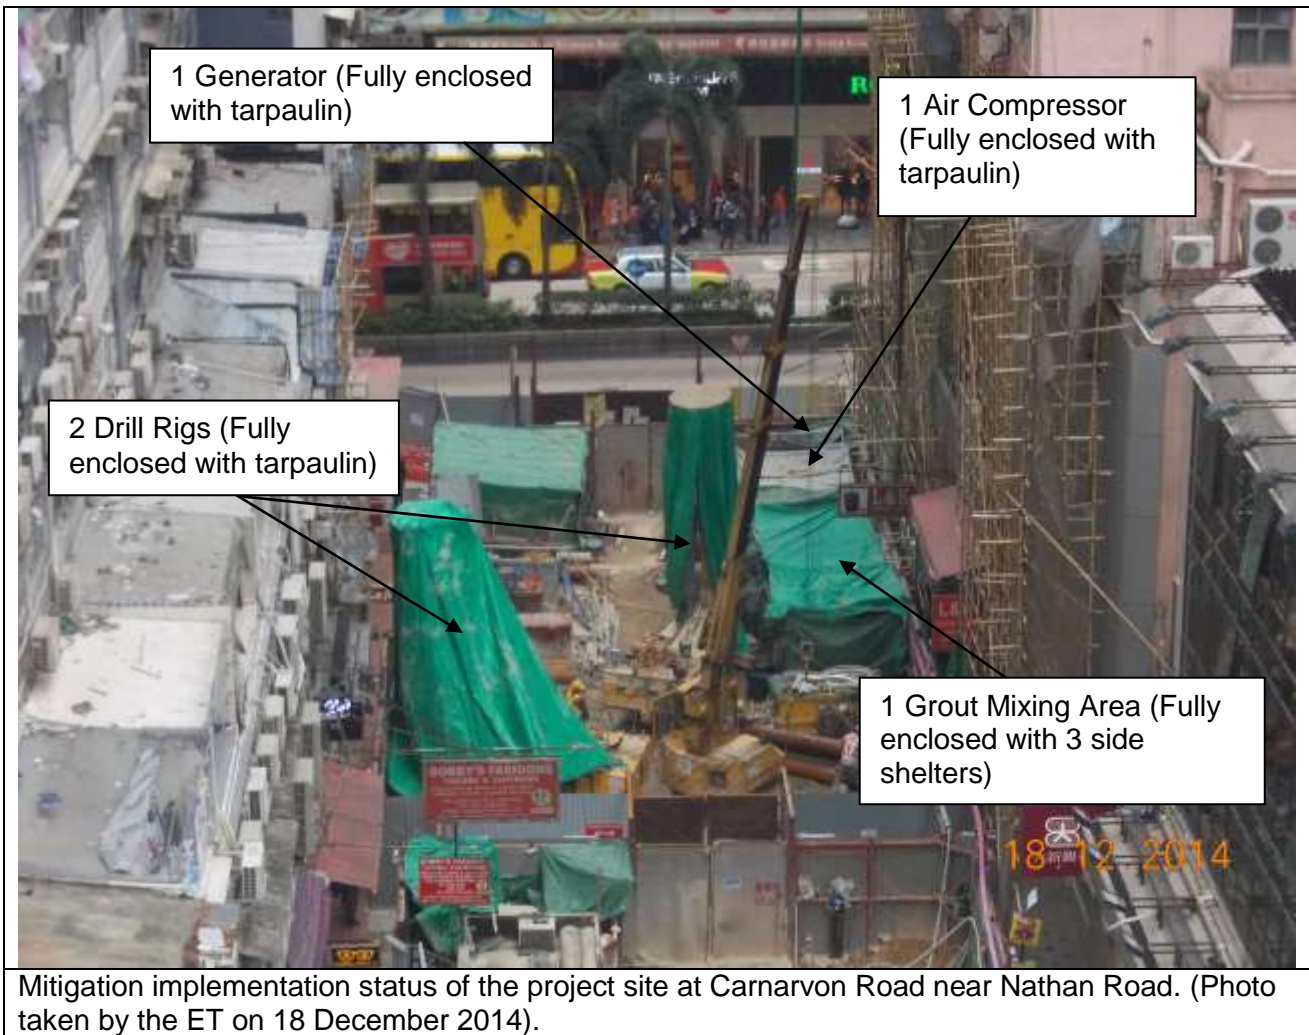
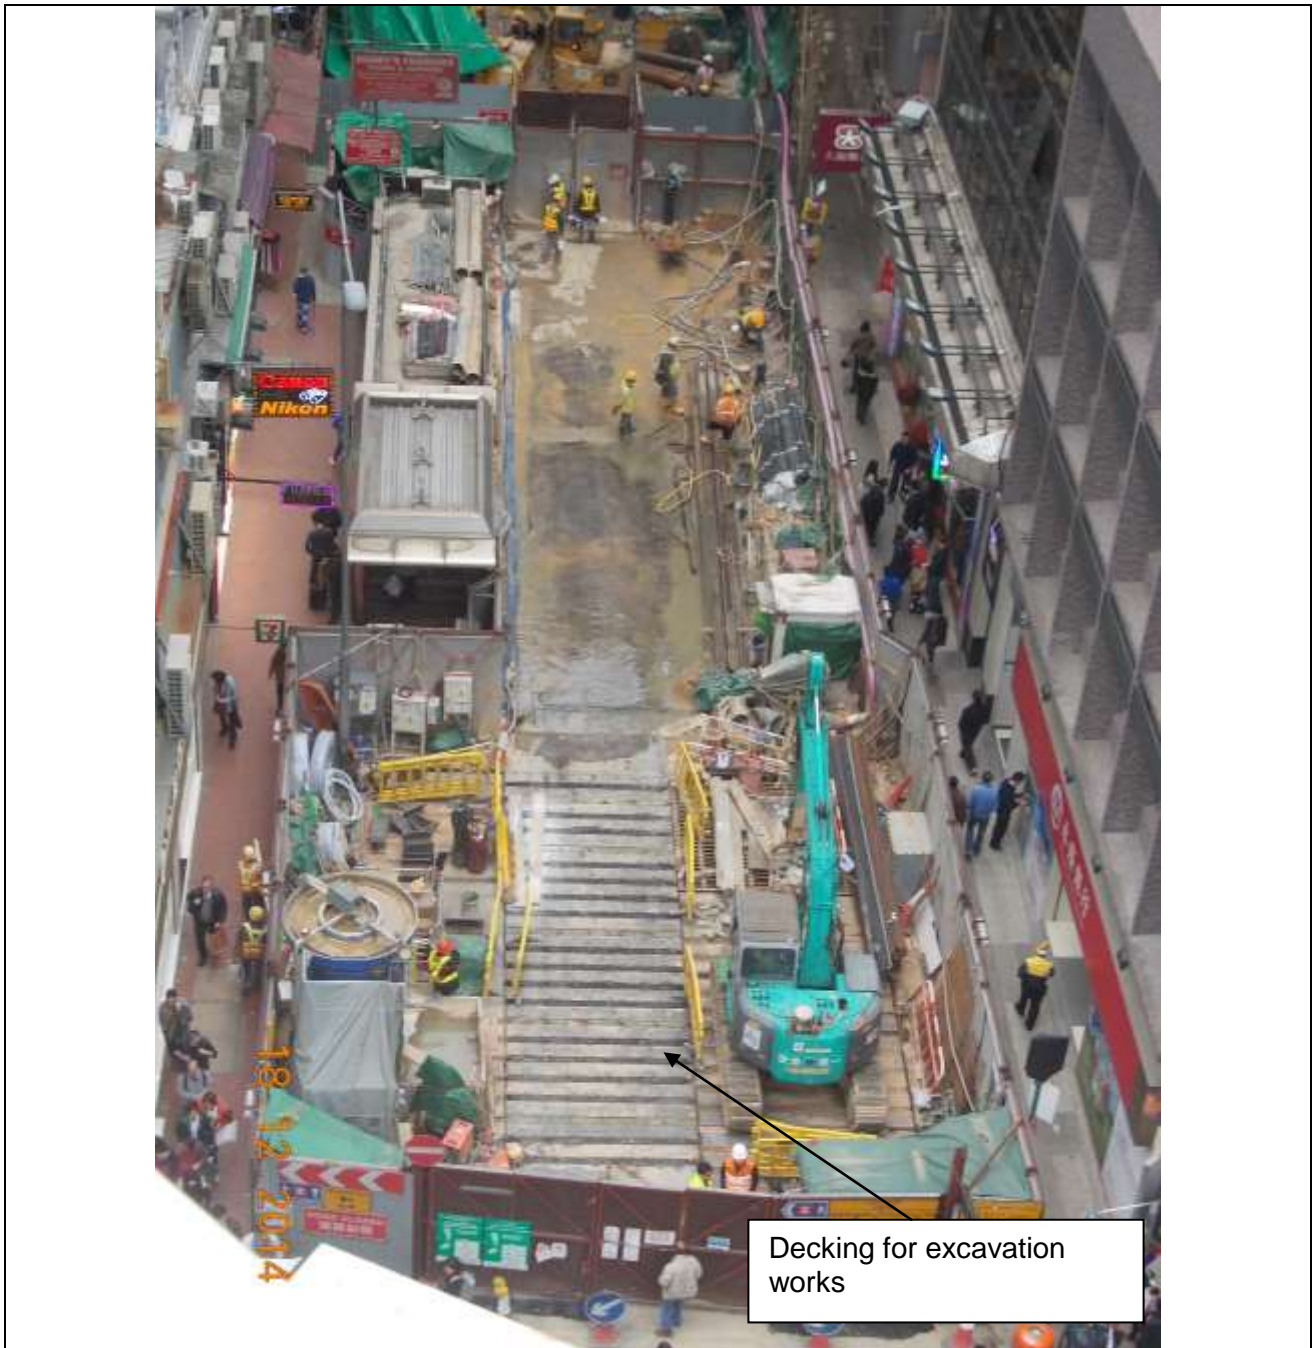
Photo(s) taken at the monitoring station at Rooftop 4/F K11 Art Mall on 18 December 2014

Mitigation implementation status of the project site at Carnarvon Road near Bristol Ave. (Photo taken by the ET on 18 December 2014).

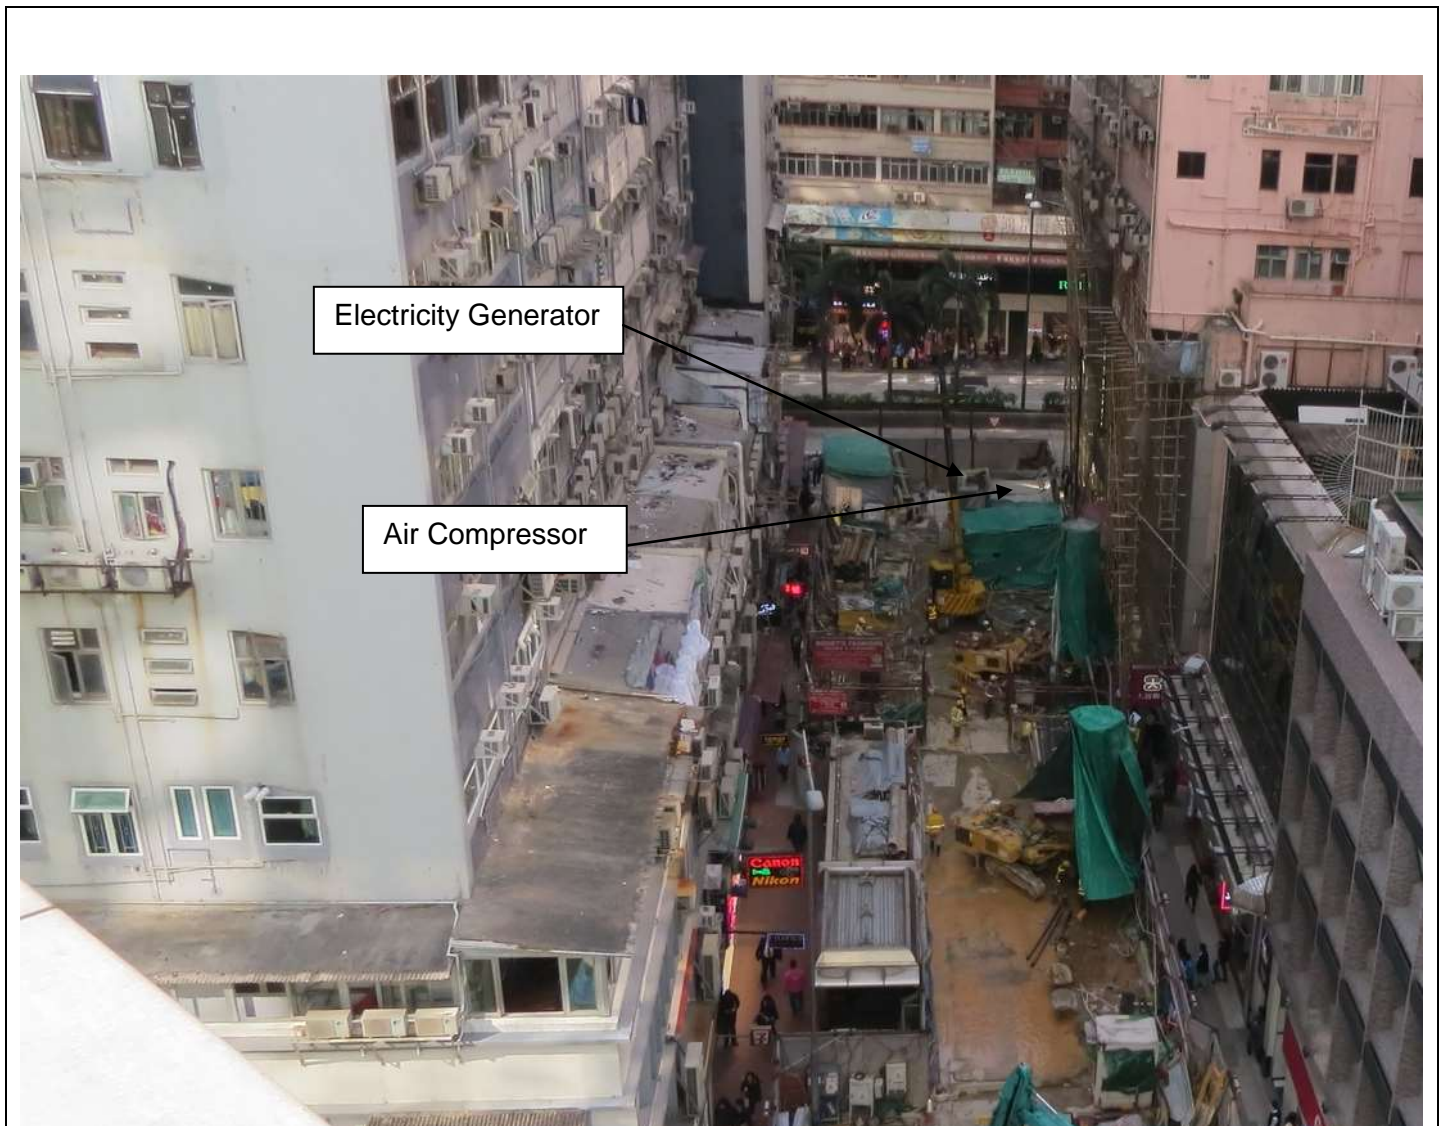
Photo(s) taken at the monitoring station at Rooftop 4/F K11 Art Mall and construction site

1) The electricity generator was located near the Nathan Road entrance before January 2015.

2) The air compressor was located near the Nathan Road entrance before January 2015.

(Photo provided by the Contractor on 07 February 2015)

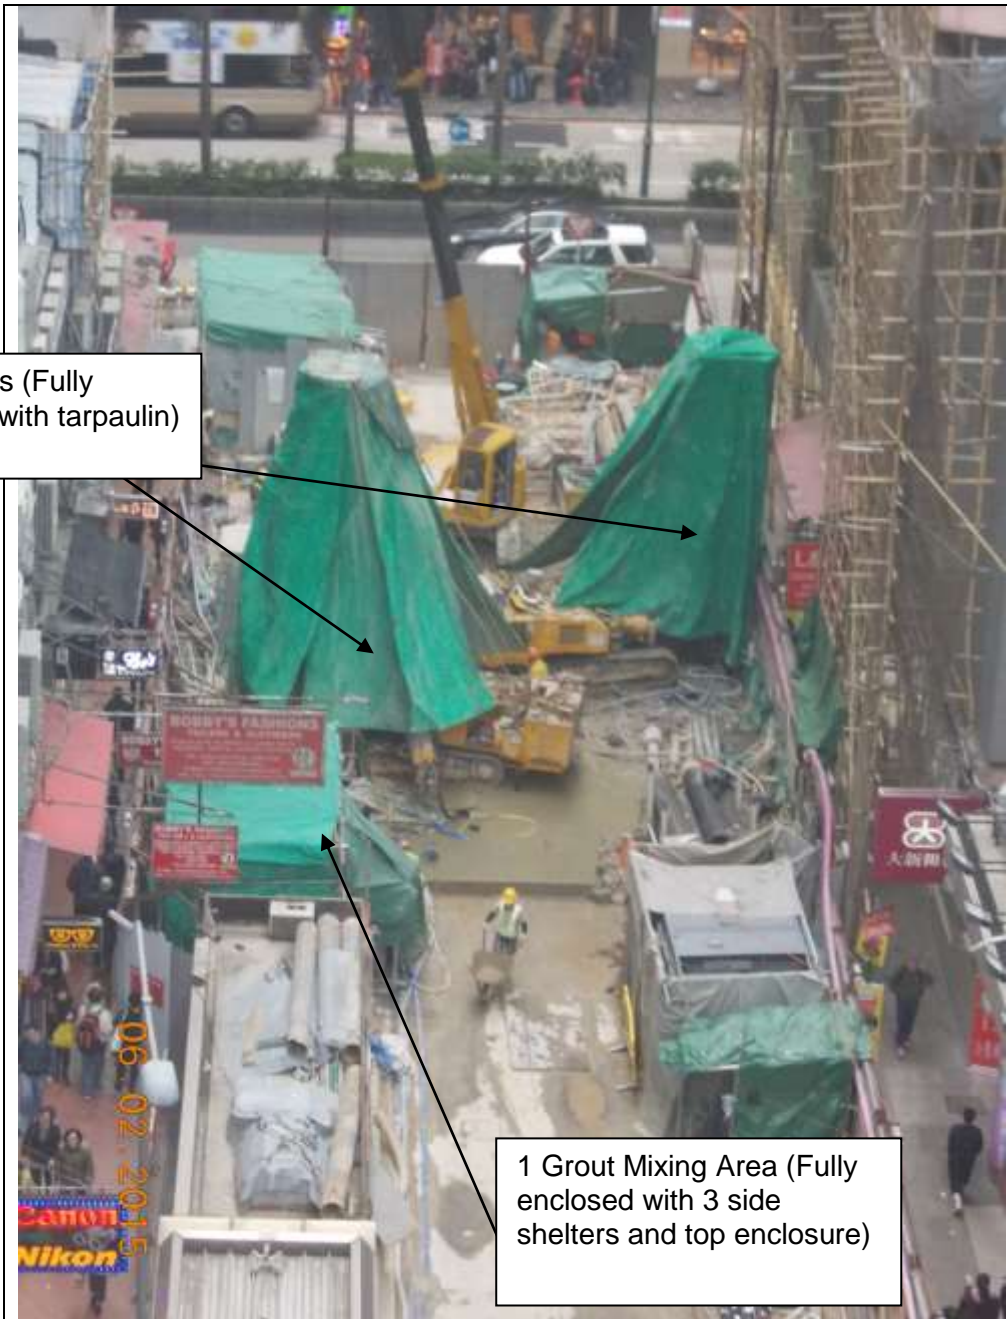
2 Drill Rigs (Fully enclosed with tarpaulin)

1 Grout Mixing Area (Fully enclosed with 3 side shelters and top enclosure)

- 1) The electricity generator has been removed from site.
- 2) The air compressor has been relocated from Nathan Road site entrance to outside Tai Sang Bank.
- 3) Mitigation implementation status of the project site at Carnarvon Road near Nathan Road.

(Photo taken by the ET on 06 February 2015).

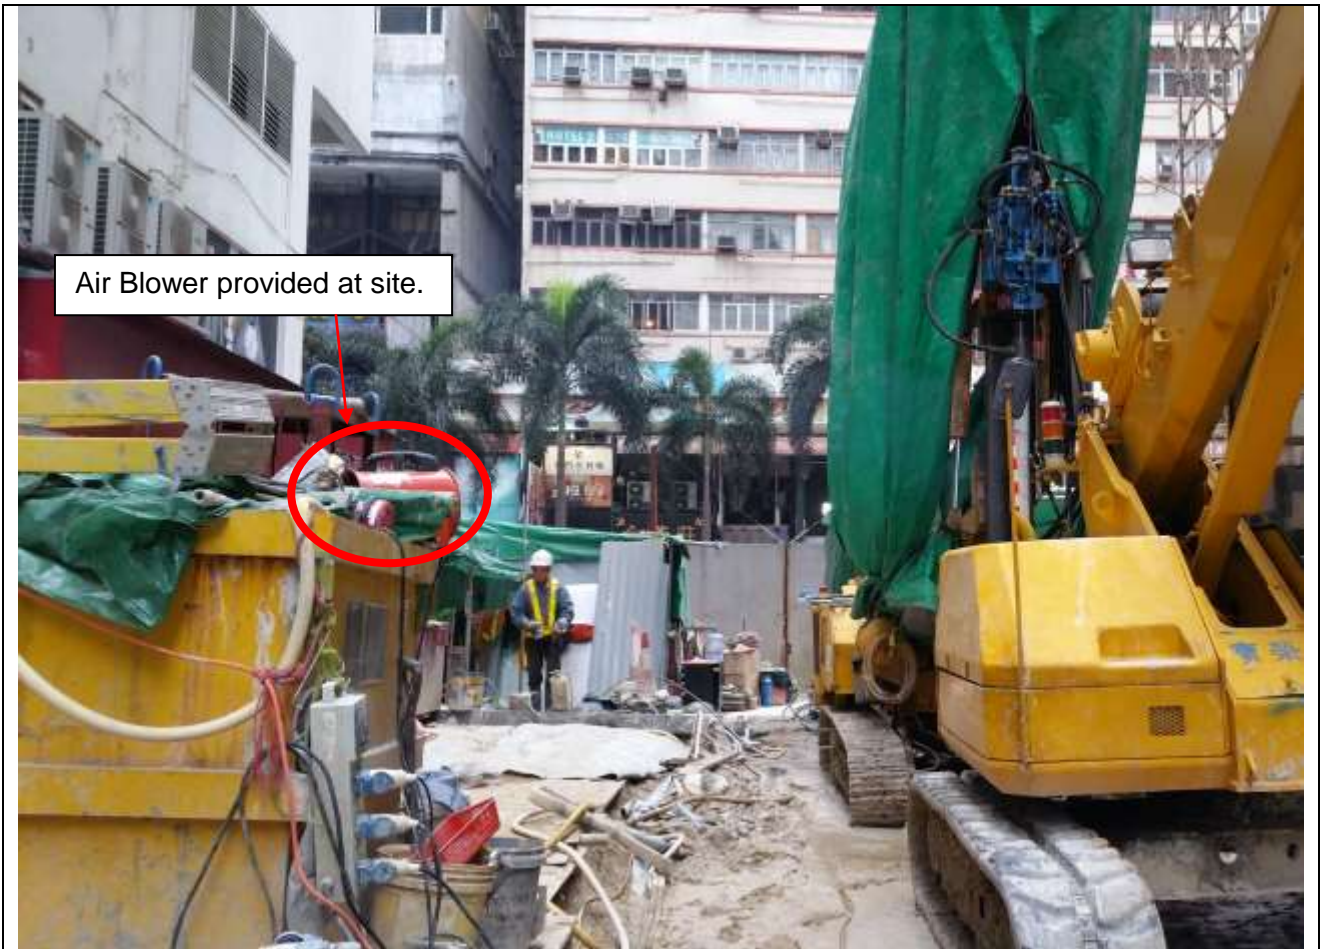
Blower was used for ventilation purpose during engine start-up at site. (Photo provided by the Contractor on 07 February 2015).
