MONTHLY REPORT (FEBRUARY 2019)

MTRCL Contract C3840-13C

Tsim Sha Tsui Station Carnarvon Road Subway
and Entrances Modification Works

**Consultancy Agreement A130-13
Independent Environmental Checker for CRS and LTS
CRS - Verification for 60th Monthly Environmental Monitoring and Audit (EM&A) Report
(February 2019) (Report No.: EB001340R0811)**

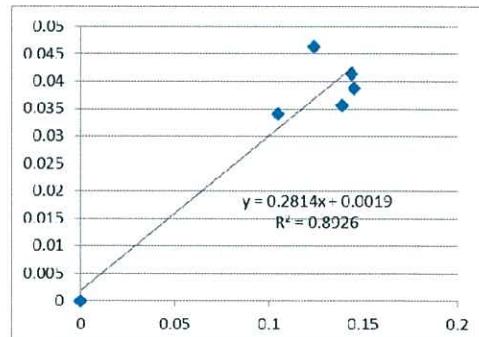
- Strong Correlation ($R>0.8$)
- Factor 0.2814 should be applied for TSP monitoring

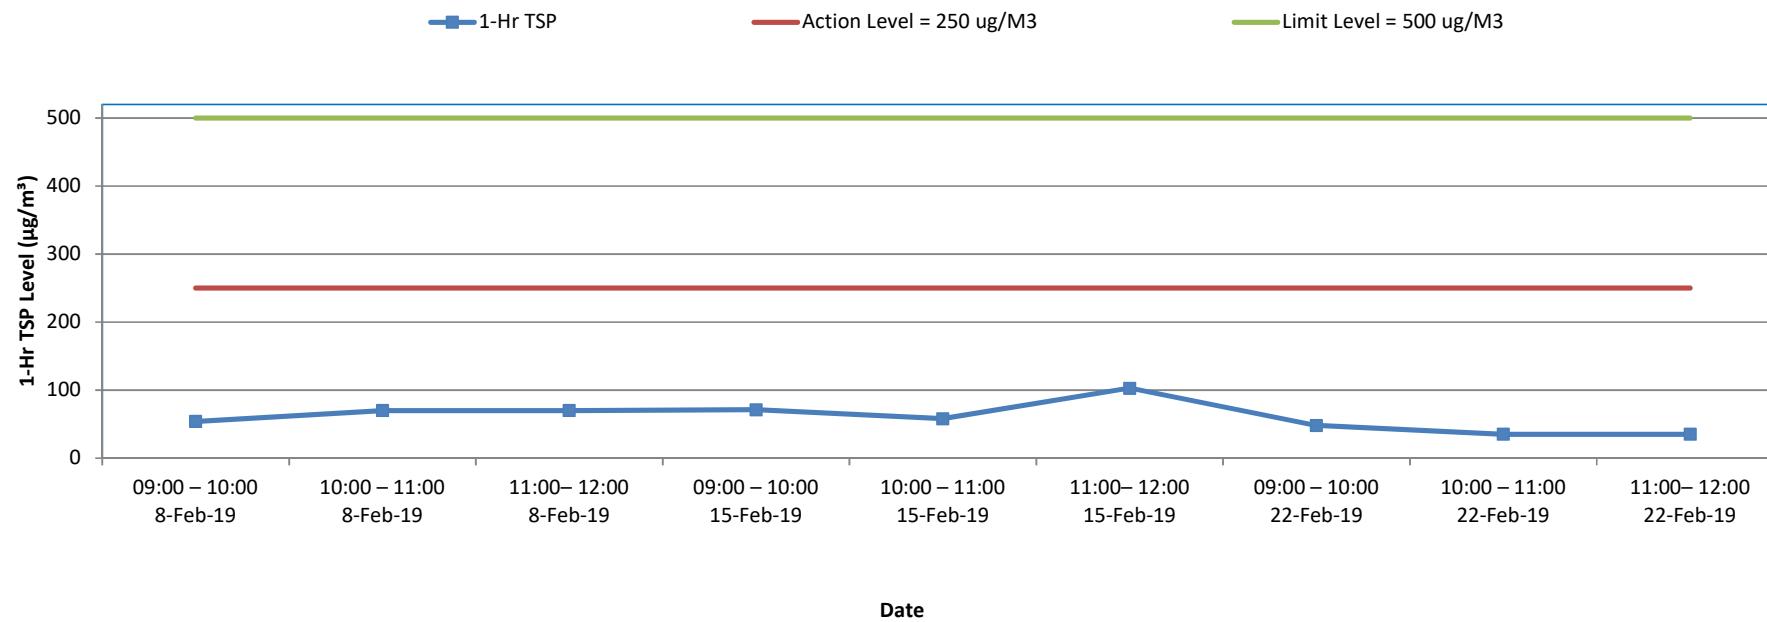
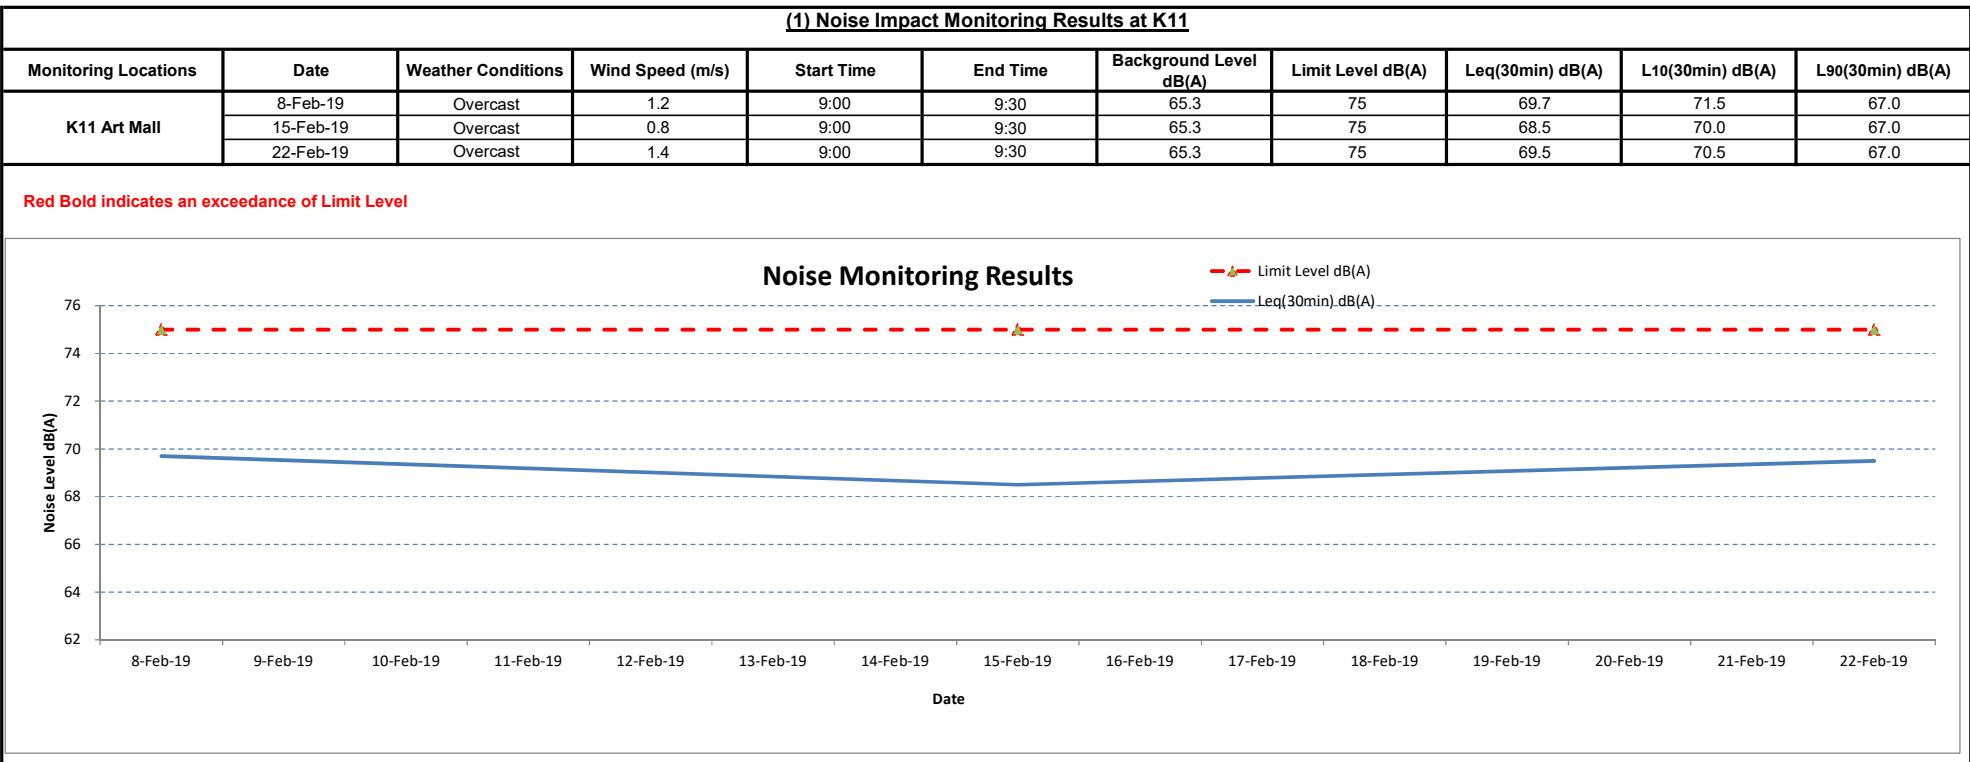
1-Hr TSP Concentration (February 2019) *

Note: * 1-Hr TSP has replaced the 24-Hr TSP since 21 September 2018 due to HVS outage
