Proposed Road Improvement Works in West Kowloon Reclamation Development – Phase 1

Environmental Monitoring & Audit Report

01/06/2018 – 30/6/2018

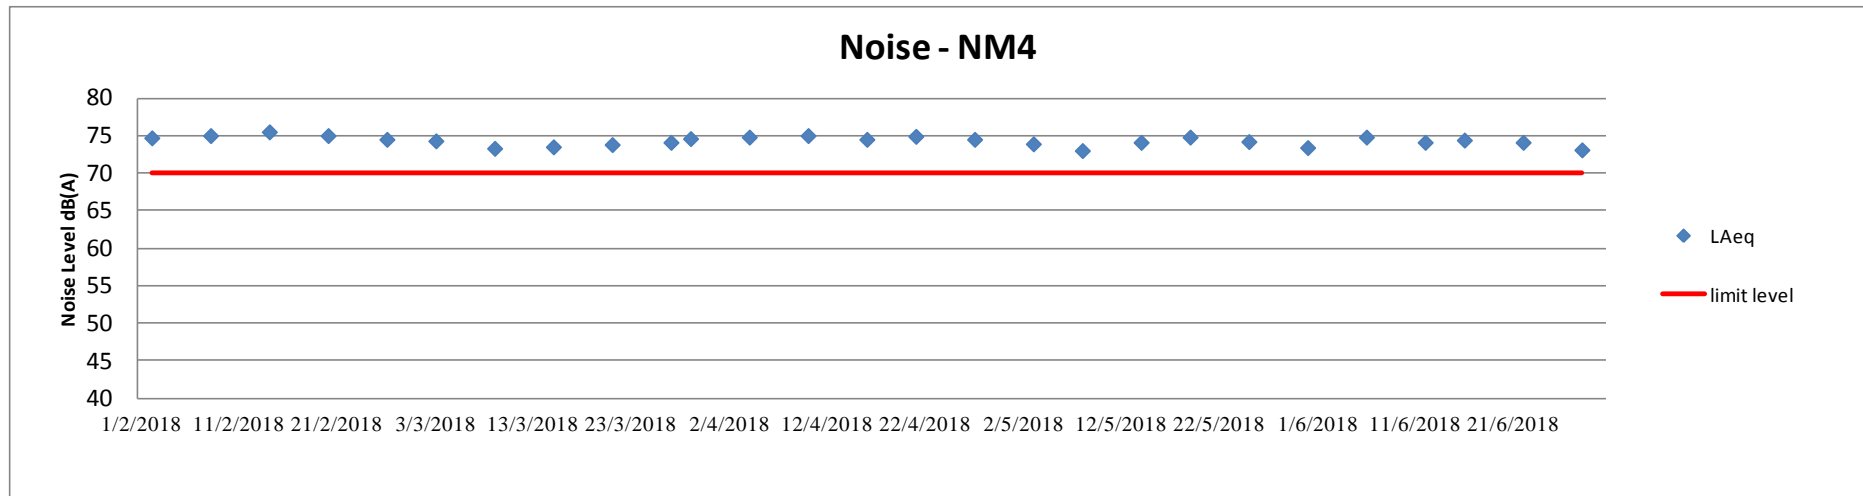
Noise Monitoring Result for NM4

The noise source for causing exceedances at NM4 was from the traffic of Canton Road. The NM4 was directly affected by the noise generated from the traffic. The recorded monitoring results at the NM4 were near the baseline noise level. The exceedances were not caused by the construction works of this project.

* Repeat noise measurement when exceedance is recorded. The result is used to confirm the findings and it would not be showed on the graph plot
