**Service Contract No. NDO 04/2019
Environmental Team for Environmental
Monitoring and Audit Works in
Construction Phase for the First Phase
Development of Kwu Tung North and
Fanling North New Development Areas**

**Monthly Environmental Monitoring and
Audit Report for November 2020
(Version 1.0)**

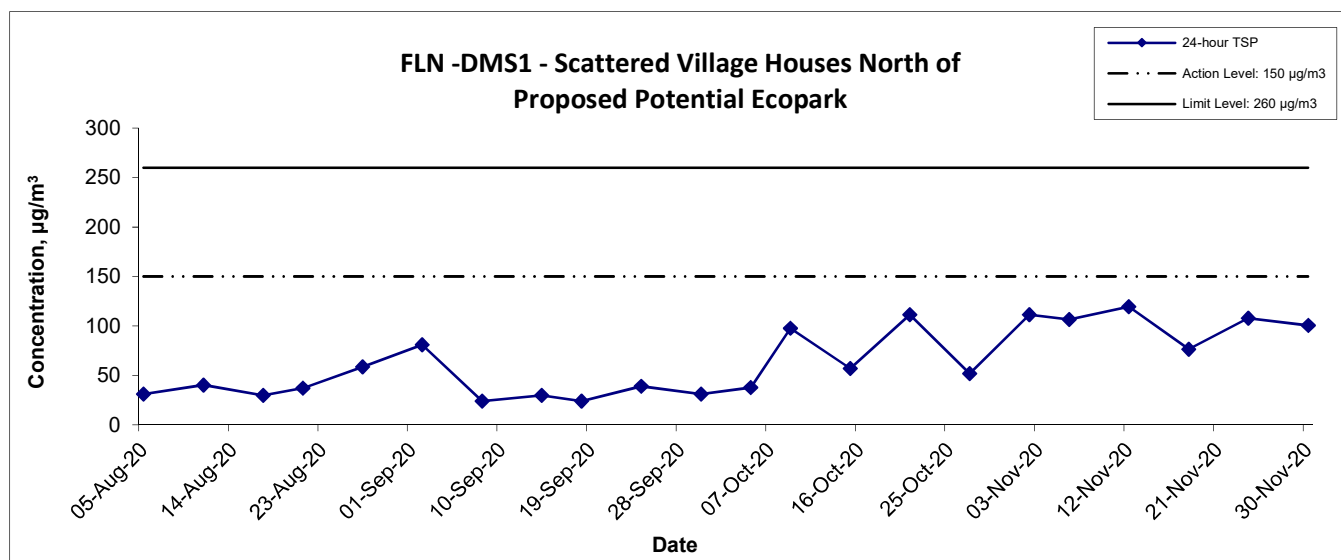
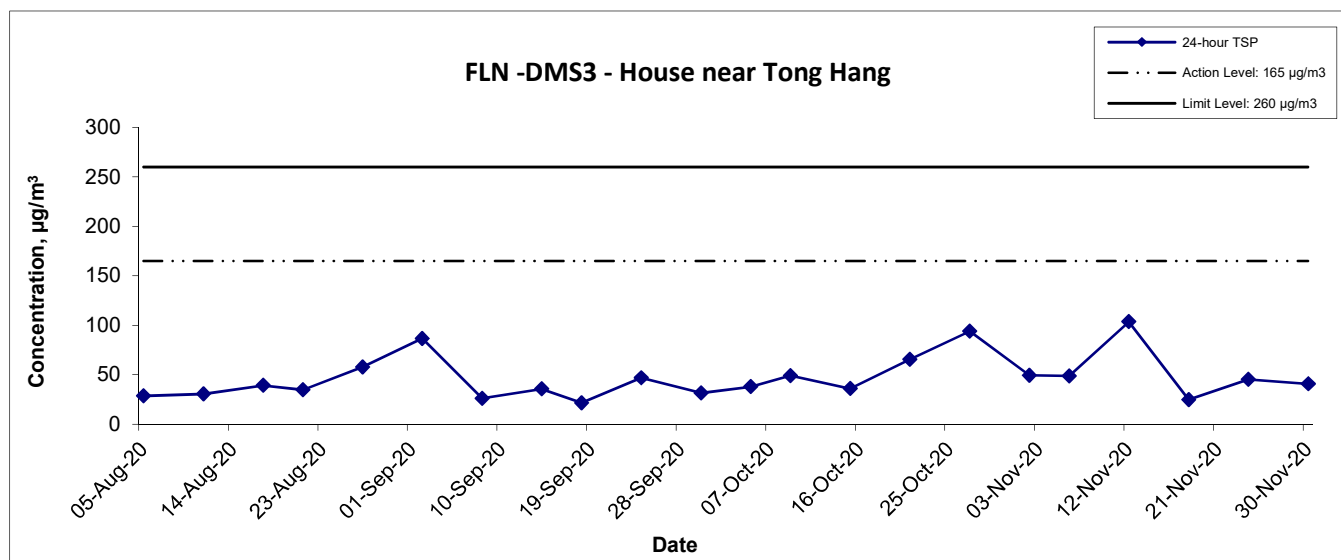
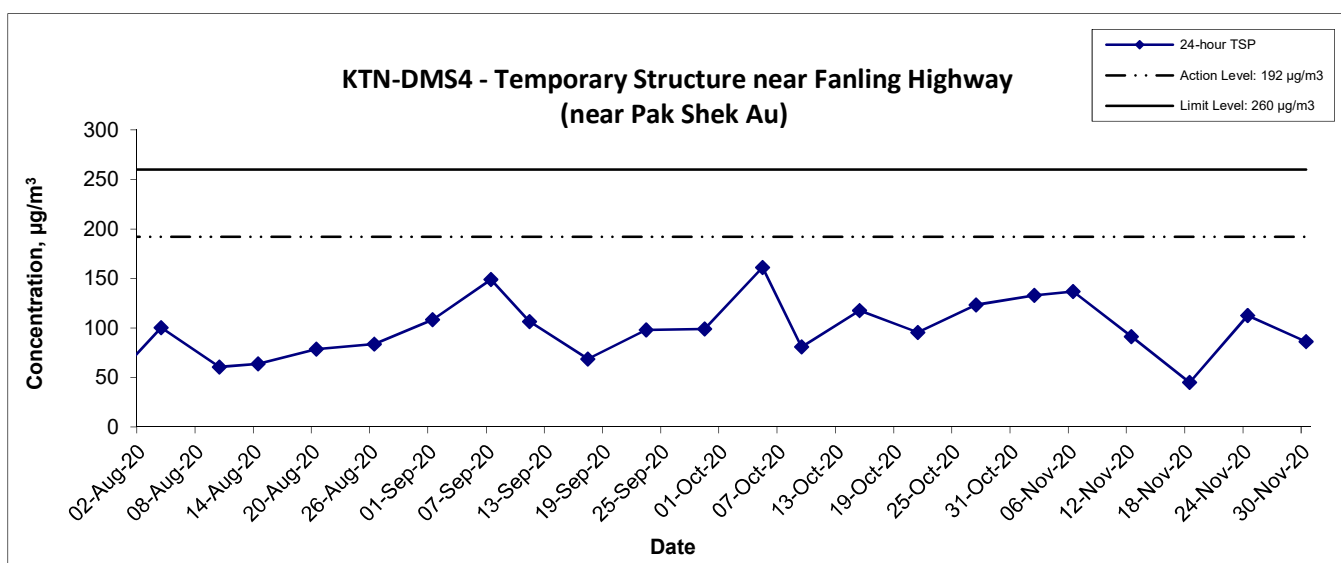
24-hr TSP Concentration Levels

Title Service Contract No. NDO 04/2019 Environmental Team for Environmental Monitoring and Audit Works in Construction Phase for the First Phase Development of Kwo Tung North and Fanling North New Development Areas Graphical Presentation of 24-hour TSP Monitoring Results	Scale N.T.S	Project No. WMA20002
