## Asia Pacific Gateway (APG) - Tseung Kwan O

### *Post Project Coral Survey Report*

7 July 2016

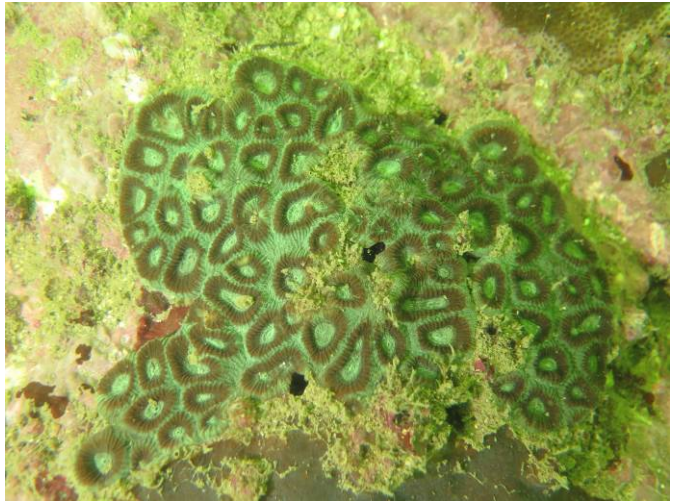
A photograph of a green, patterned coral colony, likely a species of stony coral, showing a distinct, repeating geometric pattern of small, rounded structures. The colony is situated on a rocky substrate with some surrounding algae.

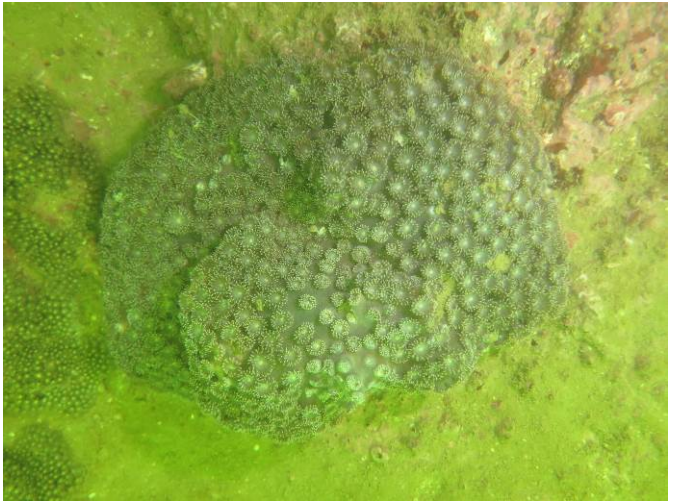
A photograph of a dense, green, rounded coral colony, possibly a species of brain coral or a similar form, characterized by its compact, somewhat circular shape and fine, repetitive surface texture.

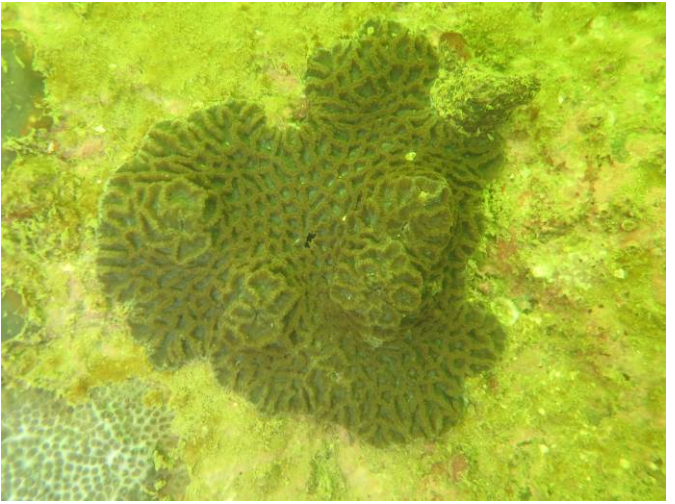
A photograph of a large, green, patterned coral colony, similar to Colony No. 13, but with a more complex, interconnected pattern of rounded structures. It is surrounded by a layer of yellowish-green algae.

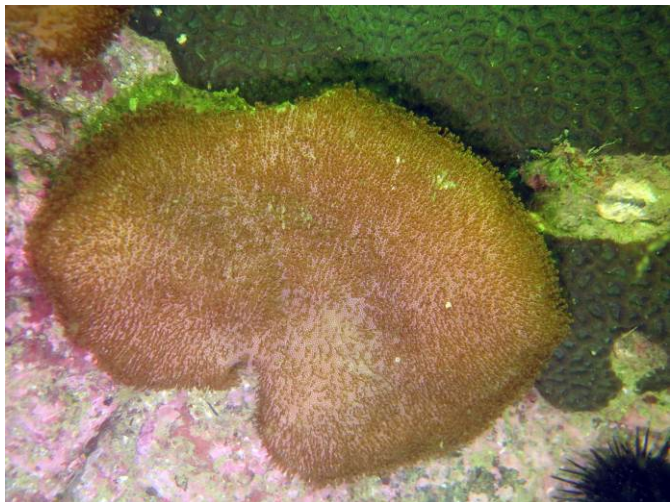
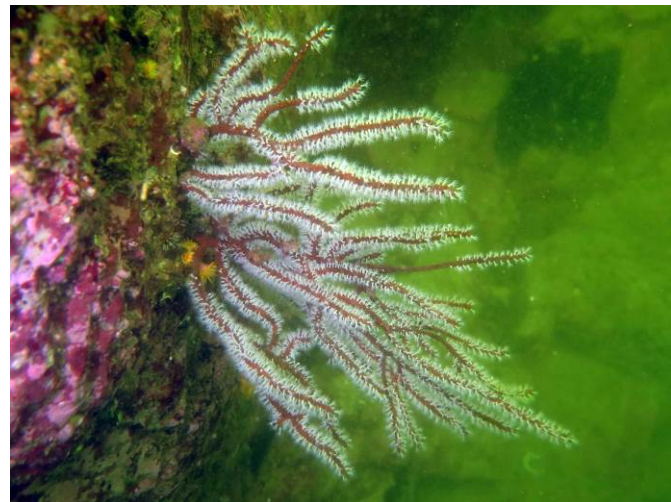
Colony No. 4	Colony No. 5	Colony No. 6

*Annex A12 Photographic Records of Identified Octocoral/ Black Coral Colonies at Control Monitoring Site (Zone C -Tung Lung Chau) during the Post Project Coral Monitoring Survey*
