## Asia Pacific Gateway (APG) - Tseung Kwan O

### *Site Inspection Report*

3 June 2016

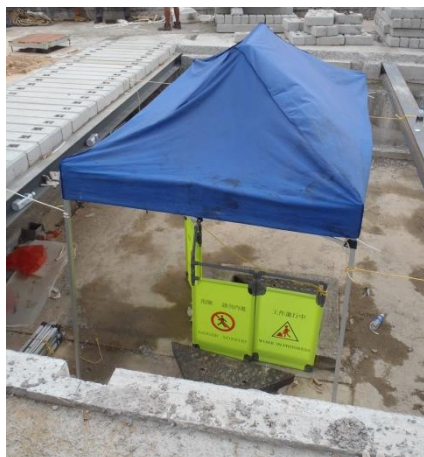
**Photo 1** - The BMH Manhole Cover was open for the Project works to occur/caution was taken during the site inspection on 26 May 2016.

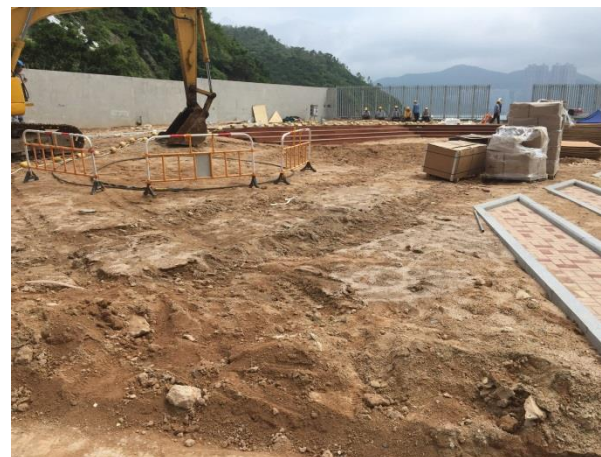
- BMH area (ie. our project site for inspection) site is within a construction site managed by CU (ie. not our Project). Checked with Mr. Ho - CU site manager, regarding the drainage system for the CU site as there was a member of area with loose soil exposed. He confirmed that the CU site drainage ran away from BMH area and drained towards public drain near the road. Drainage therefore is not considered an issue for BMH area.  
 -Some litter around the site.  
 -No noisy equipment required for BMH works - mainly manual works.

**Photo 2** - The drainage system for the CU site (within which the APG Project is located) had loose and exposed soil during the site inspection on 26 May 2016. The CU site manager confirmed that site runoff from CU site would drain away from APG BMH area and therefore the site runoff from CU site was not considered an issue for the APG BMH (see also Annex A).

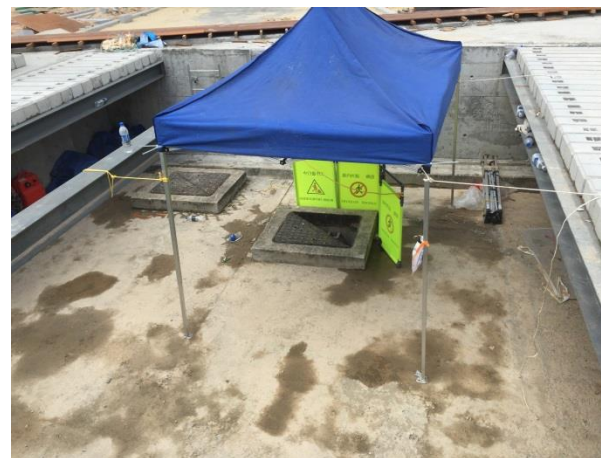
**Photo 4** - Some litter and debris were observed on the Project site during site inspection on 26 May 2016.

- Ensure site is kept clear of litter and is properly disposed of at bins provided on site. e.g. to prevent plastic bottles inadvertently entering marine environment.

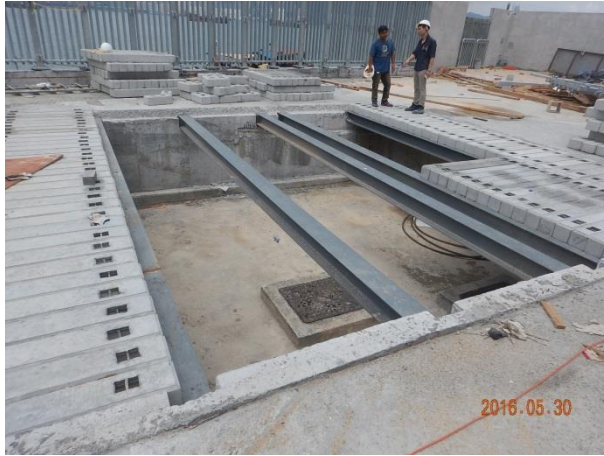
*Photo 5 - Land works were completed and BMH Manhole was closed during the Project site inspection on 30 May 2016.*
