Expansion of Hong Kong International Airport into a Three-Runway System

Construction Phase Quarterly EM&A Report
No.29 (1 January to 31 March 2023)

June 2023

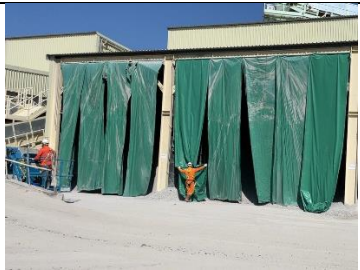
Provision of flexible curtain at the aggregate storage area entrance side to prevent dust nuisance	Provision of water spray at the main haul road	Treated marine sediment was properly covered by impervious sheet

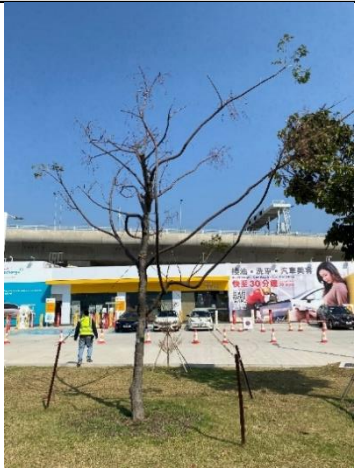
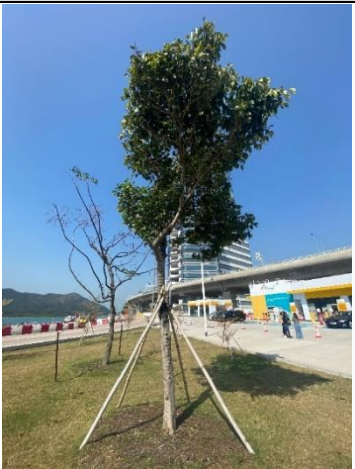
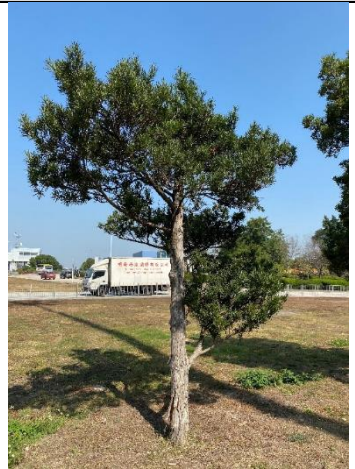
CT276	CT1253	T835

Table 2.25: Photos of the Existing Transplanted Trees Inspected in the Reporting Period
