Expansion of Hong Kong International Airport into a Three-Runway System

Construction Phase Quarterly EM&A Report
No.31 (1 July to 30 September 2023)

November 2023

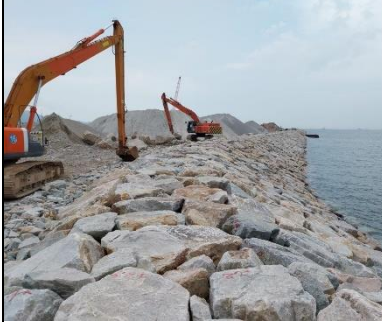
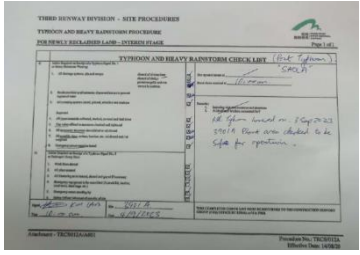
Snapshots of Good Environmental Practices in the Reporting Period

<p>Use of wet scrubber at silo exhaust pipe for dust control</p>	<p>Reuse of armour rocks for seawall construction</p>	<p>Post typhoon checking for the concrete batching plant was conducted by contractor</p>

1. Use of wet scrubber to replace traditional dust filter at silo exhaust pipe for dust control.
2. Armour rocks removed from the previous seawall were reused for seawall construction.
3. Post typhoon checking for the concrete batching plant was conducted by contractor to ensure its proper operation to prevent dust nuisance.

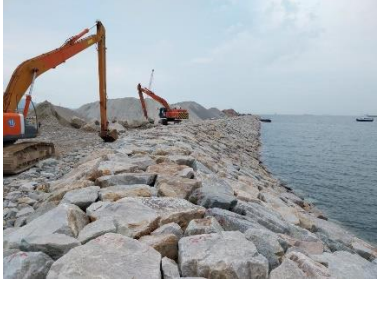
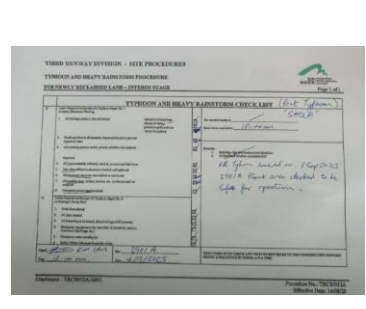
1. Use of wet scrubber to replace traditional dust filter at silo exhaust pipe for dust control.
2. Armour rocks removed from the previous seawall were reused for seawall construction.
3. Post typhoon checking for the concrete batching plant was conducted by contractor to ensure its proper operation to prevent dust nuisance..

<p>Use of wet scrubber at silo exhaust pipe for dust control</p>	<p>Reuse of armour rocks for seawall construction</p>	<p>Post typhoon checking for the concrete batching plant was conducted by contractor</p>
