EP-510/2016 – Police Facilities in Kong Nga Po

**Service Contract No. NDO 07/2019
Environmental Team for Site Formation and
Infrastructure Works for Police Facilities in
Kong Nga Po**

**Monthly Environmental Monitoring and
Audit Report for December 2020
(Version 1.0)**

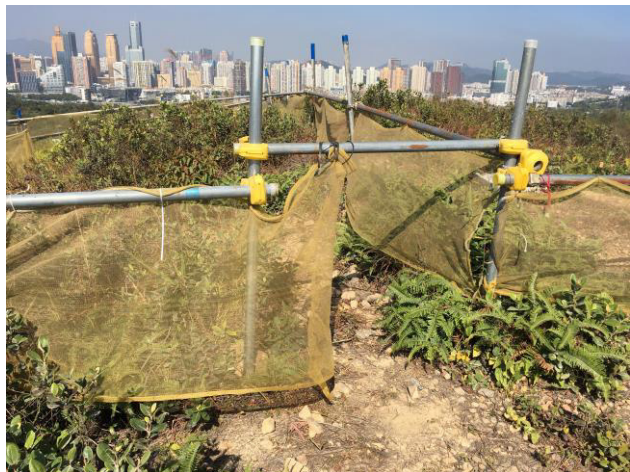
Photo 3

Description: General view of transplanted *Brainea insignis*.

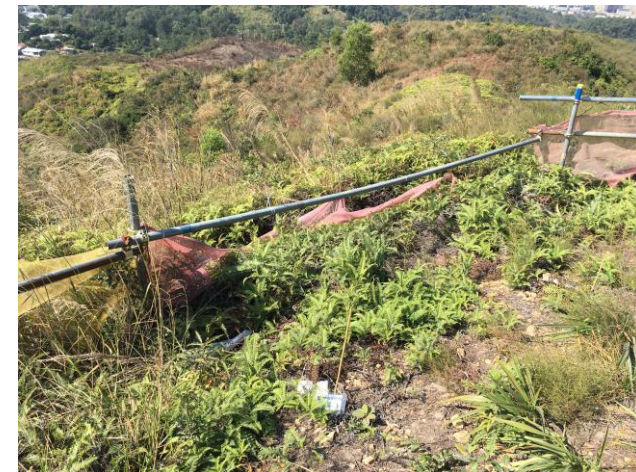
Photo 4

Description: Contractor was reminded to keep maintain the protective fencing properly and replace the loosing fencing for transplanted *Brainea insignis*.

- 5.8 During monthly monitoring, no construction activity and equipment storage was observed within the receptor site and no environmental change of receptor site was identified. A reminder was given to the Contractor to keep maintain the temporary protective fencing properly and replace the loosing fencing for the transplanted species.

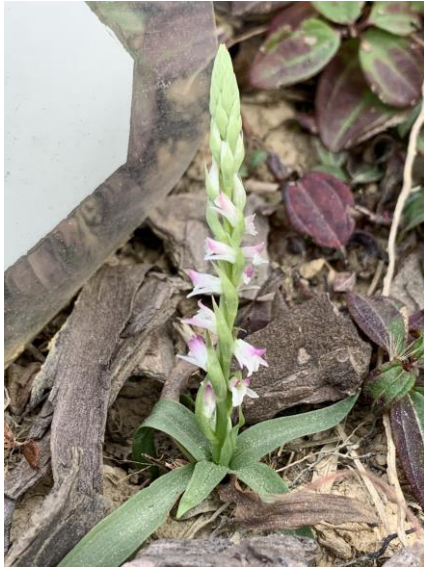
Photo 9

Description: Flowering was observed in one of the *Spiranthes sinensis*.
