**EP-510/2016 – Police Facilities in Kong Nga Po**

**Service Contract No. NDO 07/2019  
Environmental Team for Site Formation and  
Infrastructure Works for Police Facilities in  
Kong Nga Po**

**Monthly Environmental Monitoring and  
Audit Report for September 2021  
(Version 1.0)**

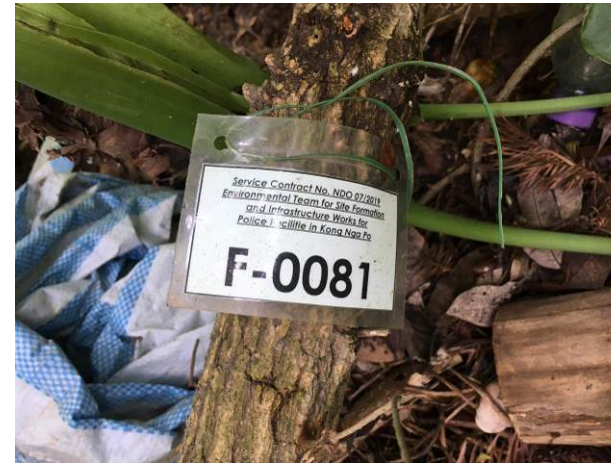
Photo 12

Description: An undersized seedling of *Keteleeria fortunei* (F-0081) was found collapsed due to internal decay.

- 5.12 During monitoring, no construction activity was observed within the area of retained species. Temporary protective fence were properly erected and maintained for the retained species. The photographic record for the collapsed individual is shown in **Appendix H**.

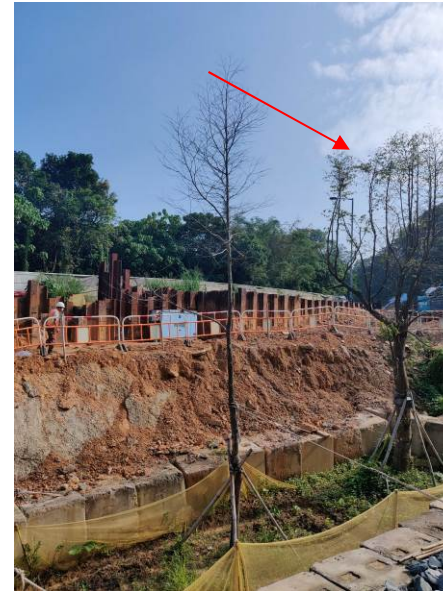
Photo 14

Description: Poor health condition of *Aquilaria sinensis* A-008 (defoliation, dead branches, dieback twigs on tree crown etc.) was found. The Contractor was reminded to take prompt action to rescue the tree accordingly to approved transplantation proposal.

- 5.10 During monthly monitoring, poor health condition of *Aquilaria sinensis* A-008, A-0009 and A-0010 (defoliation, dead branches, dieback twigs on tree crown etc.) were found. The Contractor was reminded to take prompt action to rescue the tree accordingly to approved transplantation proposal. No construction activity and equipment storage was observed within the receptor site. Temporary protective fence were properly erected and maintained for the transplanted species.

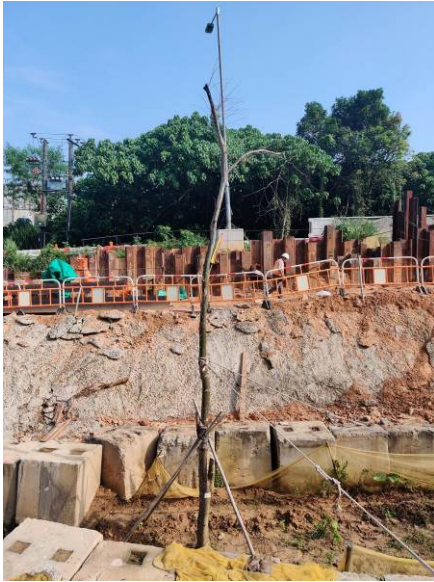
Photo 15

Description: Poor health condition of *Aquilaria sinensis* A-0010 (defoliation, dead branches, dieback twigs on tree crown etc.) was found. The Contractor was reminded to take prompt action to rescue the tree accordingly to approved transplantation proposal.

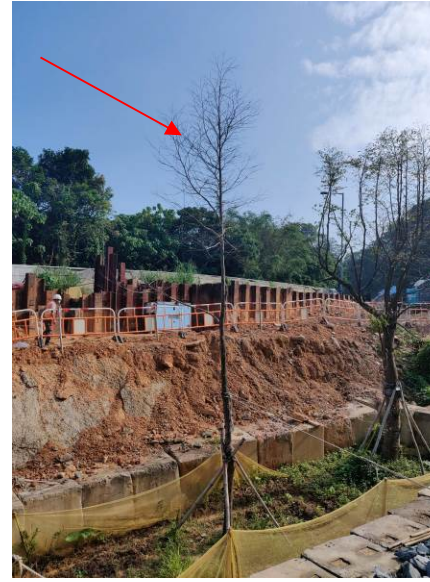
Photo 16

Description: Poor health condition of *Aquilaria sinensis* A-0009 (defoliation, dead branches, dieback twigs on tree crown etc.) was found. The Contractor was reminded to take prompt action to rescue the tree accordingly to approved transplantation proposal.
