EP-510/2016 – Police Facilities in Kong Nga Po

**Service Contract No. NDO 07/2019
Environmental Team for Site Formation and
Infrastructure Works for Police Facilities in
Kong Nga Po**

**Monthly Environmental Monitoring and
Audit Report for October 2021**

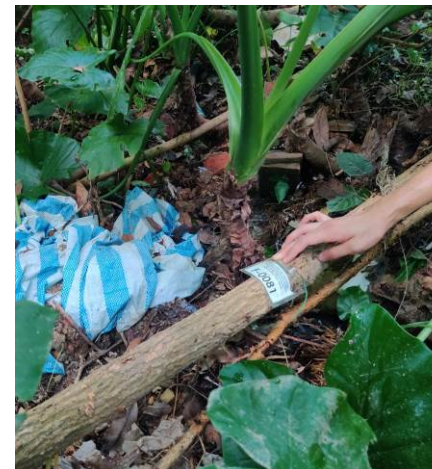
Photo 12

Description: An undersized seedling of *Keteleeria fortunei* (F-0081) was found collapsed due to internal decay.

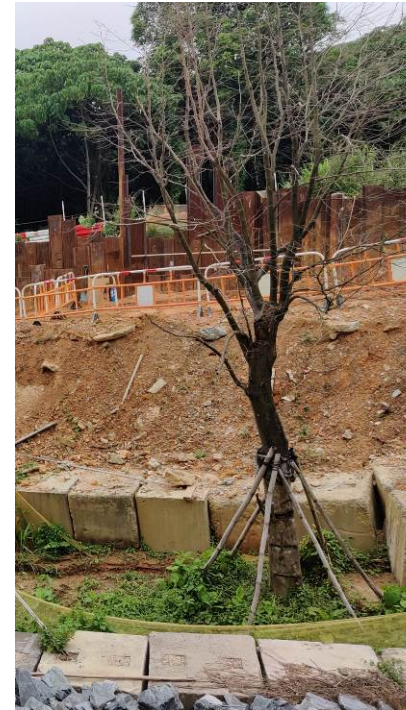
Photo 14

Description: Poor health condition of *Aquilaria sinensis* A-008 (defoliation, dead branches, dieback twigs on tree crown etc.) was found. The Contractor was reminded to take prompt action to rescue the tree accordingly to approved transplantation proposal.

- 5.10 During monthly monitoring, poor health condition of *Aquilaria sinensis* A-008, A-0009 and A-0010 (defoliation, dead branches, dieback twigs on tree crown etc.) were found. The Contractor was reminded to take prompt action to rescue the tree accordingly to approved transplantation proposal. No construction activity and equipment storage was observed within the receptor site. Temporary protective fence were properly erected and maintained for the transplanted species.

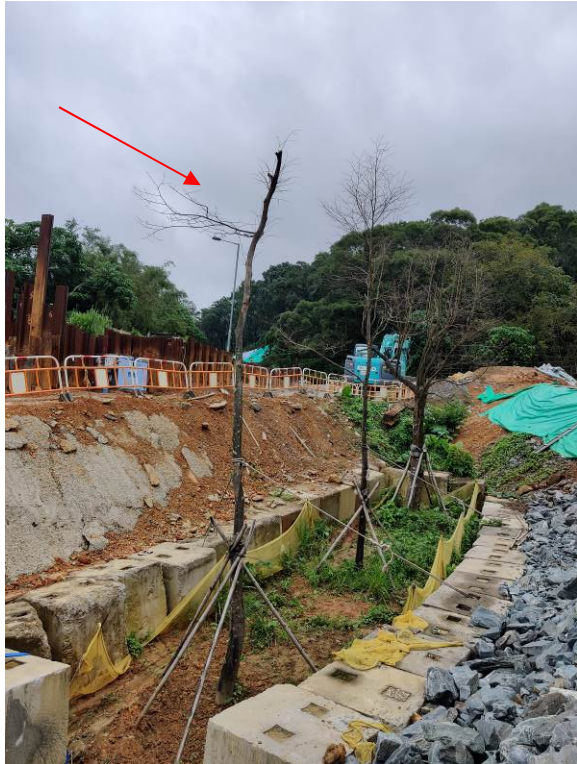
Photo 15

Description: Poor health condition of *Aquilaria sinensis* A-0010 (defoliation, dead branches, dieback twigs on tree crown etc.) was found. The Contractor was reminded to take prompt action to rescue the tree accordingly to approved transplantation proposal.

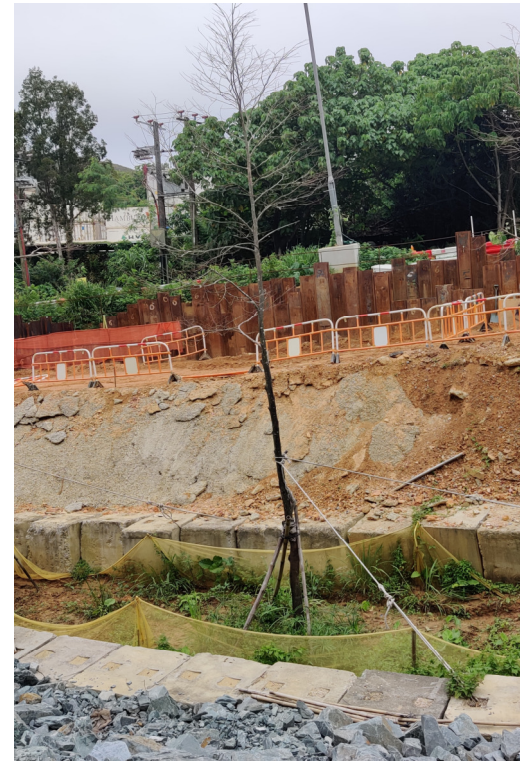
Photo 16

Description: Poor health condition of *Aquilaria sinensis* A-0009 (defoliation, dead branches, dieback twigs on tree crown etc.) was found. The Contractor was reminded to take prompt action to rescue the tree accordingly to approved transplantation proposal.
