EP-510/2016 – Police Facilities in Kong Nga Po

**Service Contract No. NDO 07/2019
Environmental Team for Site Formation and
Infrastructure Works for Police Facilities in
Kong Nga Po**

**Monthly Environmental Monitoring and
Audit Report for November 2021
(Version 1.0)**

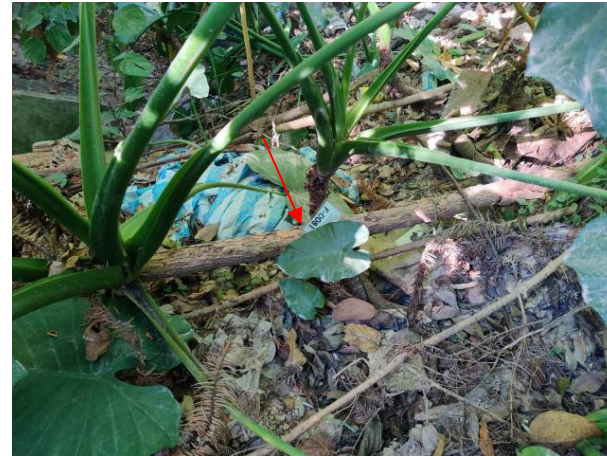
Photo 12

Description: Protective fence for *Keteleeria fortunei* are properly erected.

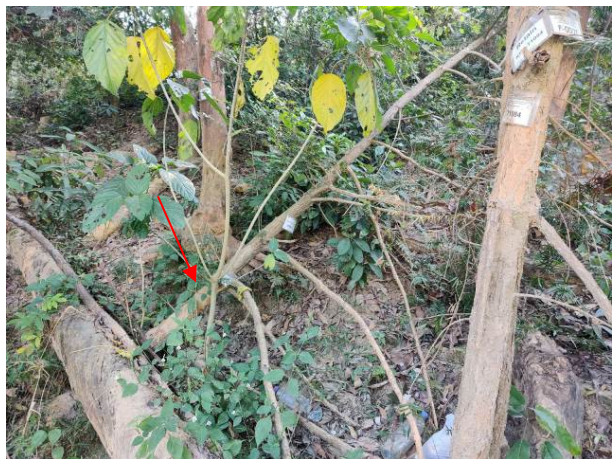
Photo 13

Description: An undersized seedling of *Keteleeria fortunei* (F-0081) was found collapsed due to internal decay.

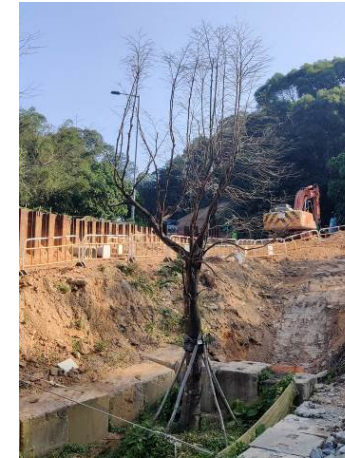
Photo 15

Description: Poor health condition of *Aquilaria sinensis* A-008 (defoliation, dead branches, dieback twigs on tree crown etc.) was found. The Contractor was reminded to take appropriate and prompt action (e.g. pruning, mulching etc.) according to the tree conditions to rescue the tree.

- 5.10 During monthly monitoring, poor health condition of *Aquilaria sinensis* A-008, A-0009 and A-0010 (defoliation, dead branches, dieback twigs on tree crown etc.) were found. The Contractor was reminded to take appropriate and prompt action to rescue the tree according to approved transplantation proposal. No construction activity and equipment storage was observed within the receptor site. Temporary protective fence was properly erected and maintained for the transplanted species.

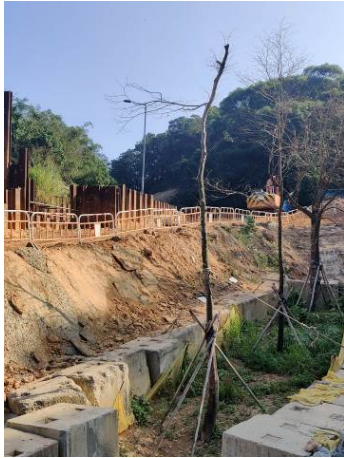
Photo 16

Description: Poor health condition of *Aquilaria sinensis* A-0010 (defoliation, dead branches, dieback twigs on tree crown etc.) was found. The Contractor was reminded to take appropriate and prompt action (e.g. pruning, mulching etc.) according to the tree conditions to rescue the tree.

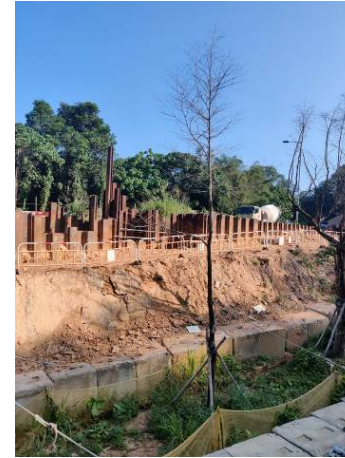
Photo 17

Description: Poor health condition of *Aquilaria sinensis* A-0009 (defoliation, dead branches, dieback twigs on tree crown etc.) was found. The Contractor was reminded to take appropriate and prompt action (e.g. pruning, mulching etc.) according to the tree conditions to rescue the tree.
