**EP-510/2016 – Police Facilities in Kong Nga Po**

**Service Contract No. NDO 07/2019  
Environmental Team for Site Formation and  
Infrastructure Works for Police Facilities in  
Kong Nga Po**

**Monthly Environmental Monitoring and  
Audit Report for January 2022  
(Version 1.0)**

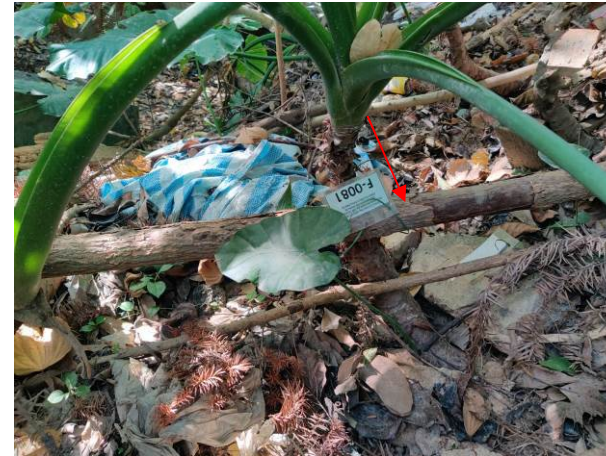
Photo 13

Description: An undersized seedling of *Keteleeria fortunei* (F-0081) was found collapsed due to internal decay.

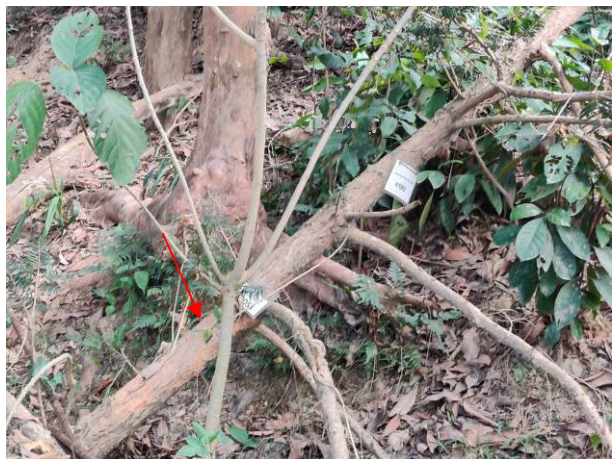
Description: An undersized seedling of *Keteleeria fortunei* (F-0051) was found uprooted by the nearby fallen tree.

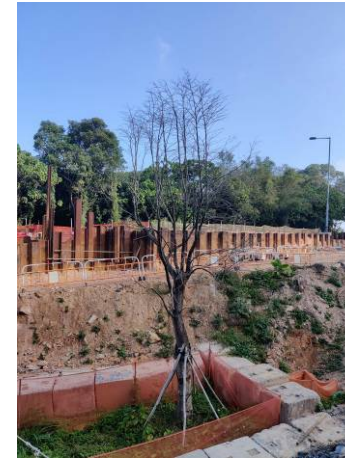
Photo 16

- 5.10 During monthly monitoring, poor health condition of *Aquilaria sinensis* A-008, A-0009 and A-0010 (dead branches, dieback twigs etc.) were still found. The Contractor was reminded to closely monitor and take appropriate and prompt action according to the tree conditions to rescue the trees with reference to the approved transplantation proposal. No construction activity and equipment storage were observed within the receptor site. Temporary protective fence was properly erected and maintained for the transplanted species. The Contractor was also recommended to check any influencing factors outside the receptor sites which are likely affected, directly or indirectly to the transplanted individuals.

Description: Poor health condition of *Aquilaria sinensis* A-008 (defoliation, dead branches, dieback twigs on tree crown etc.) was found. The Contractor was reminded to closely monitor and take appropriate and prompt action according to the tree conditions to rescue the tree.

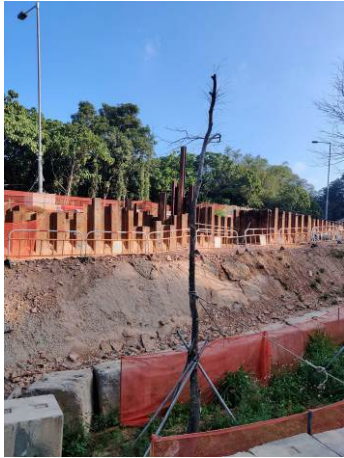
Photo 17

Description: Poor health condition of *Aquilaria sinensis* A-0010 (defoliation, dead branches, dieback twigs on tree crown etc.) was found. The Contractor was reminded to closely monitor and take appropriate and prompt action according to the tree conditions to rescue the tree.

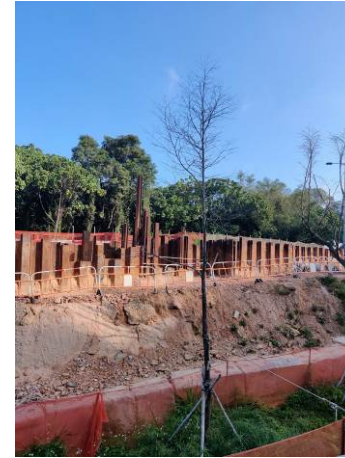
Description: Poor health condition of *Aquilaria sinensis* A-0009 (defoliation, dead branches, dieback twigs on tree crown etc.) was found. The Contractor was reminded to closely monitor and take appropriate and prompt action according to the tree conditions to rescue the tree.
