**EP-510/2016 – Police Facilities in Kong Nga Po**

**Service Contract No. NDO 07/2019  
Environmental Team for Site Formation and  
Infrastructure Works for Police Facilities in  
Kong Nga Po**

**Monthly Environmental Monitoring and  
Audit Report for June 2022  
(Version 1.0)**

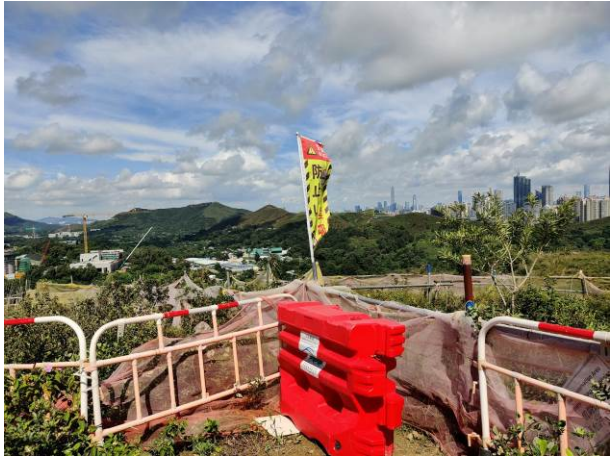
<p>Photo 1</p>

<p>Description: Protective fence for transplanted <i>Brainea insignis</i> are properly erected with warning flags for bushfire prevention.</p>	<p>Photo 2</p>   <p>Description: Protective fence for transplanted <i>Brainea insignis</i> are properly erected.</p>
<p>Photo 3</p>

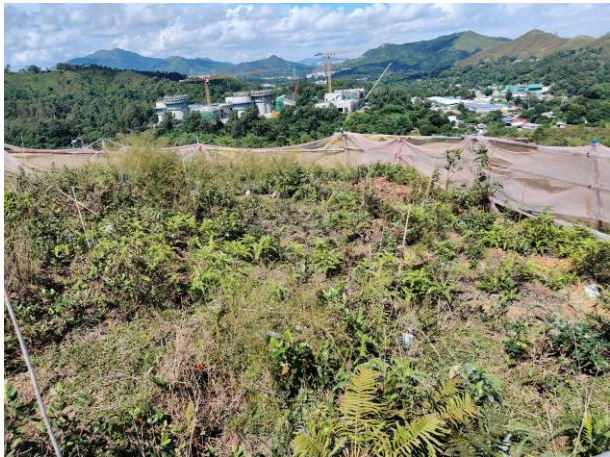
<p>Description: General view of transplanted <i>Brainea insignis</i>.</p>	<p>Photo 4</p>

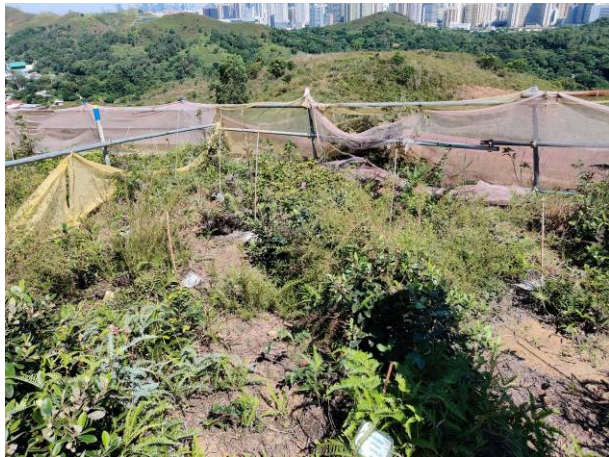
<p>Description: General view of transplanted <i>Brainea insignis</i>.</p>

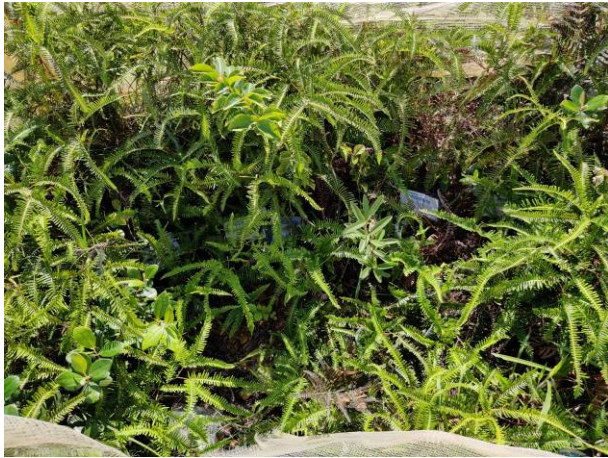
Photo 5

Description: General view of transplanted *Spiranthes sinensis*.

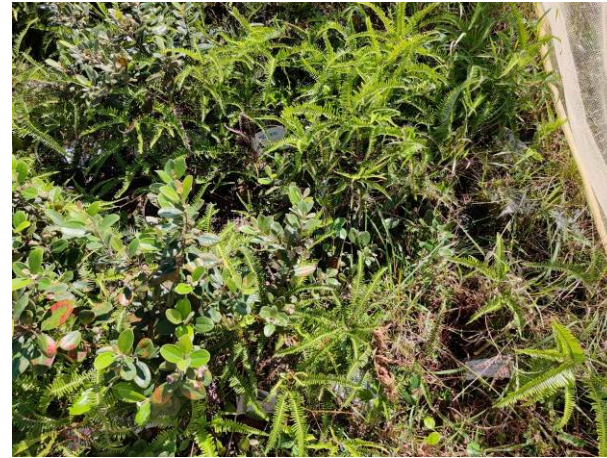
Photo 6

Description: General view of transplanted *Spiranthes sinensis*.

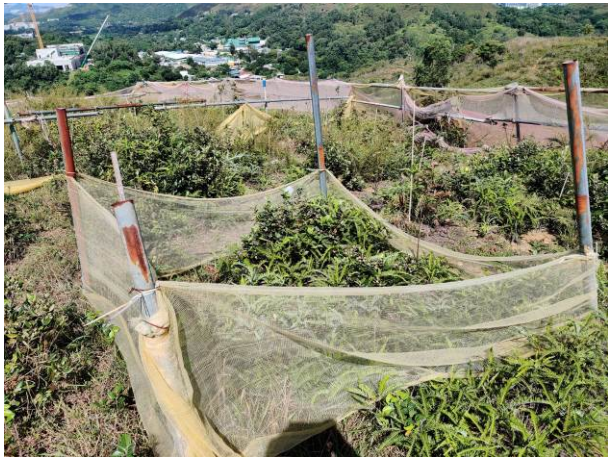
Photo 7

Description: Protective fence for transplanted *Spiranthes sinensis* are properly erected.

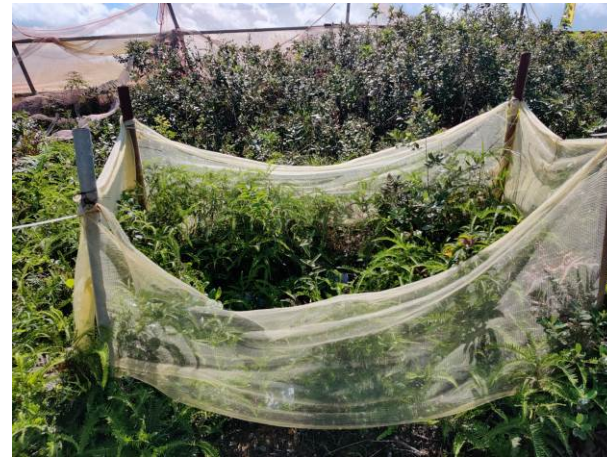
Photo 8

Description: Protective fence for transplanted *Spiranthes sinensis* are properly erected.

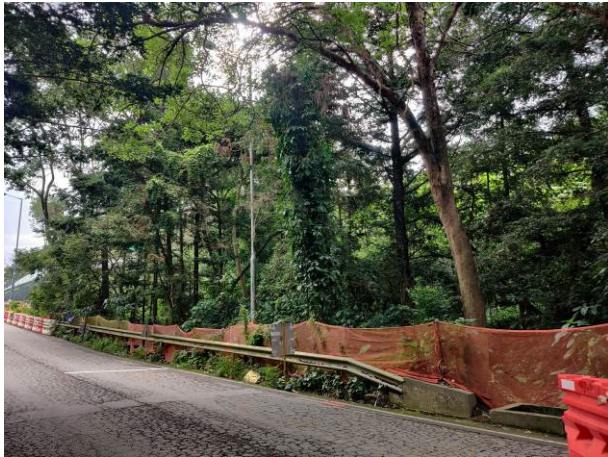
Photo 9

Description: Protective fence for *Keteleeria fortunei* are properly erected.

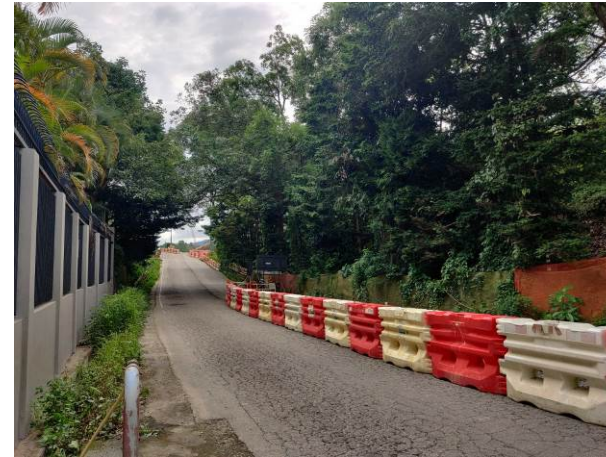
Photo 10

Description: Protective fence for *Keteleeria fortunei* are properly erected.

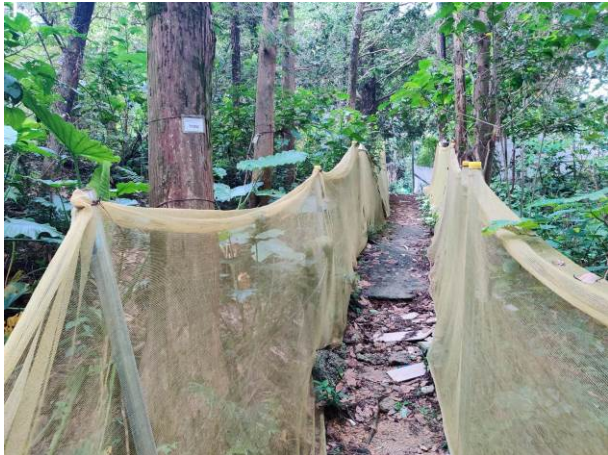
Photo 11

Description: Protective fence for *Keteleeria fortunei* are properly erected.

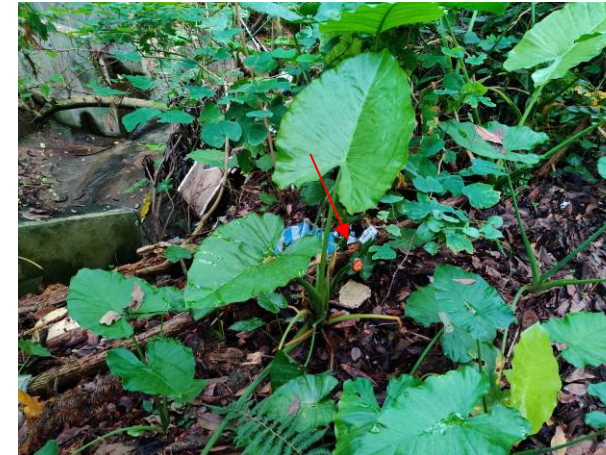
Photo 12

Description: An undersized seedling of *Keteleeria fortunei* (F-0081) was found collapsed due to internal decay.

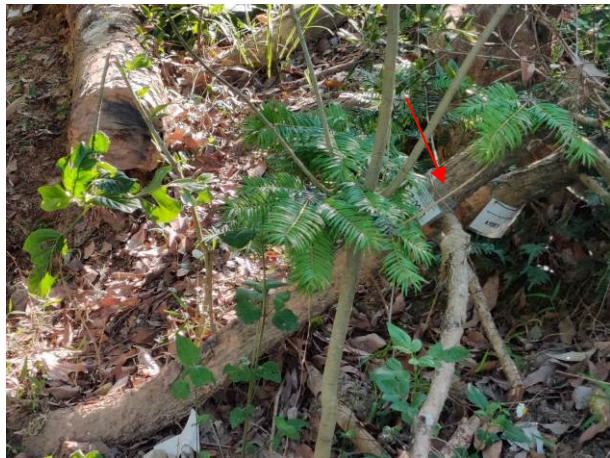
Photo 13

Description: An undersized seedling of *Keteleeria fortunei* (F-0051) was found uprooted by the nearby fallen tree.

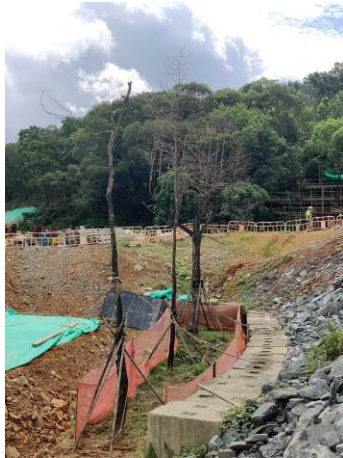
Photo 14

Description: General view of transplanted *Aquilaria sinensis* and protective fence for *Aquilaria sinensis* are properly erected.

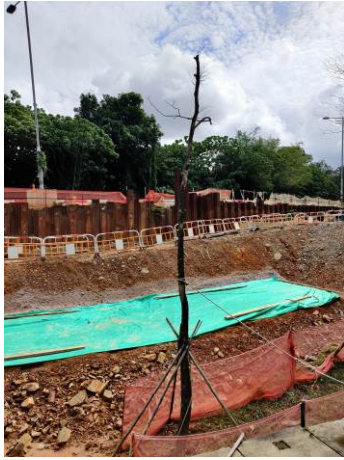
Photo 16

Description: Poor health condition of *Aquilaria sinensis* A-0010 (dead branches, dieback twigs, algae on branches etc.) was found. The Contractor was reminded to urge their landscape specialist to closely monitor and take appropriate and prompt action to rescue the plants without further delay especially during the spring season.

- 5.10 During the monthly monitoring, poor health condition of *Aquilaria sinensis* A-008, A-0009 and A-0010 (dead branches, dieback twigs, algae on the branches etc.) were found. The Contractor was reminded to urge the landscape specialist to closely monitor and take appropriate and prompt action to rescue the plants without further delay especially during the growing season.

- 5.11 In addition, the Contractor was recommended to erect and maintain the temporary protective

fence properly for *Aquilaria sinensis*. Nevertheless, no construction activity and equipment storage were observed within the receptor site.

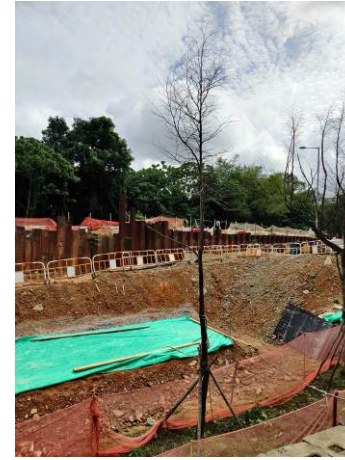
Photo 17

Description: Poor health condition of *Aquilaria sinensis* A-0009 (dead branches, dieback twigs, algae on branches etc.) was found. The Contractor was reminded to urge their landscape specialist to closely monitor and take appropriate and prompt action to rescue the plants without further delay especially during the spring season.

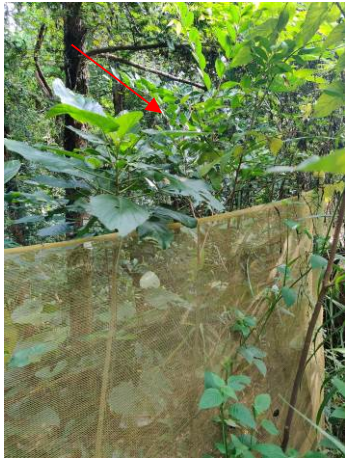
Photo 18

Description: General view of undersized seedling of *Aquilaria sinensis*

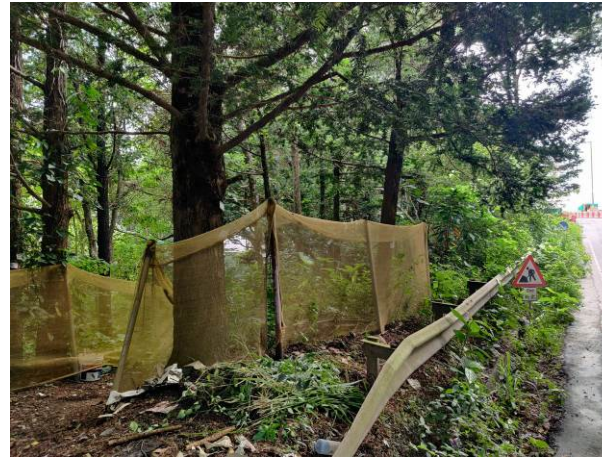
Photo 19

Description: Protective fence for undersized seedling of *Aquilaria sinensis* are properly erected.

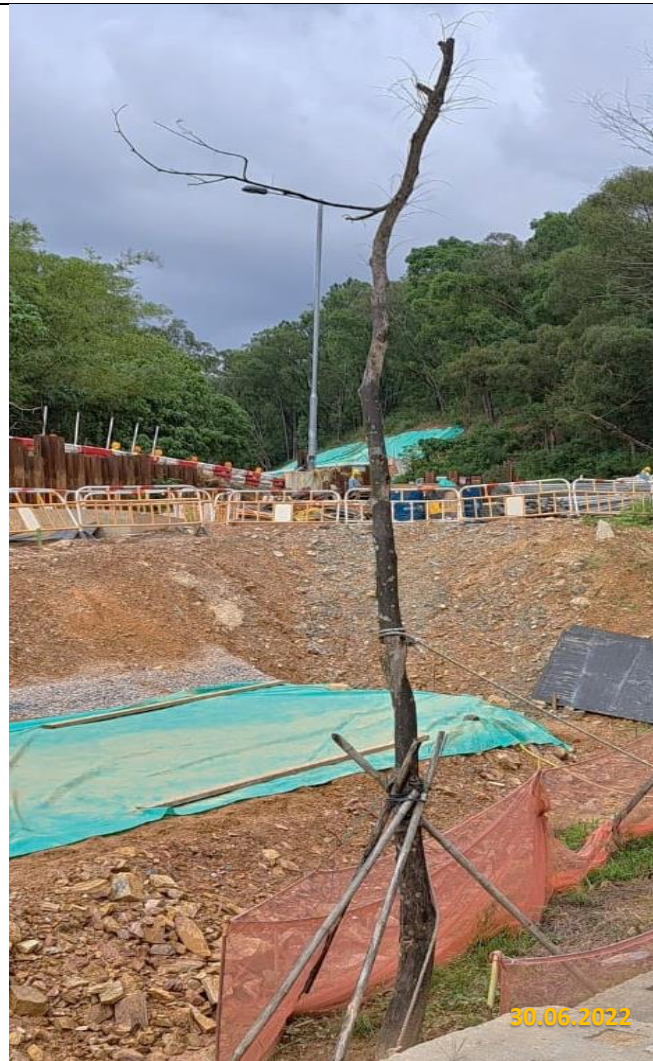
<b>Tree / Plant / Colony No.</b>	<b>Botanical Name</b>	<b>DBH (mm)</b>	<b>Height (mm)</b>	<b>Spread (mm)</b>	<b>Structural Condition (Good/Fair/Poor)</b>	<b>Form (Good/Fair/Poor)</b>	<b>Health (Good/Fair/Poor)</b>	<b>Remarks</b>
A-0010 (T1700)	<i>Aquilaria sinensis</i>	132	5000	3000	Fair	Poor	Poor	
A-0009 (T2298)	<i>Aquilaria sinensis</i>	96	6000	3000	Fair	Poor	Poor	
A-0008 (T5153)	<i>Aquilaria sinensis</i>	312	6000	4000	Fair	Poor	Poor

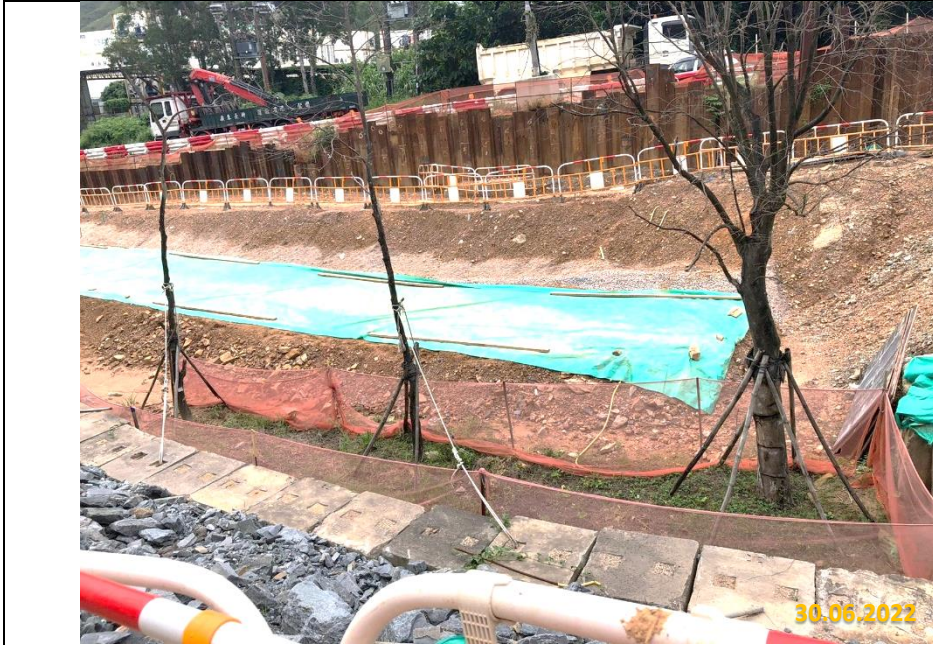
Formation of ditch to divert the surface runoff into water collection point

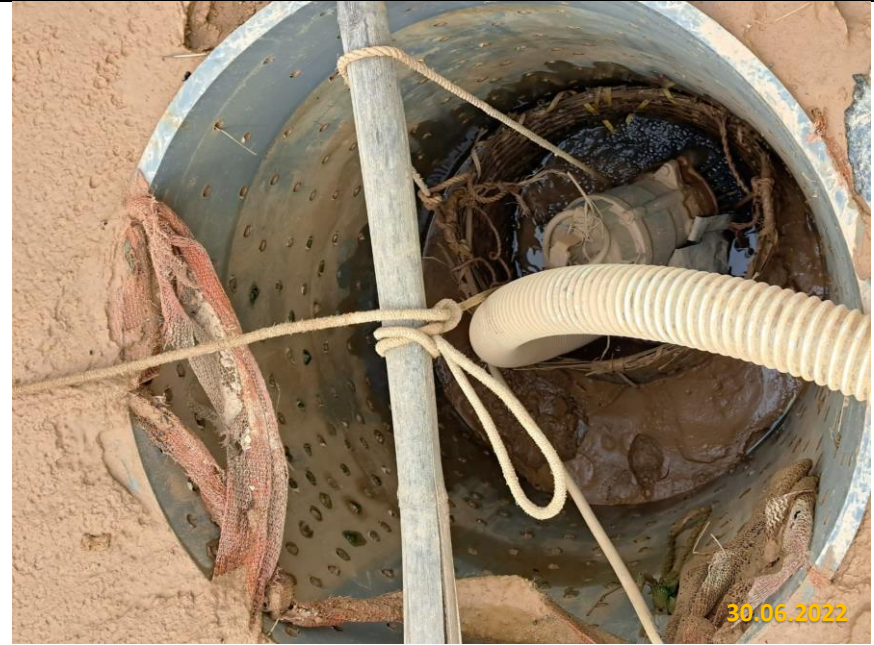
Submersible pump in place and dewatering was carrying out to drain away the collected surface runoff when it was raining

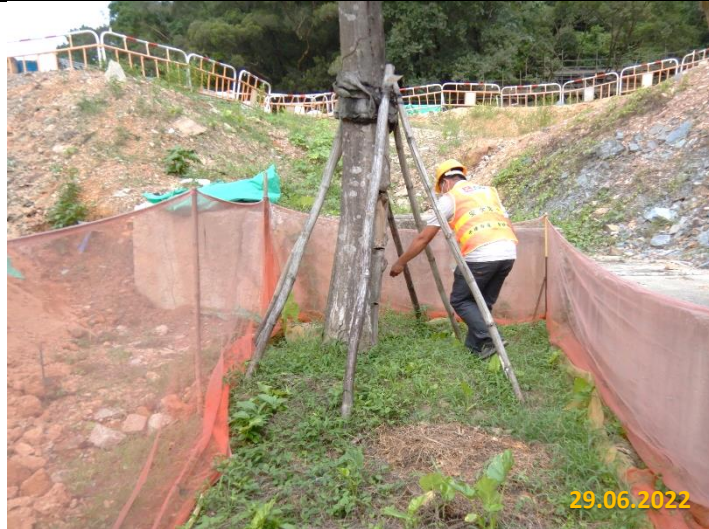
Fertilizing has been applied on *Aquilaria sinensis* A-0008 (T5153)

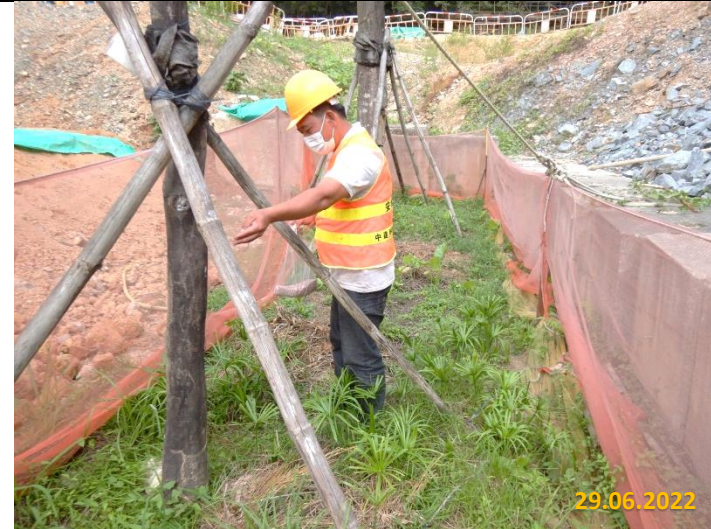
Fertilizing has been applied on *Aquilaria sinensis* A-0009 (T2298)

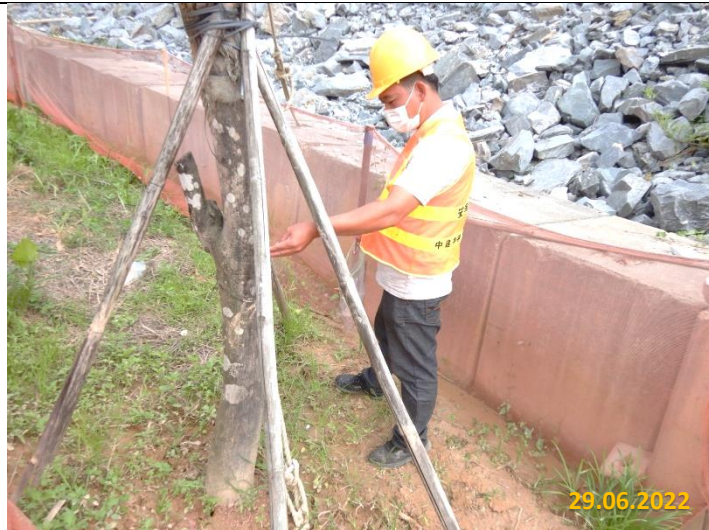
Fertilizing has been applied on *Aquilaria sinensis* A-0010 (T1700)

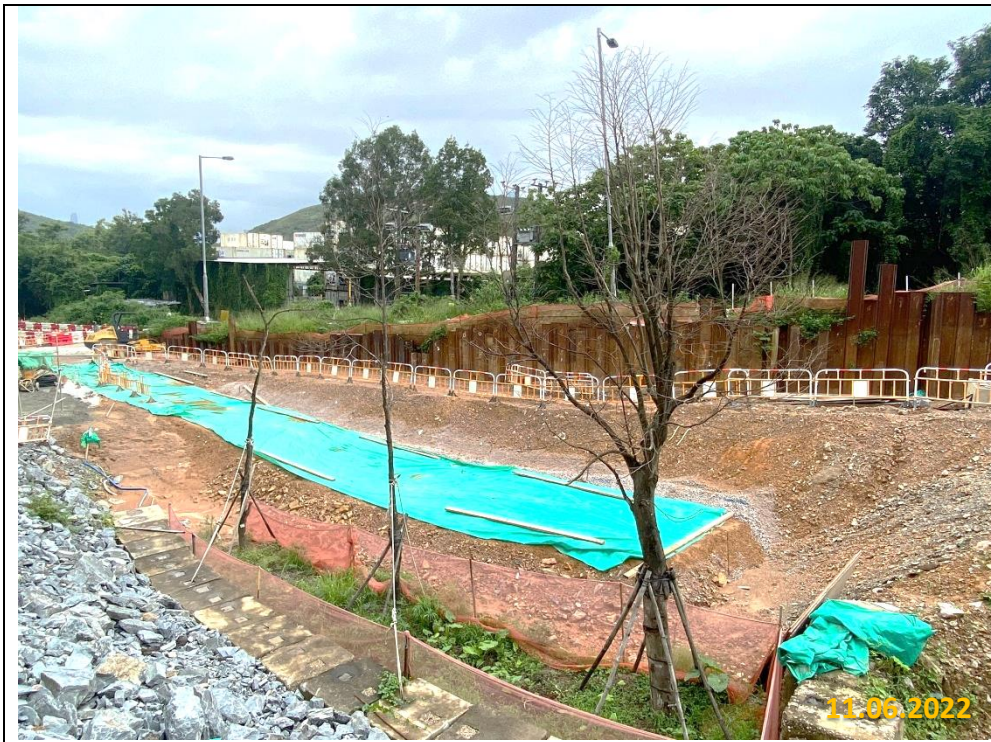
Formation of ditch to divert the surface runoff into water collection point.

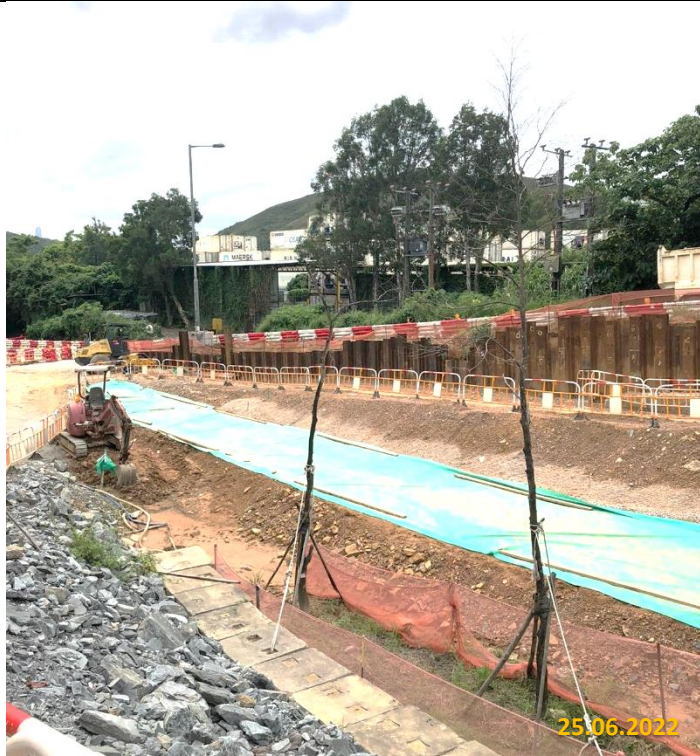
Formation of ditch to divert the surface runoff into water collection point

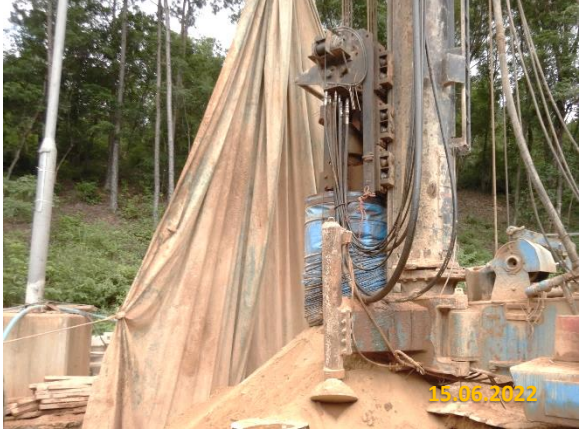
Ref*	Proposed Construction Method	Location/Working Period	Anticipated Major Impacts	Recommended Mitigation Measures	Photo Records (Partial)
EIA 5.6.1.2; EM&A Log 4.2	Pre-bored Piling Works	Kong Nga Po Road	Water Pollution	<ul style="list-style-type: none"> <li>• Re-circulation of water for dust suppression to minimize wastewater generation if possible</li> <li>• Enclosure will be provided to drill rods to minimize the risk of water spillage</li> </ul>

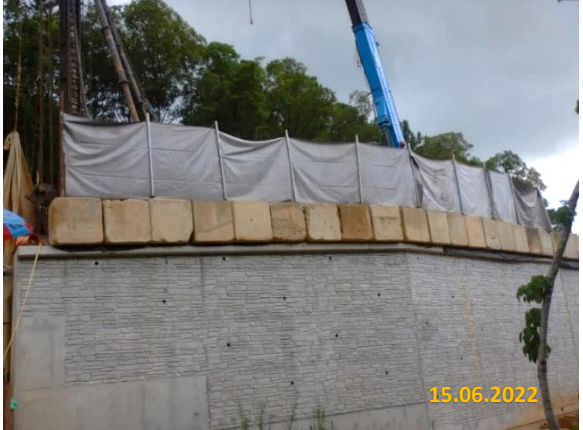
<p>By main contractor at KNP Road</p>

<p>By subcontractor at KNP Road</p>
EIA 4.4.6; EM&A Log 3.2			Noise	<ul style="list-style-type: none"> <li>• Regular inspection and maintenance of plant &amp; equipment in good condition</li> <li>• Use of proprietary noise barrier for noisy works near sensitive receiver</li> <li>• Deploy quality powered mechanical equipment if possible</li> <li>• Regular inspection and maintenance of plant &amp; equipment in good condition</li> </ul>

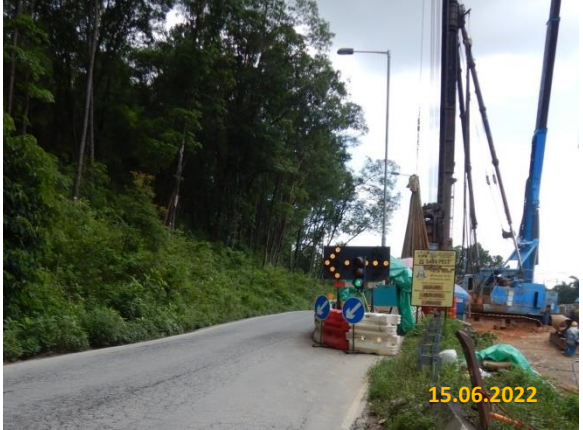
<p>By main contractor at KNP Road</p>
EIA Table 10.11 EM&A Table 9.1			Landscape and visual impact	<ul style="list-style-type: none"> <li>• Construction area had been controlled with proper fencing to minimize the landscape and visual impacts arising from construction activities</li> </ul>

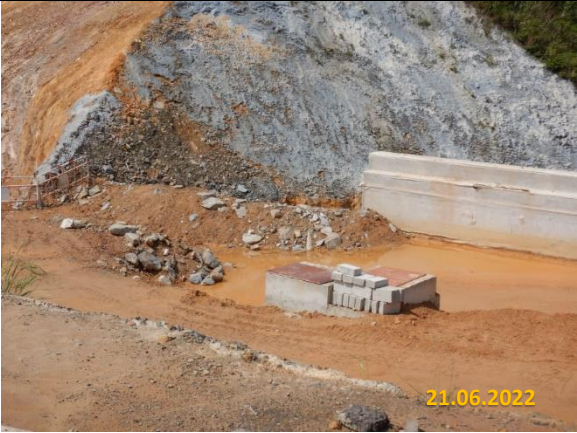
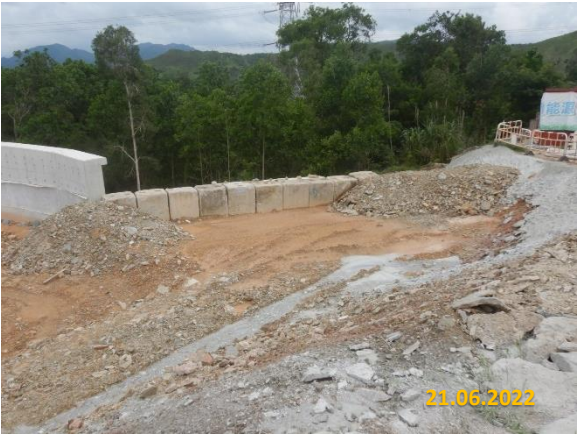
Ref*	Proposed Construction Method	Location/Working Period	Anticipated Major Impacts	Recommended Mitigation Measures	Photo Records (Partial)
EIA 5.6.1.2; EM&A Log 4.2	(Cont') Site Formation	(Cont') Kong Nga Po Main Site	Water Pollution Control	<ul style="list-style-type: none"> <li>• Appropriate and sufficient wastewater treatment according to Temporary Drainage Management Plan before discharging of wastewater</li> <li>• Regular inspection and maintenance of wastewater treatment facilities</li> <li>• Provision of soil berms, rock check dam and retention pit near excavation area/low-lying region</li> <li>• Cover the stockpiling with appropriate materials</li> <li>• Hard paving or well-compact of main haul road to minimize washout of soil</li> <li>• Slope stabilization such as hydroseeding and shotcrete provision</li> </ul>

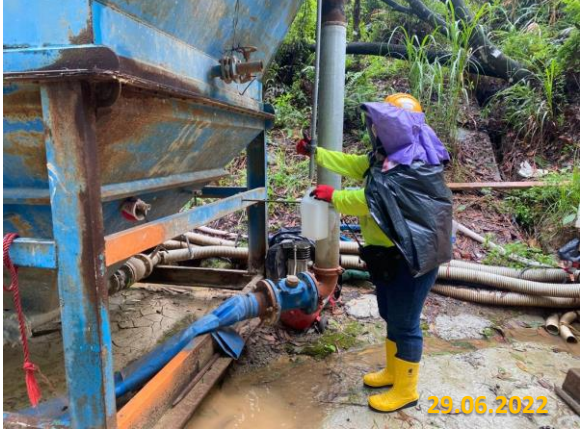
<p>By main contractor at KNP Main Site</p>
EIA 4.4.6; EM&A Log 3.2			Noise	<ul style="list-style-type: none"> <li>Regular inspection and maintenance of plant &amp; equipment in good condition</li> <li>Deploy quality powered mechanical equipment if possible</li> </ul>

Ref*	Proposed Construction Method	Location/Working Period	Anticipated Major Impacts	Recommended Mitigation Measures	Photo Records (Partial)
	(Cont') Site Formation	(Cont') Kong Nga Po Main Site		<ul style="list-style-type: none"> <li>Wheels of all vehicles and plants should be cleaned before leaving the site. The wastewater generated from wheel washing activities will be treated and reused on site</li> </ul>

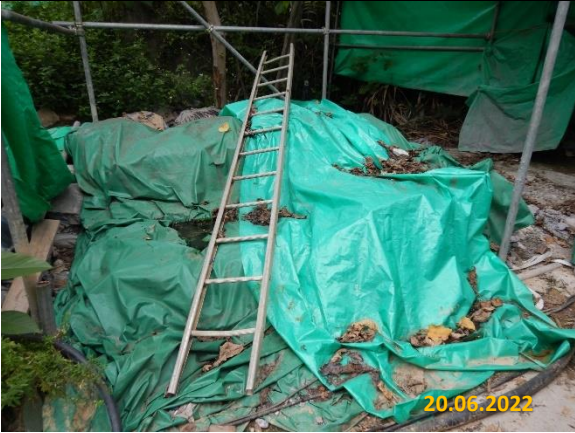
Ref*	Proposed Construction Method	Location/Working Period	Anticipated Major Impacts	Recommended Mitigation Measures	Photo Records (Partial)
EIA 3.91; EM&A Log 2.2	Reinforced Concrete Structure Construction	Kong Nga Po Main Site Kong Nga Po Road	Air	<ul style="list-style-type: none"> <li>Dusty materials that exceeded 20 bags will be stored in area sheltered on top and the three sides or covered entirely by impervious sheeting.</li> </ul>

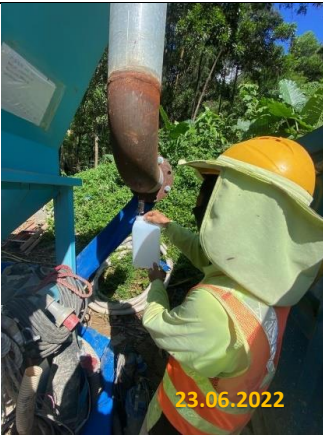
<p>By main contractor at KNP Road</p>

<p>By sub-contractor at KNP Road</p>
EIA 5.6.1.2; EM&A Log 4.2			Water pollution control	<ul style="list-style-type: none"> <li>Soil berm and retention pit will be provided for the control of water outflow</li> <li>Desilting/sedimentation devices will be provided for wastewater treatment prior to discharge</li> <li>Designated location for residual concrete washout</li> </ul>

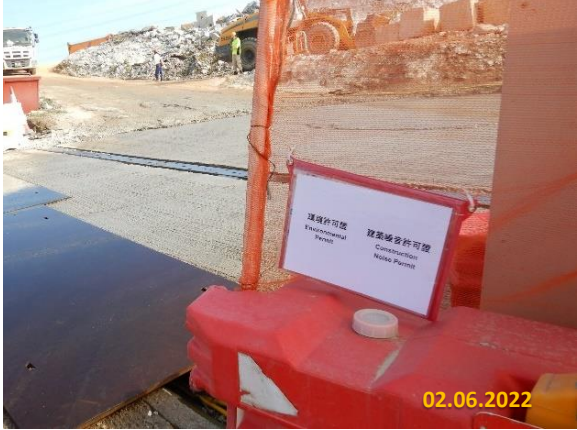
Ref*	Proposed Construction Method	Location/Working Period	Anticipated Major Impacts	Recommended Mitigation Measures	Photo Records (Partial)
EIA 4.4.6; EM&A Log 3.2	(Cont') Reinforced Concrete Structure Construction	(Cont') Kong Nga Po Main Site Kong Nga Po Road	Working in Restricted Hours	<ul style="list-style-type: none"> <li>Valid construction noise permit should be obtained and displayed on site</li> <li>In case of non-compliance with the construction noise criteria, more frequent monitoring and action should be carried out</li> </ul>

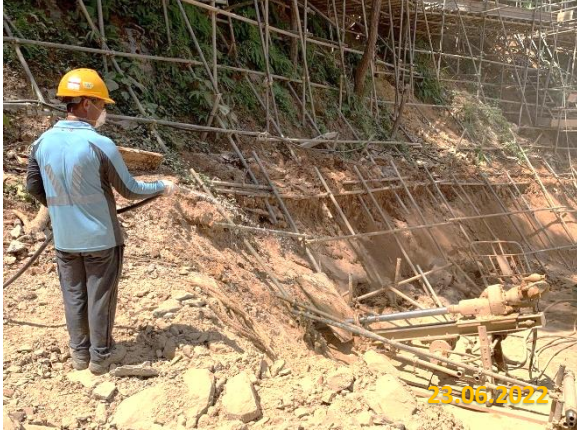
<p>By main contractor at KNP Main Site</p>
EIA 3.91; EM&A Log 2.2	Slope Upgrading Works	Kong Nga Po Main Site Kong Nga Po Road	Dust impact from soil nail works	<ul style="list-style-type: none"> <li>Three side enclosure with top shelter for cement mixing works</li> <li>Water spraying on soil nailing works</li> <li>Dusty materials exceeding 20 bags shall be stored in area sheltered on top and the three sides or covered entirely by impervious sheeting</li> </ul>

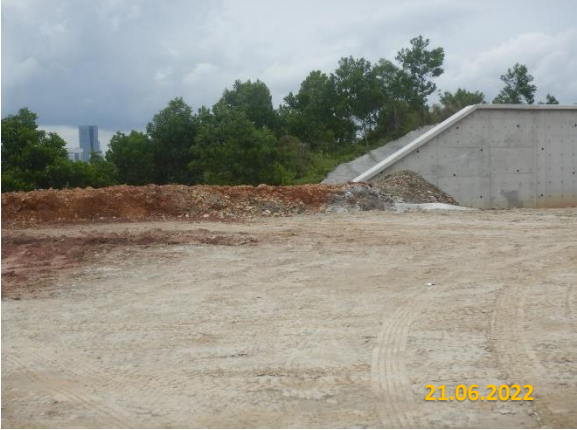
Ref*	Proposed Construction Method	Location/Working Period	Anticipated Major Impacts	Recommended Mitigation Measures	Photo Records (Partial)
EIA 5.6.1.2; EM&A Log 4.2	(Cont') Slope Upgrading Works	(Cont') Kong Nga Po Main Site Kong Nga Po Road	Water	<ul style="list-style-type: none"> <li>• Deploy desilting/sedimentation devices for wastewater treatment prior to discharge</li> <li>• Establish soil berm with retention pit to control water outflow.</li> </ul>

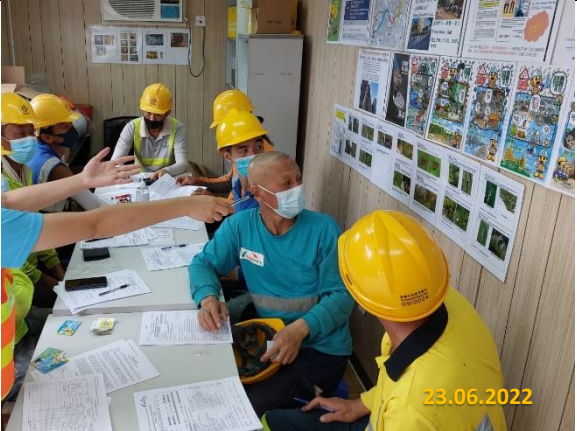
<p>By sub-contractor at KNP Main Site</p>
EIA 10.11, EM&A Log 9.4			Ecology Concern	<ul style="list-style-type: none"> <li>• Provide training to frontline workers for the conservative species</li> <li>• Provision of protective fence for the conservative species</li> <li>• Regular inspection for concerned vegetation</li> </ul>

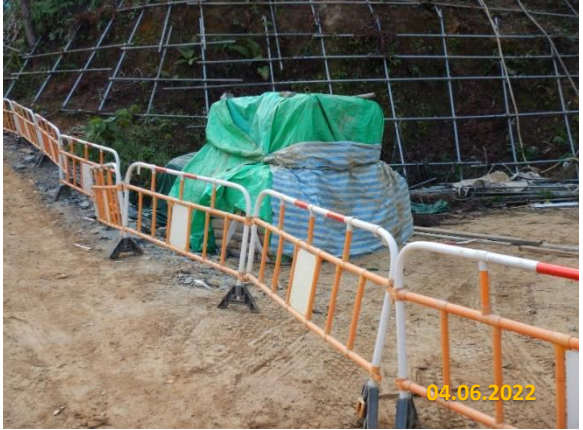
Ref*	Proposed Construction Method	Location/Working Period	Anticipated Major Impacts	Recommended Mitigation Measures	Photo Records (Partial)
EIA 3.91; EM&A Log 2.2	Trenchless Works	Kong Nga Po Road Man Kam To Road	Air Pollution	<ul style="list-style-type: none"> <li>• Regular inspection and maintenance of plant and equipment in good condition</li> <li>• Regularly clean up stockpiles and debris to avoid accumulation of materials</li> <li>• Dusty materials exceeding 20 bags shall be stored in area sheltered on top and the three sides or covered entirely by impervious sheeting.</li> </ul>

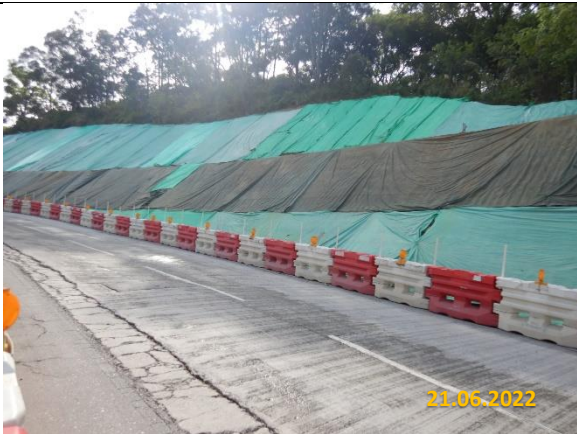
Ref*	Proposed Construction Method	Location/Working Period	Anticipated Major Impacts	Recommended Mitigation Measures	Photo Records (Partial)
EIA Table 10.11 EM&A Table 9.1	(Cont') Trenchless Works	(Cont') Kong Nga Po Road Man Kam To Road	Landscape and visual impact	<ul style="list-style-type: none"> <li>• Properly fenced off the conservative species</li> <li>• Properly implement temporary traffic arrangement which control construction area to minimize landscape and visual impacts</li> </ul>	  <p data-bbox="1415 868 1792 900">By sub-contractor at KNP Road</p>
EIA 3.91; EM&A Log 2.2	Road and Associated Works	Kong Nga Po Main Site Kong Nga Po Road	Air Pollution	<ul style="list-style-type: none"> <li>• Regular inspection and maintenance of plant and equipment in good condition</li> <li>• Regularly clean up stockpiles and debris to avoid accumulation of materials</li> </ul>

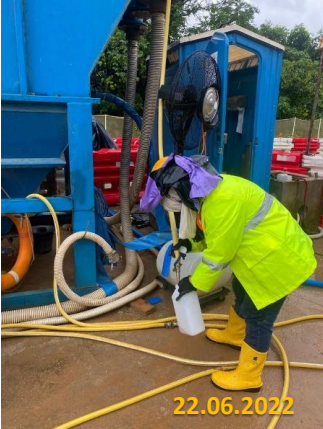
Ref*	Proposed Construction Method	Location/Working Period	Anticipated Major Impacts	Recommended Mitigation Measures	Photo Records (Partial)
EIA 5.6.1.2; EM&A Log 4.2	(Cont') Road and Associated Works	(Cont') Kong Nga Po Main Site Kong Nga Po Road	Water Pollution	<ul style="list-style-type: none"> <li>• Provide desilting/sedimentation devices for wastewater treatment before discharge</li> </ul>

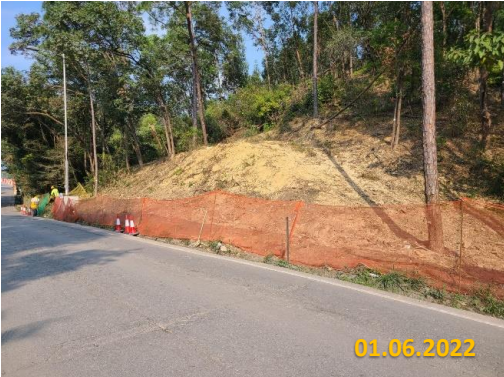
<p>By main contractor at KNP Road</p>
EIA Table 10.11 EM&A Table 9.1			Landscape and visual impact	<ul style="list-style-type: none"> <li>• Properly fenced off the conservative species</li> <li>• Properly implement temporary traffic arrangement which control construction area to minimize landscape and visual impacts</li> </ul>
