**EP-510/2016 – Police Facilities in Kong Nga Po**

**Service Contract No. NDO 07/2019  
Environmental Team for Site Formation and  
Infrastructure Works for Police Facilities in  
Kong Nga Po**

**Monthly Environmental Monitoring and  
Audit Report for August 2022  
(Version 1.0)**

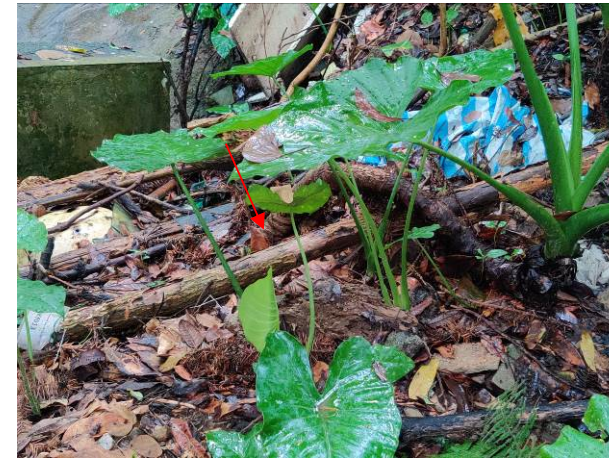
Photo 12

Description: An undersized seedling of *Keteleeria fortunei* (F-0081) was found collapsed due to internal decay.

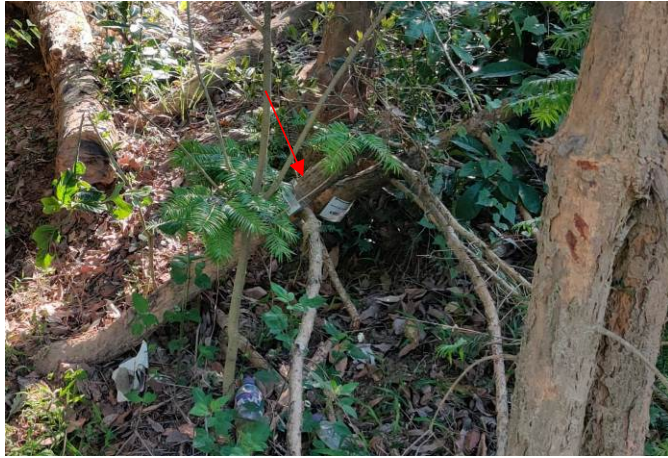
Photo 13

Description: An undersized seedling of *Keteleeria fortunei* (F-0051) was found uprooted by the nearby fallen tree.

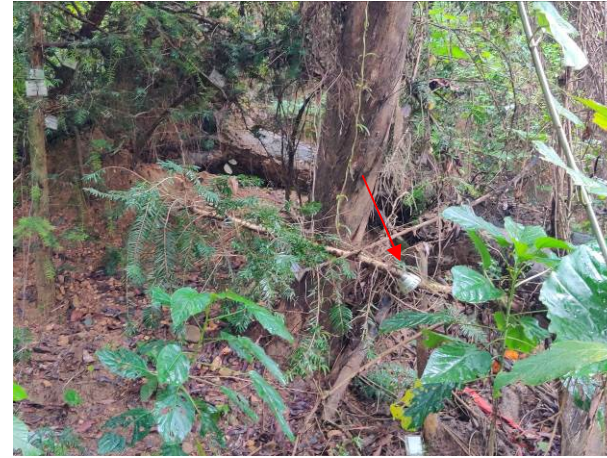
Photo 14

Description: An undersized seedling of *Keteleeria fortunei* (F-0015) was found uprooted by the nearby fallen tree

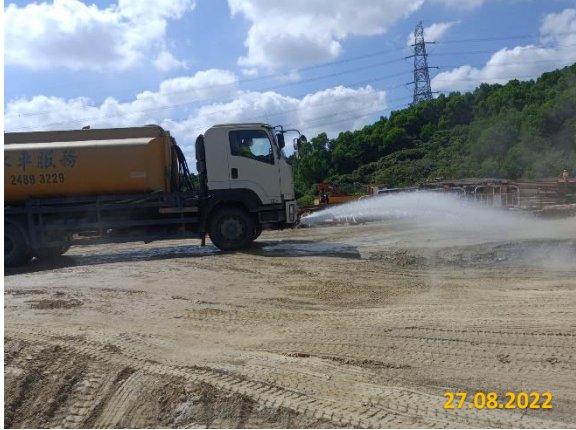
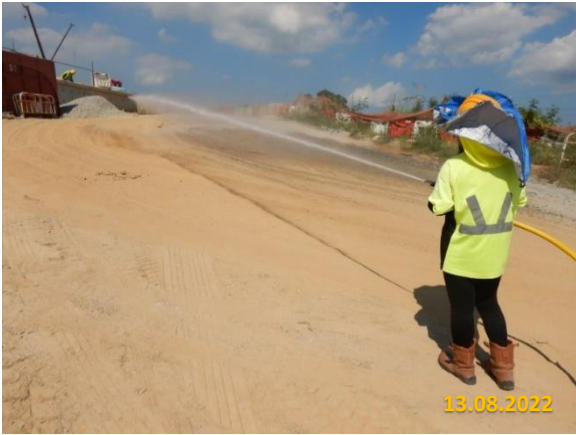
Ref*	Proposed Construction Method	Location/Working Period	Anticipated Major Impacts	Recommended Mitigation Measures	Photo Records (Partial)
EIA 3.91; EM&A Log 2.2	Site Formation	Kong Nga Po Main Site	Dust impact from excavation activities	<ul style="list-style-type: none"> <li>• Deploy water bowser for regular water spraying to enhance dust suppression</li> <li>• Manual water spraying for dusty operation where inaccessible by water bowser</li> <li>• Speed control of site transportation</li> <li>• Stockpile of dusty materials will be covered by tarpaulin to avoid wind-blown dust</li> <li>• Vehicles used for transporting dusty materials/spoils will be covered by mechanical cover before leaving the site</li> <li>• Wheel washing facilities had been provided and cleaning the wheel of all vehicles before leaving the site</li> </ul>

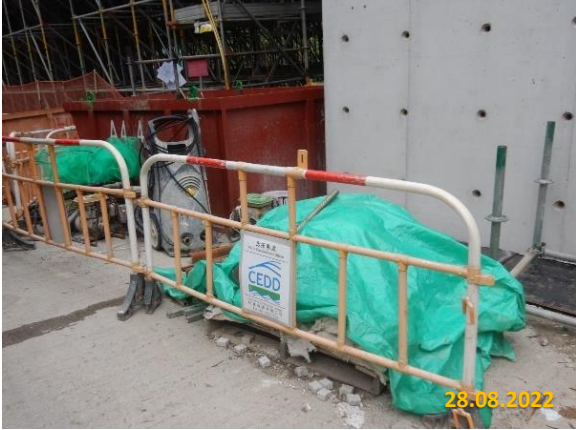
Ref*	Proposed Construction Method	Location/Working Period	Anticipated Major Impacts	Recommended Mitigation Measures	Photo Records (Partial)
EIA 3.91; EM&A Log 2.2	Reinforced Concrete Structure Construction	Kong Nga Po Main Site Kong Nga Po Road	Air	<ul style="list-style-type: none"> <li>Dusty materials that exceeded 20 bags will be stored in area sheltered on top and the three sides or covered entirely by impervious sheeting.</li> </ul>

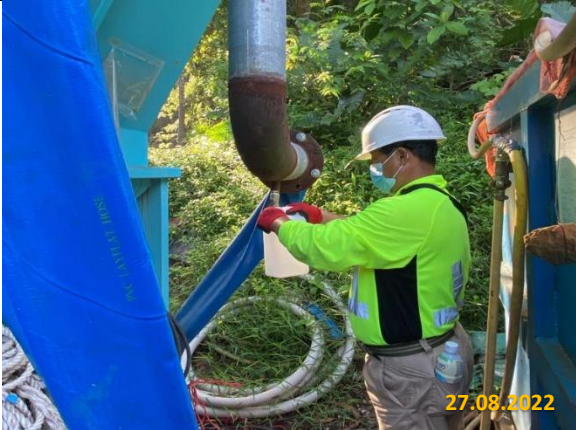
<p>By sub-contractor at KNP road</p>
EIA 5.6.1.2; EM&A Log 4.2			Waste water pollution control	<ul style="list-style-type: none"> <li>Soil berm and retention pit will be provided for the control of water outflow</li> <li>Desilting/sedimentation devices will be provided for wastewater treatment prior to discharge</li> <li>Designated location for residual concrete washout</li> </ul>
