EP-510/2016 – Police Facilities in Kong Nga Po

**Service Contract No. NDO 07/2019
Environmental Team for Site Formation and
Infrastructure Works for Police Facilities in
Kong Nga Po**

**Monthly Environmental Monitoring and
Audit Report for September 2022
(Version 1.0)**

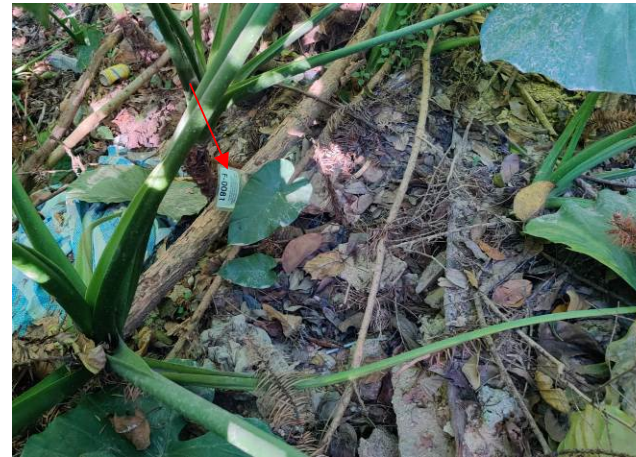
Photo 13

Description: An undersized seedling of *Keteleeria fortunei* (F-0081) was found collapsed due to internal decay.

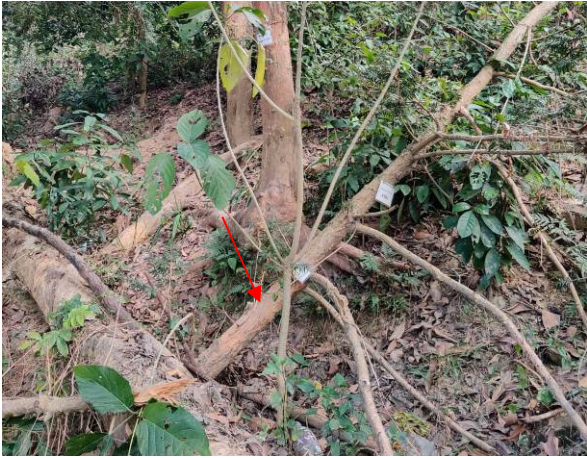
Photo 14

Description: An undersized seedling of *Keteleeria fortunei* (F-0051) was found uprooted by the nearby fallen tree.

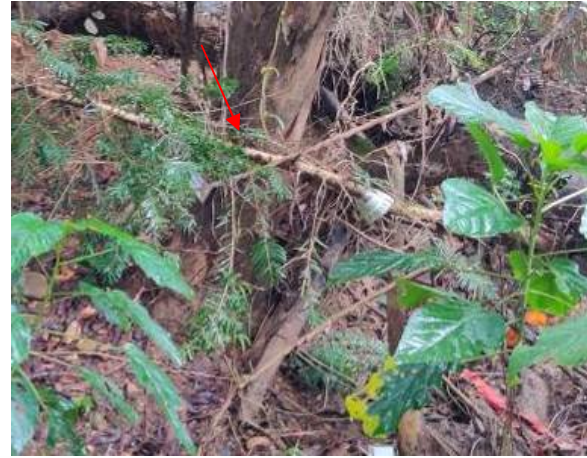
Description: An undersized seedling of *Keteleeria fortunei* (F-0015) was found uprooted by the nearby fallen tree

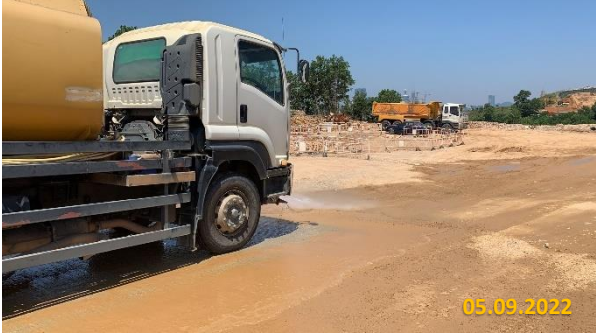
<p>05.09.2022</p> <p>By main contractor at KNP Main Site</p>

Ref*	Proposed Construction Method	Location/Working Period	Anticipated Major Impacts	Recommended Mitigation Measures	Photo Records (Partial)
EIA 3.91; EM&A Log 2.2	Site Formation	Kong Nga Po Main Site	Dust impact from excavation activities	<ul style="list-style-type: none"> • Deploy water bowser for regular water spraying to enhance dust suppression • Manual water spraying for dusty operation where inaccessible by water bowser • Speed control of site transportation • Stockpile of dusty materials will be covered by tarpaulin to avoid wind-blown dust • Vehicles used for transporting dusty materials/spoils will be covered by mechanical cover before leaving the site • Wheel washing facilities had been provided and cleaning the wheel of all vehicles before leaving the site

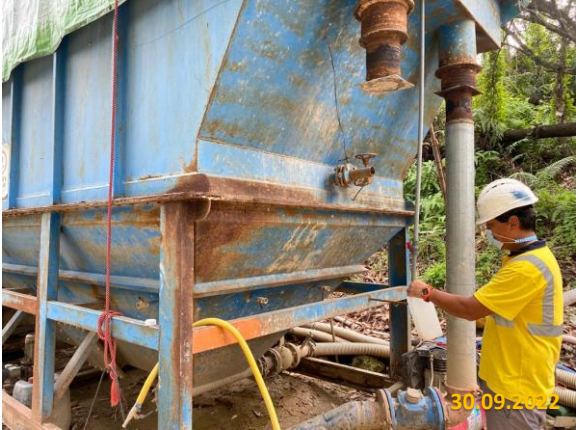
<p>By main contractor at KNP Main Site</p>
EIA 5.6.1.2; EM&A Log 4.2			Water Pollution Control	<ul style="list-style-type: none"> • Appropriate and sufficient wastewater treatment according to Temporary Drainage Management Plan before discharging of wastewater • Regular inspection and maintenance of wastewater treatment facilities • Provision of soil berms, rock check dam and retention pit near excavation area/low-lying region

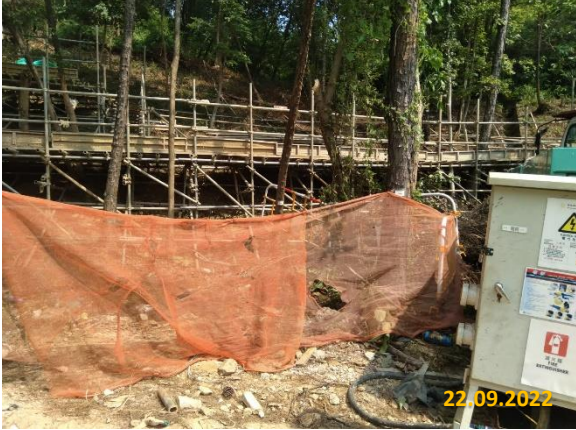
<p>By main contractor at KNP Main Site</p>

<p>By sub-contractor at KNP Main Site</p>
EIA 10.11, EM&A Log 9.4			Ecology Concern	<ul style="list-style-type: none"> • Provision of protective fence for the conservative species • Regular inspection for concerned vegetation and conservative species • Regular inspection and maintenance of plant & equipment in good condition • Deploy quality powered mechanical equipment if possible
