**EP-510/2016 – Police Facilities in Kong Nga Po**

**Service Contract No. NDO 07/2019  
Environmental Team for Site Formation and  
Infrastructure Works for Police Facilities in  
Kong Nga Po**

**Monthly Environmental Monitoring and  
Audit Report for October 2022  
(Version 1.0)**

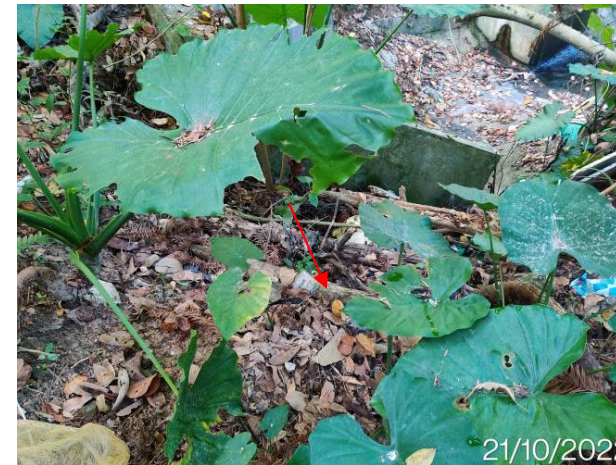
Photo 12

Description: An undersized seedling of *Keteleeria fortunei* (F-0081) was found collapsed due to internal decay.

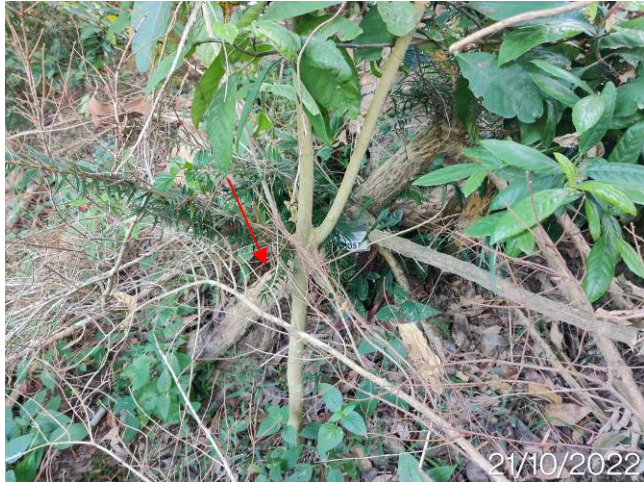
Photo 13

Description: An undersized seedling of *Keteleeria fortunei* (F-0051) was found uprooted by the nearby fallen tree.

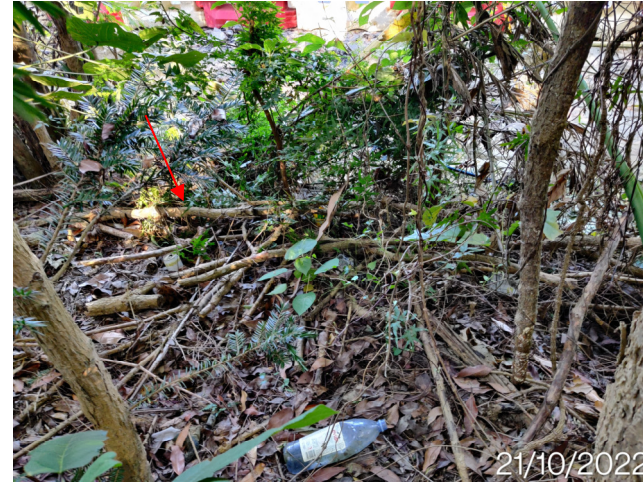
Photo 14

Description: An undersized seedling of *Keteleeria fortunei* (F-0015) was found uprooted by the nearby fallen tree

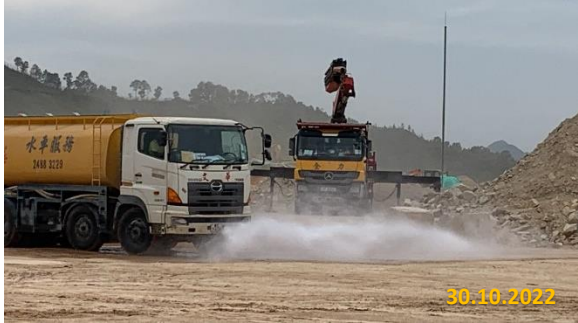
Ref*	Proposed Construction Method	Location/Working Period	Anticipated Major Impacts	Recommended Mitigation Measures	Photo Records (Partial)
EIA 3.91; EM&A Log 2.2	Site Formation	Kong Nga Po Main Site	Dust impact from excavation activities	<ul style="list-style-type: none"> <li>• Deploy water bowser for regular water spraying to enhance dust suppression</li> <li>• Manual water spraying for dusty operation where inaccessible by water bowser</li> <li>• Speed control of site transportation</li> <li>• Stockpile of dusty materials will be covered by tarpaulin to avoid wind-blown dust</li> <li>• Vehicles used for transporting dusty materials/spoils will be covered by mechanical cover before leaving the site</li> <li>• Wheel washing facilities had been provided and cleaning the wheel of all vehicles before leaving the site</li> </ul>

<p>By main contractor at KNP Main Site</p>

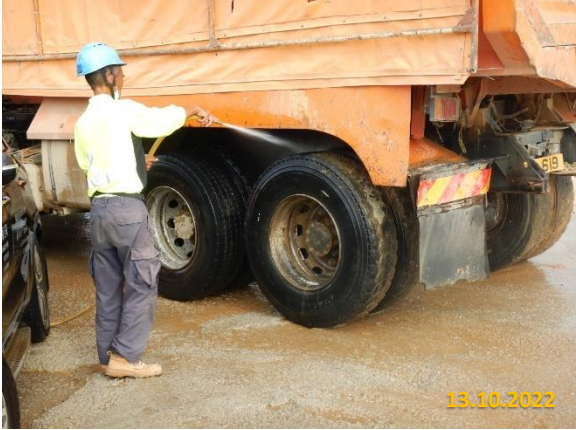
<p>By main contractor at KNP Main Site</p>
EIA 5.6.1.2; EM&A Log 4.2			Water Pollution Control	<ul style="list-style-type: none"> <li>• Appropriate and sufficient wastewater treatment according to Temporary Drainage Management Plan before discharging of wastewater</li> <li>• Regular inspection and maintenance of wastewater treatment facilities</li> <li>• Provision of soil berms, rock check dam and retention pit near excavation area/low-lying region</li> </ul>

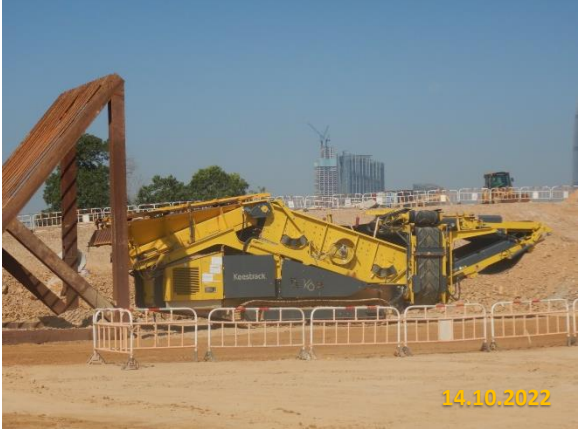
<p>By sub-contractor at KNP Main Site</p>
EIA 10.11, EM&A Log 9.4			Ecology Concern	<ul style="list-style-type: none"> <li>• Provision of protective fence for the conservative species</li> <li>• Regular inspection for concerned vegetation and conservative species</li> <li>• Regular inspection and maintenance of plant &amp; equipment in good condition</li> <li>• Deploy quality powered mechanical equipment if possible</li> </ul>

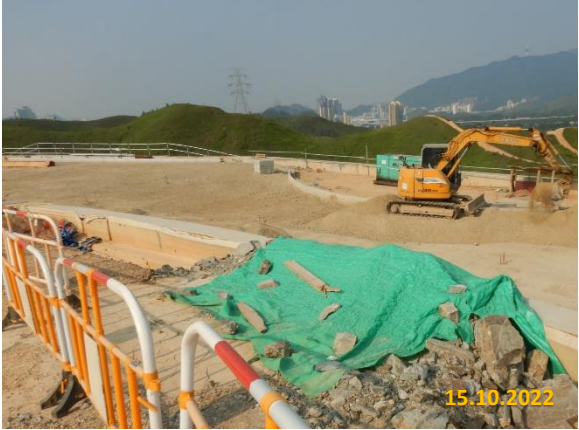
<p>By sub-contractor at KNP road</p>
EIA 5.6.1.2; EM&A Log 4.2			Waste water pollution control	<ul style="list-style-type: none"> <li>Soil berm and retention pit will be provided for the control of water outflow</li> <li>Desilting/sedimentation devices will be provided for wastewater treatment prior to discharge</li> <li>Designated location for residual concrete washout</li> </ul>
