EP-510/2016 – Police Facilities in Kong Nga Po

**Service Contract No. NDO 07/2019
Environmental Team for Site Formation and
Infrastructure Works for Police Facilities in
Kong Nga Po**

**Monthly Environmental Monitoring and
Audit Report for December 2022
(Version 2.0)**

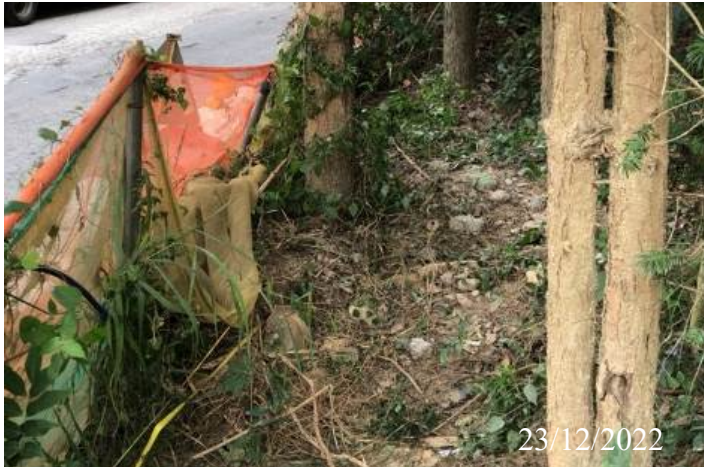
Photo 11

Description: No construction materials / wastes were observed within the protection zone for *Keteleeria fortunei*.

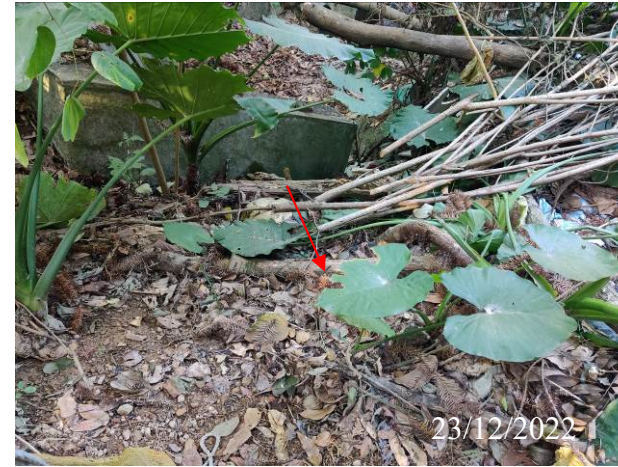
Photo 12

Description: An undersized seedling of *Keteleeria fortunei* (F-0081) was found collapsed due to internal decay.

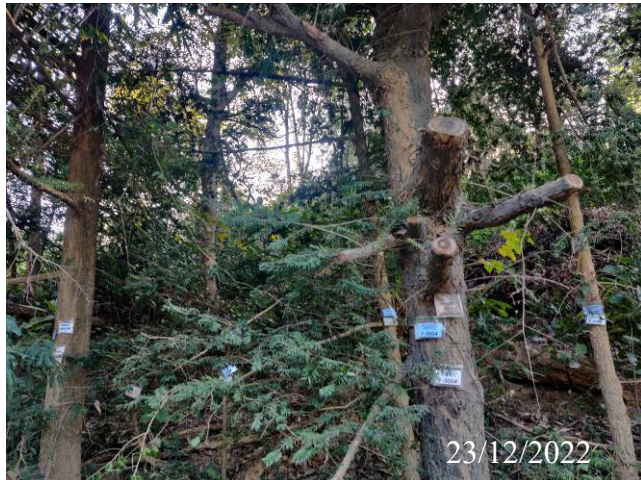
Photo 13

Description: The Contractor was reminded again to arrange the landscape specialist to inspect the health condition of *Keteleeria fortunei* in which the branches were cut.

- 1) Coordinate and arrange landscape specialist to visit / monitor those *Keteleeria fortune* with broken branches;
- 2) To arrange the new tags for those *Brainea insignis* with missing tags;
- 3) To replace the faded plant labels identified in the receptor site.

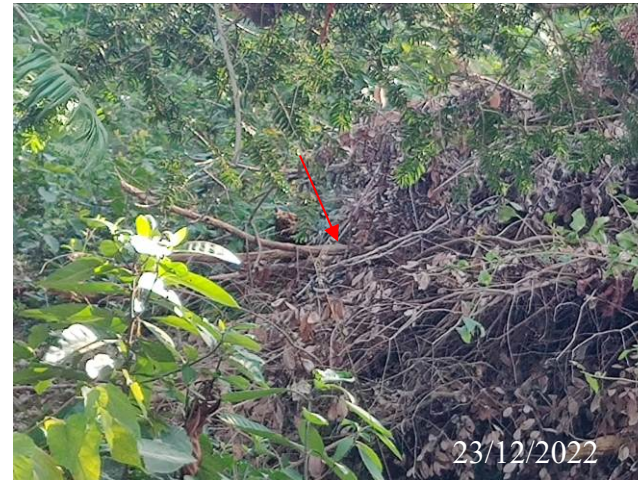
Photo 14

Description: An undersized seedling of *Keteleeria fortunei* (F-0052) was found dead. Poor health condition was recorded during the baseline vegetation survey.

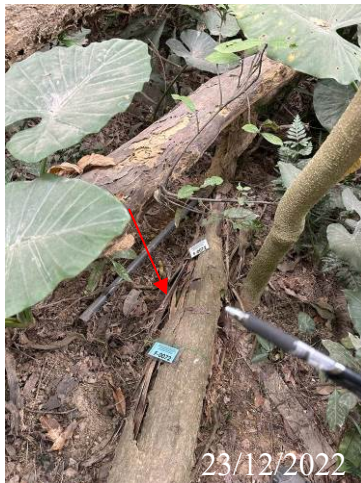
Photo 15

Description: *Keteleeria fortunei* (F-0072) was found dead. Poor health condition was recorded during the baseline vegetation survey.
