EP-510/2016 – Police Facilities in Kong Nga Po

**Service Contract No. NDO 07/2019
Environmental Team for Site Formation and
Infrastructure Works for Police Facilities in
Kong Nga Po**

**Monthly Environmental Monitoring and
Audit Report for January 2023
(Version 1.0)**

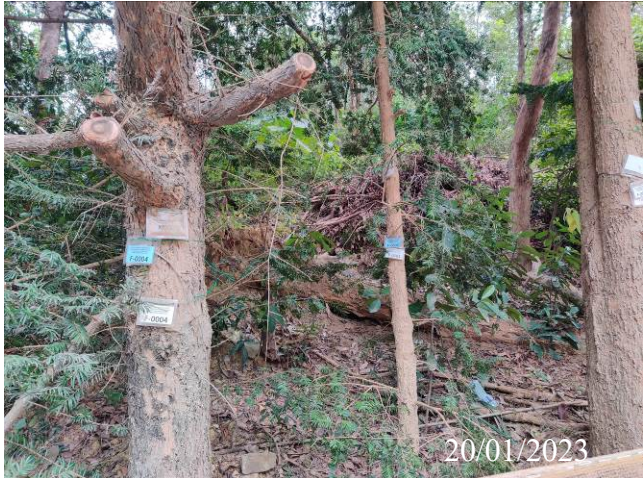
Photo 13

Description: The Contractor was reminded again to arrange the landscape specialist to provide mitigation measures / follow up action for those *Keteleeria fortune* with broken branches.

5.1 and photographic record and checklists for monthly monitoring are shown in **Appendix H**. The health conditions of the transplanted / retained species are generally in fair to poor condition. The Contractor was reminded to closely monitor the transplanted species and implemented the protection measures according to the approved transplantation proposal to protect the transplanted / retained species. In addition, the Contractor was also reminded to coordinate with the landscape specialist to provide mitigation measures / follow up actions for those *Keteleeria fortunei* with broken branches.

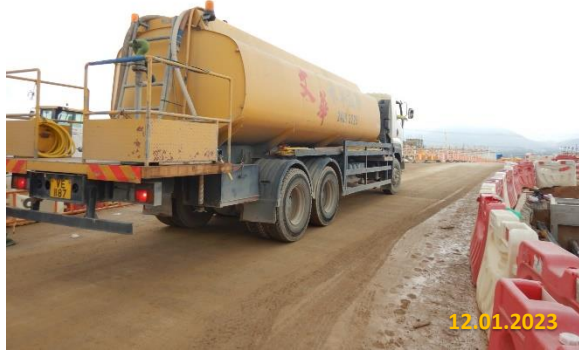
Ref*	Proposed Construction Method**	Location/Working Period	Anticipated Major Impacts	Recommended Mitigation Measures	Photo Records (Partial)
EIA 3.91; EM&A Log 2.2	Site Formation	Kong Nga Po Main Site	Dust impact from excavation activities and earth moving	<ul style="list-style-type: none"> • Use of regular water spraying (once every 1.25 hours or 8 times per day) at all active works area exposed site surfaces and unpaved roads, particularly during dry weather • Deploy water bowser for regular water spraying to enhance dust suppression • Manual water spraying for dusty operation where inaccessible by water bowser • Speed control of site transportation • Stockpile of dusty materials will be covered by tarpaulin to avoid wind-blown dust • Vehicles used for transporting dusty materials/spoils will be covered by mechanical cover before leaving the site • Wheel washing facilities had been provided and cleaning the wheel of all vehicles before leaving the site

<p>12.01.2023</p> <p>By main contractor at KNP Main Site</p>

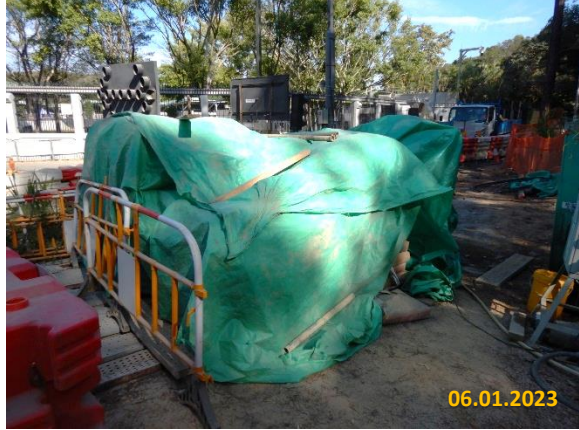
Ref*	Proposed Construction Method**	Location/Working Period	Anticipated Major Impacts	Recommended Mitigation Measures	Photo Records (Partial)
EIA 3.91; EM&A Log 2.2	Reinforced Concrete Structure Construction Including Bridge Deck	Kong Nga Po Main Site Kong Nga Po Road	Air	<ul style="list-style-type: none"> Dusty materials that exceeded 20 bags will be stored in area sheltered on top and the three sides or covered entirely by impervious sheeting.

<p>By sub-contractor at KNP road</p>
EIA 5.6.1.2; EM&A Log 4.2			Waste water pollution control	<ul style="list-style-type: none"> Soil berm and retention pit will be provided for the control of water outflow Desilting/sedimentation devices will be provided for wastewater treatment prior to discharge Designated location for residual concrete washout

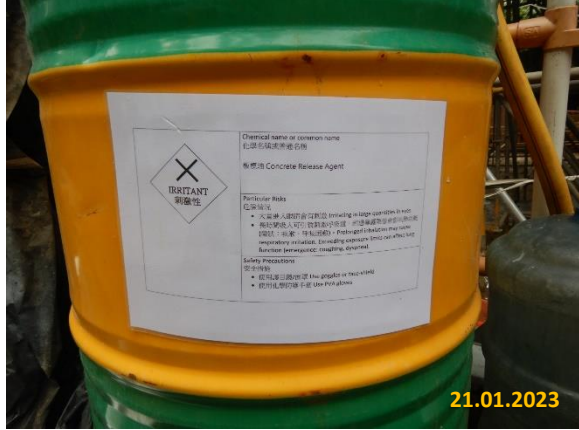
Ref*	Proposed Construction Method**	Location/Working Period	Anticipated Major Impacts	Recommended Mitigation Measures	Photo Records (Partial)
EIA 7.5.1.4; EM&A Log 6.2			Chemicals for concreting works	<ul style="list-style-type: none"> Chemical for concreting works should be stored in designated area with proper labelling and packing Designated location for residual concrete washout

<p>21.01.2023</p> <p>By sub-contractor at KNP Road</p>
EIA 3.91; EM&A Log 2.2	Slope Upgrading Works	Kong Nga Po Main Site Kong Nga Po Road	Dust impact from soil nail works	<ul style="list-style-type: none"> Three side enclosure with top shelter for cement mixing works Water spraying on soil nailing works Dusty materials exceeding 20 bags shall be stored in area sheltered on top and the three sides or covered entirely by impervious sheeting
