EP-510/2016 – Police Facilities in Kong Nga Po

**Service Contract No. NDO 07/2019
Environmental Team for Site Formation and
Infrastructure Works for Police Facilities in
Kong Nga Po**

**Monthly Environmental Monitoring and
Audit Report for February 2023
(Version 1.0)**

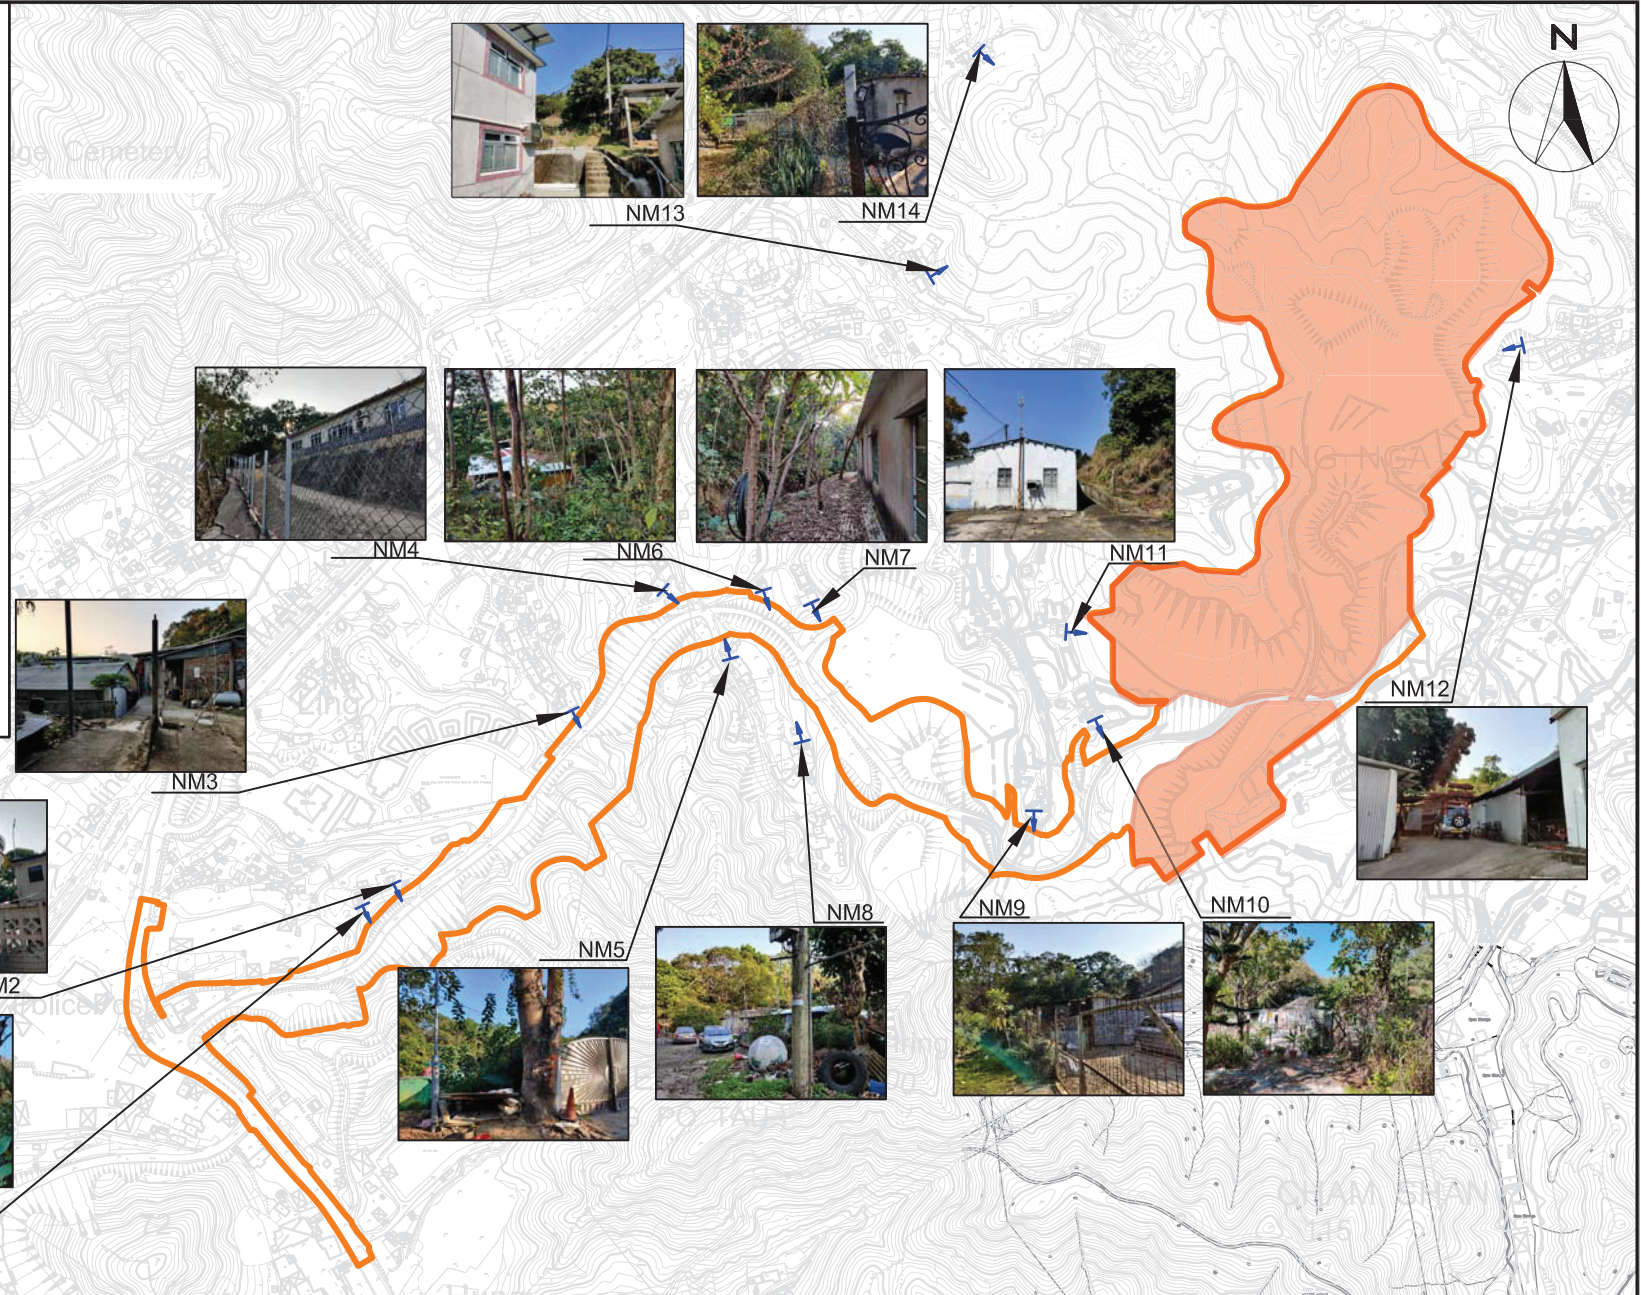
Service Contract No. NDO 07/2019
 Environmental Team for Site Formation and Infrastructure Works for Police Facilities in Kong Nga Po
Noise Monitoring Stations

Noise Monitoring Stations	
ID	Description
NM1	Village House, Sha Ling
NM2	Village House, Sha Ling
NM3	Village House No. 248, Sha Ling
NM4	Village House, Sha Ling
NM5	Village House No. 270, Sha Ling
NM6	Village House, Sha Ling
NM7	Village House, Sha Ling
NM8	Village House, Sha Ling
NM9	Village House, Kong Nga Po
NM10	Village House, Kong Nga Po
NM11	Village House, Kong Nga Po
NM12	Village House, Kong Nga Po
NM13	Village House, Kong Nga Po
NM14	Village House, near Man Kam To Road

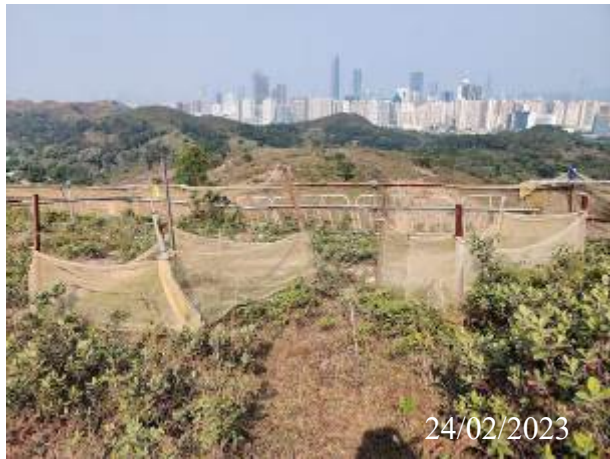
Photo 5

Description: Protective fence for transplanted *Spiranthes sinensis* are properly erected.

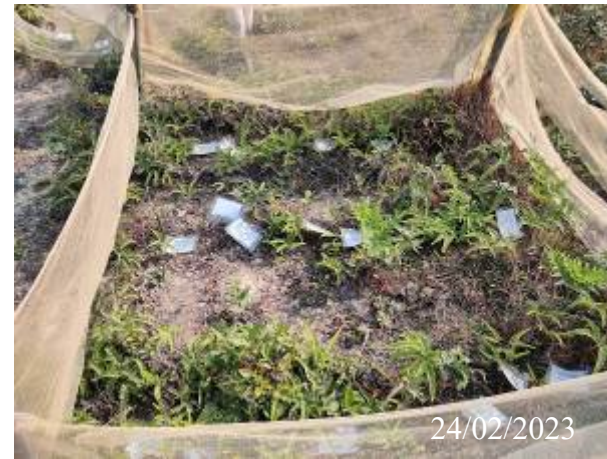
Photo 6

Description: Protective fence for transplanted *Spiranthes sinensis* are properly erected.

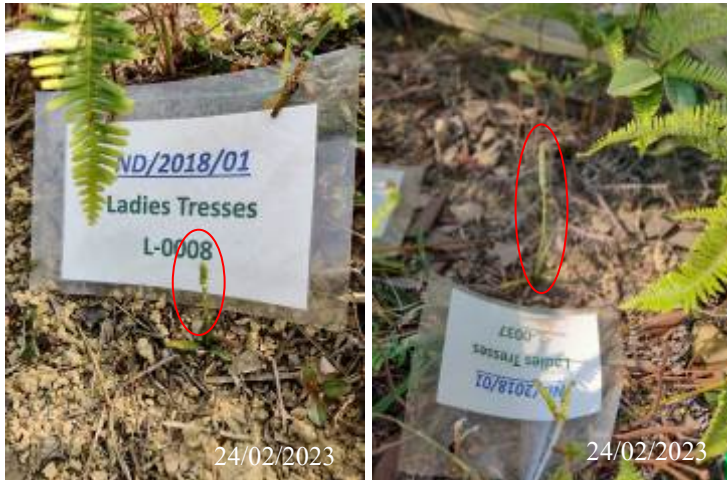
Photo 7

Description: Flower buds of *Spiranthes sinensis* are observed.

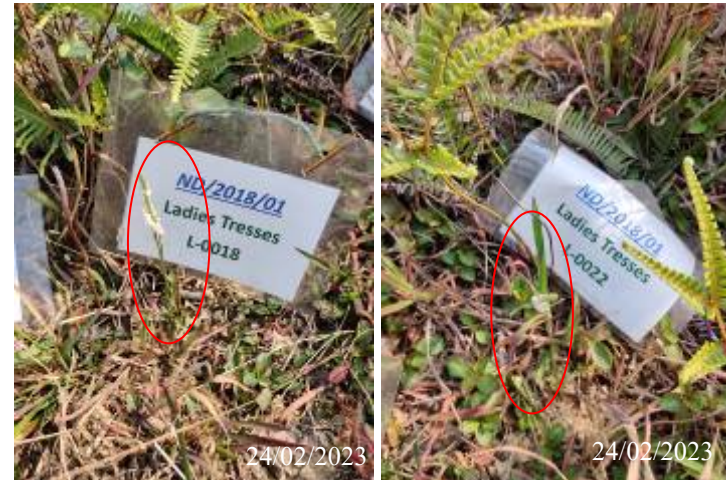
Photo 8

Description: Flowering of *Spiranthes sinensis* are observed.

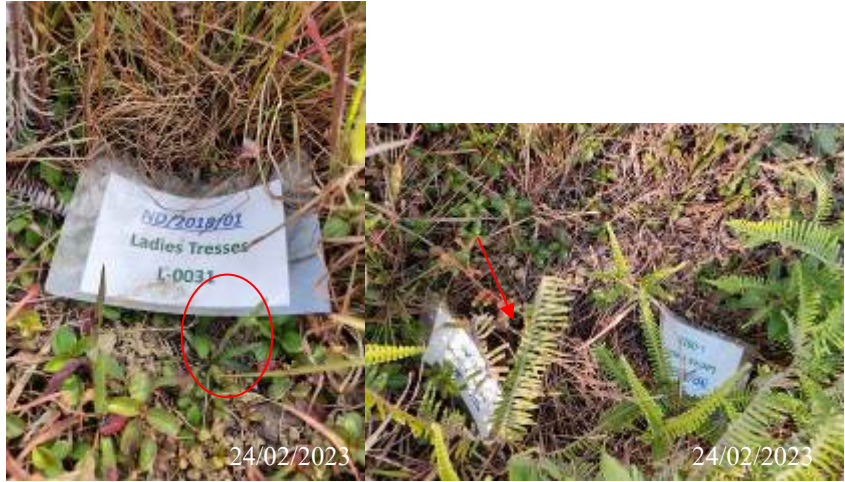
Photo 9

Description: Flower buds of *Spiranthes sinensis* are observed.

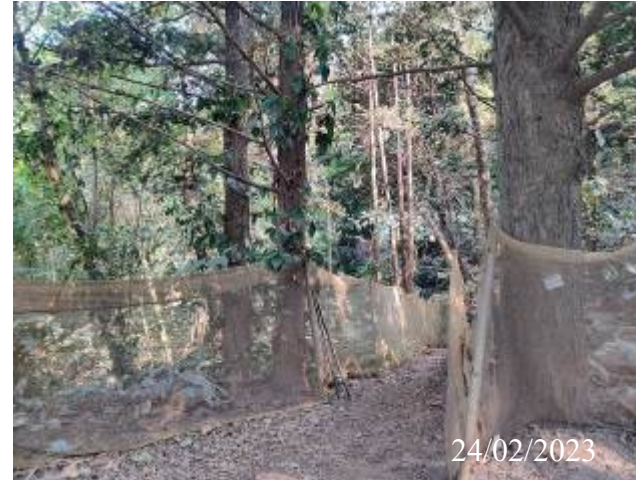
Photo 11

Description: Protective fence for *Keteleeria fortunei* are properly erected.

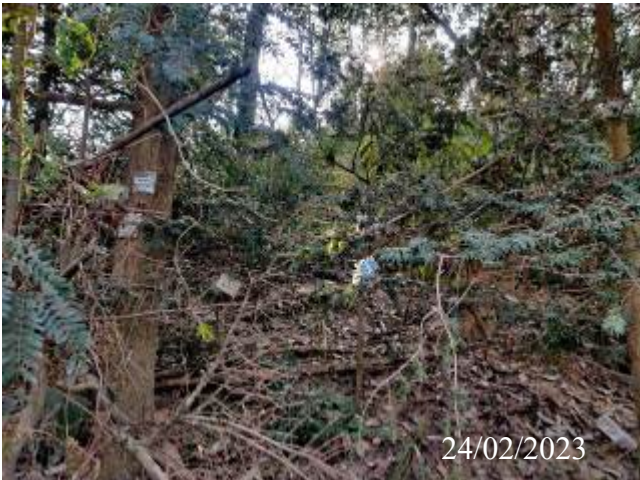
Photo 12

Description: General view of *Keteleeria fortunei*

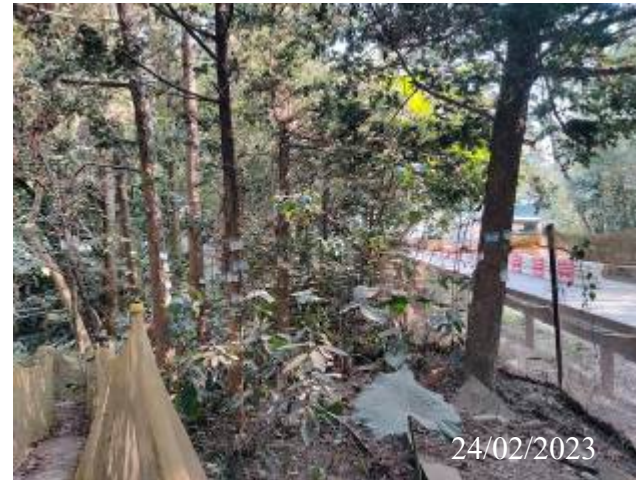
Photo 13

Description: General view of *Keteleeria fortunei*

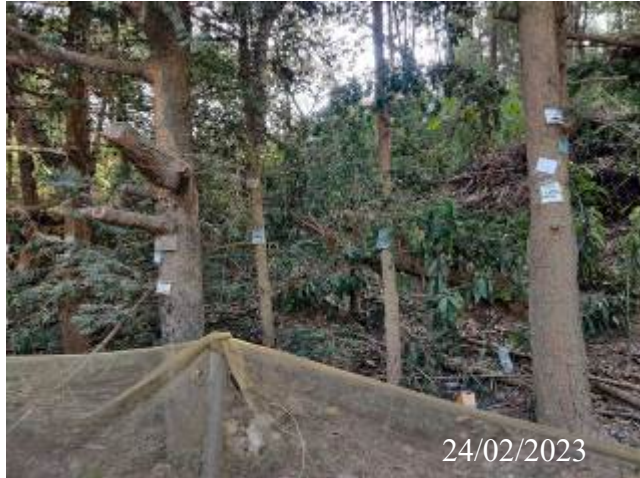
Photo 14

Description: The Contractor has arranged Landscape Specialist to visit those *Keteleeria fortune* with broken branches. According to Landscape Specialist, no action is required at this stage. The Contractor was reminded to closely monitor the health condition of those *Keteleeria fortune* with hard pruned.

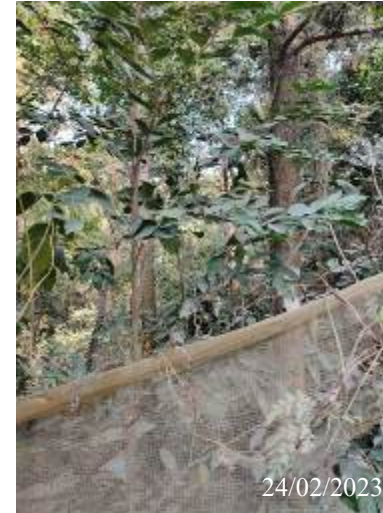
Photo 16

Description: General view of undersized seedling of *Aquilaria sinensis*

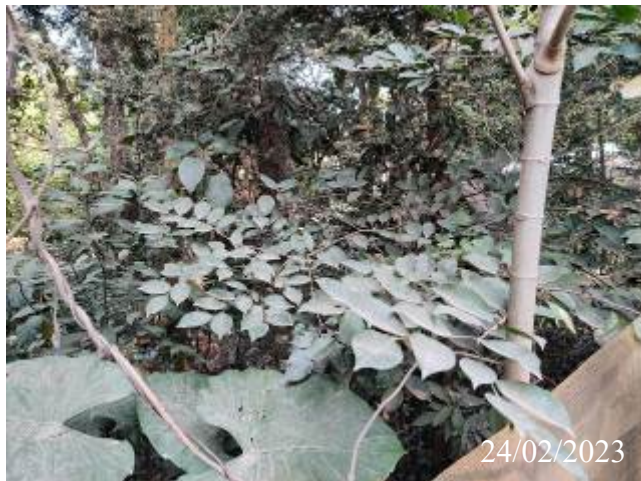
Photo 17

Description: General view of undersized seedling of *Aquilaria sinensis*

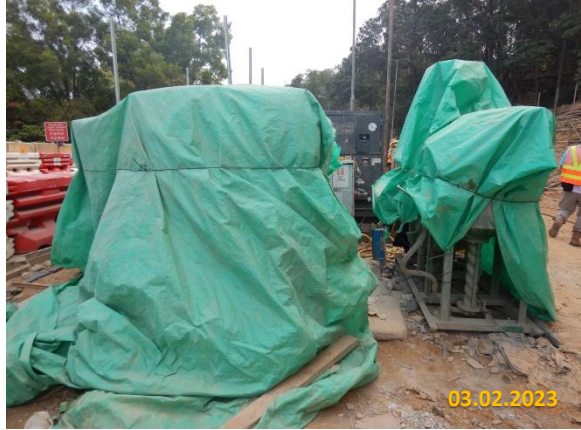
Ref*	Proposed Construction Method**	Location/Working Period	Anticipated Major Impacts	Recommended Mitigation Measures	Photo Records (Partial)
EIA 3.91; EM&A Log 2.2	Reinforced Concrete Structure Construction Including Bridge Deck	Kong Nga Po Main Site Kong Nga Po Road	Air	<ul style="list-style-type: none"> Dusty materials that exceeded 20 bags will be stored in area sheltered on top and the three sides or covered entirely by impervious sheeting.

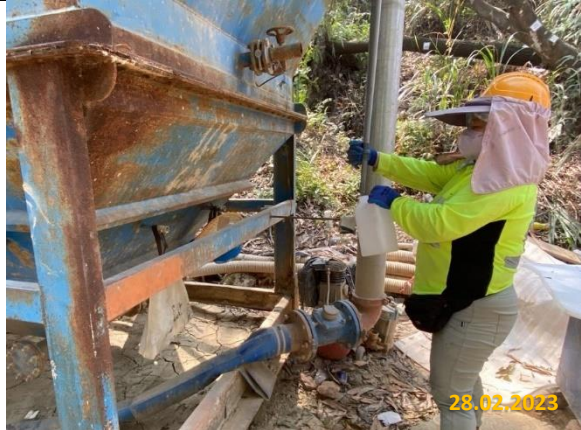
<p>03.02.2023</p> <p>By sub-contractor at KNP road</p>
EIA 5.6.1.2; EM&A Log 4.2			Waste water pollution control	<ul style="list-style-type: none"> Soil berm and retention pit will be provided for the control of water outflow Desilting/sedimentation devices will be provided for wastewater treatment prior to discharge Designated location for residual concrete washout

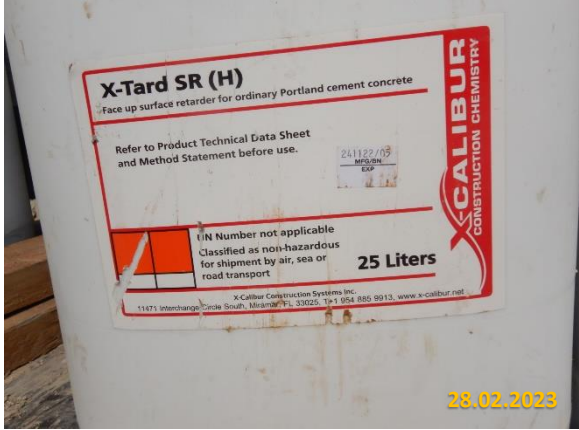
Ref*	Proposed Construction Method**	Location/Working Period	Anticipated Major Impacts	Recommended Mitigation Measures	Photo Records (Partial)
EIA 7.5.1.4; EM&A Log 6.2	(Cont') Reinforced Concrete Structure Construction Including Bridge Deck	(Cont') Kong Nga Po Main Site Kong Nga Po Road	Chemicals for concreting works	<ul style="list-style-type: none"> Chemical for concreting works should be stored in designated area with proper labelling and packing Designated location for residual concrete washout

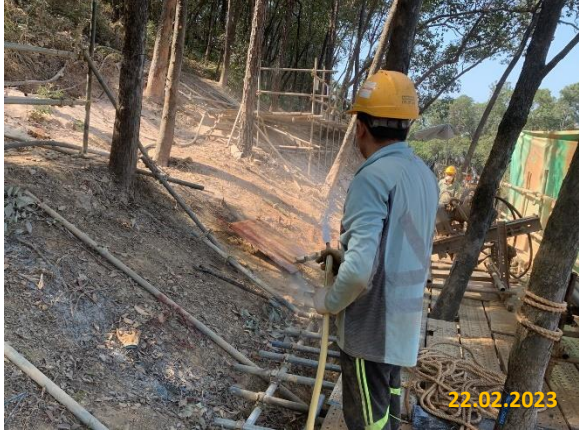
<p>By sub-contractor at KNP Road</p>
EIA 3.91; EM&A Log 2.2	Slope Upgrading Works	Kong Nga Po Main Site Kong Nga Po Road	Dust impact from soil nail works	<ul style="list-style-type: none"> Three side enclosure with top shelter for cement mixing works Water spraying on soil nailing works Dusty materials exceeding 20 bags shall be stored in area sheltered on top and the three sides or covered entirely by impervious sheeting

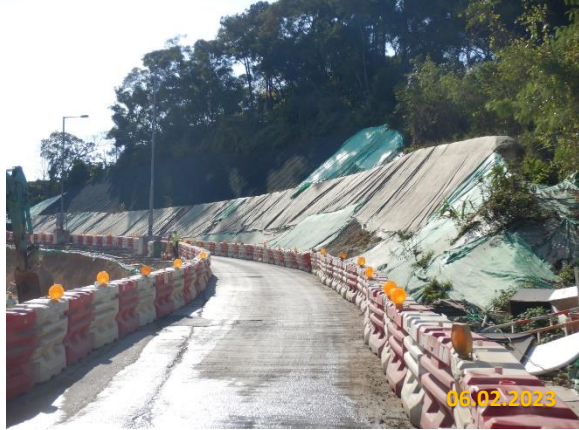
Ref*	Proposed Construction Method**	Location/Working Period	Anticipated Major Impacts	Recommended Mitigation Measures	Photo Records (Partial)
EIA 5.6.1.2; EM&A Log 4.2	(Cont') Slope Upgrading Works	(Cont') Kong Nga Po Main Site Kong Nga Po Road	Water	<ul style="list-style-type: none"> • Deploy desilting/sedimentation devices for wastewater treatment prior to discharge • Establish soil berm with retention pit to control water outflow

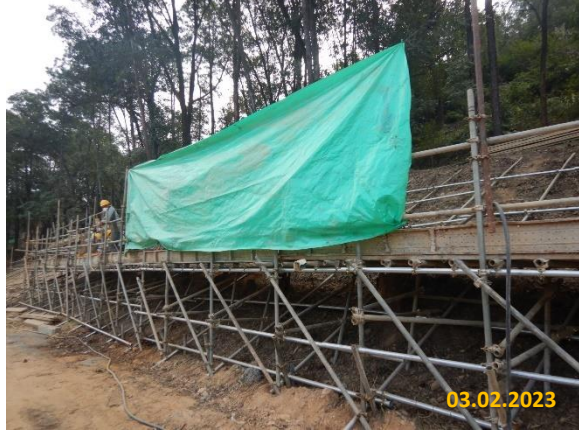
<p>By sub-contractor at KNP Main Site</p>
EIA 4.4.6; EM&A Log 3.2			Noise	<ul style="list-style-type: none"> • Regular inspection and maintenance of plant and equipment in good condition • Provide noise barriers for soil nailing works where near the sensitive receiver

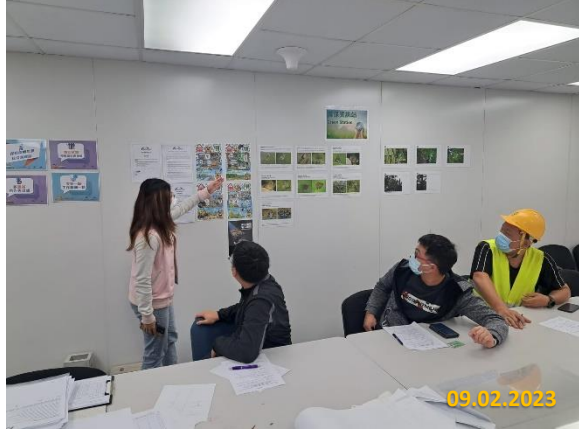
Ref*	Proposed Construction Method**	Location/Working Period	Anticipated Major Impacts	Recommended Mitigation Measures	Photo Records (Partial)
EIA 10.11, EM&A Log 9.4	(Cont') Slope Upgrading Works	(Cont') Kong Nga Po Main Site Kong Nga Po Road	Ecology Concern	<ul style="list-style-type: none"> • Provide training to frontline workers for the conservative species • Provision of protective fence for the conservative species • Regular inspection for concerned vegetation

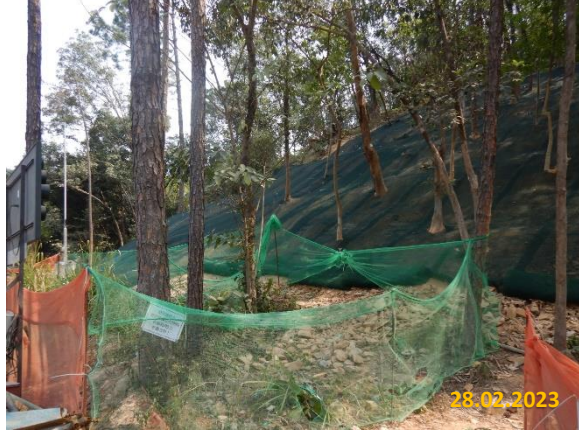
<p data-bbox="1451 869 1892 901">By main contractor at KNP Main Site</p>
EIA Table 10.11 EM&A Table 9.1			Landscape and visual impact	<ul style="list-style-type: none"> • Properly fenced off the conservative species • Preservation of existing trees will be undertaken in accordance with DEVB TC(W) 7/2015 and Guidelines for Tree Risk Assessment and Management Arrangement

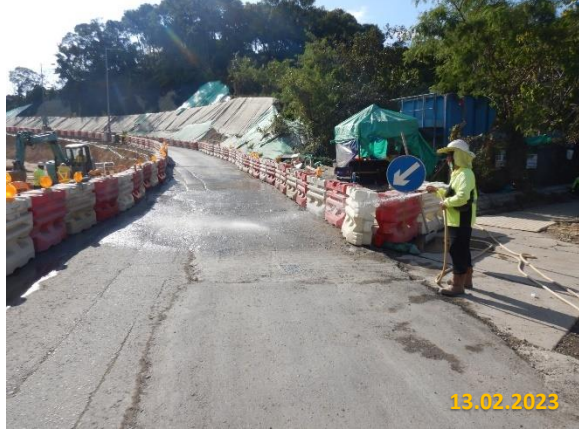
Ref*	Proposed Construction Method**	Location/Working Period	Anticipated Major Impacts	Recommended Mitigation Measures	Photo Records (Partial)
EIA 3.91; EM&A Log 2.2	Trenchless Works	Kong Nga Po Road Man Kam To Road	Air	<ul style="list-style-type: none"> Regular inspection and maintenance of plant and equipment in good condition Regularly clean up stockpiles and debris to avoid accumulation of materials Dusty materials exceeding 20 bags shall be stored in area sheltered on top and the three sides or covered entirely by impervious sheeting.

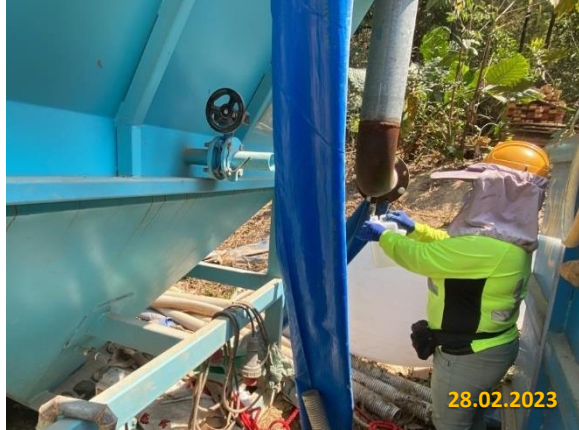
<p>By sub-contractor at KNP Main Site</p>
EIA 5.6.1.2; EM&A Log 4.2			Water	<ul style="list-style-type: none"> Provide desilting/sedimentation devices for wastewater treatment before discharge

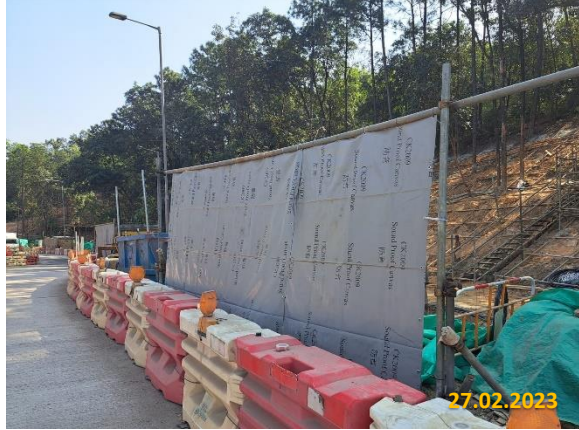
Ref*	Proposed Construction Method**	Location/Working Period	Anticipated Major Impacts	Recommended Mitigation Measures	Photo Records (Partial)
EIA 4.4.6; EM&A Log 3.2	(Cont') Trenchless Works	(Cont') Kong Nga Po Road Man Kam To Road	Noise from roadworks	<ul style="list-style-type: none"> Enclose the noisy part of machineries with noise isolating mats during hard surface breaking

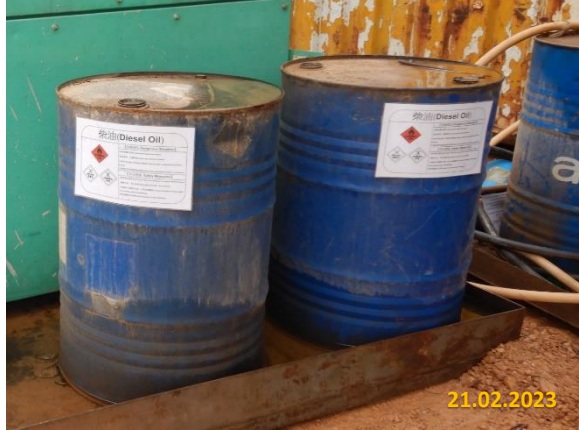
<p>By main contractor at KNP Road</p>
EIA 7.5.1.4; EM&A Log 6.2			Chemical Waste	<ul style="list-style-type: none"> Drip tray and chemical spillage kit shall be provided on site

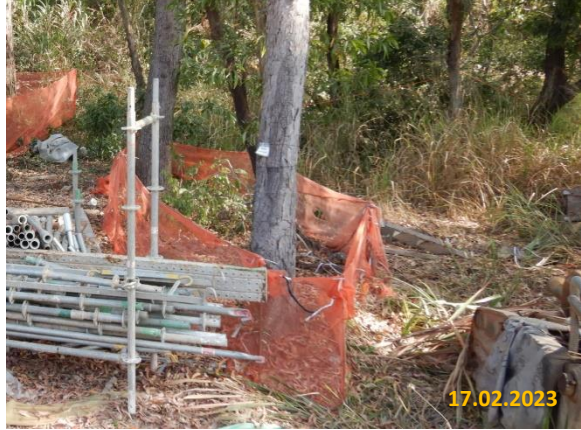
Ref*	Proposed Construction Method**	Location/Working Period	Anticipated Major Impacts	Recommended Mitigation Measures	Photo Records (Partial)
EIA Table 10.11 EM&A Table 9.1	(Cont') Trenchless Works	(Cont') Kong Nga Po Road Man Kam To Road	Landscape and visual impact	<ul style="list-style-type: none"> • Properly fenced off the conservative species • Properly implement temporary traffic arrangement which control construction area to minimize landscape and visual impacts

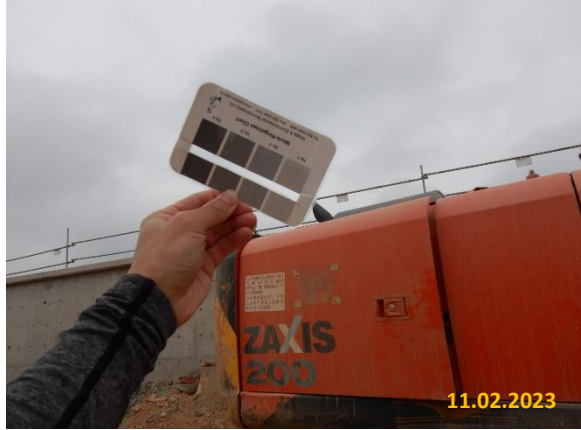
<p>By sub-contractor at KNP Road</p>
EIA 3.91; EM&A Log 2.2	Road and Associated Works	Kong Nga Po Main Site Kong Nga Po Road	Air Dust impact from excavation activities and earth moving	<ul style="list-style-type: none"> • Use of regular water spraying (once every 1.25 hours or 8 times per day) at all active works area exposed site surfaces and unpaved roads, particularly during dry weather • Regular inspection and maintenance of plant and equipment in good condition • Regularly clean up stockpiles and debris to avoid accumulation of materials

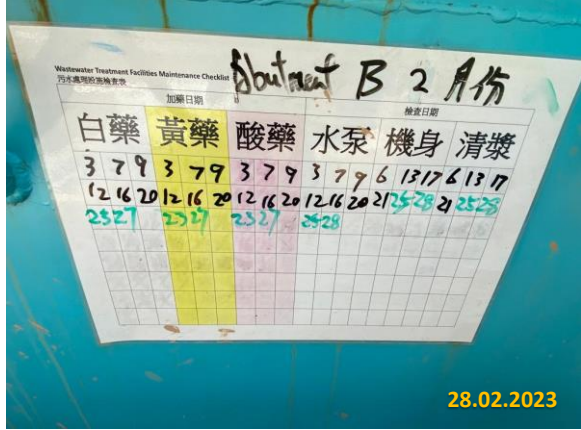
Ref*	Proposed Construction Method**	Location/Working Period	Anticipated Major Impacts	Recommended Mitigation Measures	Photo Records (Partial)
EIA 5.6.1.2; EM&A Log 4.2	(Con't) Road and Associated Works	(Con't) Kong Nga Po Main Site Kong Nga Po Road	Water	<ul style="list-style-type: none"> Provide desilting/sedimentation devices for wastewater treatment before discharge

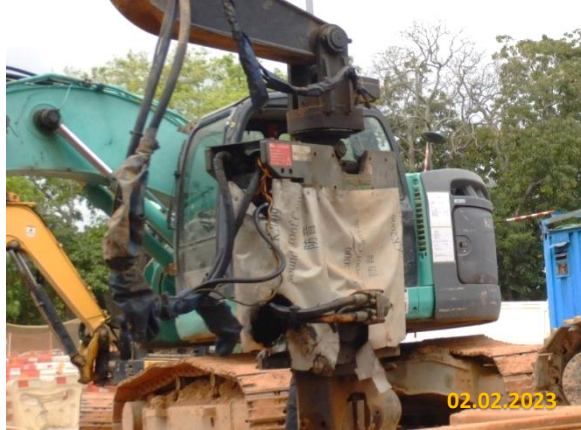
<p>28.02.2023</p> <p>By main contractor at KNP Road</p>
EIA 4.4.6; EM&A Log 3.2			Noise from roadworks	<ul style="list-style-type: none"> Enclose the noisy part of machineries with noise isolating mats during hard surface breaking

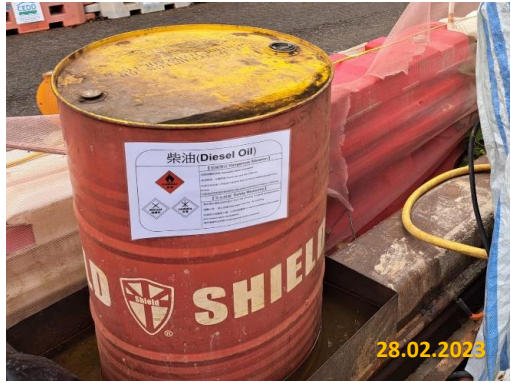
Ref*	Proposed Construction Method**	Location/Working Period	Anticipated Major Impacts	Recommended Mitigation Measures	Photo Records (Partial)
EIA 7.5.1.4; EM&A Log 6.2	(Con't) Road and Associated Works	(Con't) Kong Nga Po Main Site Kong Nga Po Road	Chemical Waste	<ul style="list-style-type: none"> Drip tray and chemical spillage kit shall be provided on site

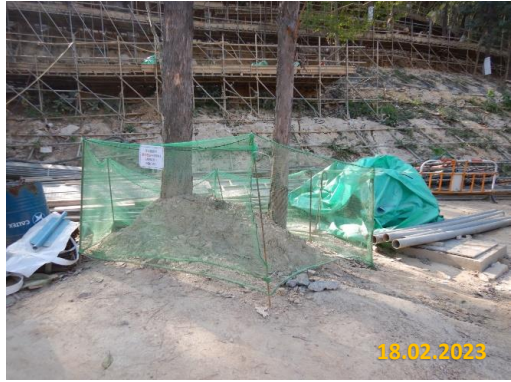
<p>By main contractor at KNP Road</p>
EIA Table 10.11 EM&A Table 9.1			Landscape and visual impact	<ul style="list-style-type: none"> Properly fenced off the conservative species Properly implement temporary traffic arrangement which control construction area to minimize landscape and visual impacts

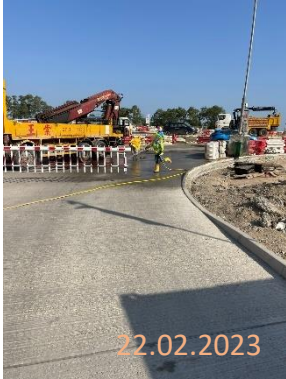
Ref*	Proposed Construction Method	Location/Working Period	Anticipated Major Impacts	Recommended Mitigation Measures	Photo Records (Partial)
EIA 3.9.1; EM&A Log 2.2	Setting up of temporary site office and site entrance	Kong Nga Po Site	Dust impact	<ul style="list-style-type: none"> • Deploy water bowser for regular water spraying to enhance dust suppression • Manual water spraying for dust suppression

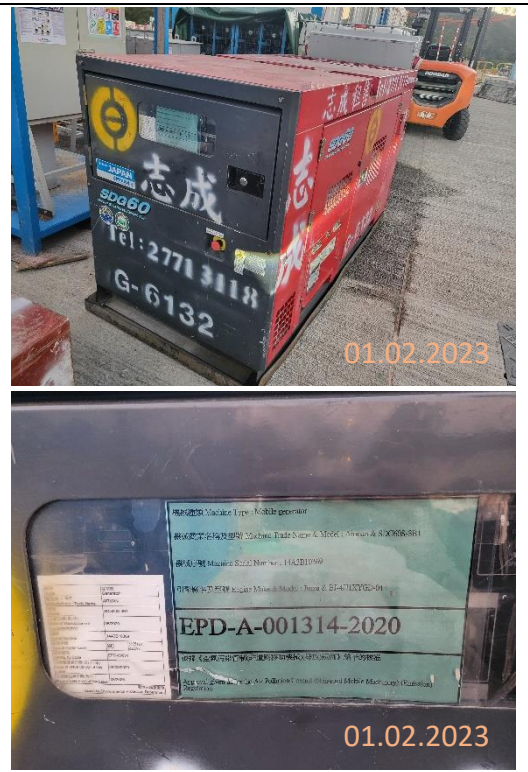
<p>EIA 4.4.6; EM&A Log 3.2</p>			<p>Noise</p>	<ul style="list-style-type: none"> Regular inspection and maintenance of plant & equipment in good condition Deploy Quality Powered Mechanical Equipment (QPME) if possible

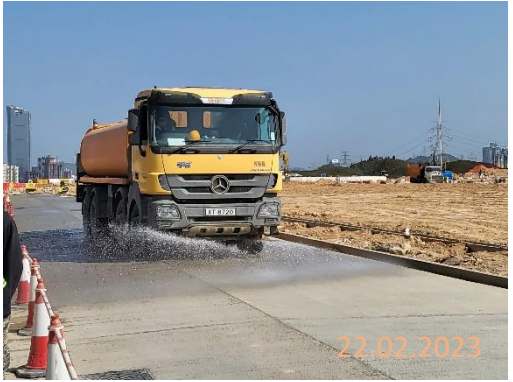
<p>EIA 3.9.1; EM&A Log 2.2</p>	<p>Ground Investigation</p>	<p>Kong Nga Po Site</p>	<p>Dust impact</p>	<ul style="list-style-type: none"> • Deploy water bowser for regular water spraying to enhance dust suppression • Manual water spraying for dust suppression • Regular inspection and maintenance of plant and equipment in good condition • Cover dusty materials with impervious sheets

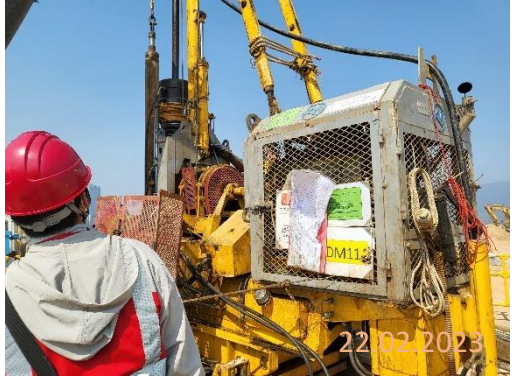
<p>By subcontractor at KNP site</p>
<p>EIA 4.4.6; EM&A Log 3.2</p>			<p>Noise</p>	<ul style="list-style-type: none"> • Regular inspection and maintenance of plant & equipment in good condition • Deploy Quality Powered Mechanical Equipment (QPME) if possible • Noise enclosure or acoustic shed should be used to cover stationary PME such as air compressor or generator.

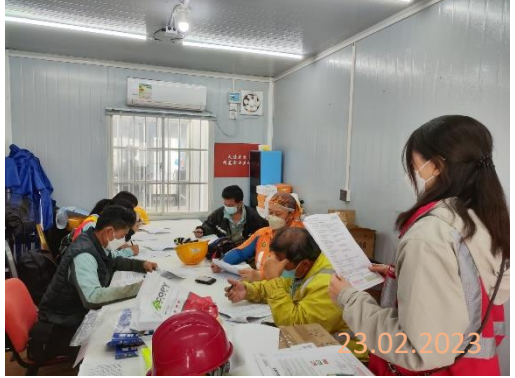
<p data-bbox="1630 639 2029 671">By main contractor at KNP site</p>
<p data-bbox="203 691 403 767">EIA 9.7.1 and EM&A Log 8.3</p>			<p data-bbox="916 691 1133 722">Ecology Concern</p>	<ul data-bbox="1184 691 1610 1102" style="list-style-type: none"> <li data-bbox="1184 691 1610 815">• Provide training to workers about the conservative species <li data-bbox="1184 834 1610 959">• Provision of protective fence for the conservative species <li data-bbox="1184 978 1610 1102">• Regular inspection for concerned vegetation and conservative species
