EP-510/2016 – Police Facilities in Kong Nga Po

**Service Contract No. NDO 07/2019
Environmental Team for Site Formation and
Infrastructure Works for Police Facilities in
Kong Nga Po**

**Monthly Environmental Monitoring and
Audit Report for March 2023
(Version 1.0)**

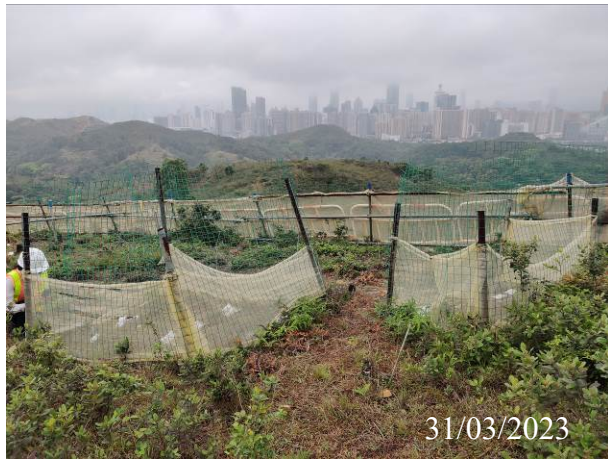
Photo 5

Description: Protective fence for transplanted *Spiranthes sinensis* are properly erected.

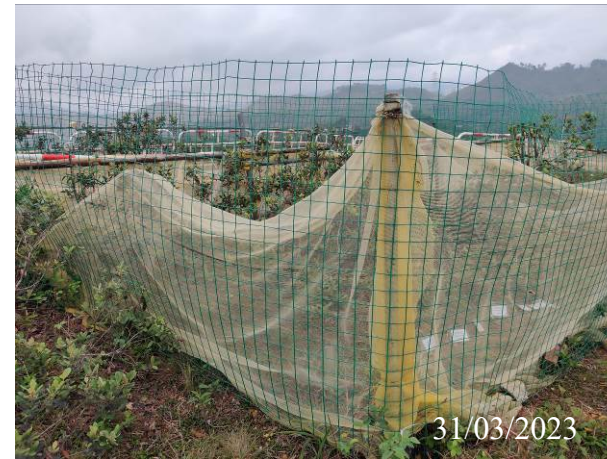
Photo 6

Description: Protective fence for transplanted *Spiranthes sinensis* are properly erected.

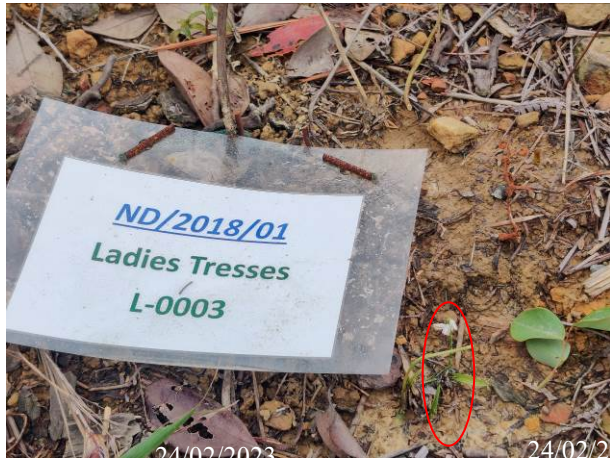
Photo 7

Description: Flowering of *Spiranthes sinensis* are observed.

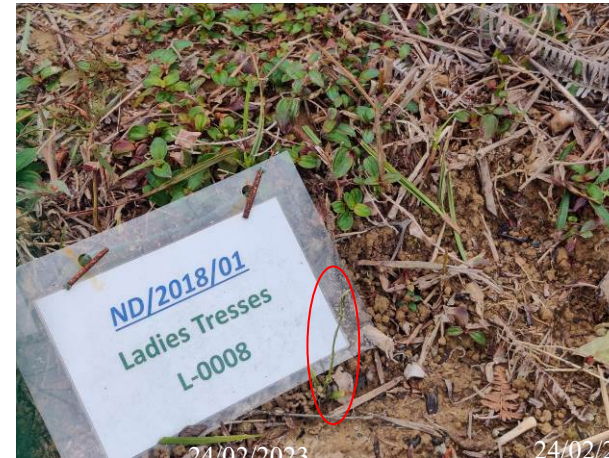
Photo 8

Description: Flowering of *Spiranthes sinensis* are observed.

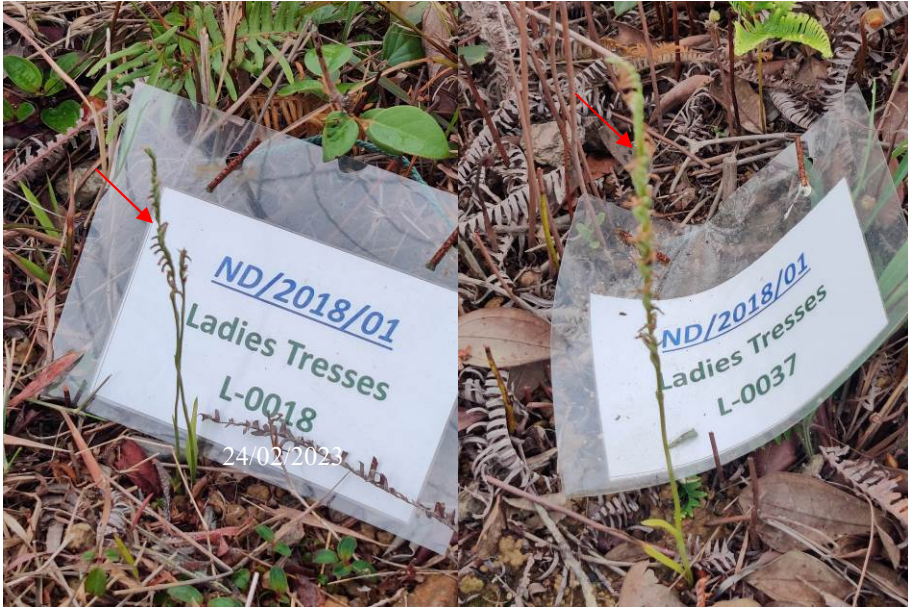
Photo 9

Description: Flowering of *Spiranthes sinensis* are observed.

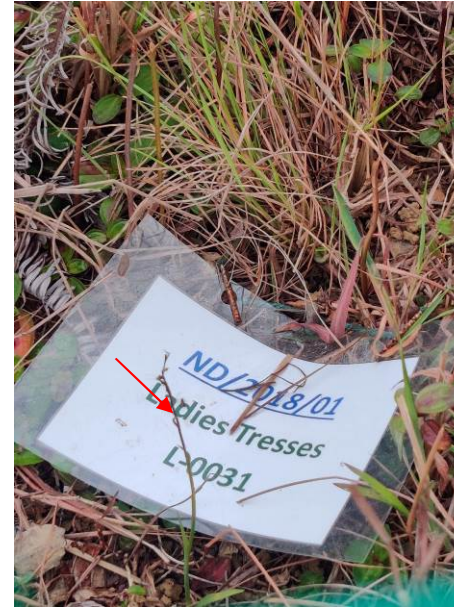
Photo 10

Description: Flowering of *Spiranthes sinensis* are observed.

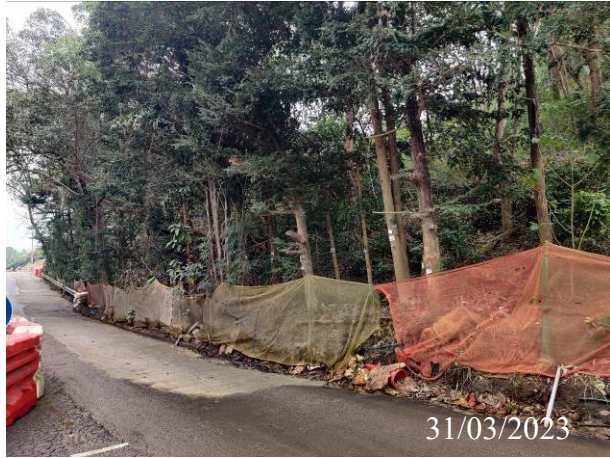
Photo 11

Description: Protective fence for *Keteleeria fortunei* are properly erected.

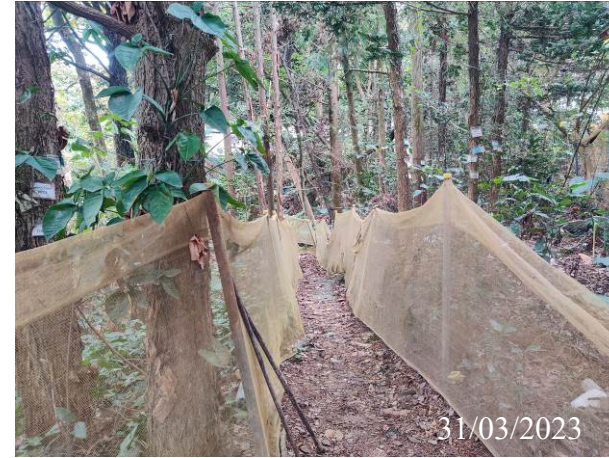
Photo 12

Description: Protective fence for *Keteleeria fortunei* are properly erected.

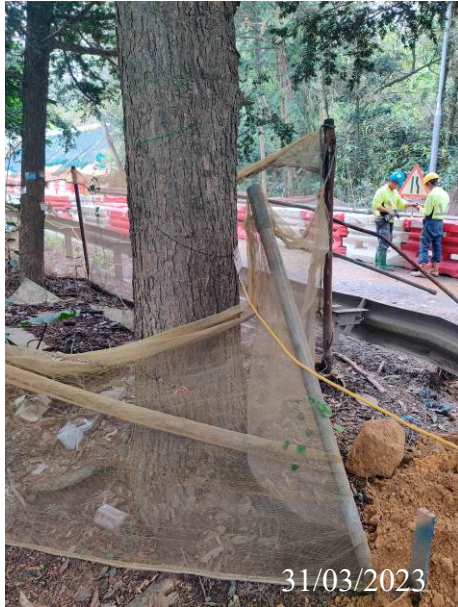
Photo 15

Description: The temporary protective fence should be properly erected and maintained for *Keteleeria fortunei*.

- ① No construction activities was observed at the location of the flora species of conservation interest.
- ② The temporary protective fence should be properly erected and maintained for *Keiskeeria fortunei*.
- ③ The construction waste materials at near the tree protection zone should be cleared for *Keiskeeria fortunei*.

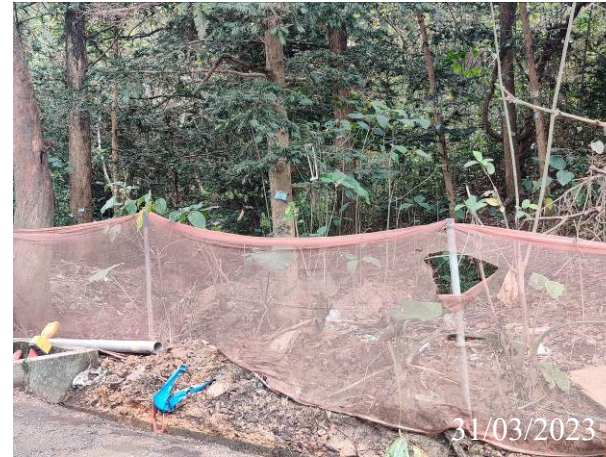
Photo 16

Description: The construction waste materials at near the tree protection zone for *Keteleeria fortunei* should be cleared.

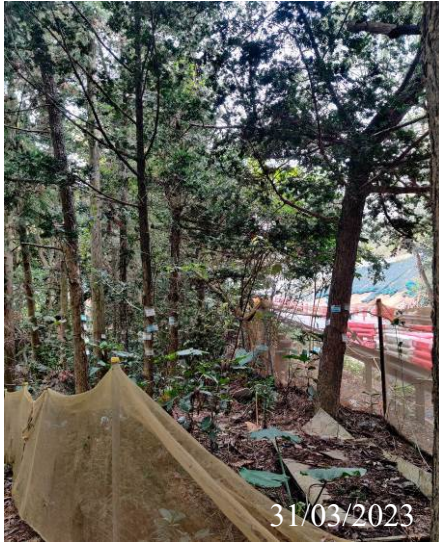
Photo 17

Description: Protective fence for undersized seedling of *Aquilaria sinensis* are properly erected.

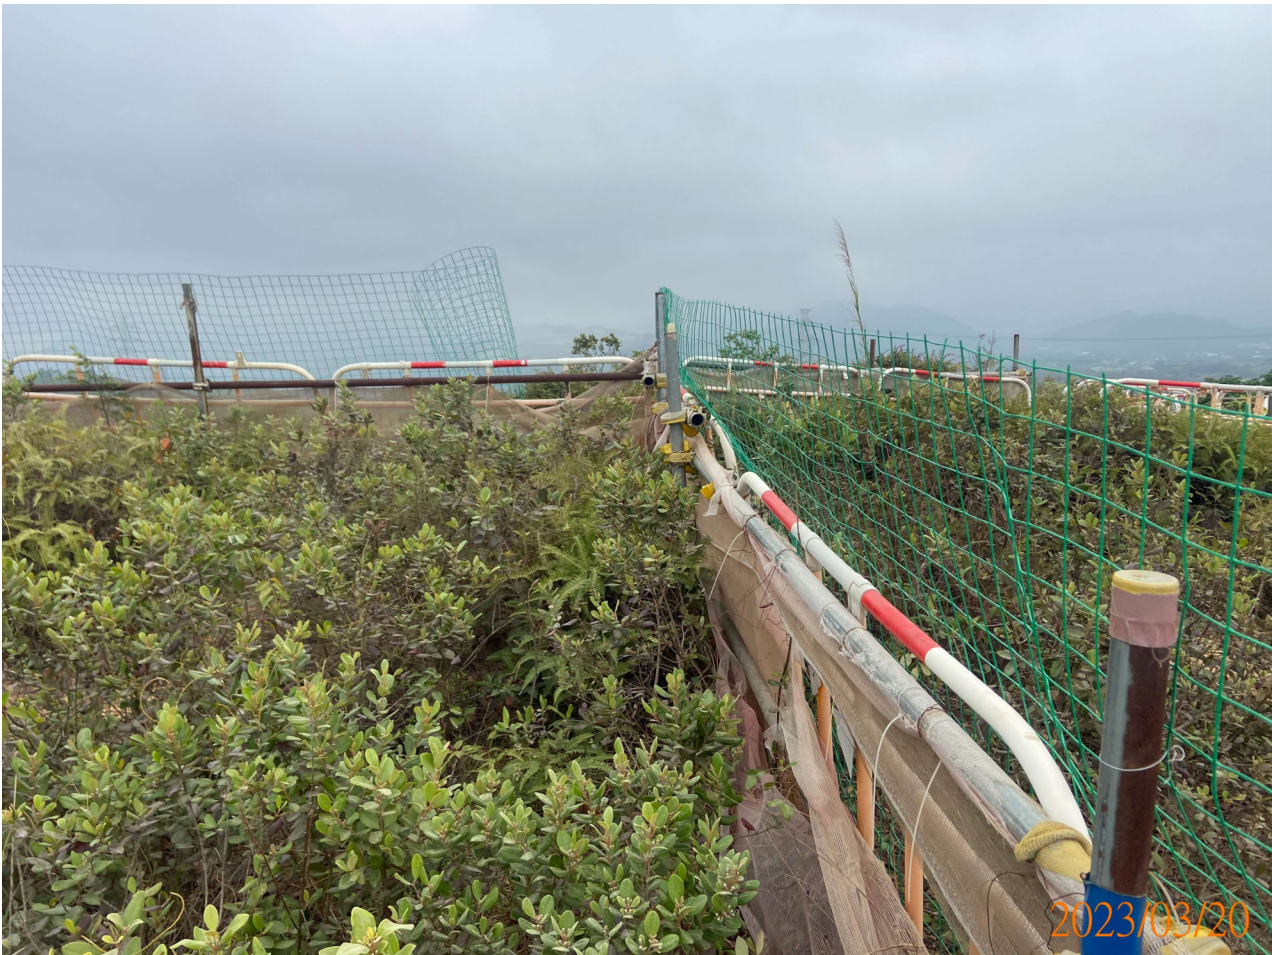
Installation of protection fence (1)

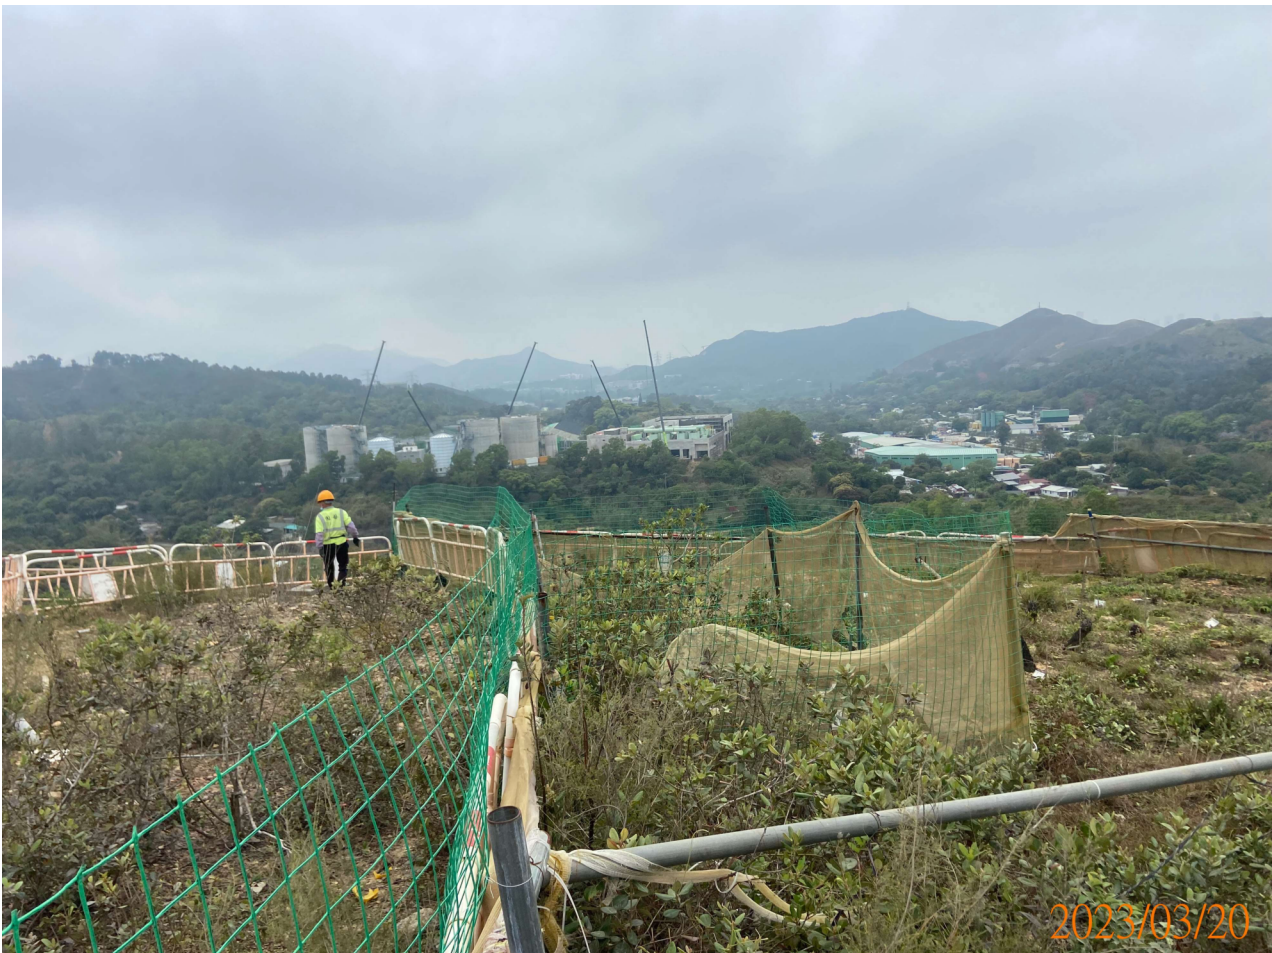
Installation of protection fence (2)

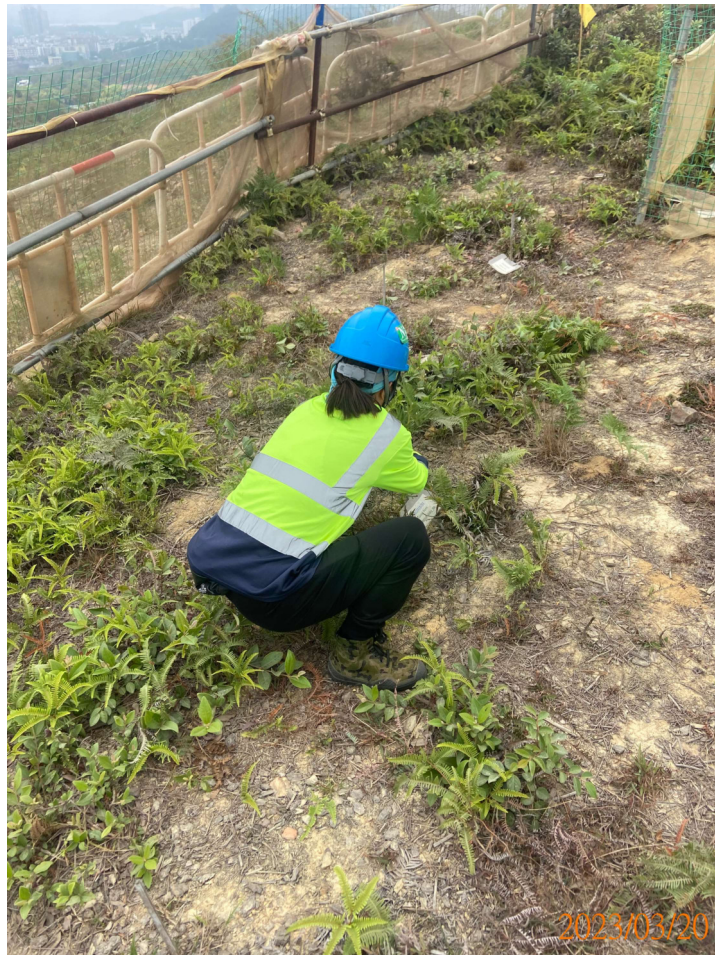
weeding (1)

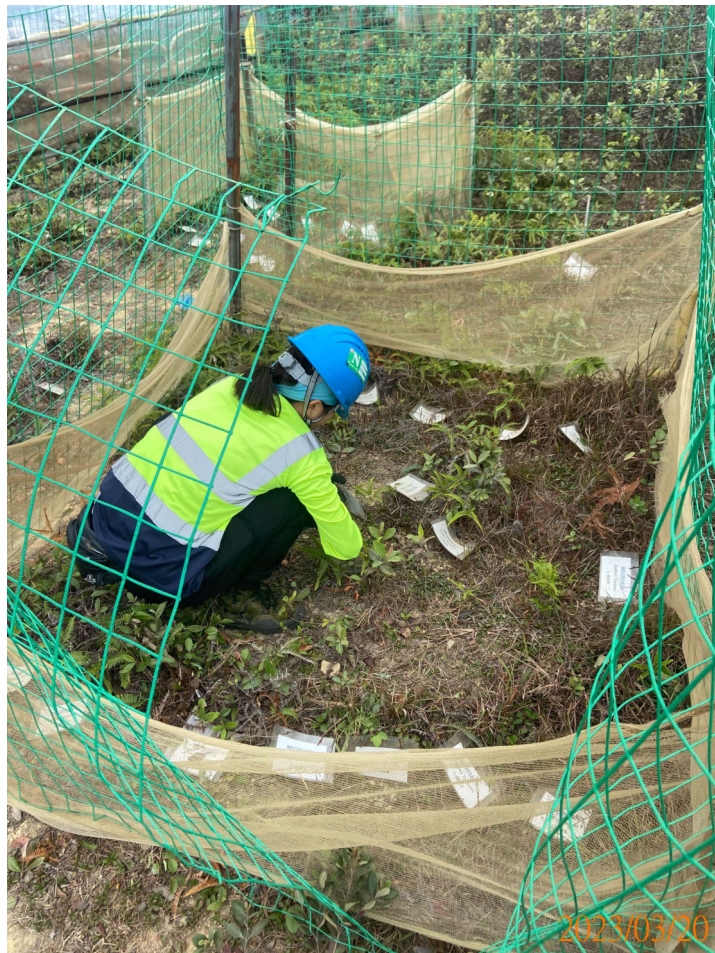
weeding (2)

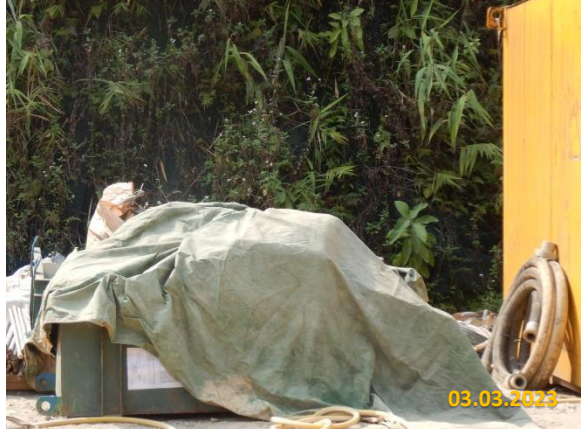
Ref*	Proposed Construction Method**	Location/Working Period	Anticipated Major Impacts	Recommended Mitigation Measures	Photo Records (Partial)
EIA 3.91; EM&A Log 2.2	Reinforced Concrete Structure Construction Including Bridge Deck	Kong Nga Po Main Site Kong Nga Po Road	Air	<ul style="list-style-type: none"> Dusty materials that exceeded 20 bags will be stored in area sheltered on top and the three sides or covered entirely by impervious sheeting

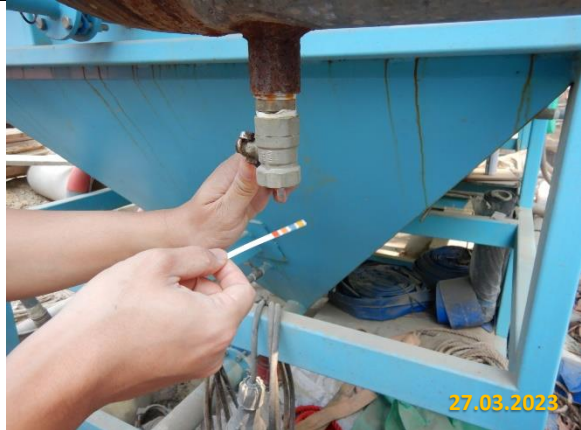
<p>By sub-contractor at KNP road</p>
EIA 5.6.1.2; EM&A Log 4.2			Waste water pollution control	<ul style="list-style-type: none"> Soil berm and retention pit will be provided for the control of water outflow Desilting/sedimentation devices will be provided for wastewater treatment prior to discharge Designated location for residual concrete washout

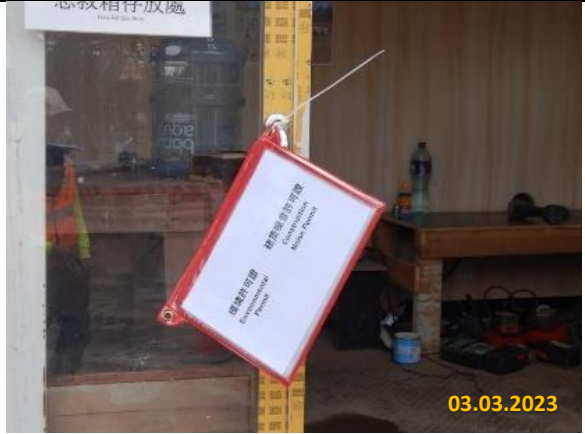
Ref*	Proposed Construction Method**	Location/Working Period	Anticipated Major Impacts	Recommended Mitigation Measures	Photo Records (Partial)
EIA 4.4.6; EM&A Log 3.2	(Cont') Reinforced Concrete Structure Construction	(Cont') Kong Nga Po Main Site Kong Nga Po Road	Noise	<ul style="list-style-type: none"> Well-planning of concreting works to prevent working in restricted hours 	
EIA 4.4.6; EM&A Log 3.2	Including Bridge Deck		Working in Restricted Hours	<ul style="list-style-type: none"> Valid construction noise permit should be obtained and displayed on site In case of non-compliance with the construction noise criteria, more frequent monitoring and action should be carried out

<p>By main contractor at KNP road</p>

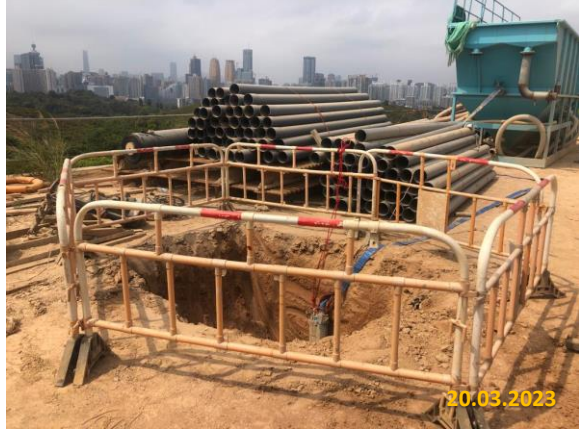
Ref*	Proposed Construction Method**	Location/Working Period	Anticipated Major Impacts	Recommended Mitigation Measures	Photo Records (Partial)
EIA 5.6.1.2; EM&A Log 4.2	(Cont') Slope Upgrading Works	(Cont') Kong Nga Po Main Site Kong Nga Po Road	Water	<ul style="list-style-type: none"> • Deploy desilting/sedimentation devices for wastewater treatment prior to discharge • Establish soil berm with retention pit to control water outflow

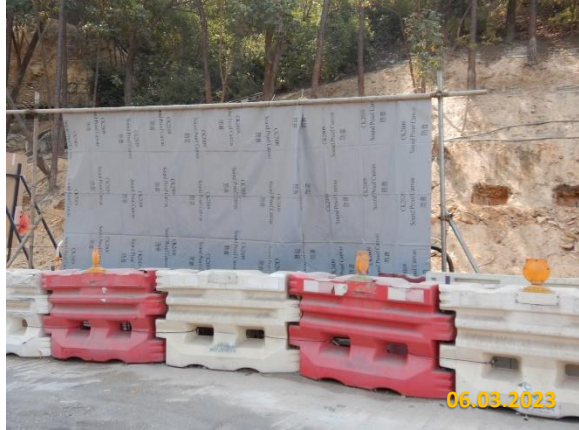
<p data-bbox="1451 869 1881 901">By sub-contractor at KNP Main Site</p>
EIA 4.4.6; EM&A Log 3.2			Noise	<ul style="list-style-type: none"> • Regular inspection and maintenance of plant and equipment in good condition • Provide noise barriers for soil nailing works where near the sensitive receiver

<p data-bbox="1451 1353 1825 1385">By sub-contractor at KNP Road</p>

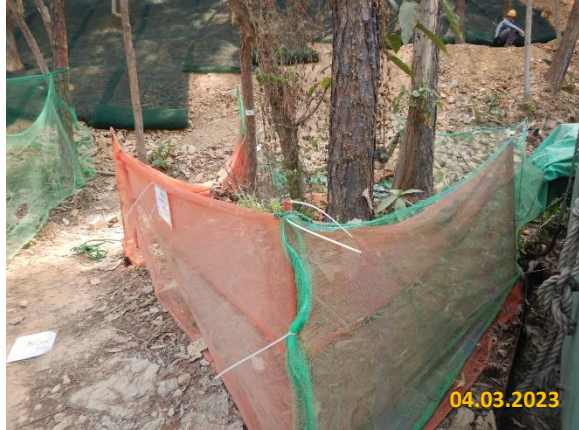
<p>By main contractor at KNP Main Site</p>
EIA Table 10.11 EM&A Table 9.1			Landscape and visual impact	<ul style="list-style-type: none"> • Properly fenced off the conservative species • Preservation of existing trees will be undertaken in accordance with DEVB TC(W) 7/2015 and Guidelines for Tree Risk Assessment and Management Arrangement

<p>By main contractor at KNP Road</p>

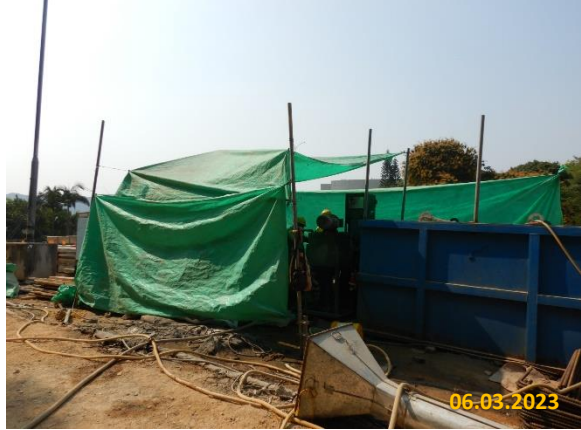
Ref*	Proposed Construction Method**	Location/Working Period	Anticipated Major Impacts	Recommended Mitigation Measures	Photo Records (Partial)
EIA 3.91; EM&A Log 2.2	Trenchless Works	Kong Nga Po Road Man Kam To Road	Air	<ul style="list-style-type: none"> Regular inspection and maintenance of plant and equipment in good condition Regularly clean up stockpiles and debris to avoid accumulation of materials Dusty materials exceeding 20 bags shall be stored in area sheltered on top and the three sides or covered entirely by impervious sheeting.

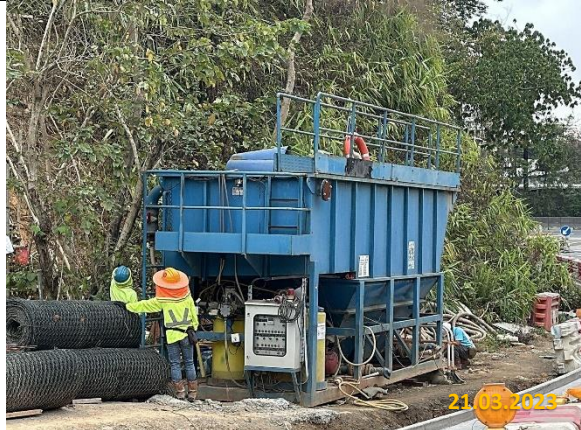
<p>By sub-contractor at KNP Main Site</p>
EIA 5.6.1.2; EM&A Log 4.2			Water	<ul style="list-style-type: none"> Provide desilting/sedimentation devices for wastewater treatment before discharge

<p>By main contractor at KNP Road</p>

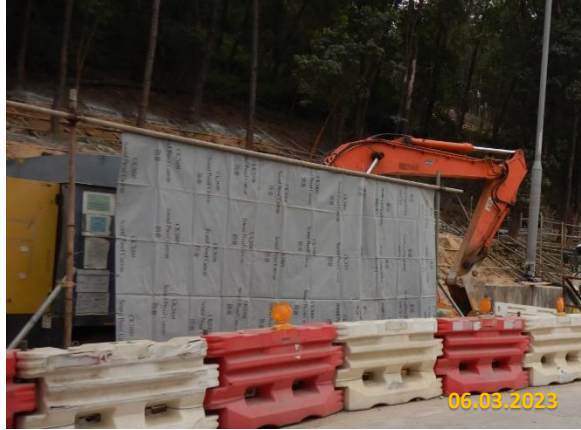
Ref*	Proposed Construction Method**	Location/Working Period	Anticipated Major Impacts	Recommended Mitigation Measures	Photo Records (Partial)
EIA 4.4.6; EM&A Log 3.2	(Cont') Trenchless Works	(Cont') Kong Nga Po Road Man Kam To Road	Noise from roadworks	<ul style="list-style-type: none"> Enclose the noisy part of machineries with noise isolating mats during hard surface breaking

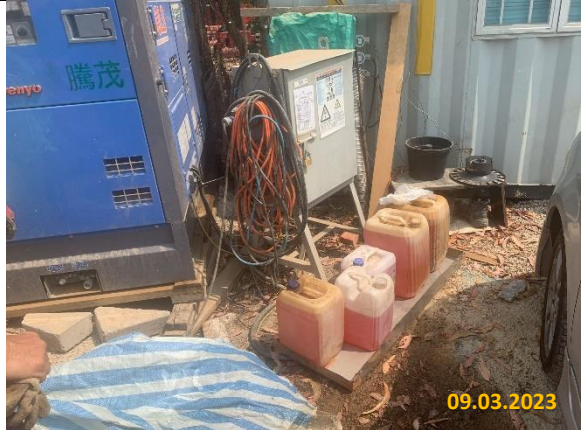
<p>By main contractor at KNP Road</p>
EIA 7.5.1.4; EM&A Log 6.2			Chemical Waste	<ul style="list-style-type: none"> Drip tray and chemical spillage kit shall be provided on site

<p>By sub-contractor at KNP Road</p>

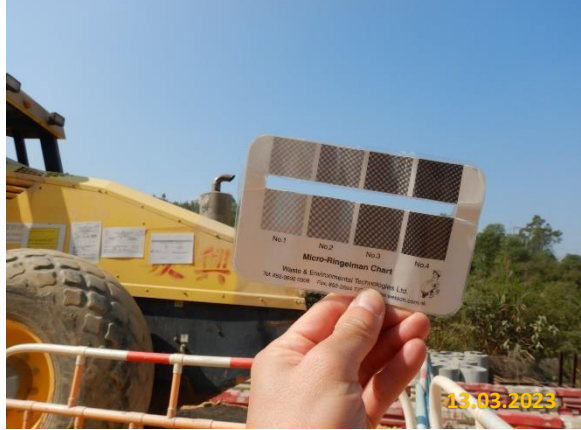
<p>By sub-contractor at KNP Road</p>
EIA 3.91; EM&A Log 2.2	Road and Associated Works	Kong Nga Po Main Site Kong Nga Po Road	Air Dust impact from excavation activities and earth moving	<ul style="list-style-type: none"> • Use of regular water spraying (once every 1.25 hours or 8 times per day) at all active works area exposed site surfaces and unpaved roads, particularly during dry weather • Regular inspection and maintenance of plant and equipment in good condition • Regularly clean up stockpiles and debris to avoid accumulation of materials

<p>By sub-contractor at KNP Road</p>

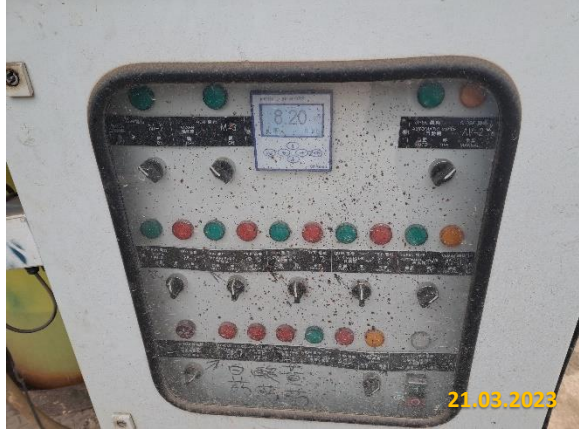
Ref*	Proposed Construction Method**	Location/Working Period	Anticipated Major Impacts	Recommended Mitigation Measures	Photo Records (Partial)
EIA 5.6.1.2; EM&A Log 4.2	(Con't) Road and Associated Works	(Con't) Kong Nga Po Main Site Kong Nga Po Road	Water	<ul style="list-style-type: none"> Provide desilting/sedimentation devices for wastewater treatment before discharge

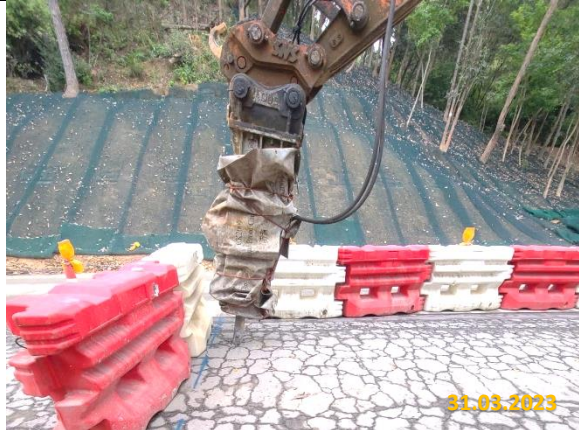
<p>By main contractor at KNP Road</p>
EIA 4.4.6; EM&A Log 3.2			Noise from roadworks	<ul style="list-style-type: none"> Enclose the noisy part of machineries with noise isolating mats during hard surface breaking

<p>By sub-contractor at KNP Road</p>

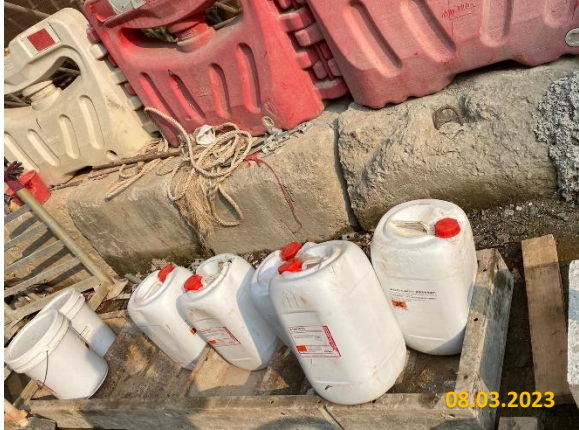
Ref*	Proposed Construction Method**	Location/Working Period	Anticipated Major Impacts	Recommended Mitigation Measures	Photo Records (Partial)
EIA 7.5.1.4; EM&A Log 6.2	(Con't) Road and Associated Works	(Con't) Kong Nga Po Main Site Kong Nga Po Road	Chemical Waste	<ul style="list-style-type: none"> Drip tray and chemical spillage kit shall be provided on site

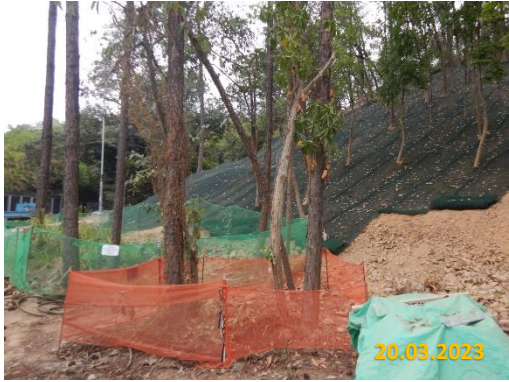
<p>By main contractor at KNP Road</p>
EIA Table 10.11 EM&A Table 9.1			Landscape and visual impact	<ul style="list-style-type: none"> Properly fenced off the conservative species Properly implement temporary traffic arrangement which control construction area to minimize landscape and visual impacts

<p>By main contractor at KNP Road</p>

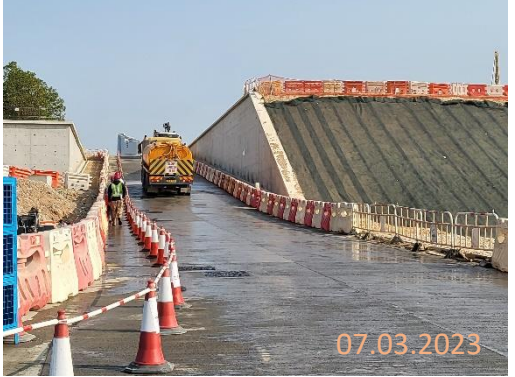
Ref*	Proposed Construction Method	Location/Working Period	Anticipated Major Impacts	Recommended Mitigation Measures	Photo Records (Partial)
EIA 3.9.1; EM&A Log 2.2	Ground Investigation	Kong Nga Po Site	Dust impact	<ul style="list-style-type: none"> • Deploy water bowser for regular water spraying to enhance dust suppression • Manual water spraying for dust suppression • Regular inspection and maintenance of plant and equipment in good condition • Cover dusty materials with impervious sheets

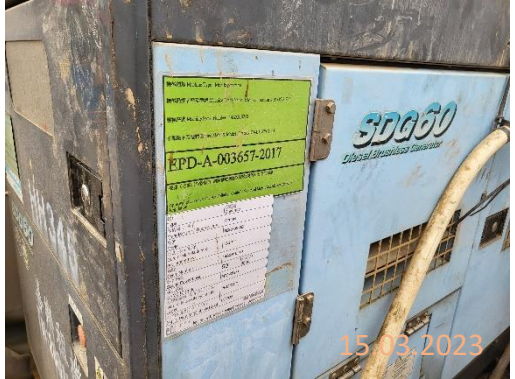
<p data-bbox="1630 638 2004 670">By subcontractor at KNP site</p>
<p data-bbox="203 689 403 769">EIA 4.4.6; EM&A Log 3.2</p>			<p data-bbox="916 689 994 721">Noise</p>	<ul data-bbox="1184 689 1610 1248" style="list-style-type: none"> • Regular inspection and maintenance of plant & equipment in good condition • Deploy Quality Powered Mechanical Equipment (QPME) if possible • Noise enclosure or acoustic shed should be used to cover stationary PME such as air compressor or generator.

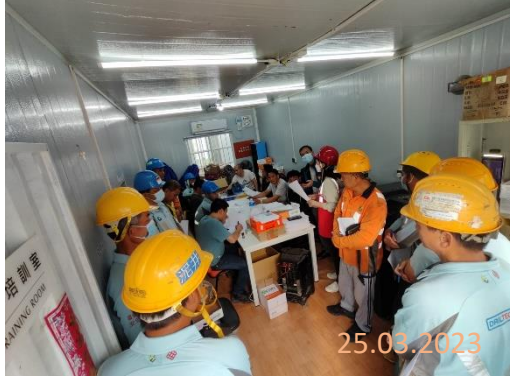
<p>EIA 9.7.1 and EM&A Log 8.3</p>			<p>Ecology Concern</p>	<ul style="list-style-type: none"> • Provide training to workers about the conservative species • Provision of protective fence for the conservative species • Regular inspection for concerned vegetation and conservative species
