EP-510/2016 – Police Facilities in Kong Nga Po

**Service Contract No. NDO 07/2019
Environmental Team for Site Formation and
Infrastructure Works for Police Facilities in
Kong Nga Po**

**Monthly Environmental Monitoring and
Audit Report for August 2023
(Version 1.0)**

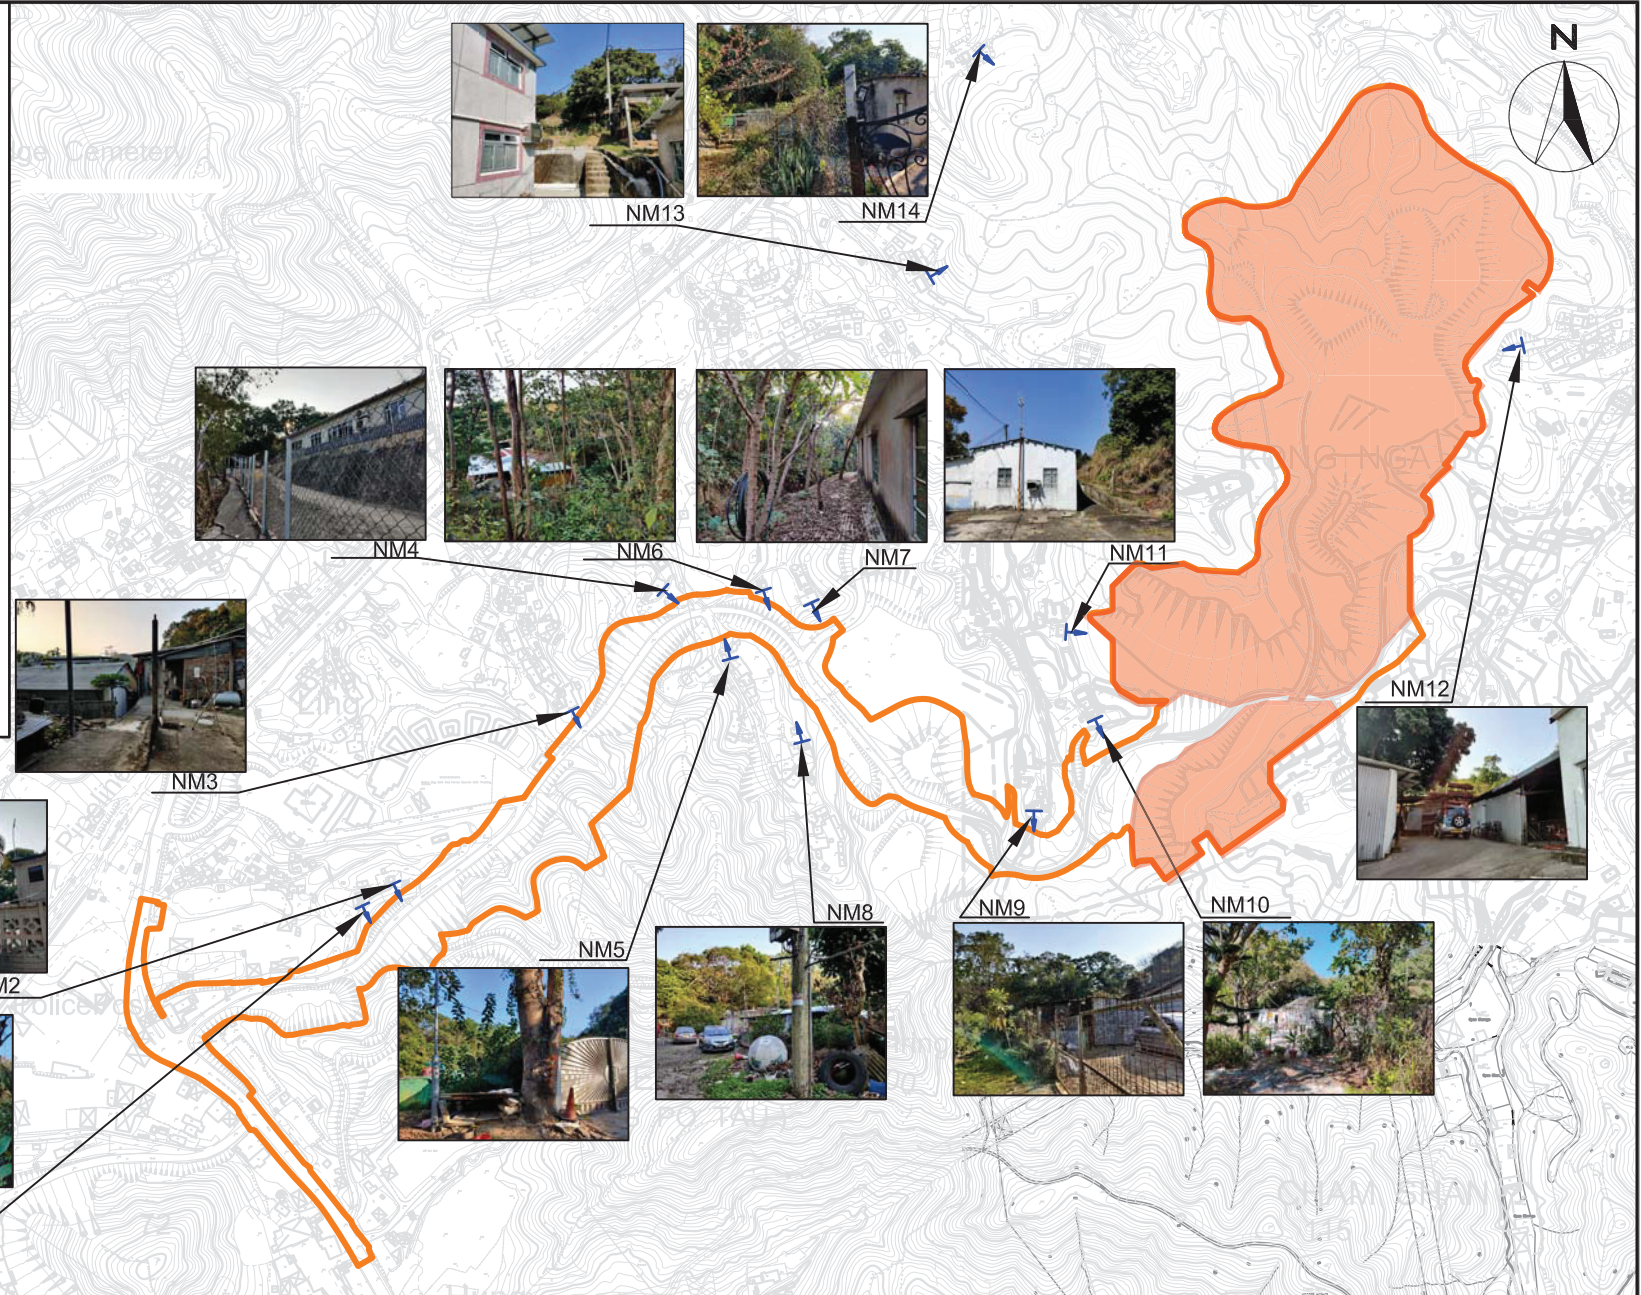
Service Contract No. NDO 07/2019
 Environmental Team for Site Formation and Infrastructure Works for Police Facilities in Kong Nga Po
Noise Monitoring Stations

Noise Monitoring Stations	
ID	Description
NM1	Village House, Sha Ling
NM2	Village House, Sha Ling
NM3	Village House No. 248, Sha Ling
NM4	Village House, Sha Ling
NM5	Village House No. 270, Sha Ling
NM6	Village House, Sha Ling
NM7	Village House, Sha Ling
NM8	Village House, Sha Ling
NM9	Village House, Kong Nga Po
NM10	Village House, Kong Nga Po
NM11	Village House, Kong Nga Po
NM12	Village House, Kong Nga Po
NM13	Village House, Kong Nga Po
NM14	Village House, near Man Kam To Road

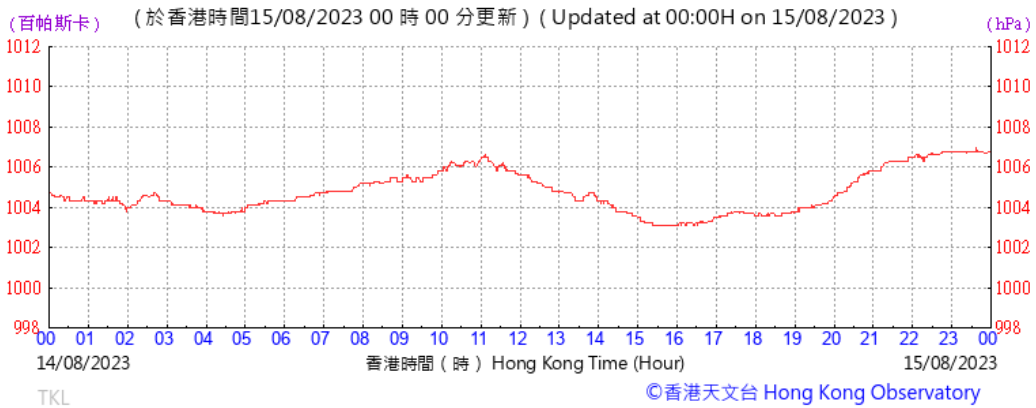
Pressure:

Title	Service Contract No. NDO 07/2019	Scale	Project	
	Environmental Team for Site Formation and Infrastructure Works for Police Facilities in Kong Nga Po	N.T.S	No. WMA20001	
Meteorological Data at Ta Kwu Ling Weather Station		Date	Appendix	
		Aug 23	G

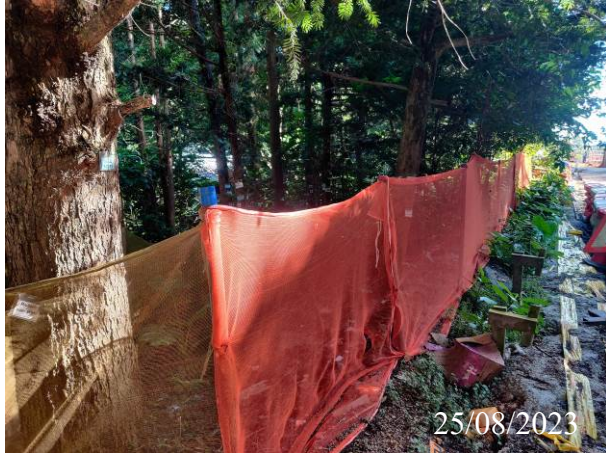
Photo 5

Description: Protective fence for undersized seedling of *Aquilaria sinensis* are properly erected.

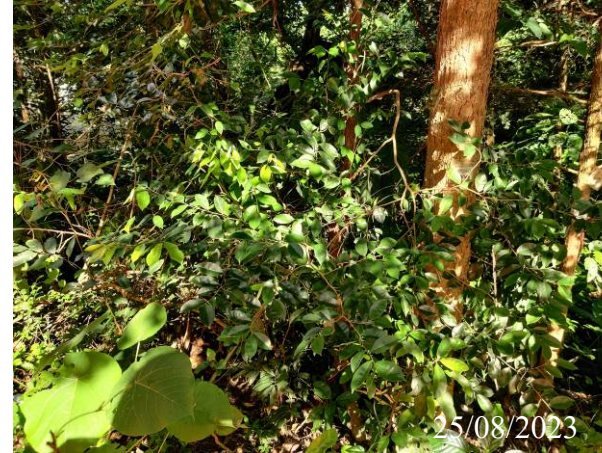
Photo 6

Description: General view of undersized seedling of *Aquilaria sinensis*

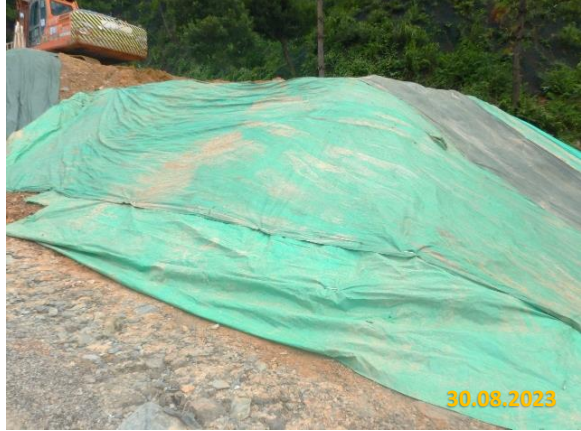
Ref*	Proposed Construction Method**	Location/Working Period	Anticipated Major Impacts	Recommended Mitigation Measures	Photo Records (Partial)
EIA 3.91; EM&A Log 2.2	Slope Upgrading Works	Kong Nga Po Main Site Kong Nga Po Road	Dust impact from soil nail works	<ul style="list-style-type: none"> • Three side enclosure with top shelter for cement mixing works • Water spraying on soil nailing works • Dusty materials exceeding 20 bags shall be stored in area sheltered on top and the three sides or covered entirely by impervious sheeting

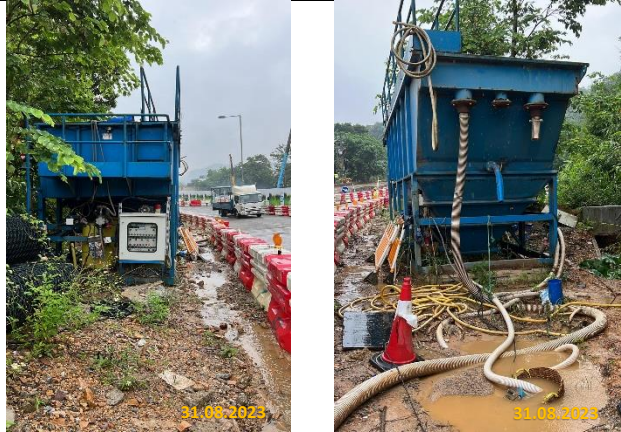
<p>30.08.2023</p> <p>By sub-contractor at KNP Road</p>
EIA 5.6.1.2; EM&A Log 4.2			Water	<ul style="list-style-type: none"> • Deploy desilting/sedimentation devices for wastewater treatment prior to discharge • Establish soil berm with retention pit to control water outflow

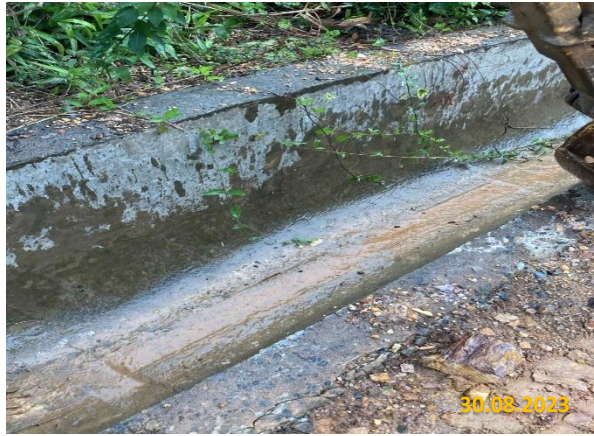
<p>30.08.2023</p> <p>By main contractor at KNP Road</p>

Ref*	Proposed Construction Method**	Location/Working Period	Anticipated Major Impacts	Recommended Mitigation Measures	Photo Records (Partial)
EIA 4.4.6; EM&A Log 3.2	(Cont') Slope Upgrading Works	(Cont') Kong Nga Po Main Site Kong Nga Po Road	Noise	<ul style="list-style-type: none"> Regular inspection and maintenance of plant and equipment in good condition Provide noise barriers for soil nailing works where near the sensitive receiver

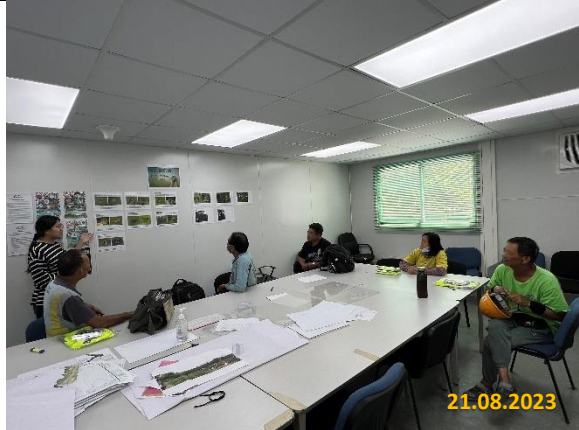
<p>By sub-contractor at KNP Road</p>
EIA 10.11, EM&A Log 9.4			Ecology Concern	<ul style="list-style-type: none"> Provide training to frontline workers for the conservative species Provision of protective fence for the conservative species Regular inspection for concerned vegetation

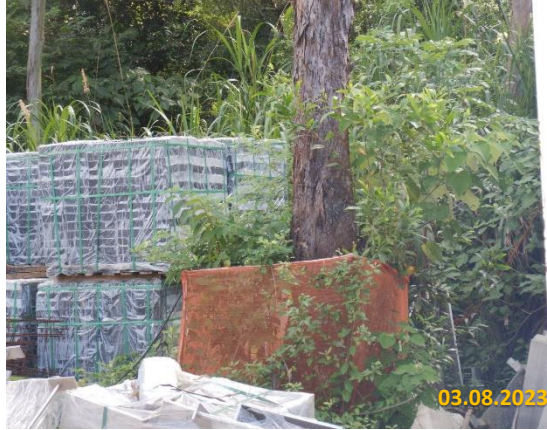
Ref*	Proposed Construction Method**	Location/Working Period	Anticipated Major Impacts	Recommended Mitigation Measures	Photo Records (Partial)
EIA Table 10.11 EM&A Table 9.1			Landscape and visual impact	<ul style="list-style-type: none"> • Properly fenced off the conservative species • Preservation of existing trees will be undertaken in accordance with DEVB TC(W) 7/2015 and Guidelines for Tree Risk Assessment and Management Arrangement

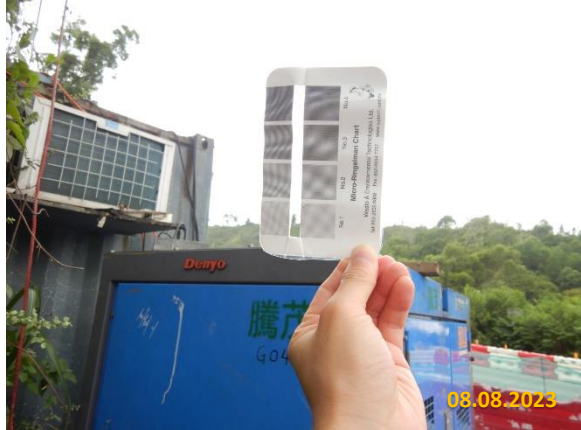
<p data-bbox="1451 868 1845 900">By main contractor at KNP Road</p>
EIA 3.91; EM&A Log 2.2	Road and Associated Works	Kong Nga Po Main Site Kong Nga Po Road	Air Dust impact from excavation activities and earth moving	<ul style="list-style-type: none"> • Use of regular water spraying (once every 1.25 hours or 8 times per day) at all active works area exposed site surfaces and unpaved roads, particularly during dry weather • Regular inspection and maintenance of plant and equipment in good condition • Regularly clean up stockpiles and debris to avoid accumulation of materials

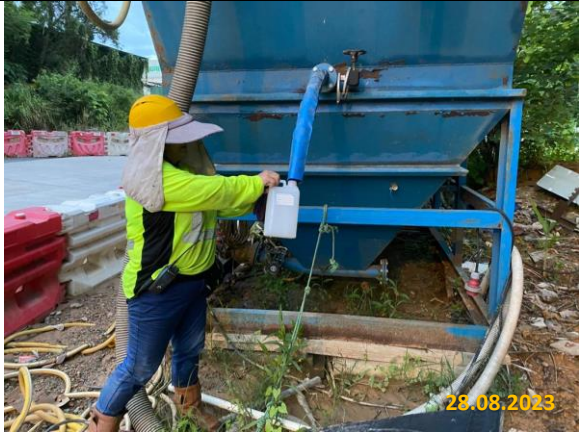
Ref*	Proposed Construction Method**	Location/Working Period	Anticipated Major Impacts	Recommended Mitigation Measures	Photo Records (Partial)
EIA 5.6.1.2; EM&A Log 4.2	(Con't) Road and Associated Works	(Con't) Kong Nga Po Main Site Kong Nga Po Road	Water	<ul style="list-style-type: none"> Provide desilting/sedimentation devices for wastewater treatment before discharge

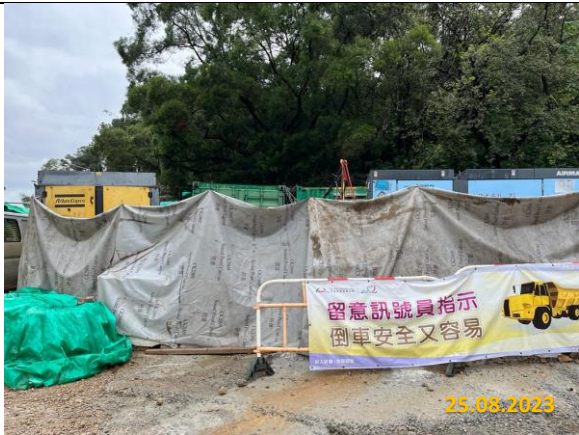
<p>By main contractor at KNP Road</p>
EIA 4.4.6; EM&A Log 3.2			Noise from roadworks	<ul style="list-style-type: none"> Enclose the noisy part of machineries with noise isolating mats during hard surface breaking / for operating plants

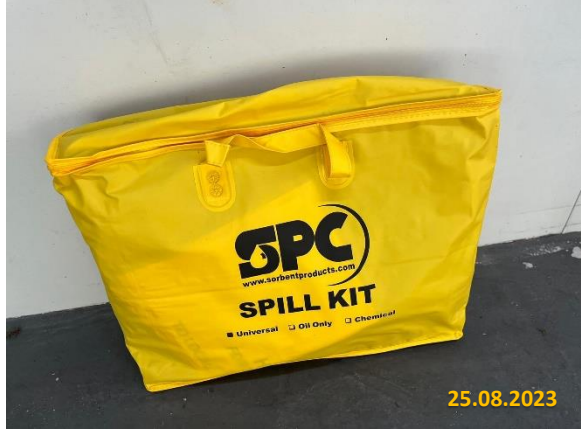
Ref*	Proposed Construction Method**	Location/Working Period	Anticipated Major Impacts	Recommended Mitigation Measures	Photo Records (Partial)
EIA 7.5.1.4; EM&A Log 6.2	(Con't) Road and Associated Works	(Con't) Kong Nga Po Main Site Kong Nga Po Road	Chemical Waste	<ul style="list-style-type: none"> Drip tray and chemical spillage kit shall be provided on site

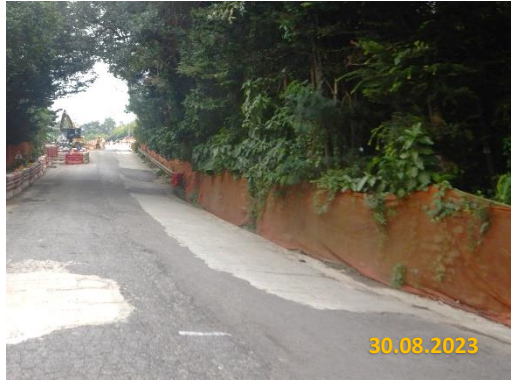
<p>25.08.2023</p> <p>By main contractor at KNP Road</p>
EIA Table 10.11 EM&A Table 9.1			Landscape and visual impact	<ul style="list-style-type: none"> Properly fenced off the conservative species Properly implement temporary traffic arrangement which control construction area to minimize landscape and visual impacts

<p>30.08.2023</p> <p>By main contractor at KNP Road</p>
