EP-510/2016 – Police Facilities in Kong Nga Po

**Service Contract No. NDO 07/2019
Environmental Team for Site Formation and
Infrastructure Works for Police Facilities in
Kong Nga Po**

**Monthly Environmental Monitoring and
Audit Report for October 2023
(Version 1.0)**

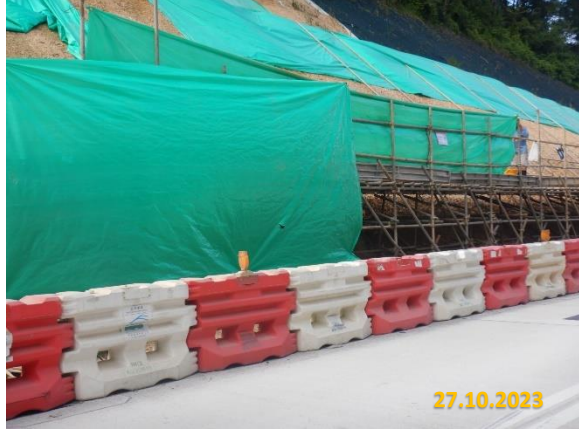
Ref*	Proposed Construction Method**	Location/Working Period	Anticipated Major Impacts	Recommended Mitigation Measures	Photo Records (Partial)
EIA 3.91; EM&A Log 2.2	Slope Upgrading Works	Kong Nga Po Main Site Kong Nga Po Road	Dust impact from soil nail works	<ul style="list-style-type: none"> • Three side enclosure with top shelter for cement mixing works • Water spraying on soil nailing works • Dusty materials exceeding 20 bags shall be stored in area sheltered on top and the three sides or covered entirely by impervious sheeting

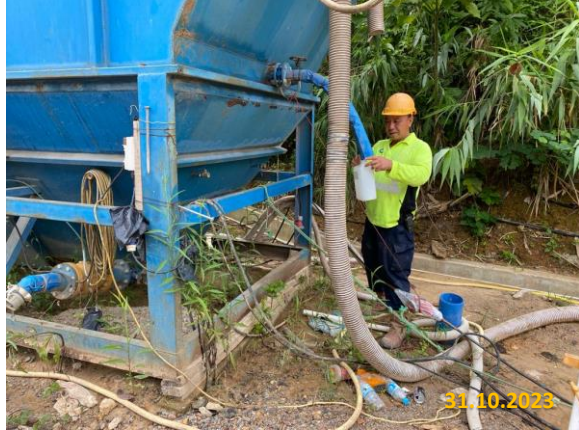
<p data-bbox="1451 869 1825 901">By sub-contractor at KNP Road</p>
EIA 5.6.1.2; EM&A Log 4.2			Water	<ul style="list-style-type: none"> • Deploy desilting/sedimentation devices for wastewater treatment prior to discharge • Establish soil berm with retention pit to control water outflow

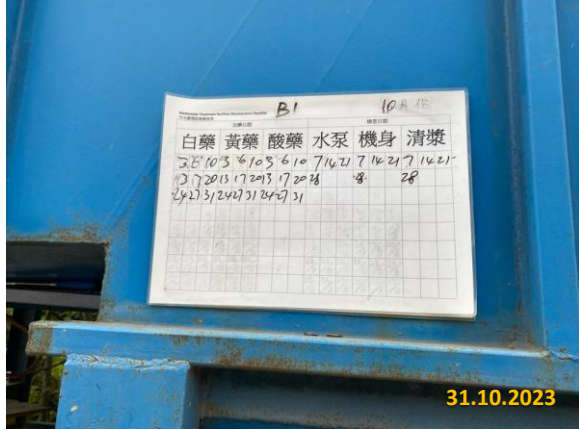
Ref*	Proposed Construction Method**	Location/Working Period	Anticipated Major Impacts	Recommended Mitigation Measures	Photo Records (Partial)
	(Cont') Slope Upgrading Works	(Cont') Kong Nga Po Main Site Kong Nga Po Road

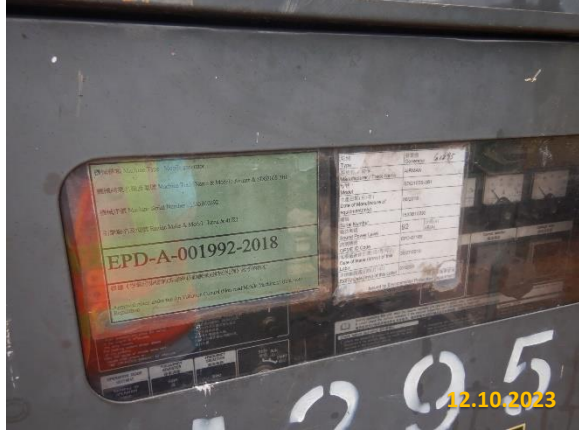
<p>By main contractor at KNP Road</p>
EIA 4.4.6; EM&A Log 3.2	(Cont')	(Cont')	Noise	<ul style="list-style-type: none"> Regular inspection and maintenance of plant and equipment in good condition Provide noise barriers for soil nailing works where near the sensitive receiver

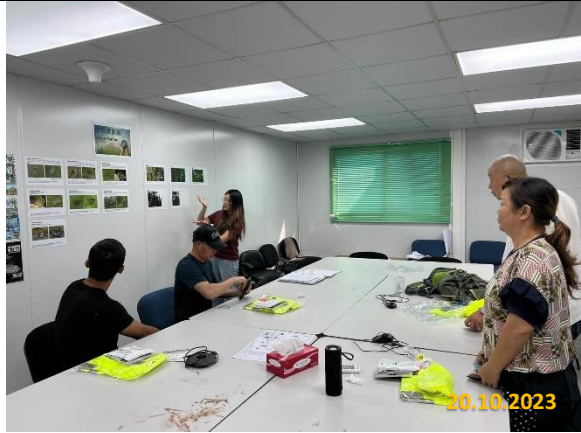
Ref*	Proposed Construction Method**	Location/Working Period	Anticipated Major Impacts	Recommended Mitigation Measures	Photo Records (Partial)
EIA 10.11, EM&A Log 9.4	Slope Upgrading Works	Kong Nga Po Main Site Kong Nga Po Road	Ecology Concern	<ul style="list-style-type: none"> • Provide training to frontline workers for the conservative species • Provision of protective fence for the conservative species • Regular inspection for concerned vegetation

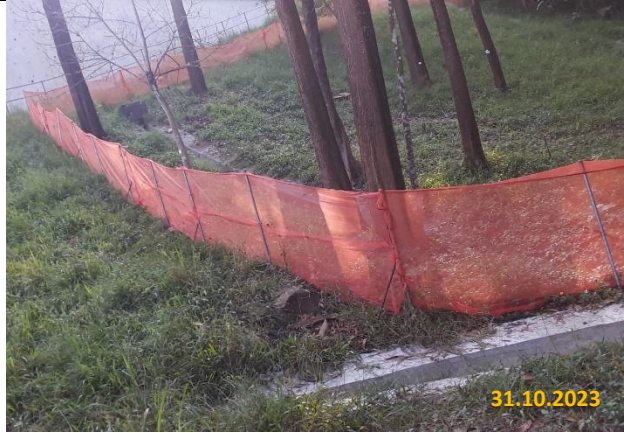
<p>By main contractor at KNP Main Site</p>
EIA Table 10.11 EM&A Table 9.1			Landscape and visual impact	<ul style="list-style-type: none"> • Properly fenced off the conservative species • Preservation of existing trees will be undertaken in accordance with DEVB TC(W) 7/2015 and Guidelines for Tree Risk Assessment and Management Arrangement

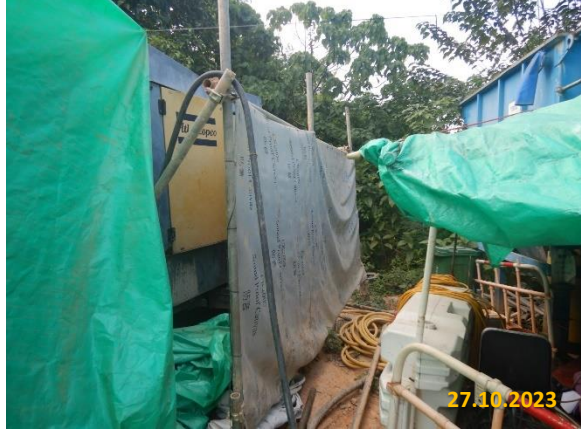
Ref*	Proposed Construction Method**	Location/Working Period	Anticipated Major Impacts	Recommended Mitigation Measures	Photo Records (Partial)
EIA 4.4.6; EM&A Log 3.2			Noise from roadworks	<ul style="list-style-type: none"> Enclose the noisy part of machineries with noise isolating mats during hard surface breaking / for operating plants

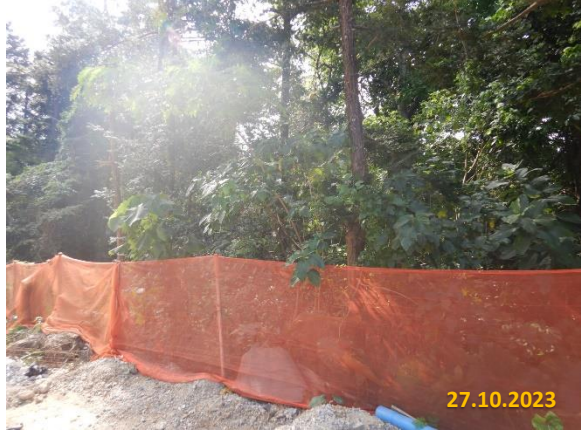
Ref*	Proposed Construction Method**	Location/Working Period	Anticipated Major Impacts	Recommended Mitigation Measures	Photo Records (Partial)
EIA Table 10.11 EM&A Table 9.1			Landscape and visual impact	<ul style="list-style-type: none"> • Properly fenced off the conservative species • Properly implement temporary traffic arrangement which control construction area to minimize landscape and visual impacts
