EP-510/2016 – Police Facilities in Kong Nga Po

**Service Contract No. NDO 07/2019
Environmental Team for Site Formation and
Infrastructure Works for Police Facilities in
Kong Nga Po**

**Monthly Environmental Monitoring and
Audit Report for December 2023
(Version 1.0)**

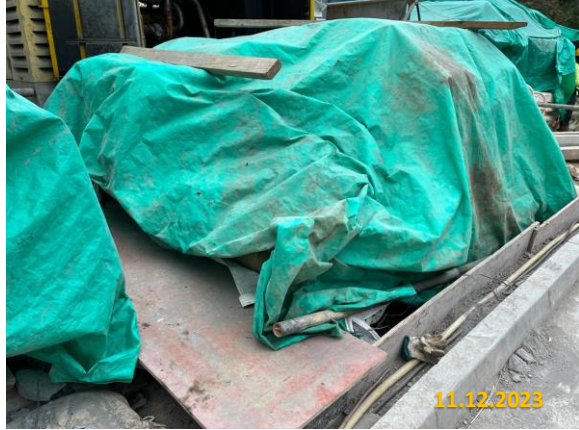
Ref*	Proposed Construction Method**	Location/Working Period	Anticipated Major Impacts	Recommended Mitigation Measures	Photo Records (Partial)
EIA 3.91; EM&A Log 2.2	Slope Upgrading Works	Kong Nga Po Main Site Kong Nga Po Road	Dust impact from soil nail works	<ul style="list-style-type: none"> • Three side enclosure with top shelter for cement mixing works • Water spraying on soil nailing works • Dusty materials exceeding 20 bags shall be stored in area sheltered on top and the three sides or covered entirely by impervious sheeting

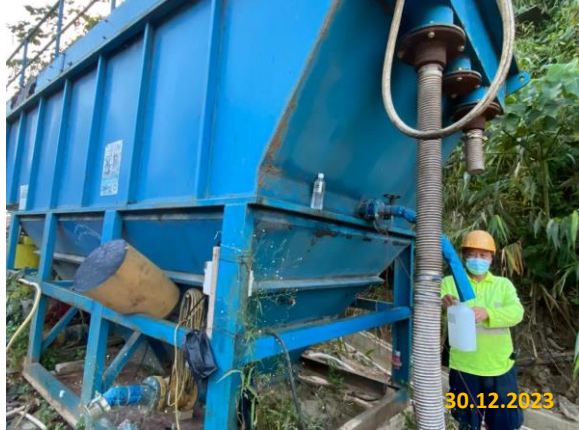
<p>By sub-contractor at KNP Road</p>
EIA 5.6.1.2; EM&A Log 4.2			Water	<ul style="list-style-type: none"> • Deploy desilting/sedimentation devices for wastewater treatment prior to discharge • Establish soil berm with retention pit to control water outflow

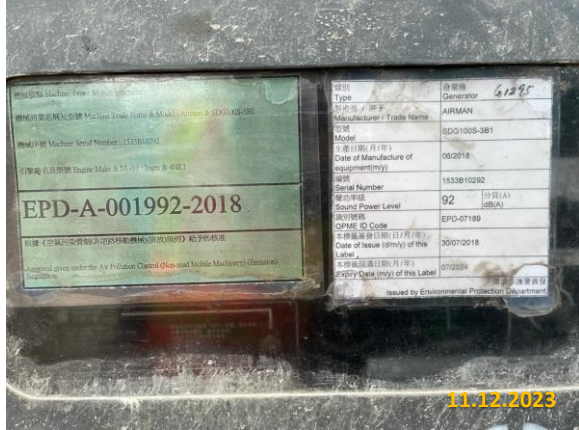
<p>By main contractor at KNP Road</p>
EIA 4.4.6; EM&A Log 3.2			Noise	<ul style="list-style-type: none"> Regular inspection and maintenance of plant and equipment in good condition Provide noise barriers for soil nailing works where near the sensitive receiver

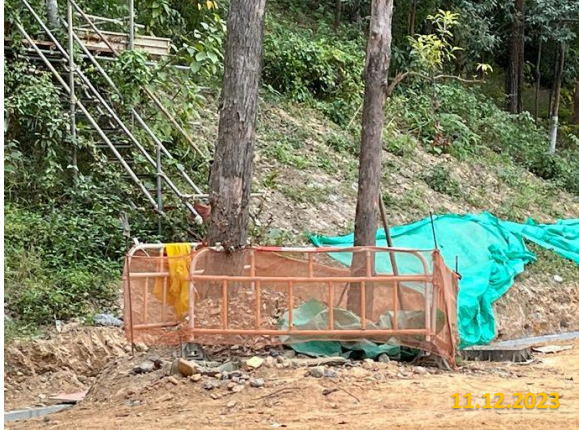
<p>By main contractor at KNP Main Site</p>
EIA Table 10.11 EM&A Table 9.1			Landscape and visual impact	<ul style="list-style-type: none"> • Properly fenced off the conservative species • Preservation of existing trees will be undertaken in accordance with DEVB TC(W) 7/2015 and Guidelines for Tree Risk Assessment and Management Arrangement

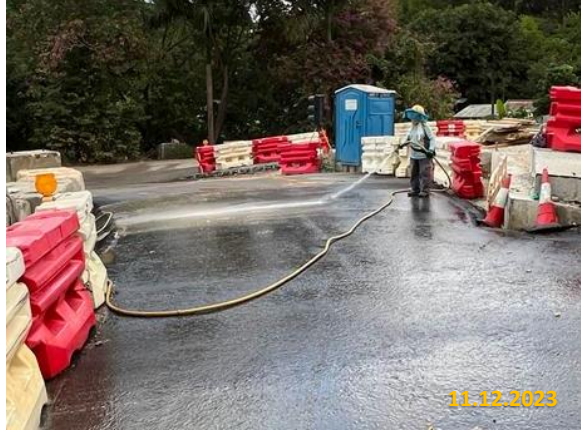
Ref*	Proposed Construction Method**	Location/Working Period	Anticipated Major Impacts	Recommended Mitigation Measures	Photo Records (Partial)
EIA 3.91; EM&A Log 2.2	Road and Associated Works	Kong Nga Po Main Site Kong Nga Po Road	Air Dust impact from excavation activities and earth moving	<ul style="list-style-type: none"> • Use of regular water spraying (once every 1.25 hours or 8 times per day) at all active works area exposed site surfaces and unpaved roads, particularly during dry weather • Regular inspection and maintenance of plant and equipment in good condition • Regularly clean up stockpiles and debris to avoid accumulation of materials

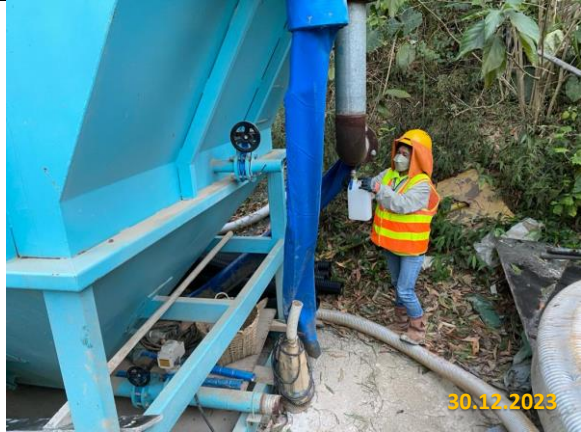
<p>By sub-contractor at KNP Road</p>
EIA 5.6.1.2; EM&A Log 4.2			Water	<ul style="list-style-type: none"> • Provide desilting/sedimentation devices for wastewater treatment before discharge

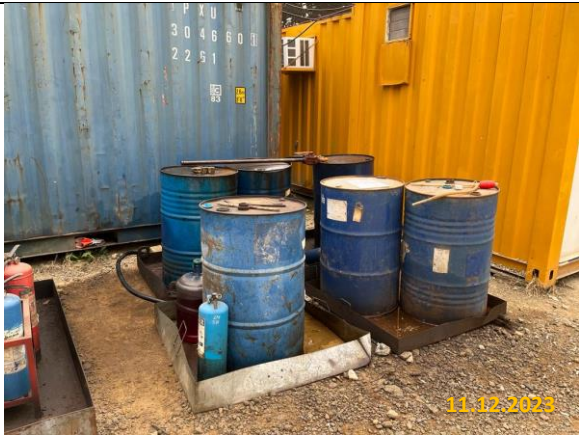
<p>By sub-contractor at KNP Road</p>
EIA 7.5.1.4; EM&A Log 6.2			Chemical Waste	<ul style="list-style-type: none"> Drip tray and chemical spillage kit shall be provided on site

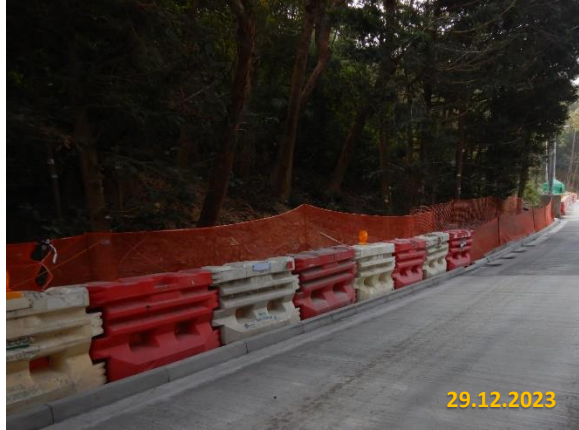
Ref*	Proposed Construction Method**	Location/Working Period	Anticipated Major Impacts	Recommended Mitigation Measures	Photo Records (Partial)
EIA Table 10.11 EM&A Table 9.1	(Con't) Road and Associated Works	(Con't) Kong Nga Po Main Site Kong Nga Po Road	Landscape and visual impact	<ul style="list-style-type: none"> • Properly fenced off the conservative species • Properly implement temporary traffic arrangement which control construction area to minimize landscape and visual impacts
