EP-510/2016 – Police Facilities in Kong Nga Po

**Service Contract No. NDO 07/2019
Environmental Team for Site Formation and
Infrastructure Works for Police Facilities in
Kong Nga Po**

**Quarterly Environmental Monitoring and
Audit Report for April to June 2022
(Version 1.0)**

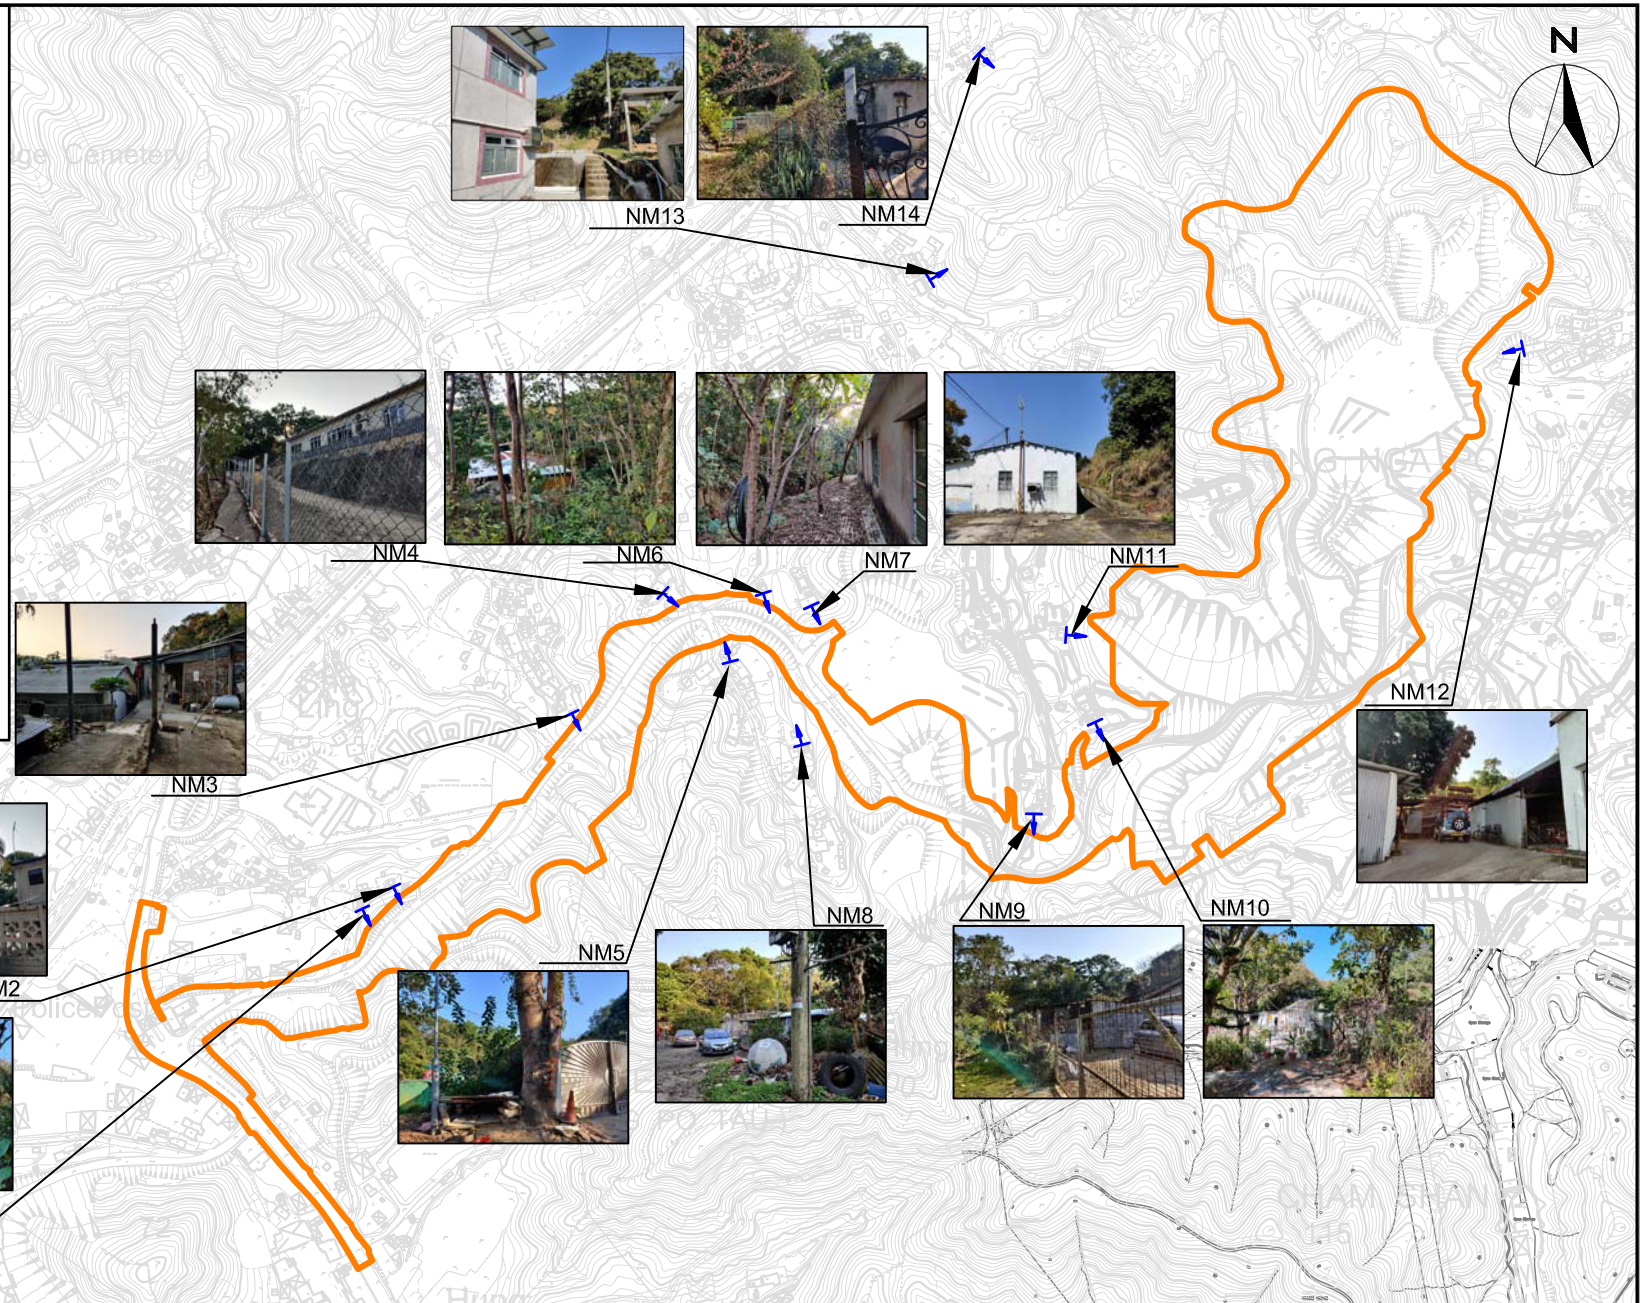
Service Contract No. NDO 07/2019
 Environmental Team for Site Formation and Infrastructure Works for Police Facilities in Kong Nga Po
Noise Monitoring Stations

NOISE MONITORING STATIONS	
I.D	Description
NM1	Village House, Sha Ling
NM2	Village House, Sha Ling
NM3	Village House No. 248, Sha Ling
NM4	Village House, Sha Ling
NM5	Village House No. 270, Sha Ling
NM6	Village House, Sha Ling
NM7	Village House, Sha Ling
NM8	Village House, Sha Ling
NM9	Village House, Kong Nga Po
NM10	Village House, Kong Nga Po
NM11	Village House, Kong Nga Po
NM12	Village House, Kong Nga Po
NM13	Village House, Kong Nga Po
NM14	Village House, near Man Kam To Road

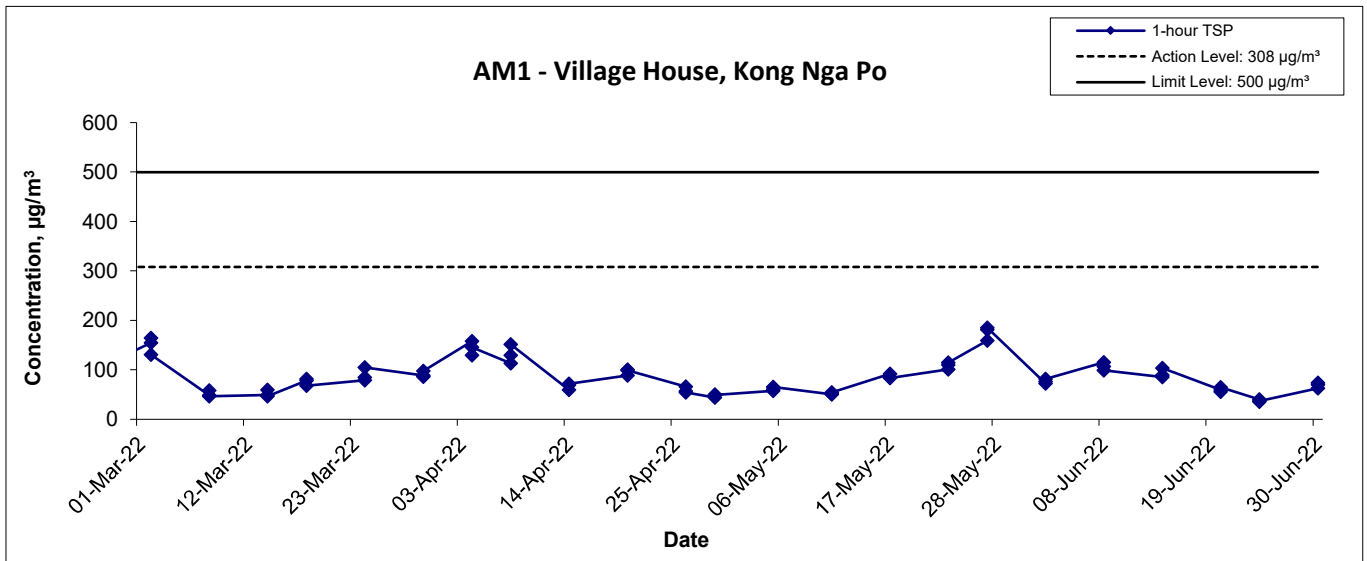
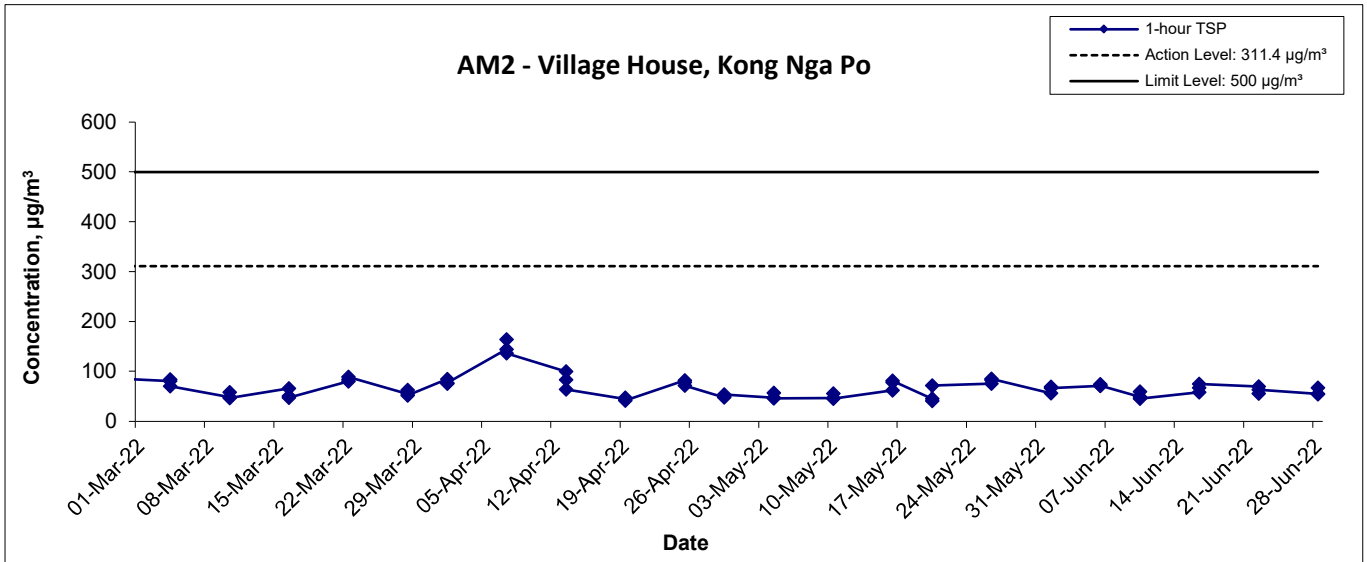
Title Service Contract No. NDO 07/2019 Environmental Team for Site Formation and Infrastructure Works for Police Facilities in Kong Nga Po Graphical Presentation of 1-hour TSP Monitoring Results	Scale N.T.S	Project No. WMA20001

**APPENDIX B
1-HOUR TSP MONITORING
GRAPHICAL PRESENTATION**

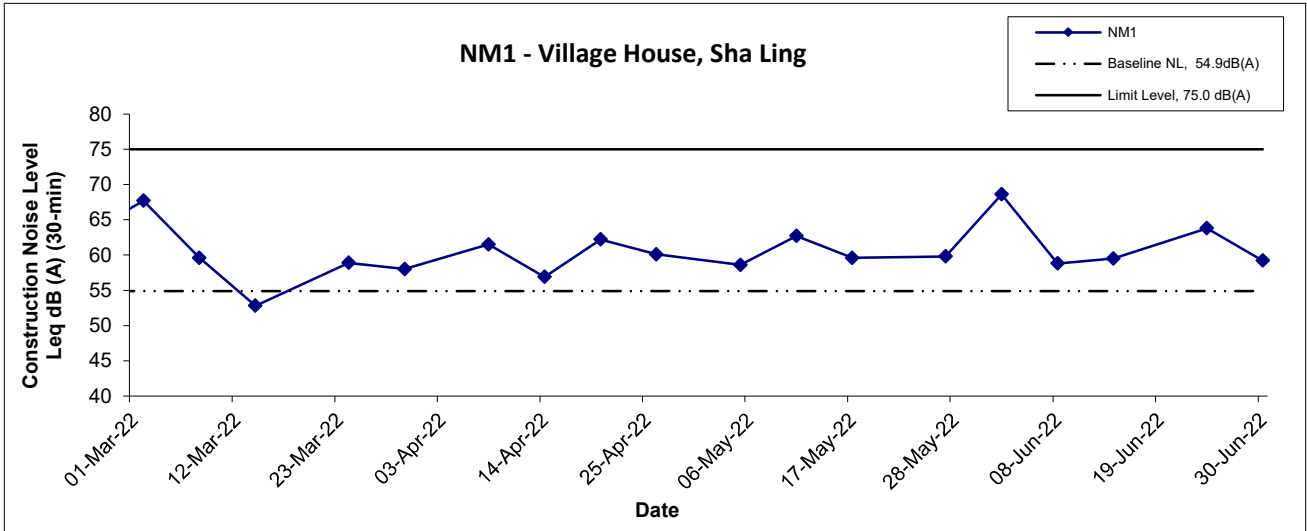
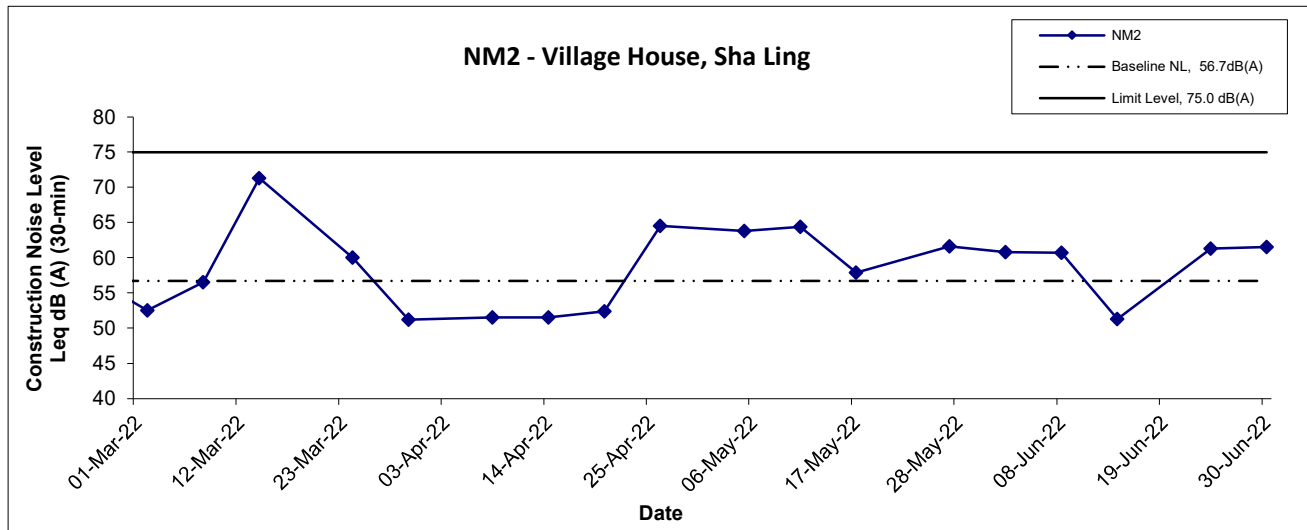
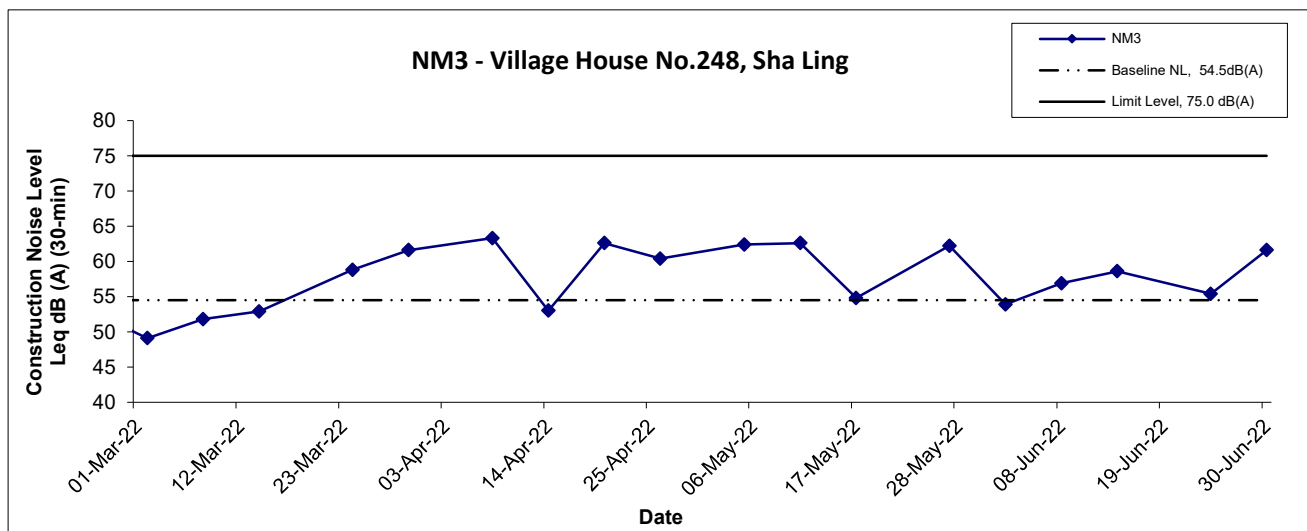
Title Service Contract No. NDO 07/2019 Environmental Team for Site Formation and Infrastructure Works for Police Facilities in Kong Nga Po Graphical Presentation of Construction Noise Monitoring Results	Scale	N.T.S	Project No.	WMA20001
	Date	Jun 22	Appendix	C

Noise Levels

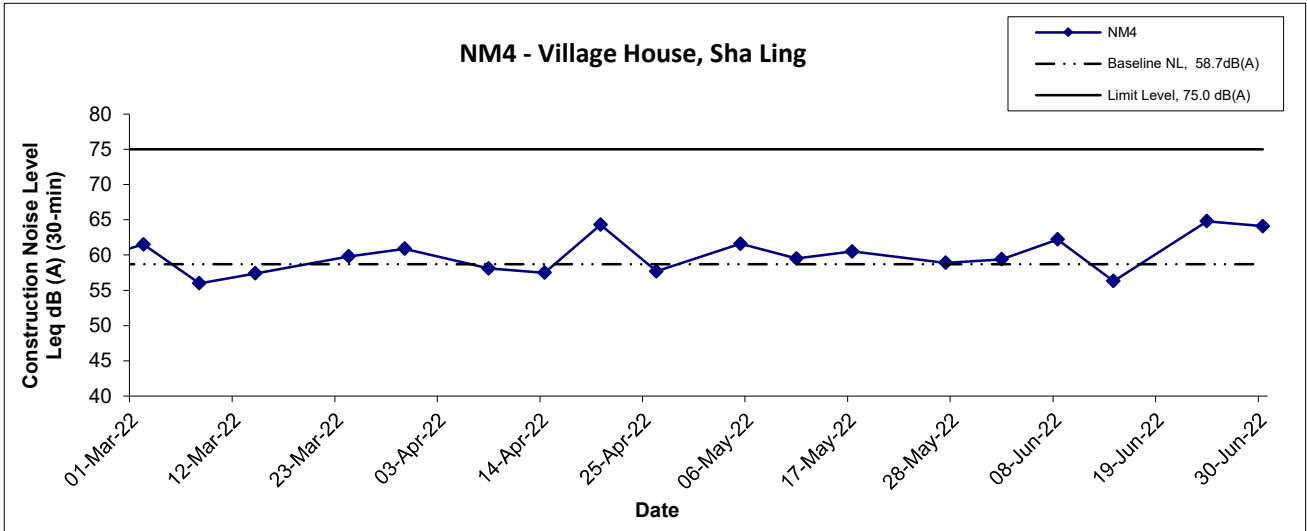
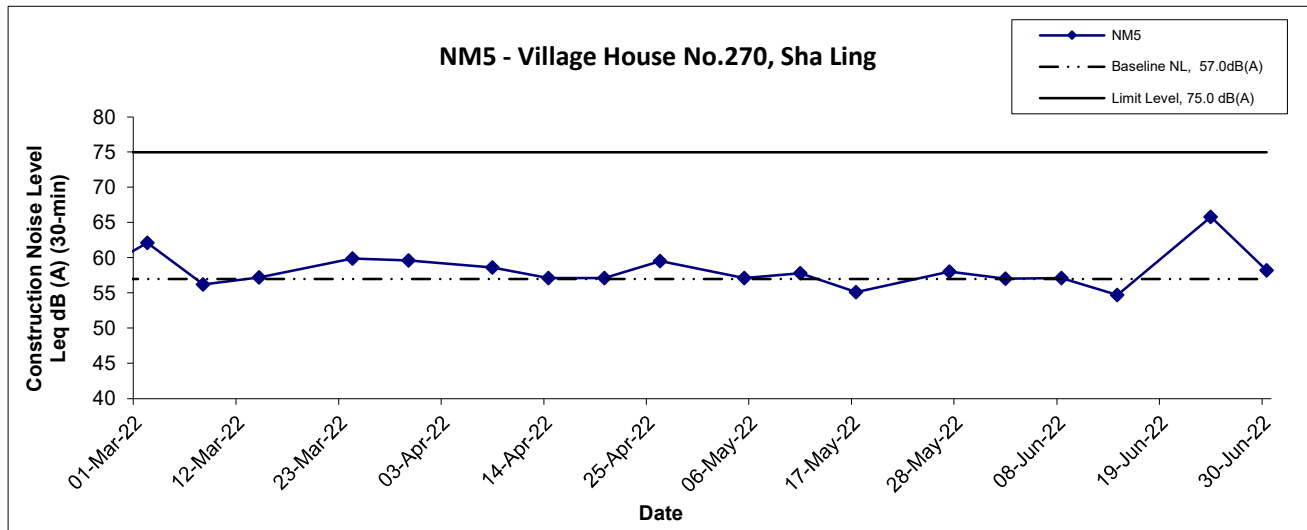
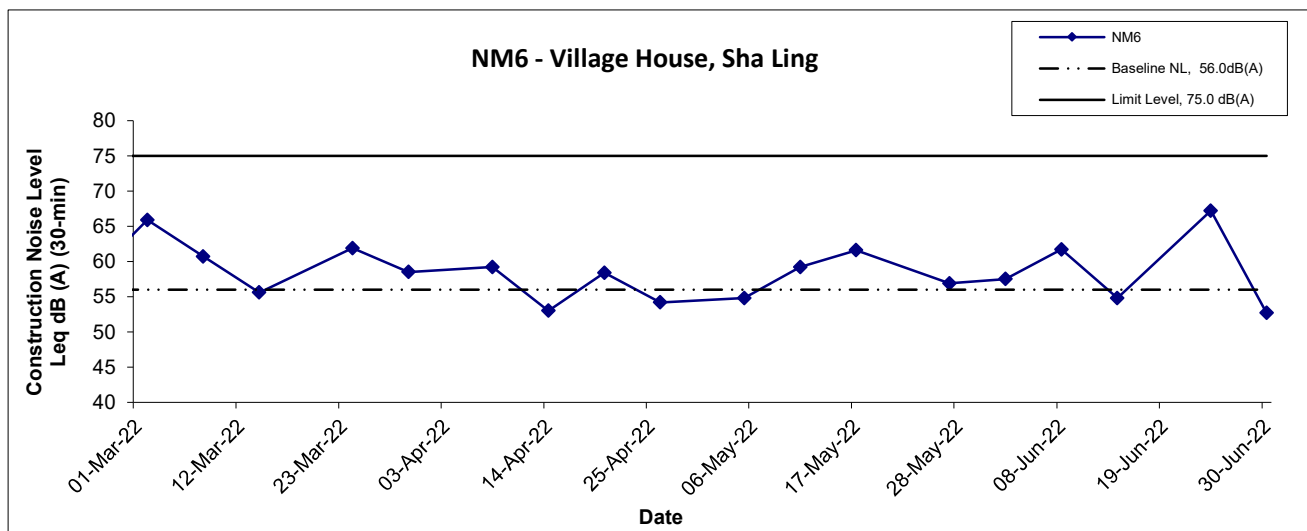
Title Service Contract No. NDO 07/2019 Environmental Team for Site Formation and Infrastructure Works for Police Facilities in Kong Nga Po Graphical Presentation of Construction Noise Monitoring Results	Scale N.T.S	Project No. WMA20001	
	Date Jun 22	Appendix C

Noise Levels

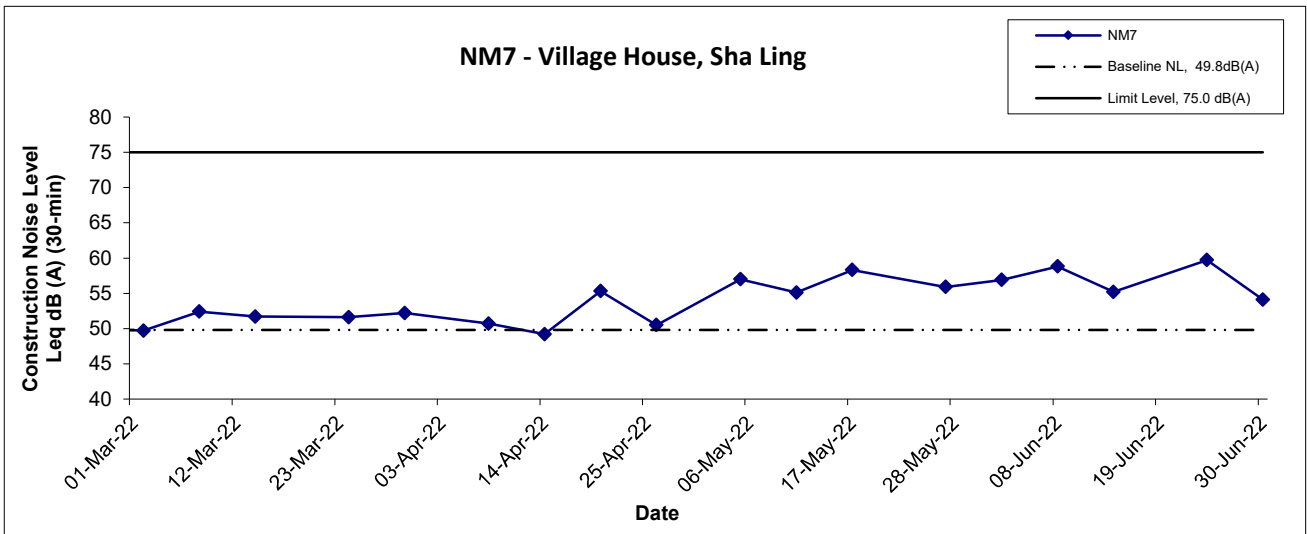
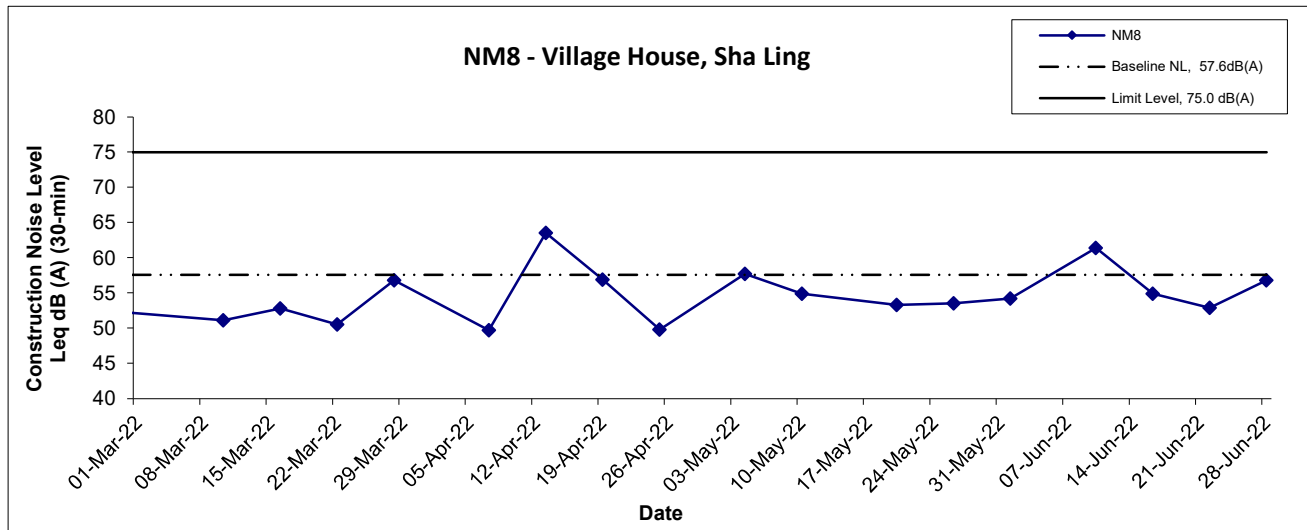
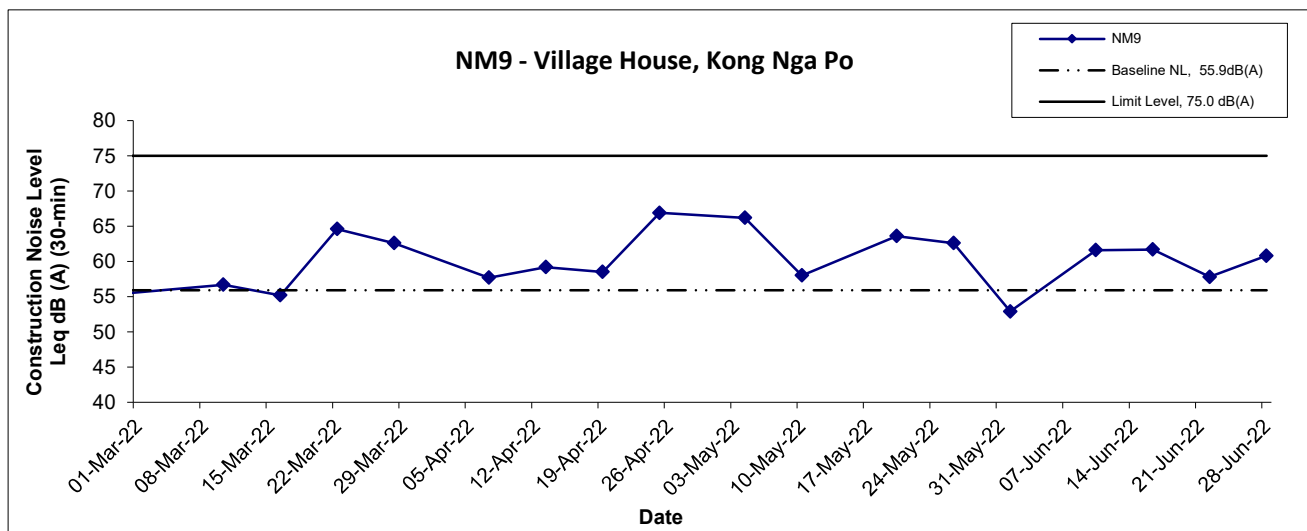
Title Service Contract No. NDO 07/2019 Environmental Team for Site Formation and Infrastructure Works for Police Facilities in Kong Nga Po Graphical Presentation of Construction Noise Monitoring Results	Scale	N.T.S	Project No.	WMA20001
	Date	Jun 22	Appendix	C

Noise Levels

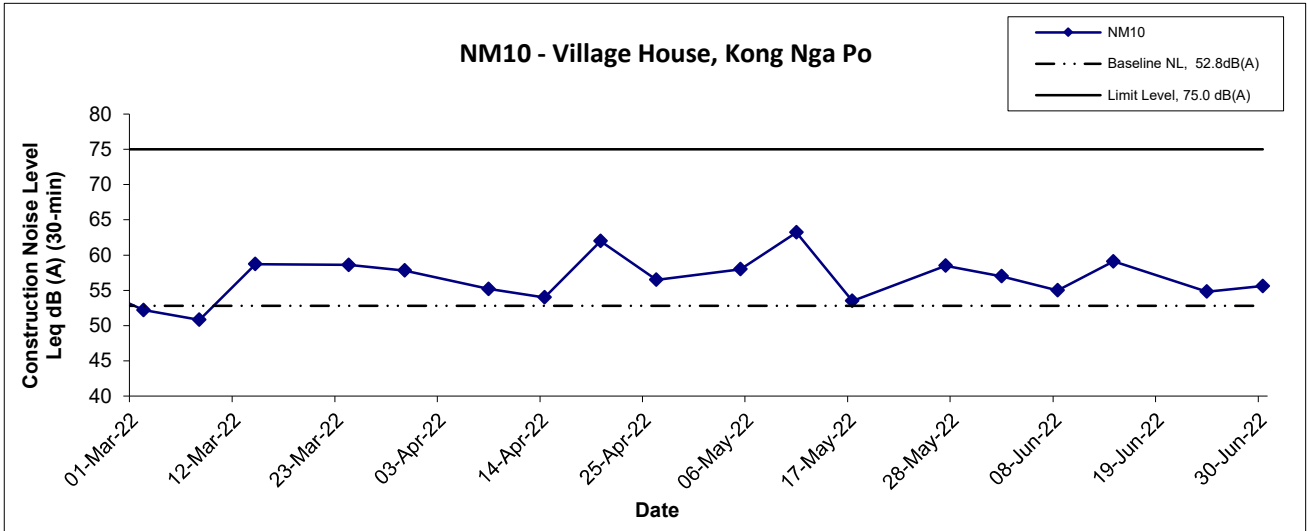
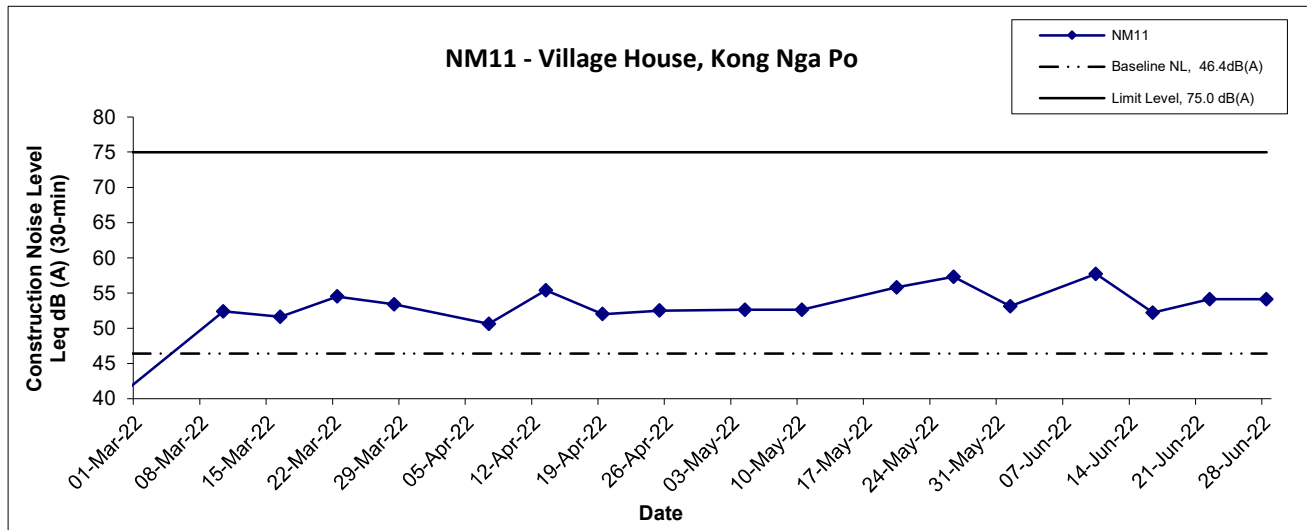
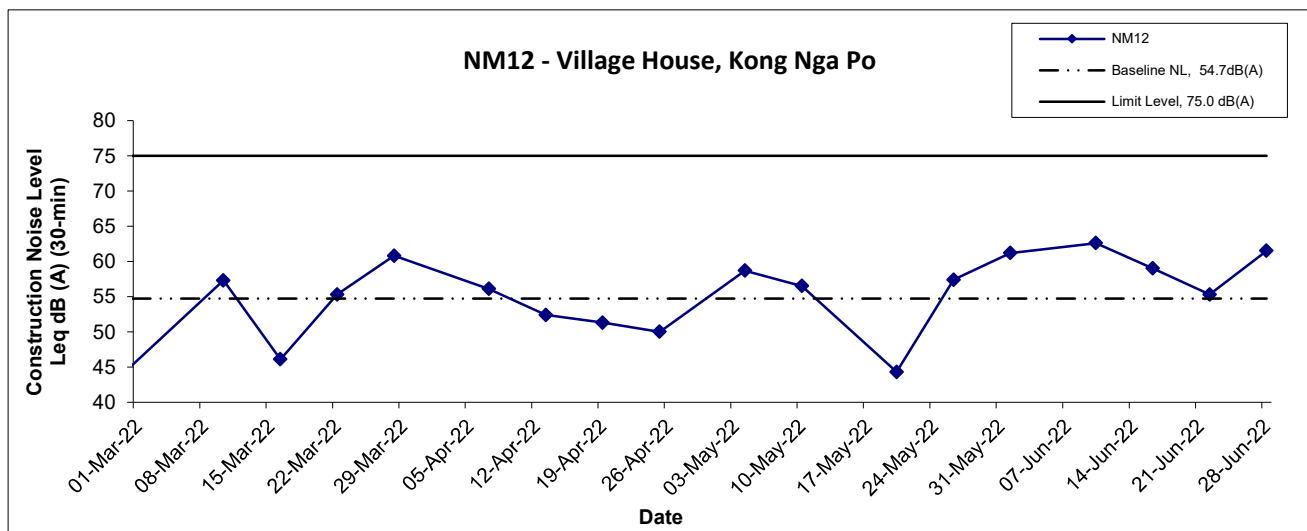
Title Service Contract No. NDO 07/2019 Environmental Team for Site Formation and Infrastructure Works for Police Facilities in Kong Nga Po Graphical Presentation of Construction Noise Monitoring Results	Scale	N.T.S	Project No.	WMA20001
	Date	Jun 22	Appendix	C

Noise Levels

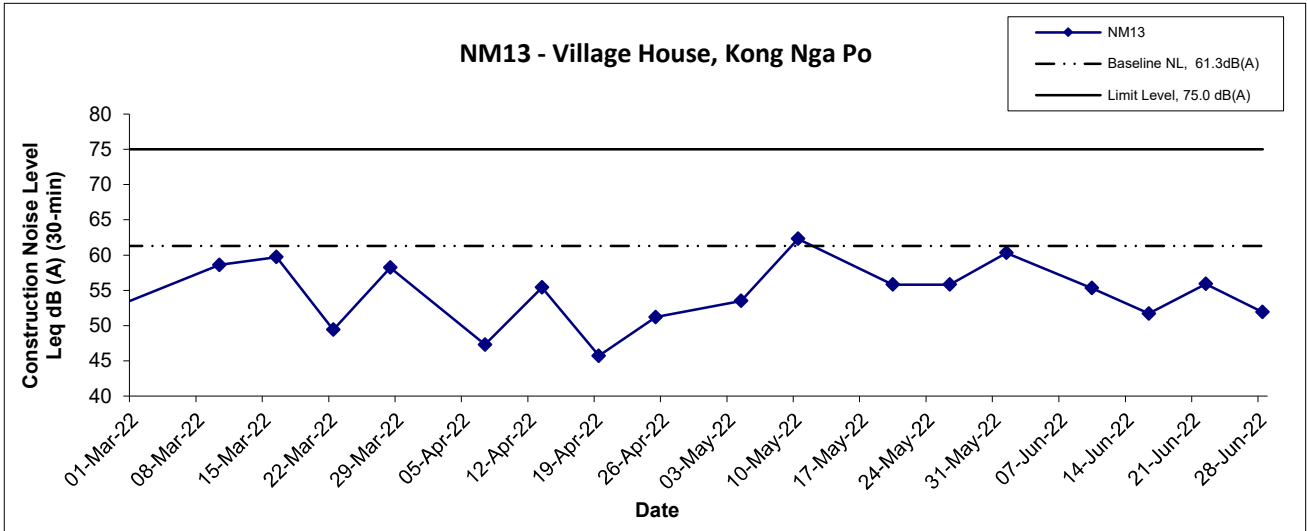
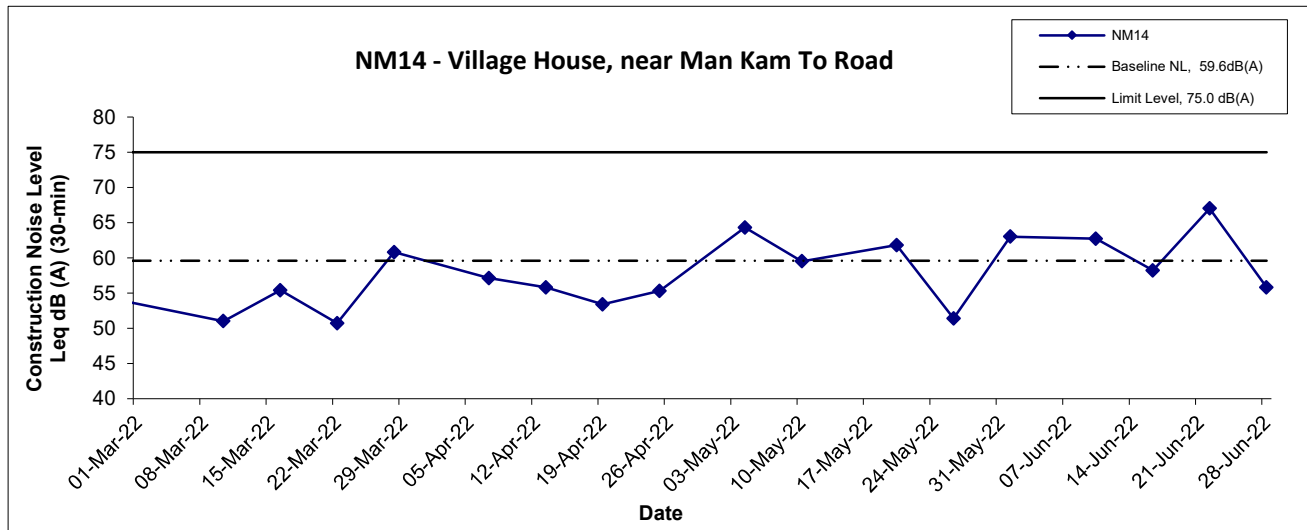
Title Service Contract No. NDO 07/2019 Environmental Team for Site Formation and Infrastructure Works for Police Facilities in Kong Nga Po Graphical Presentation of Construction Noise Monitoring Results	Scale N.T.S	Project No. WMA20001	匯力 consulting . testing . research
	Date Jun 22	Appendix C

Noise Levels
