## EP-510/2016 – Police Facilities in Kong Nga Po

### Service Contract No. NDO 07/2019 Environmental Team for Site Formation and Infrastructure Works for Police Facilities in Kong Nga Po

### Quarterly Environmental Monitoring and Audit Report for July to September 2022 (Version 1.0)

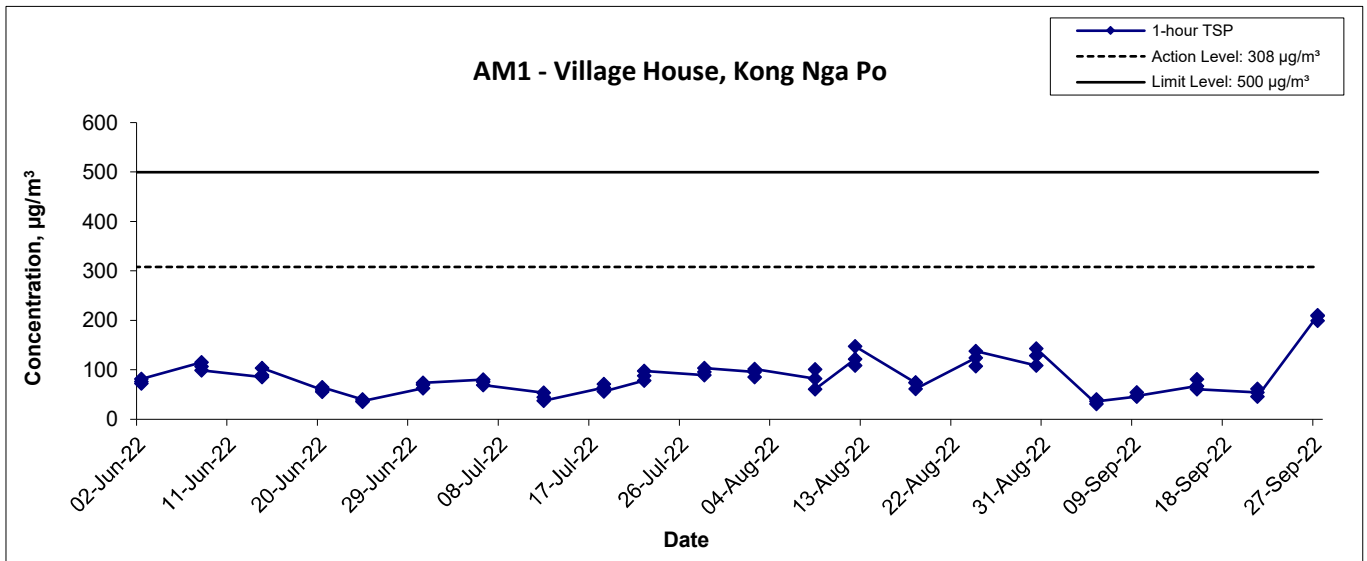
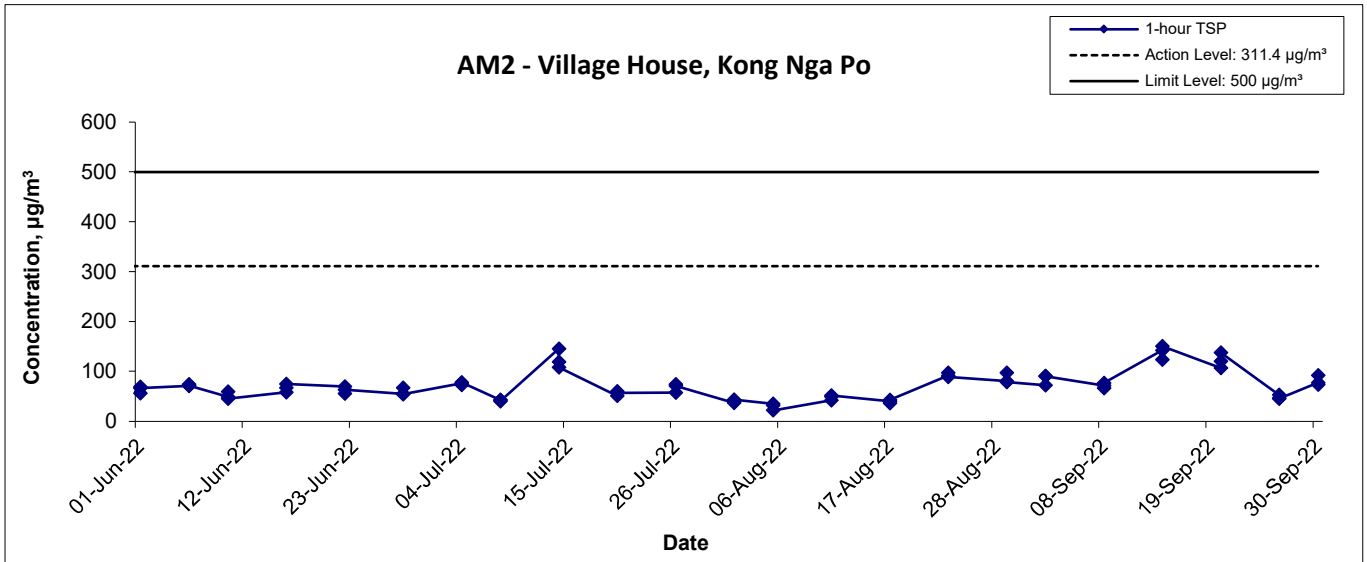
Title Service Contract No. NDO 07/2019 Environmental Team for Site Formation and Infrastructure Works for Police Facilities in Kong Nga Po Graphical Presentation of 1-hour TSP Monitoring Results	Scale N.T.S	Project No. WMA20001

### 1-hr TSP Concentration Levels

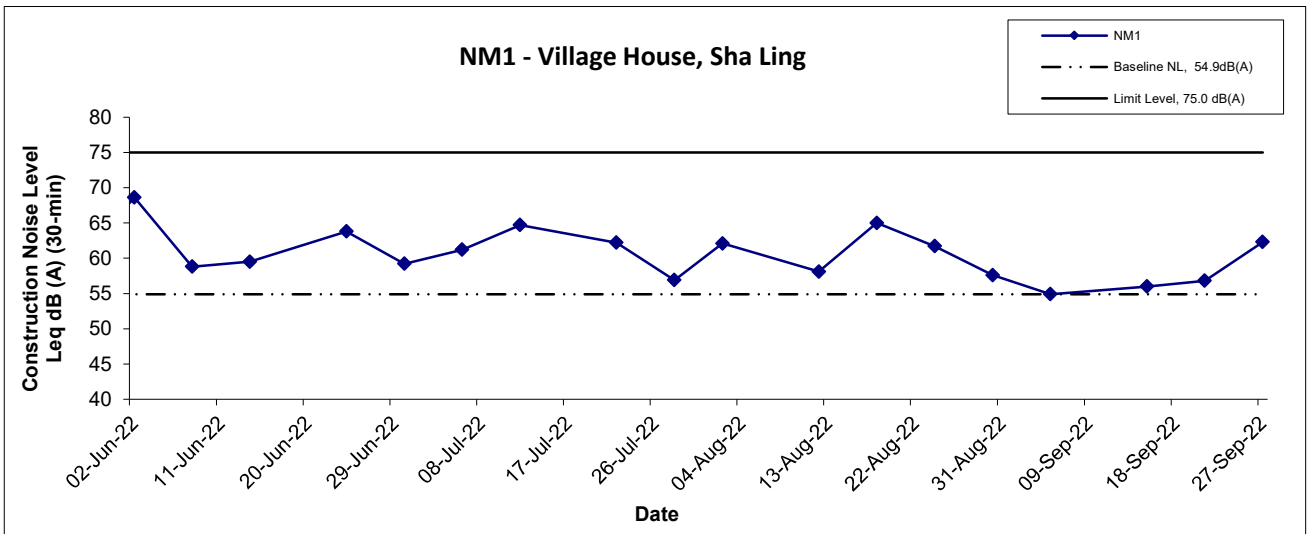
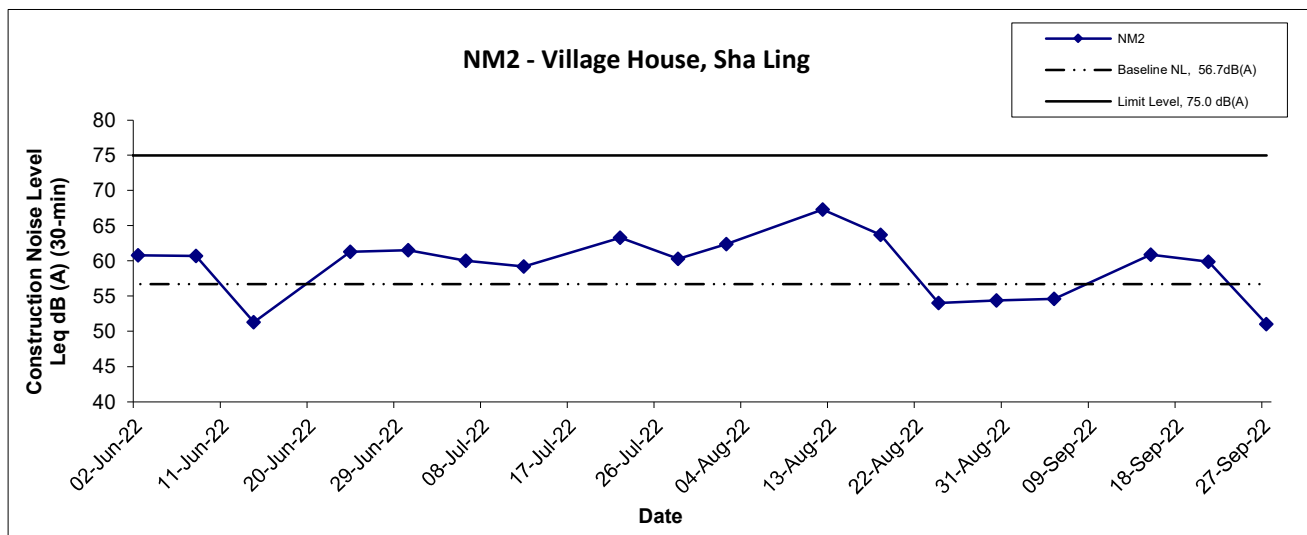
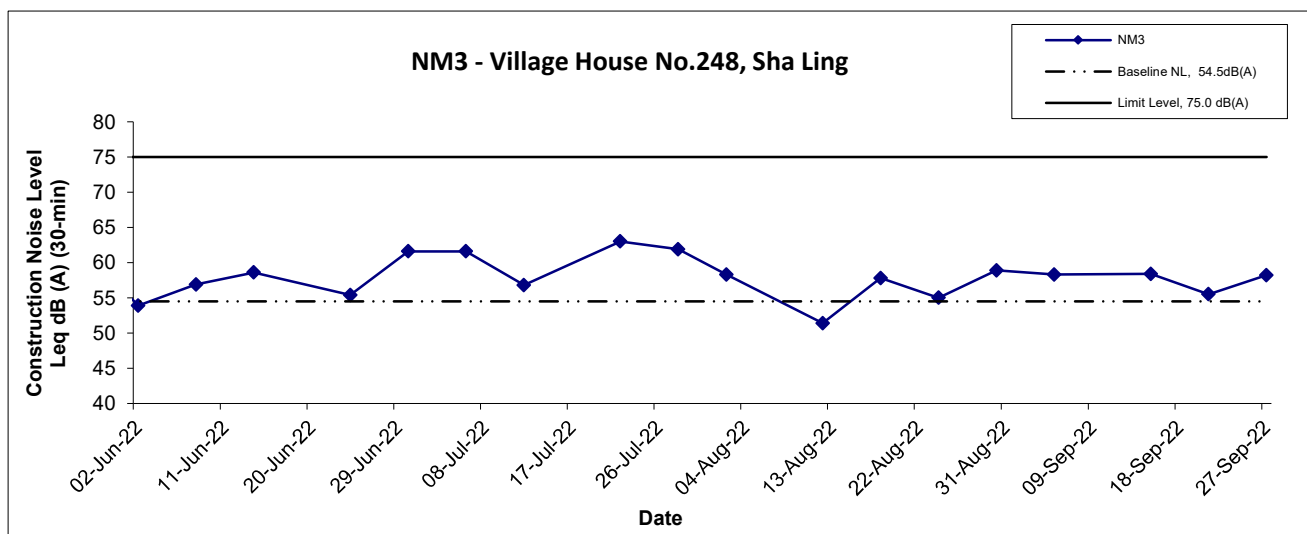
Title Service Contract No. NDO 07/2019 Environmental Team for Site Formation and Infrastructure Works for Police Facilities in Kong Nga Po Graphical Presentation of Construction Noise Monitoring Results	Scale	N.T.S	Project No.	WMA20001
	Date	Sept 22	Appendix	C

## Noise Levels

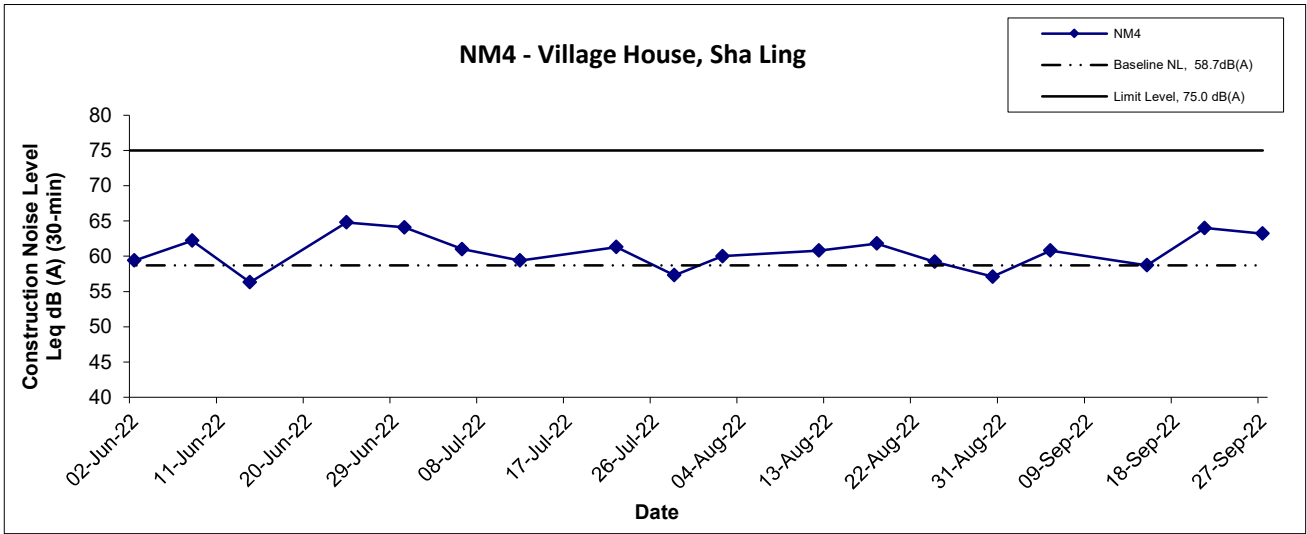
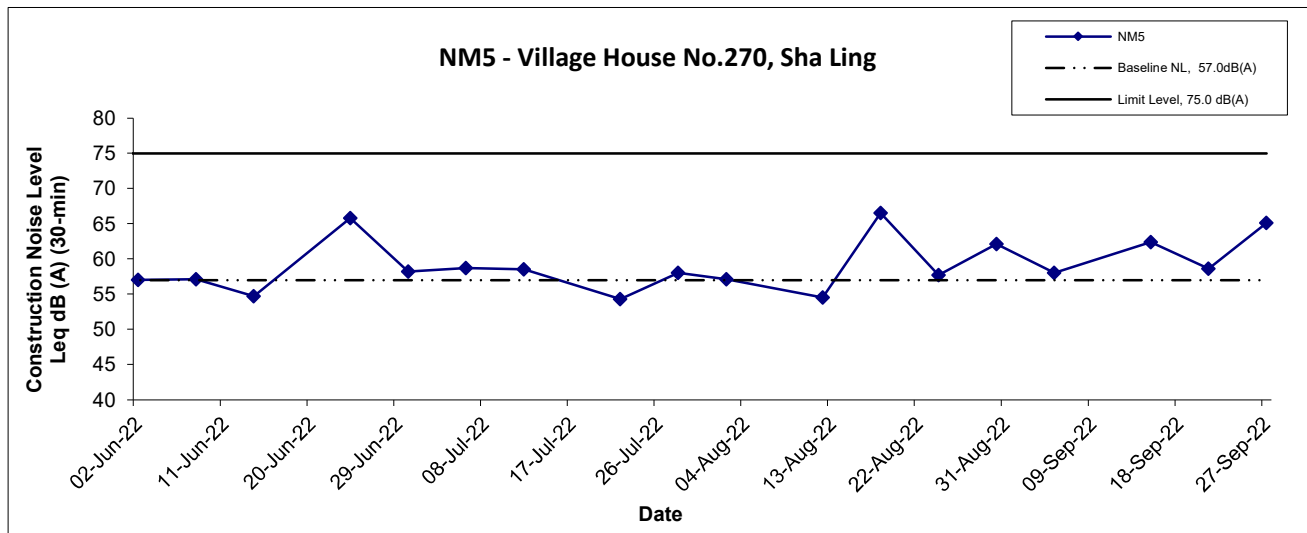
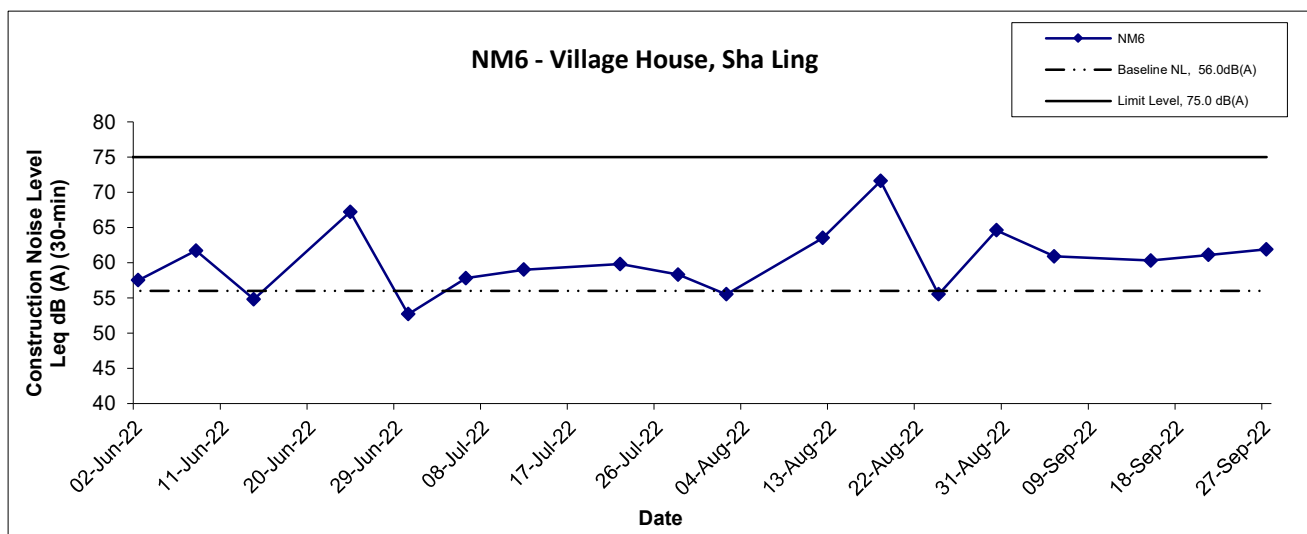
Title Service Contract No. NDO 07/2019 Environmental Team for Site Formation and Infrastructure Works for Police Facilities in Kong Nga Po Graphical Presentation of Construction Noise Monitoring Results	Scale	Project No.	consulting . testing . research
	N.T.S	WMA20001	
Date	Sept 22	Appendix	C

## Noise Levels

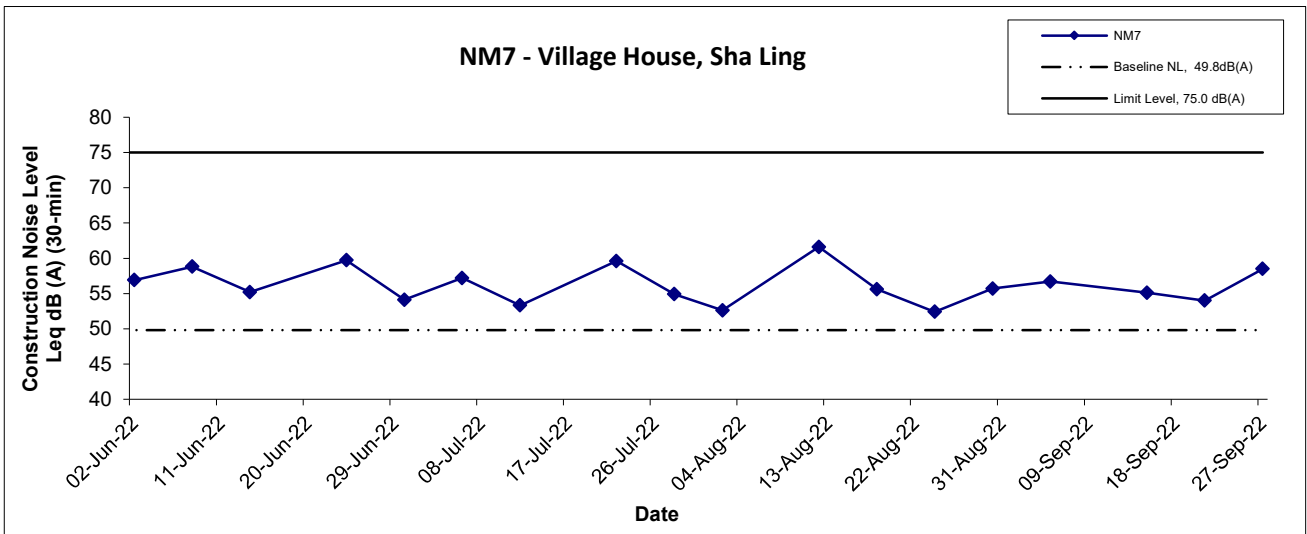
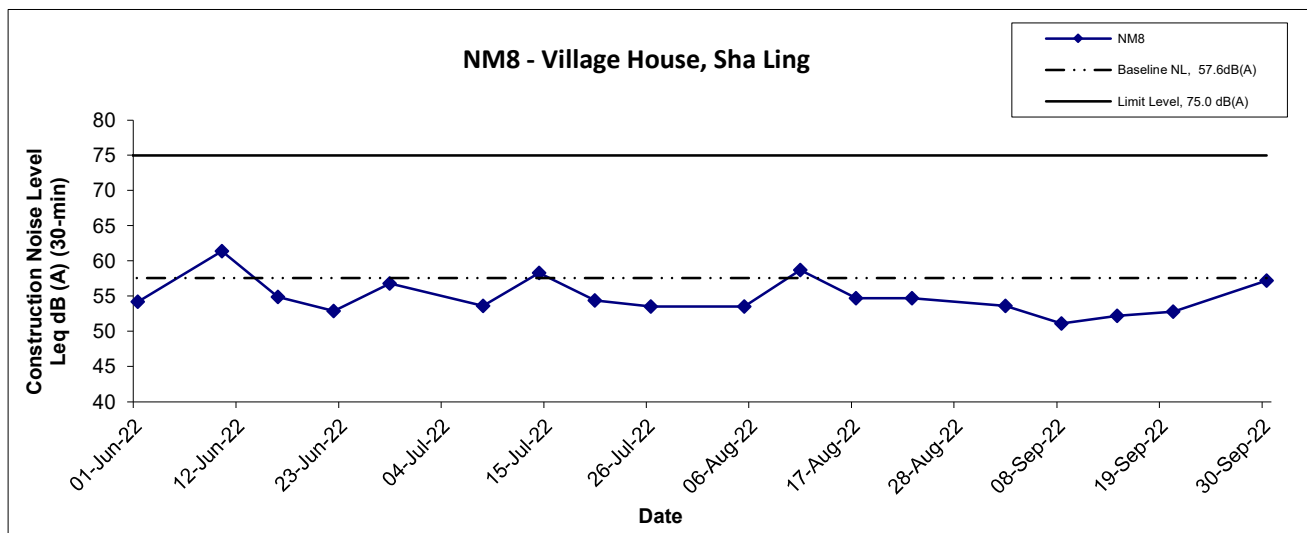
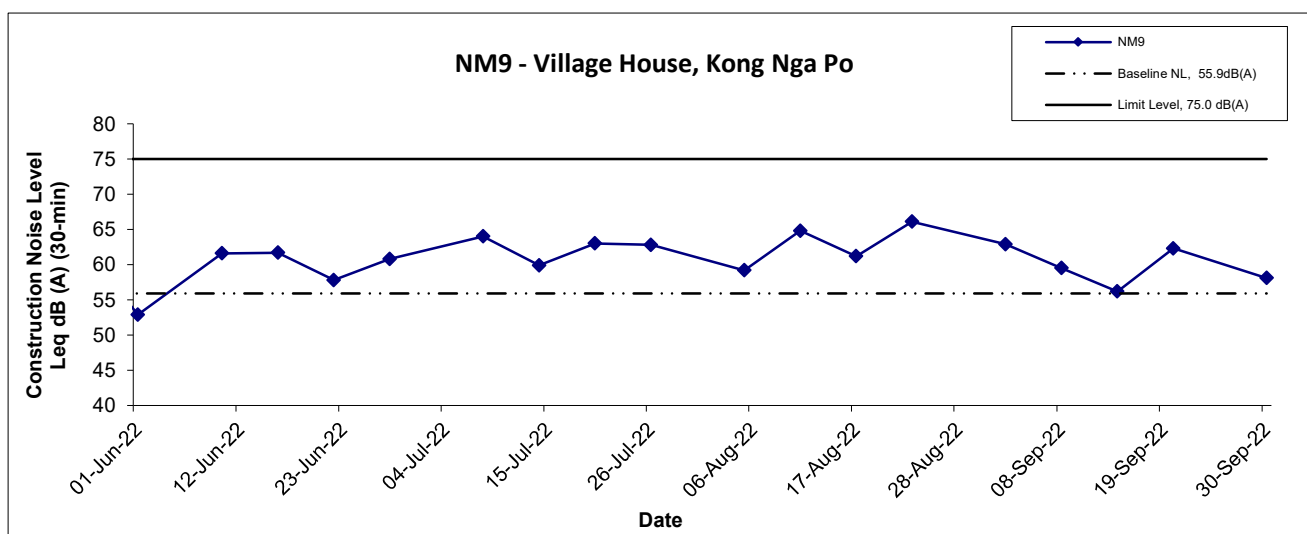
Title Service Contract No. NDO 07/2019 Environmental Team for Site Formation and Infrastructure Works for Police Facilities in Kong Nga Po Graphical Presentation of Construction Noise Monitoring Results	Scale	Project No.	consulting . testing . research
	N.T.S	WMA20001	
Date	Sept 22	Appendix	C

## Noise Levels

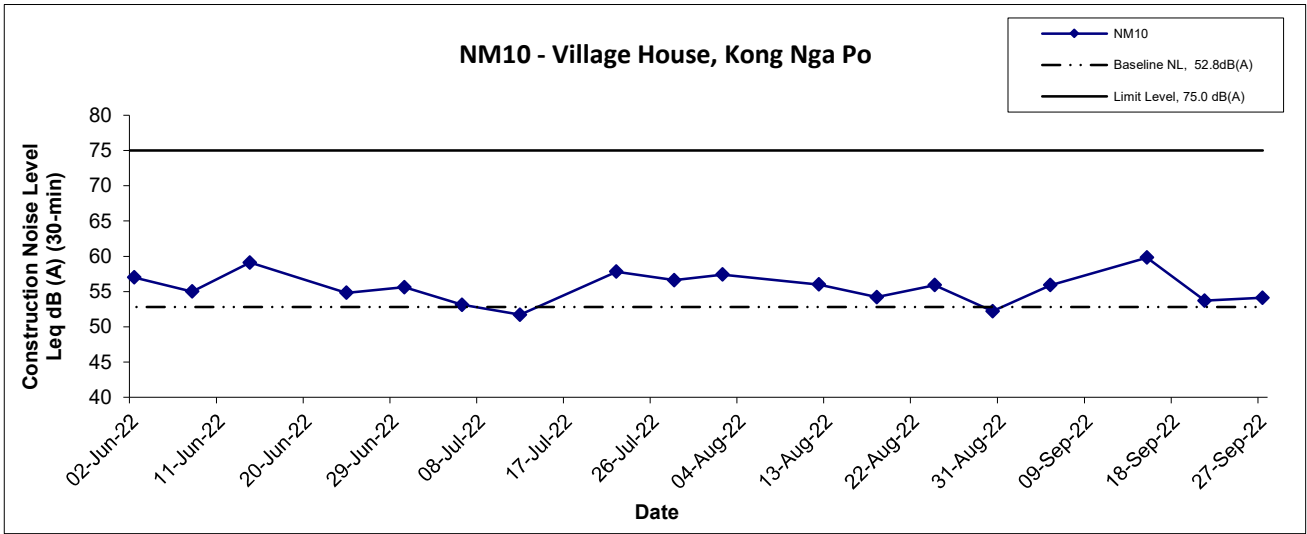
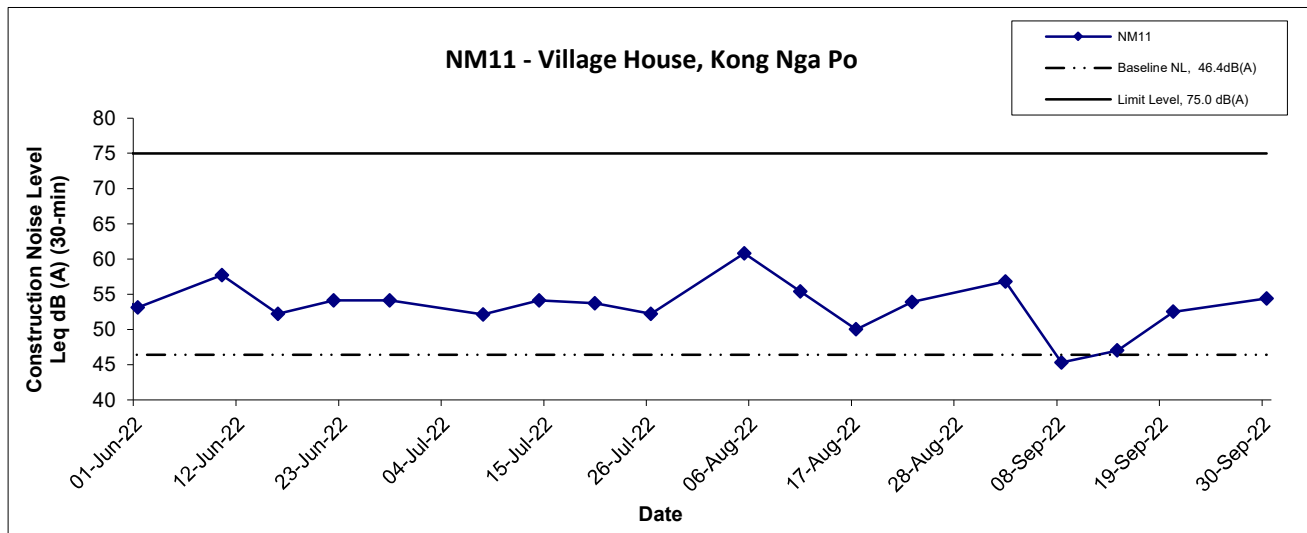
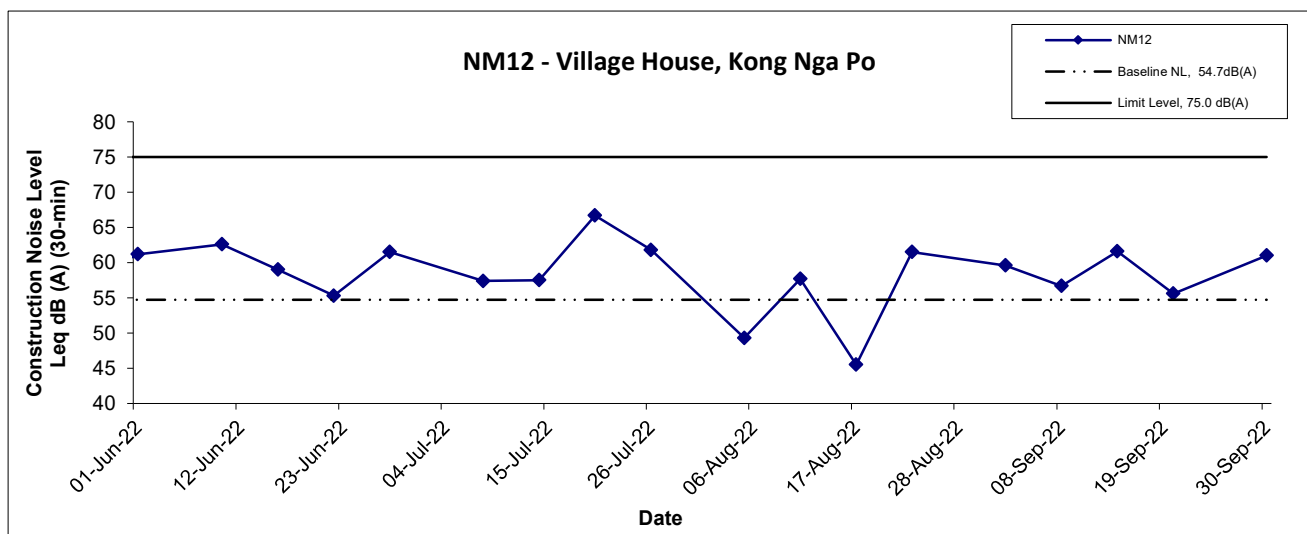
Title Service Contract No. NDO 07/2019 Environmental Team for Site Formation and Infrastructure Works for Police Facilities in Kong Nga Po Graphical Presentation of Construction Noise Monitoring Results	Scale N.T.S	Project No. WMA20001	consulting . testing . research
	Date Sept 22	Appendix C

## Noise Levels

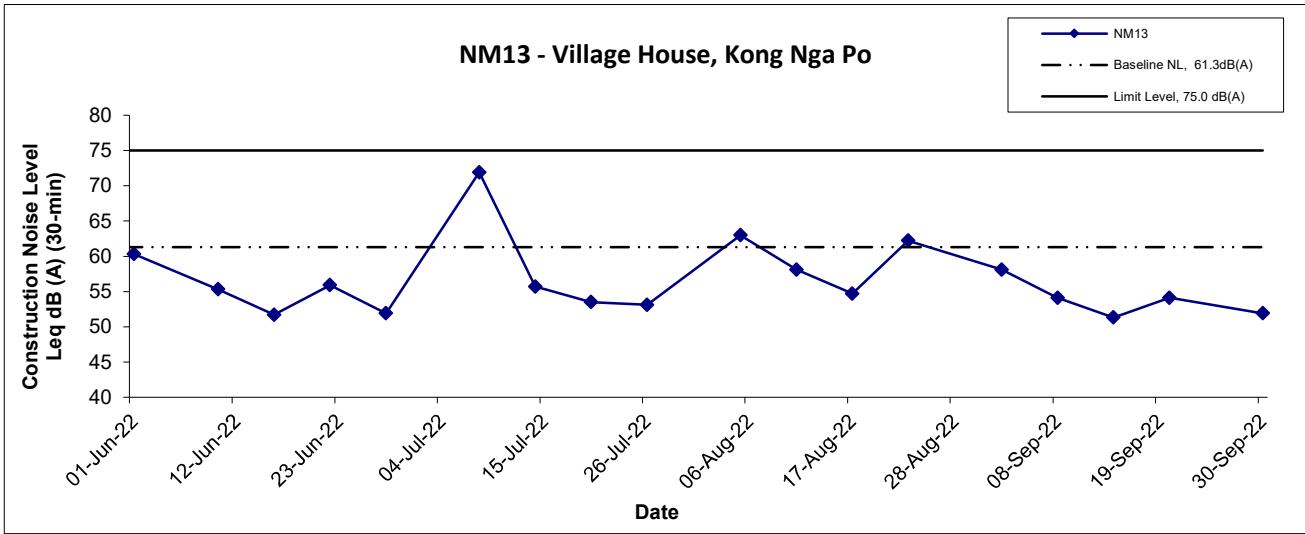
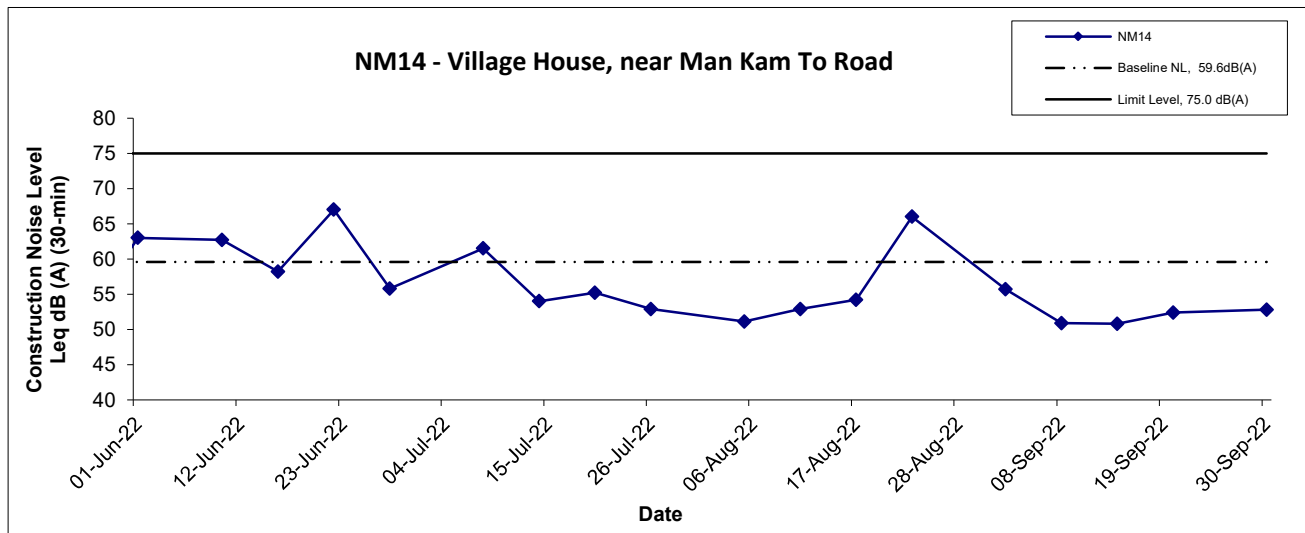
Title Service Contract No. NDO 07/2019 Environmental Team for Site Formation and Infrastructure Works for Police Facilities in Kong Nga Po Graphical Presentation of Construction Noise Monitoring Results	Scale N.T.S	Project No. WMA20001	consulting . testing . research
	Date Sept 22	Appendix C

## Noise Levels
