EP-510/2016 – Police Facilities in Kong Nga Po

**Service Contract No. NDO 07/2019
Environmental Team for Site Formation and
Infrastructure Works for Police Facilities in
Kong Nga Po**

**Quarterly Environmental Monitoring and
Audit Report for July to September 2023
(Version 1.0)**

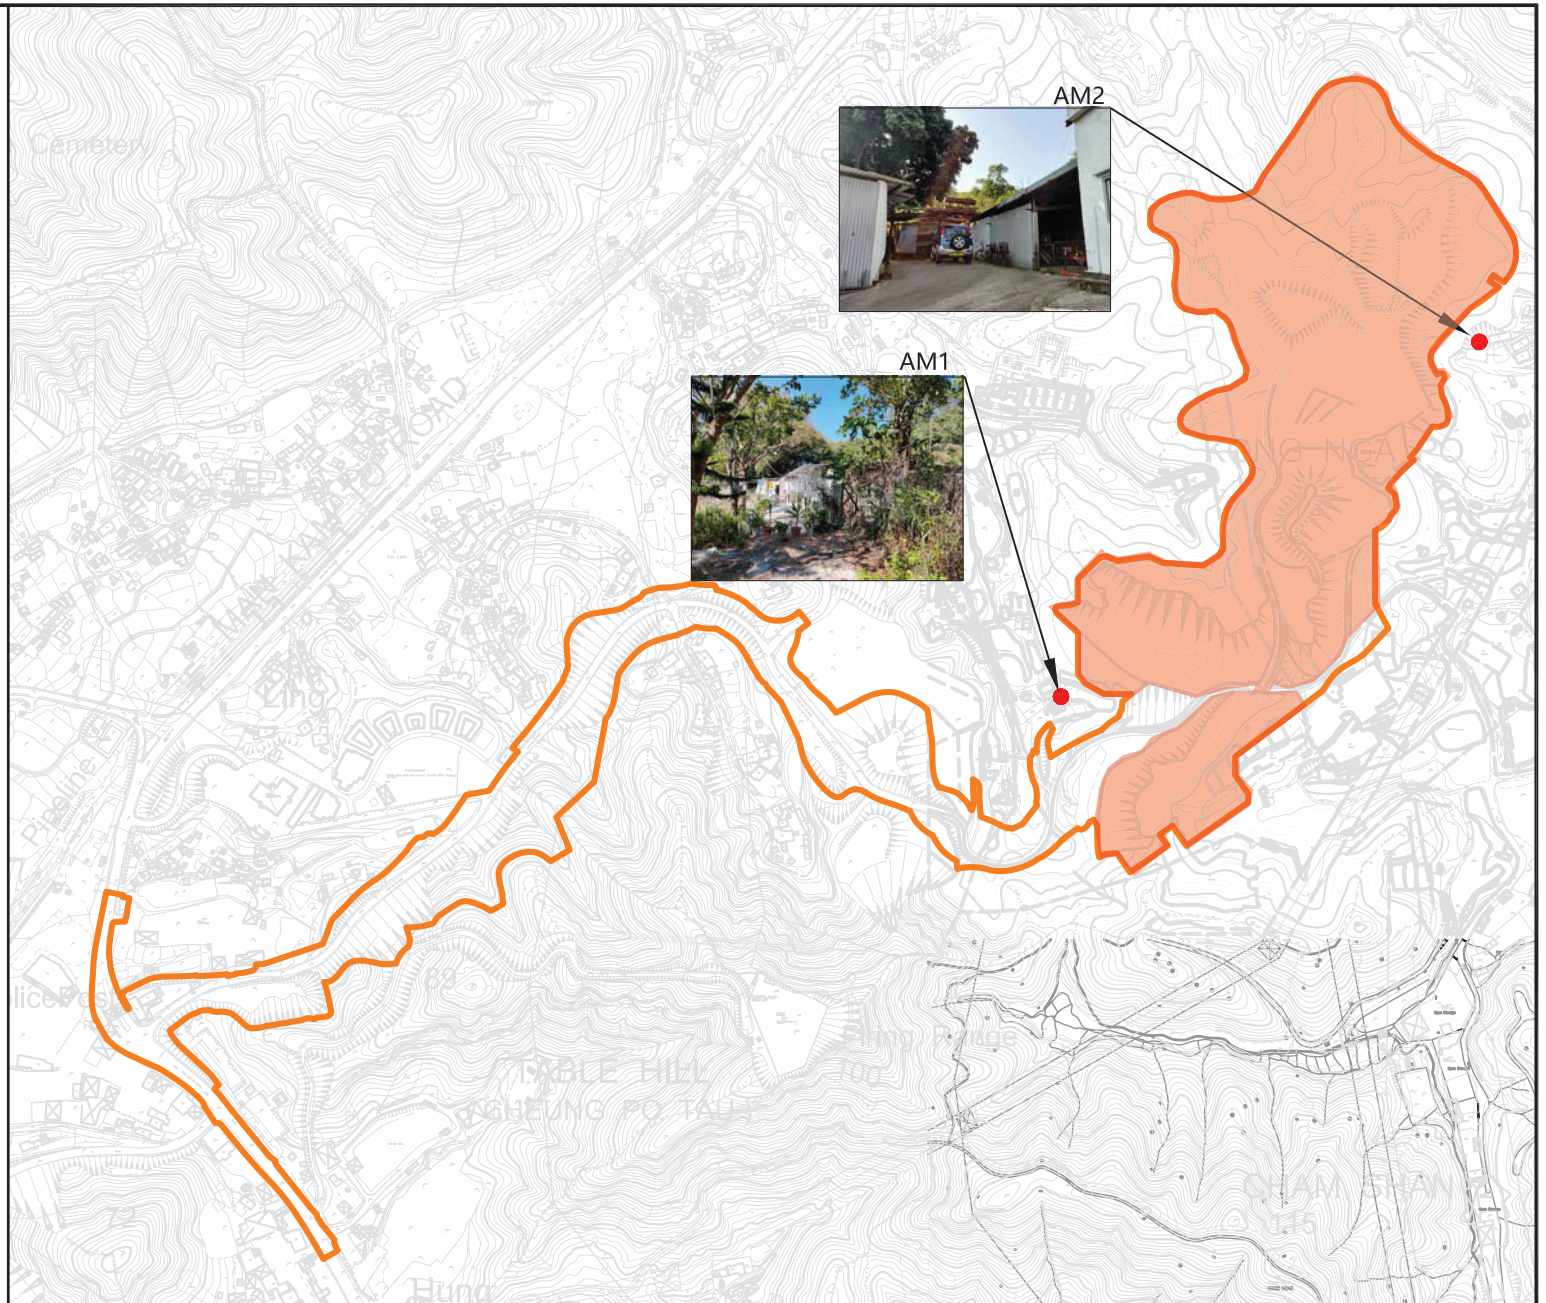
Air Quality Monitoring Stations	
ID	Description
AM1	Village House, Kong Nga Po
AM2	Village House, Kong Nga Po

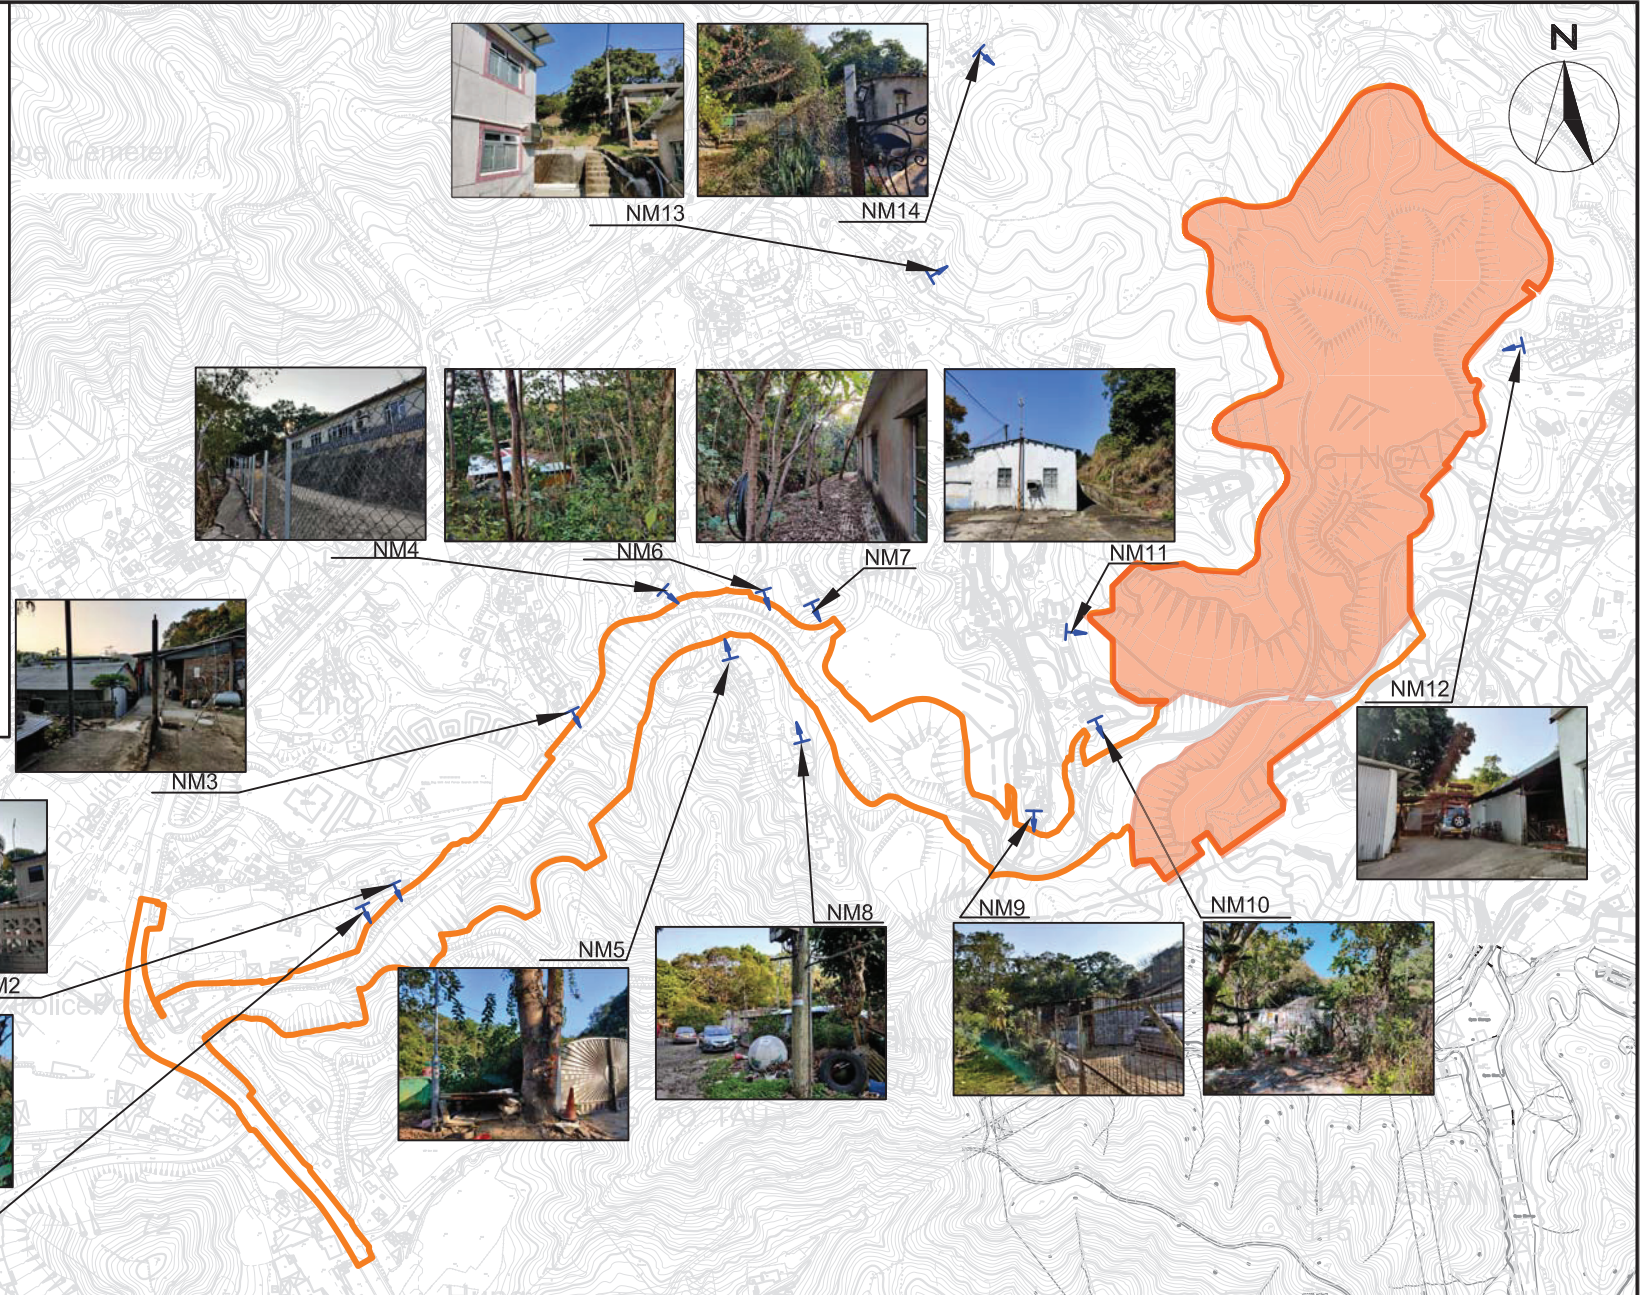
Noise Monitoring Stations	
ID	Description
NM1	Village House, Sha Ling
NM2	Village House, Sha Ling
NM3	Village House No. 248, Sha Ling
NM4	Village House, Sha Ling
NM5	Village House No. 270, Sha Ling
NM6	Village House, Sha Ling
NM7	Village House, Sha Ling
NM8	Village House, Sha Ling
NM9	Village House, Kong Nga Po
NM10	Village House, Kong Nga Po
NM11	Village House, Kong Nga Po
NM12	Village House, Kong Nga Po
NM13	Village House, Kong Nga Po
NM14	Village House, near Man Kam To Road

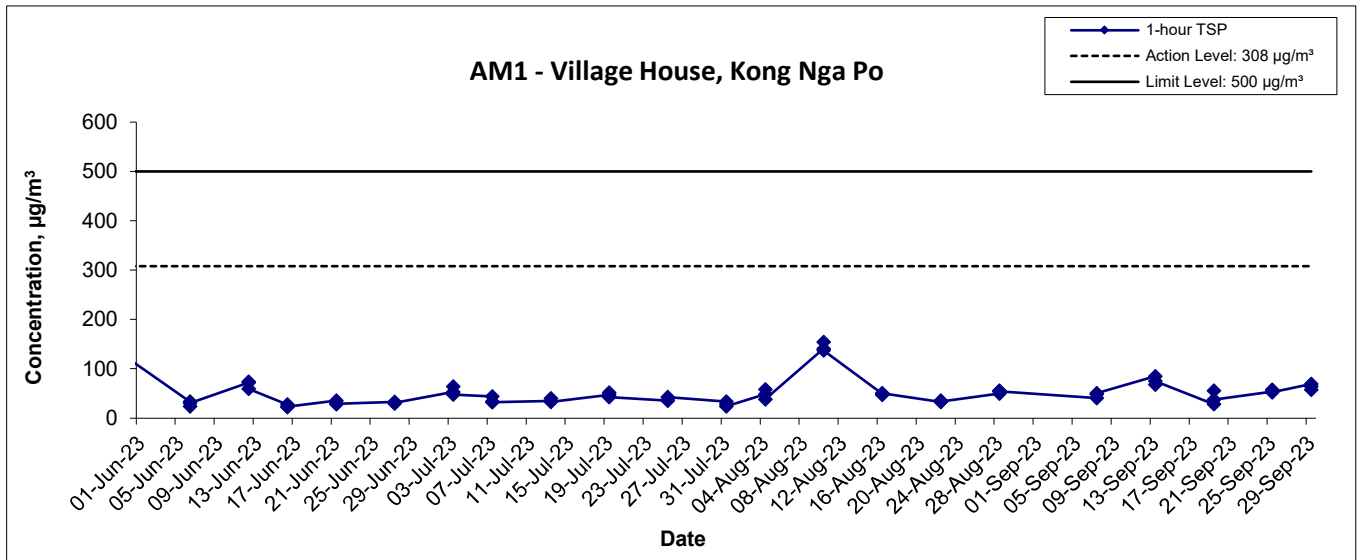
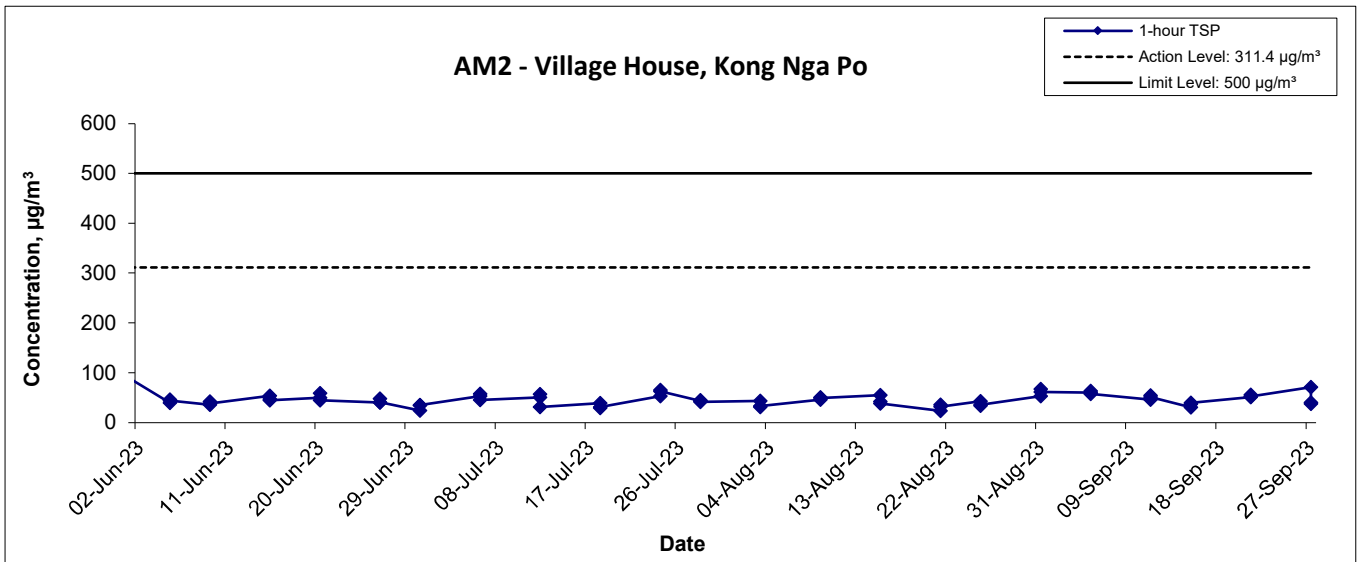
1-hr TSP Concentration Levels

Title Service Contract No. NDO 07/2019 Environmental Team for Site Formation and Infrastructure Works for Police Facilities in Kong Nga Po Graphical Presentation of 1-hour TSP Monitoring Results	Scale N.T.S	Project No. WMA20001

- 4.2 All construction air quality monitoring was conducted as scheduled during the reporting quarter except air quality monitoring on 1 September 2023 was cancelled due to adverse weather condition (Typhoon Signal No. 8 – SAOLA).
- 4.3 No Action/Limit Level exceedance was recorded in this reporting quarter. A summary of exceedance is attached in **Appendix E**.
- 4.4 **Table 4.1** summarizes the air quality monitoring results which were extracted from the monthly reports for this Project. The graphical presentation of the air quality monitoring results are shown in **Appendix B**.

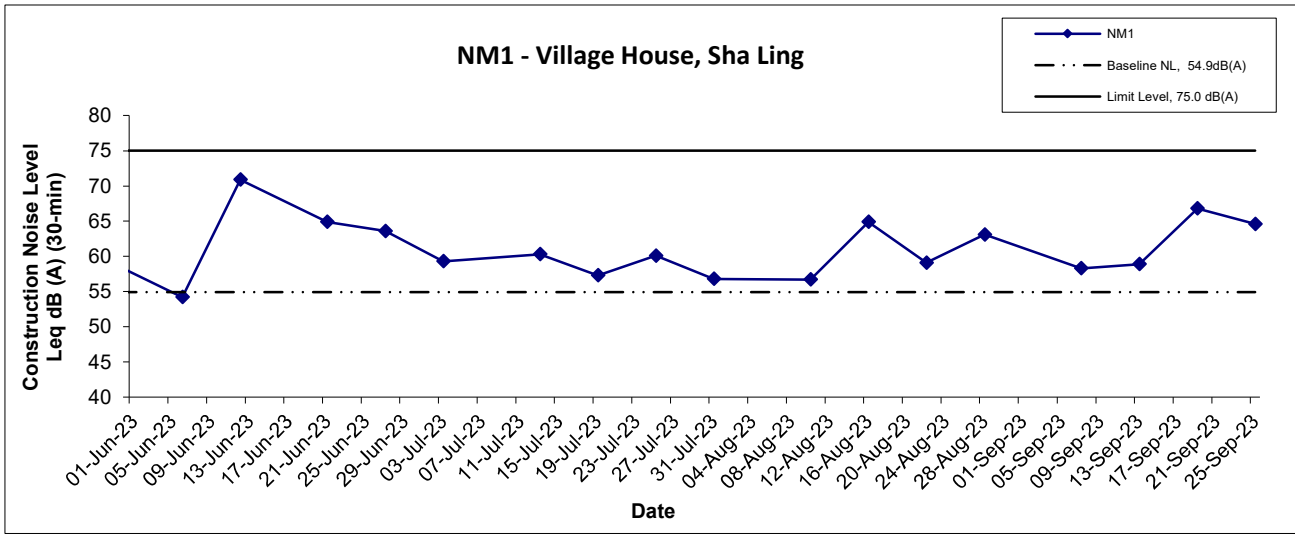
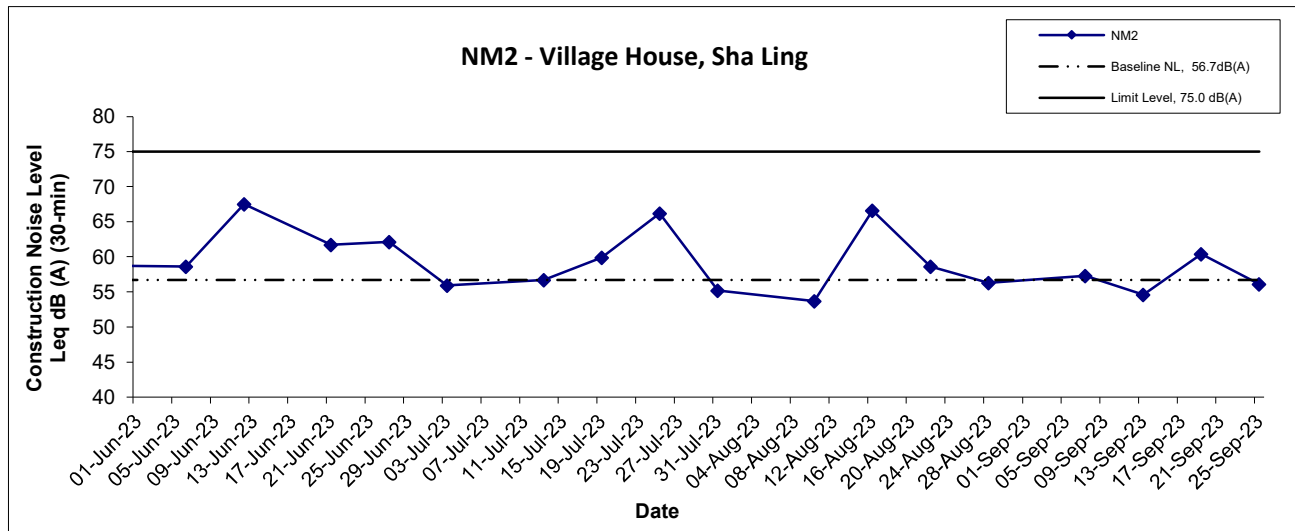
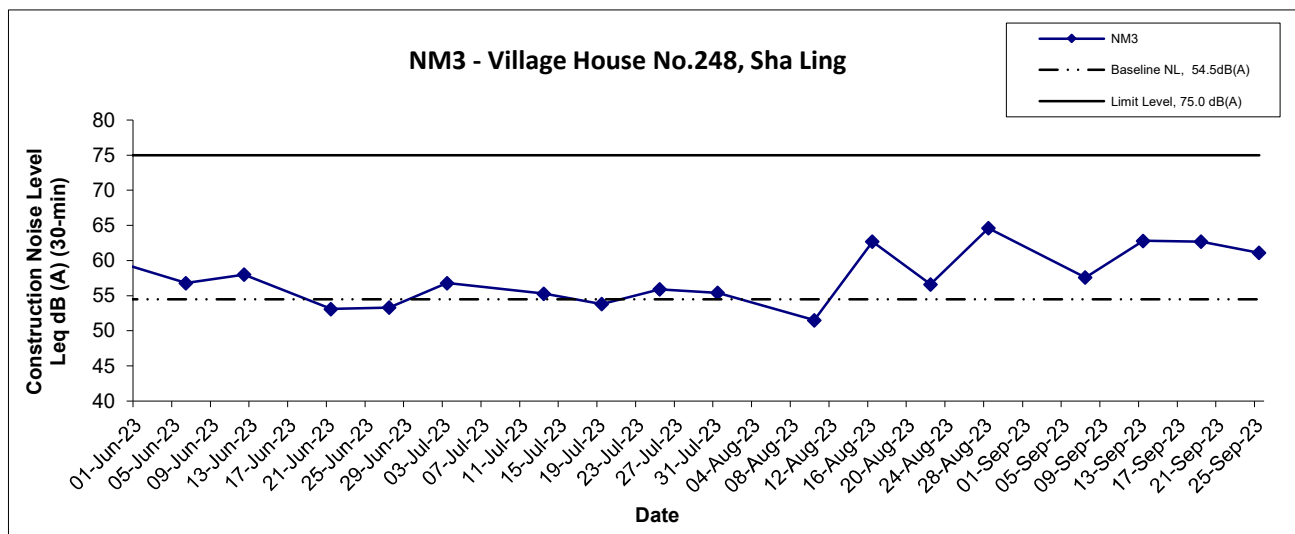
Noise Levels

Title Service Contract No. NDO 07/2019 Environmental Team for Site Formation and Infrastructure Works for Police Facilities in Kong Nga Po Graphical Presentation of Construction Noise Monitoring Results	Scale N.T.S	Project No. WMA20001	匯力 consulting . testing . research
	Date Sept 23	Appendix C

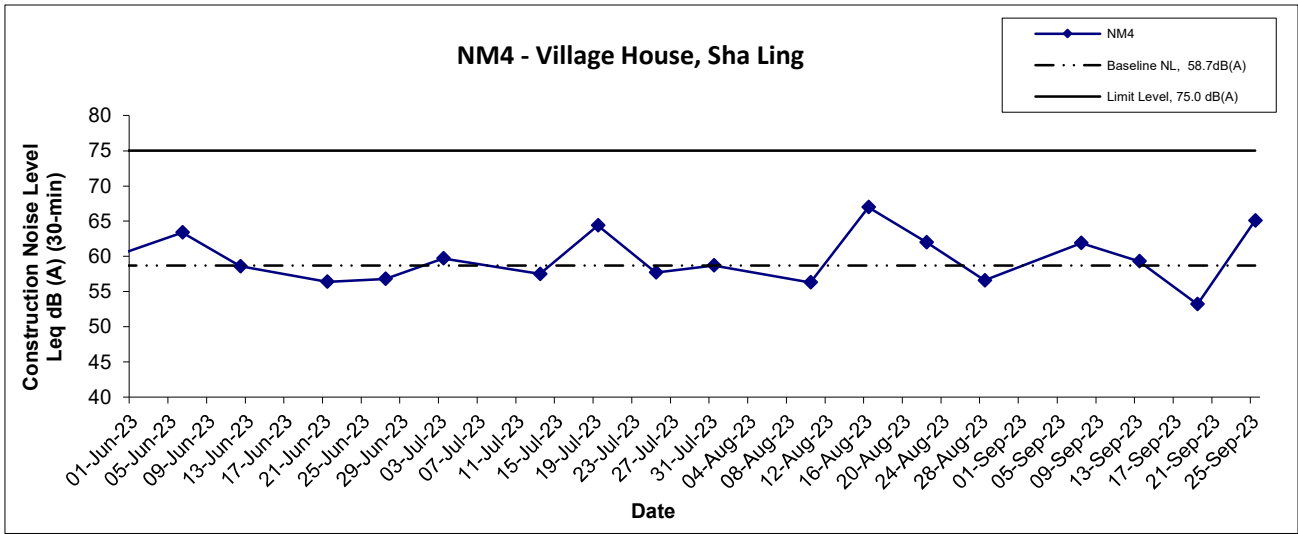
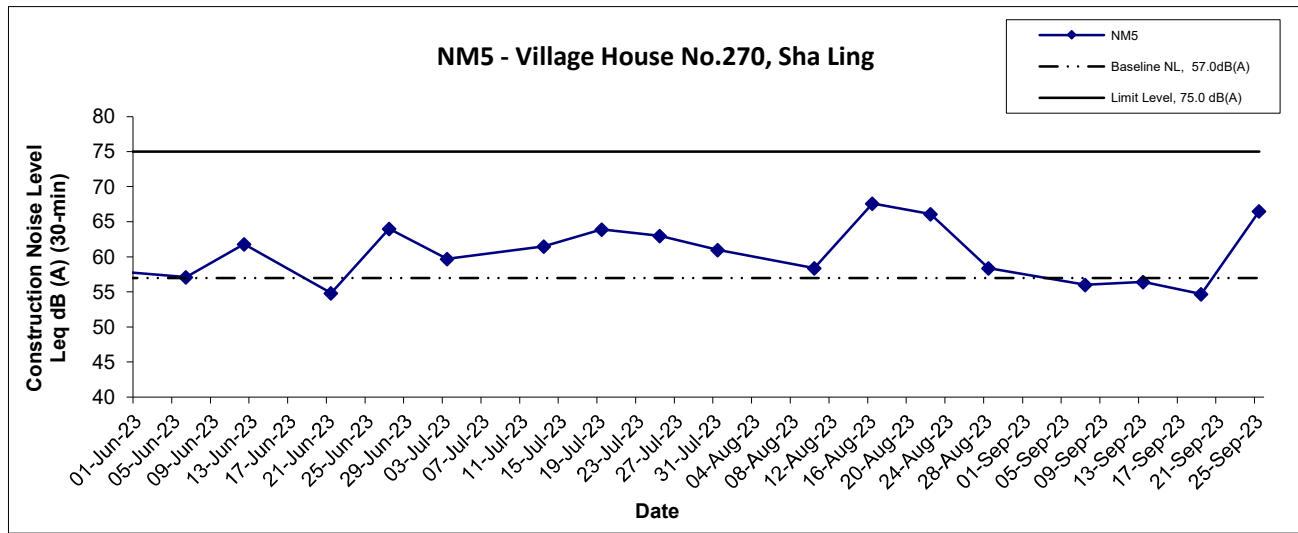
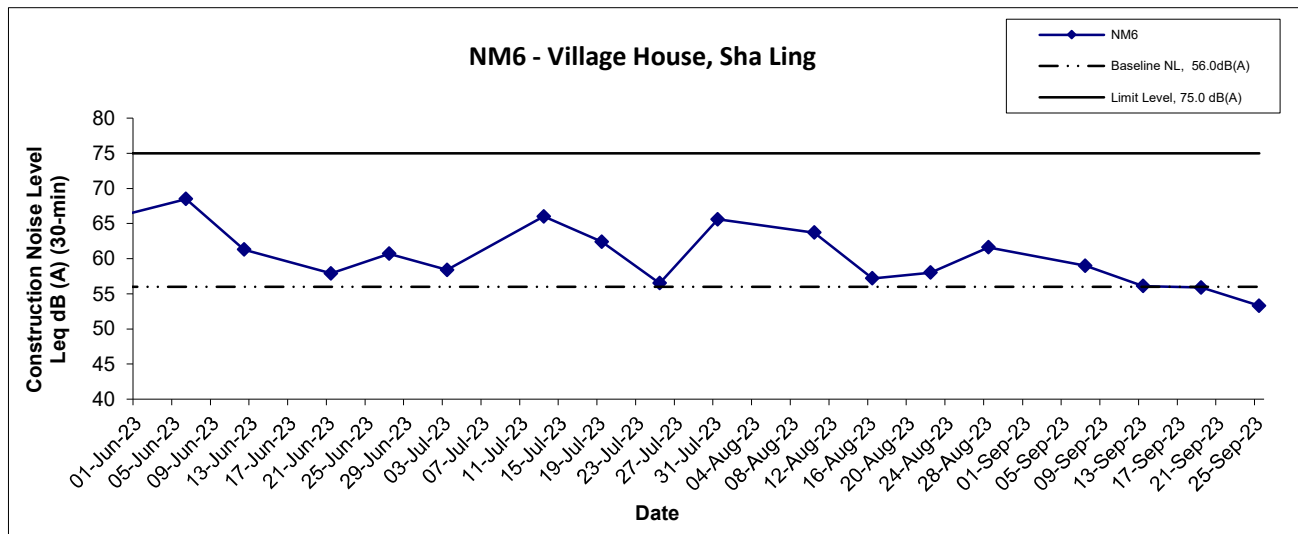
Noise Levels

Title Service Contract No. NDO 07/2019 Environmental Team for Site Formation and Infrastructure Works for Police Facilities in Kong Nga Po Graphical Presentation of Construction Noise Monitoring Results	Scale N.T.S	Project No. WMA20001	consulting . testing . research
	Date Sept 23	Appendix C

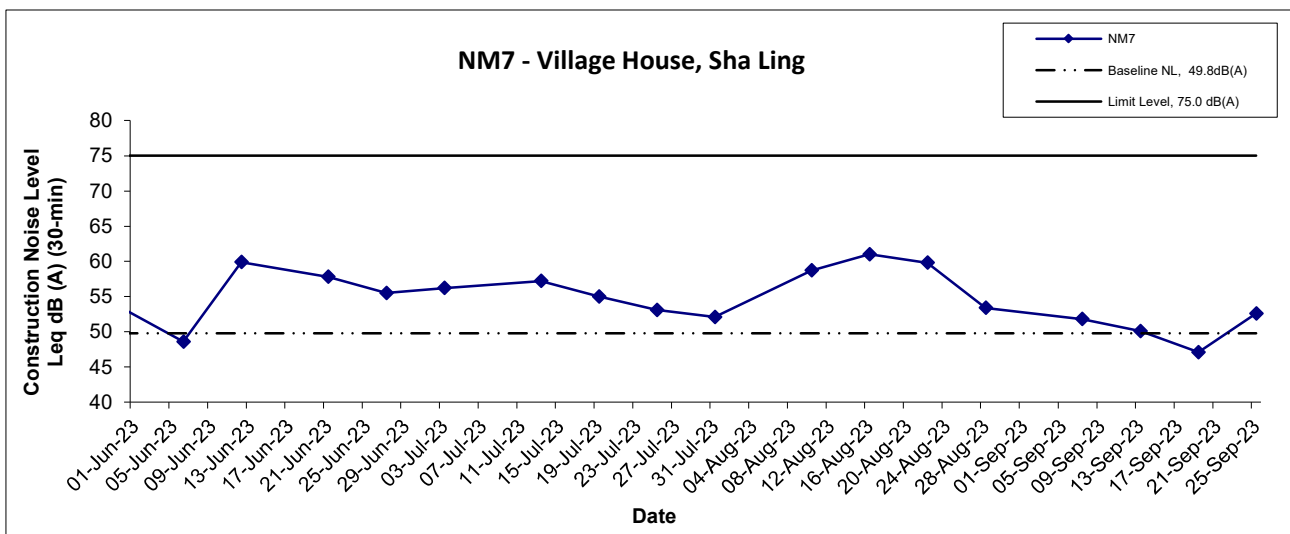
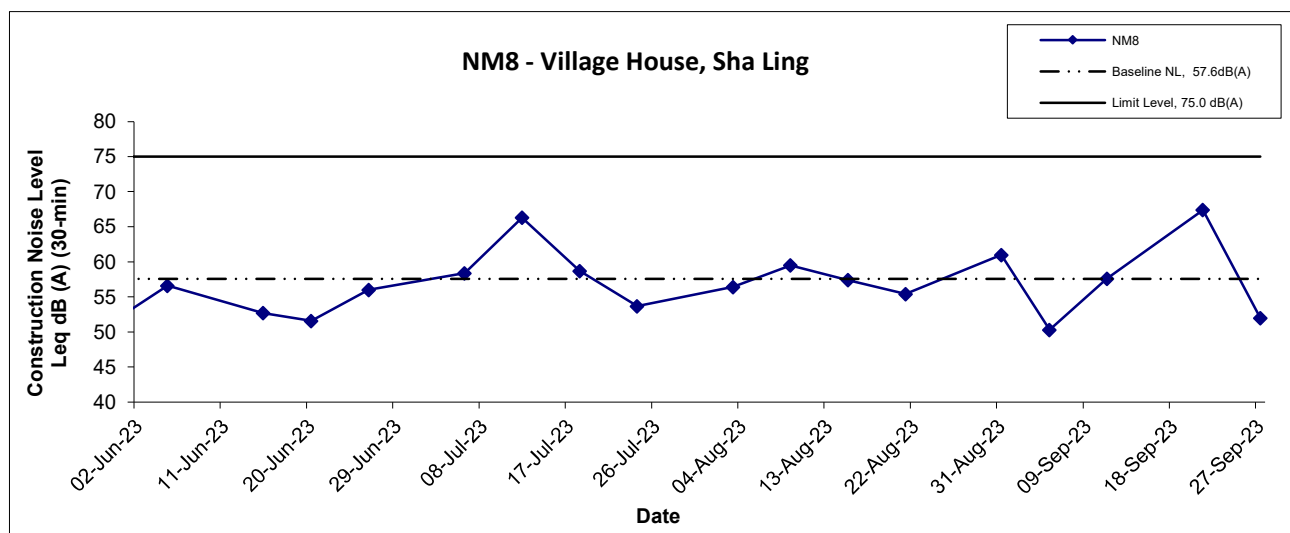
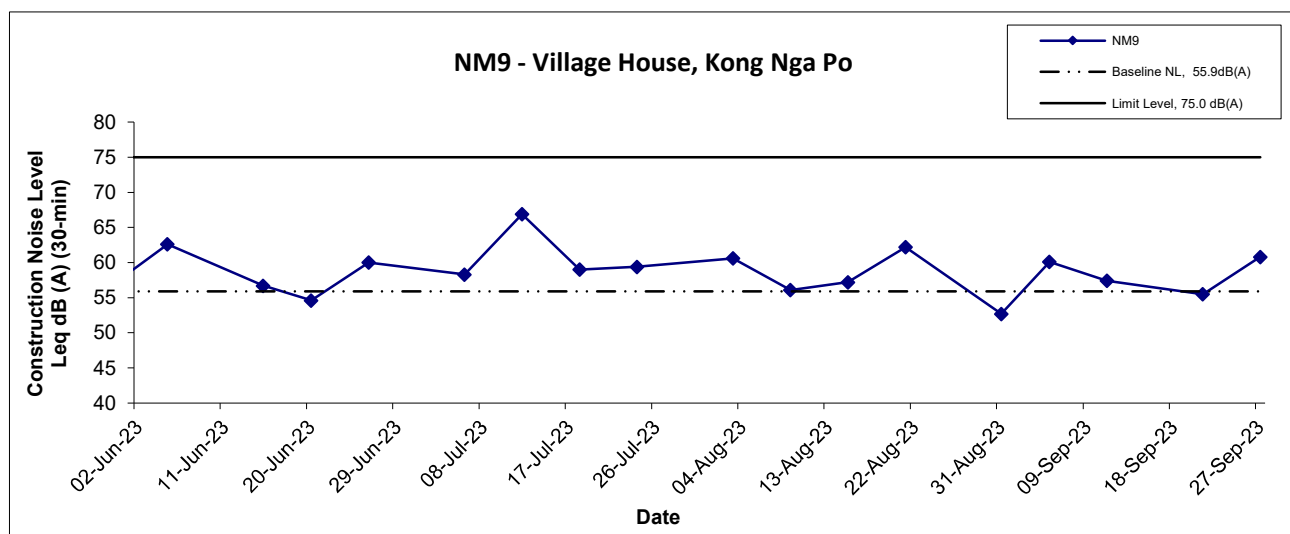
Noise Levels

Title Service Contract No. NDO 07/2019 Environmental Team for Site Formation and Infrastructure Works for Police Facilities in Kong Nga Po Graphical Presentation of Construction Noise Monitoring Results	Scale N.T.S	Project No. WMA20001	匯力 consulting . testing . research
	Date Sept 23	Appendix C

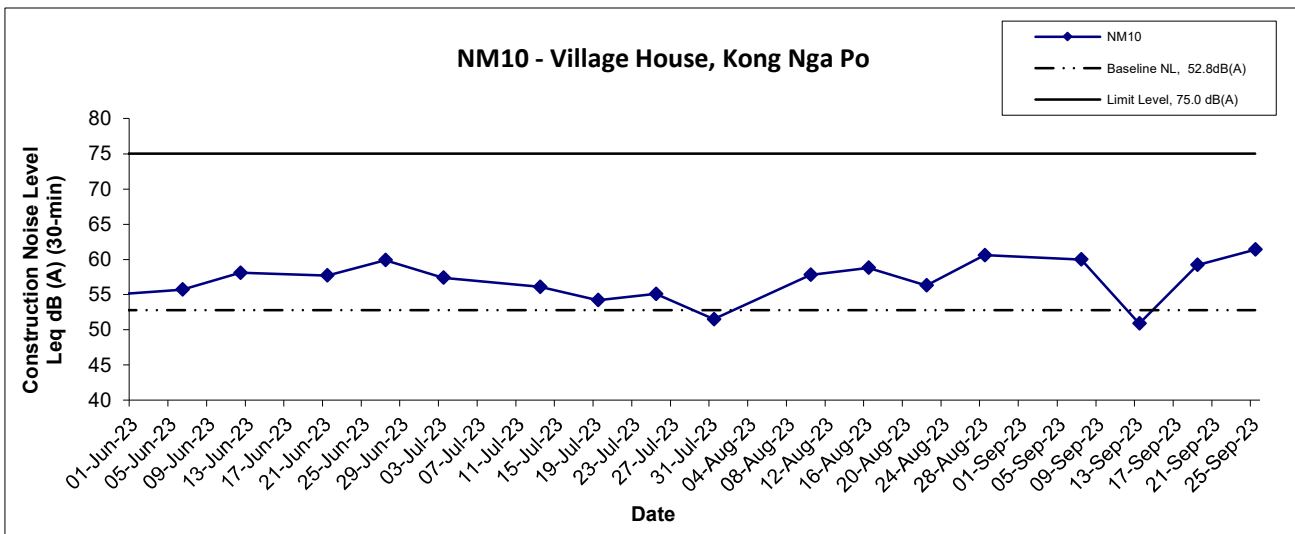
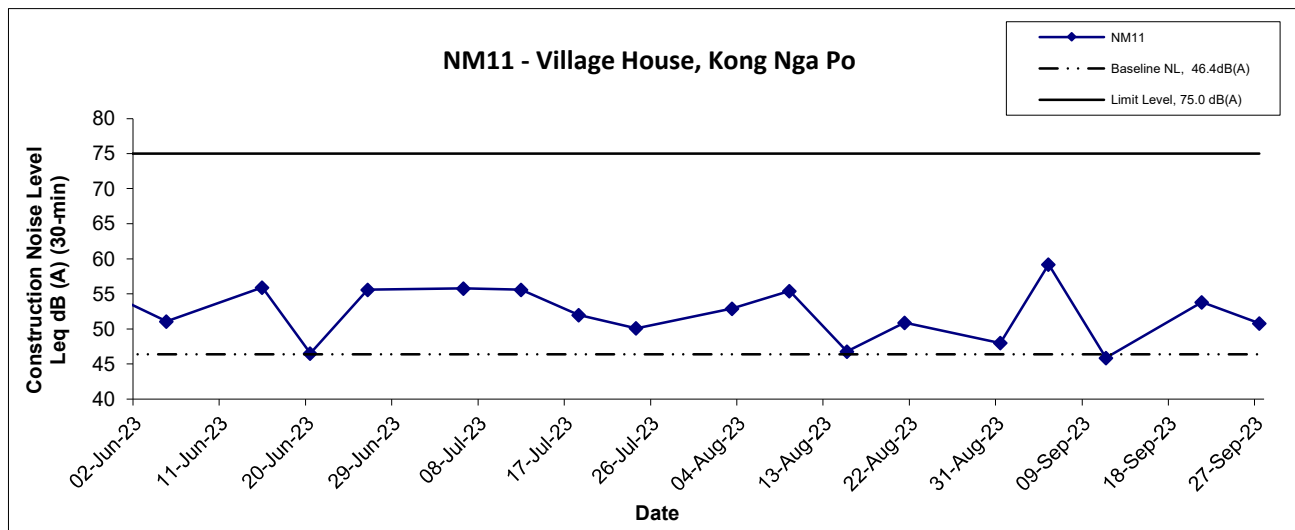
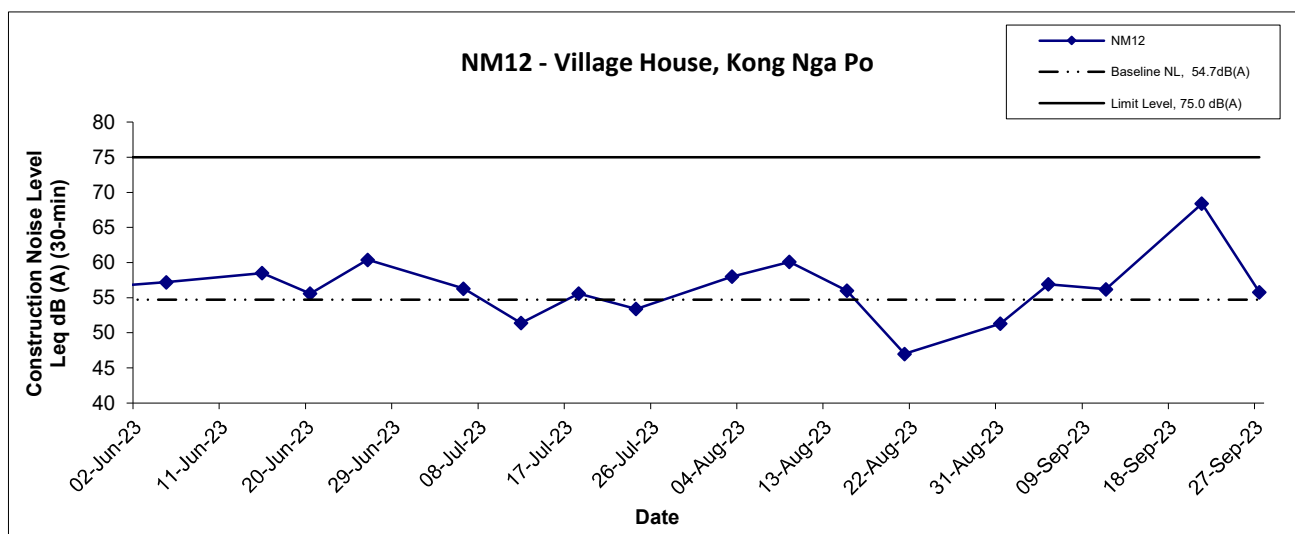
Noise Levels

Title Service Contract No. NDO 07/2019 Environmental Team for Site Formation and Infrastructure Works for Police Facilities in Kong Nga Po Graphical Presentation of Construction Noise Monitoring Results	Scale N.T.S	Project No. WMA20001	consulting . testing . research
	Date Sept 23	Appendix C

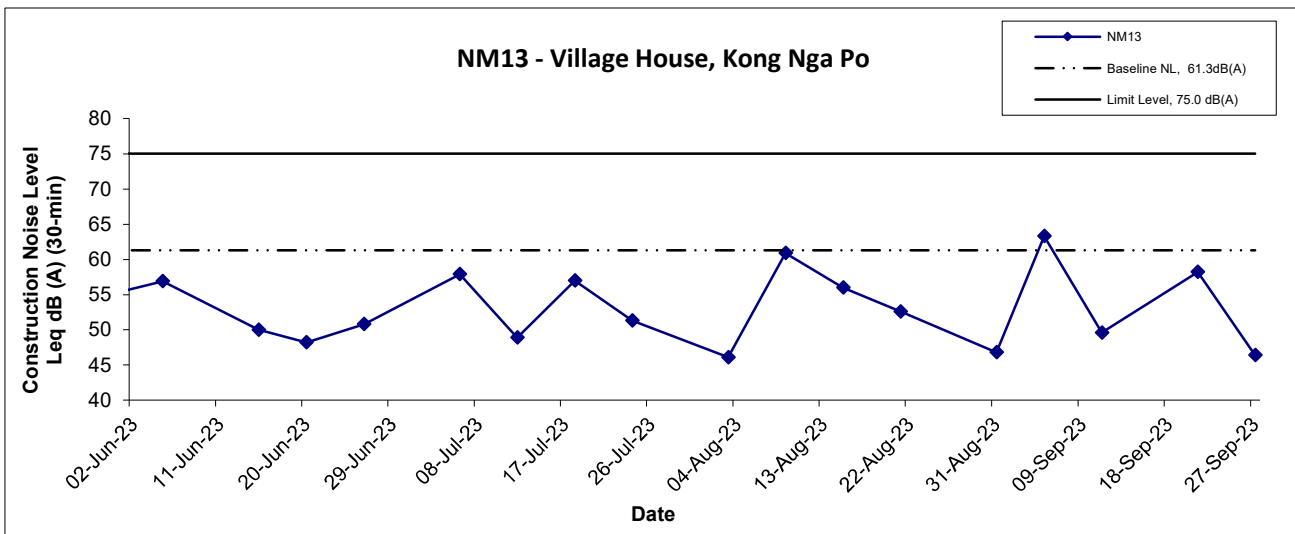
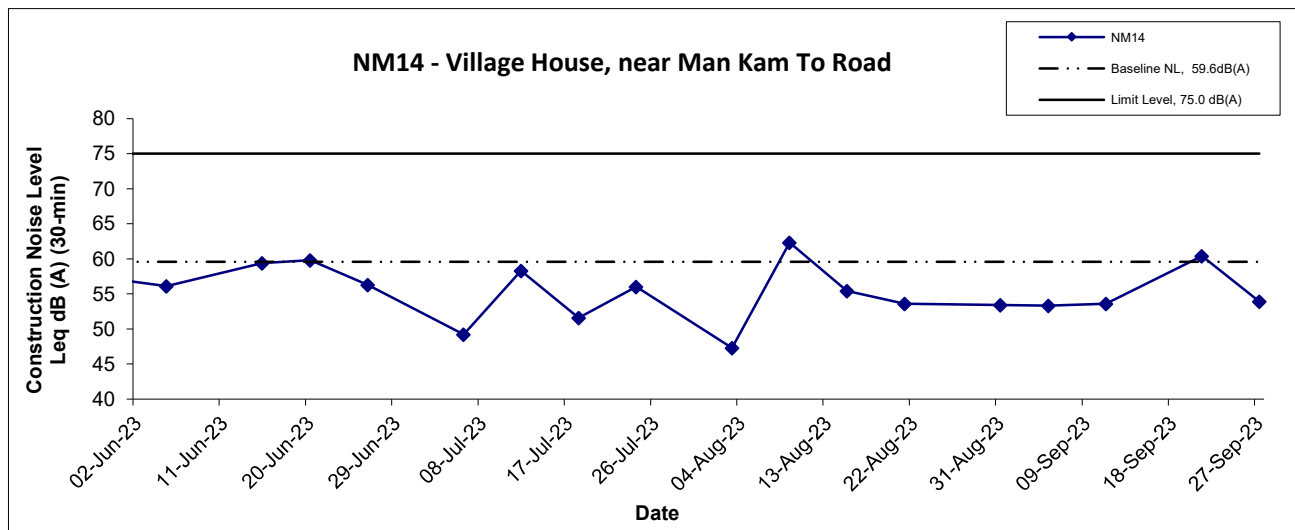
Noise Levels

Title Service Contract No. NDO 07/2019 Environmental Team for Site Formation and Infrastructure Works for Police Facilities in Kong Nga Po Graphical Presentation of Construction Noise Monitoring Results	Scale N.T.S	Project No. WMA20001	 consulting . testing . research
	Date Sept 23	Appendix C
