Service Contract No: EDO/01/2017
Environmental Team for
Development of Anderson Road Quarry Site
Road Improvement Works
Monthly EM&A Report (September 2020)

**ENVIRONMENTAL TEAM FOR
DEVELOPMENT OF
ANDERSON ROAD QUARRY SITE -
ROAD IMPROVEMENT WORKS**

MONTHLY ENVIRONMENTAL MONITORING & AUDIT REPORT

SEPTEMBER 2020

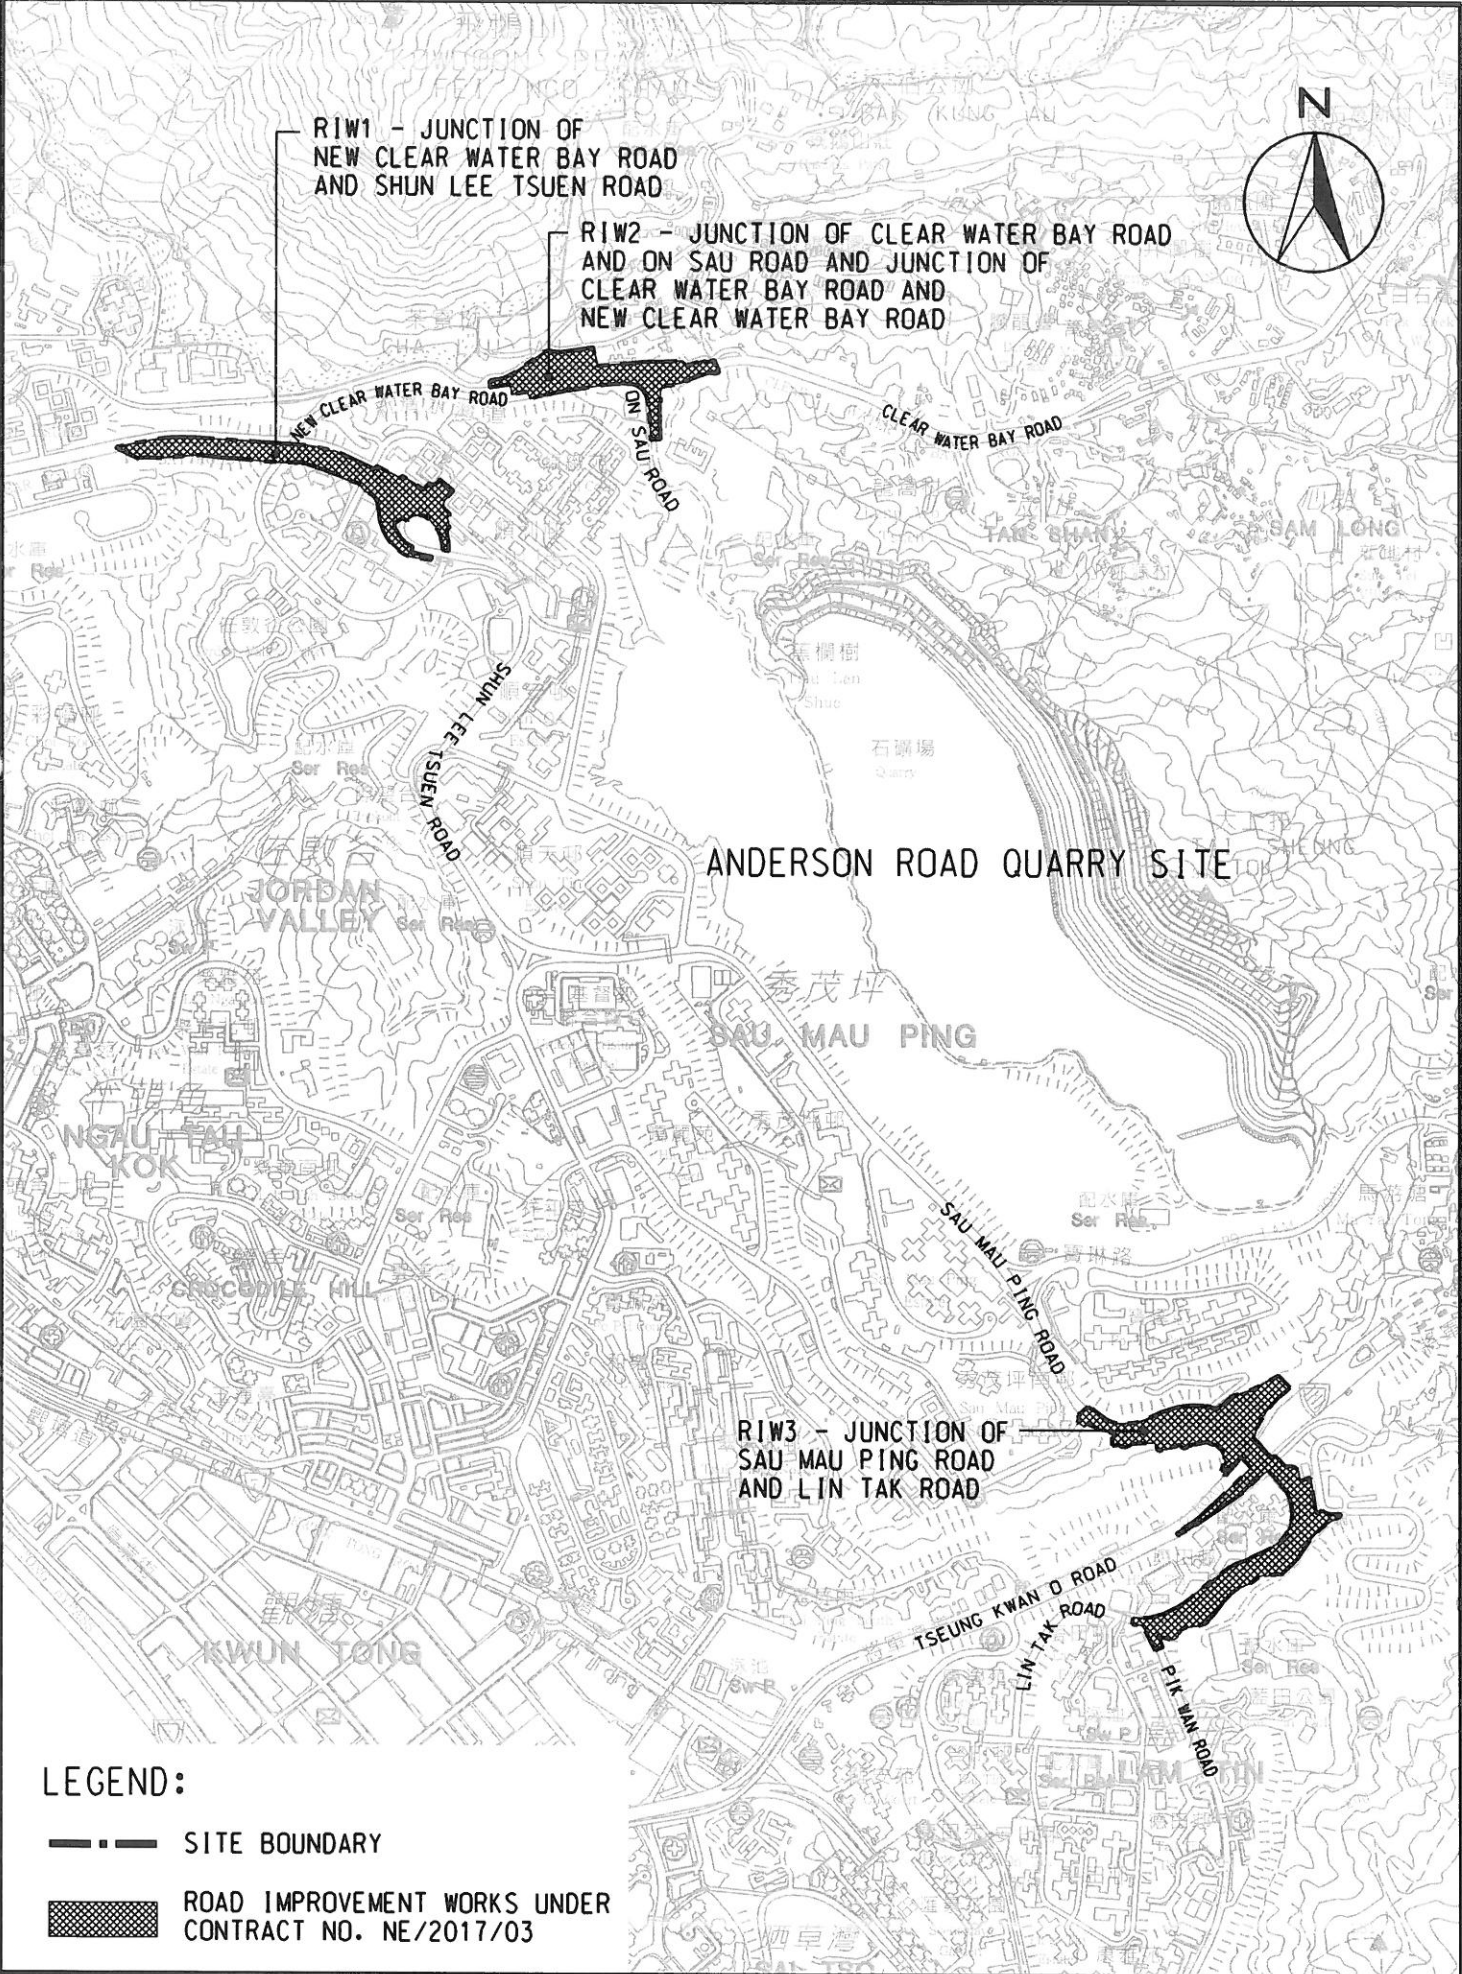
Figure 2.1

Project Layout

- SITE BOUNDARY
- ▨ ROAD IMPROVEMENT WORKS UNDER CONTRACT NO. NE/2017/03

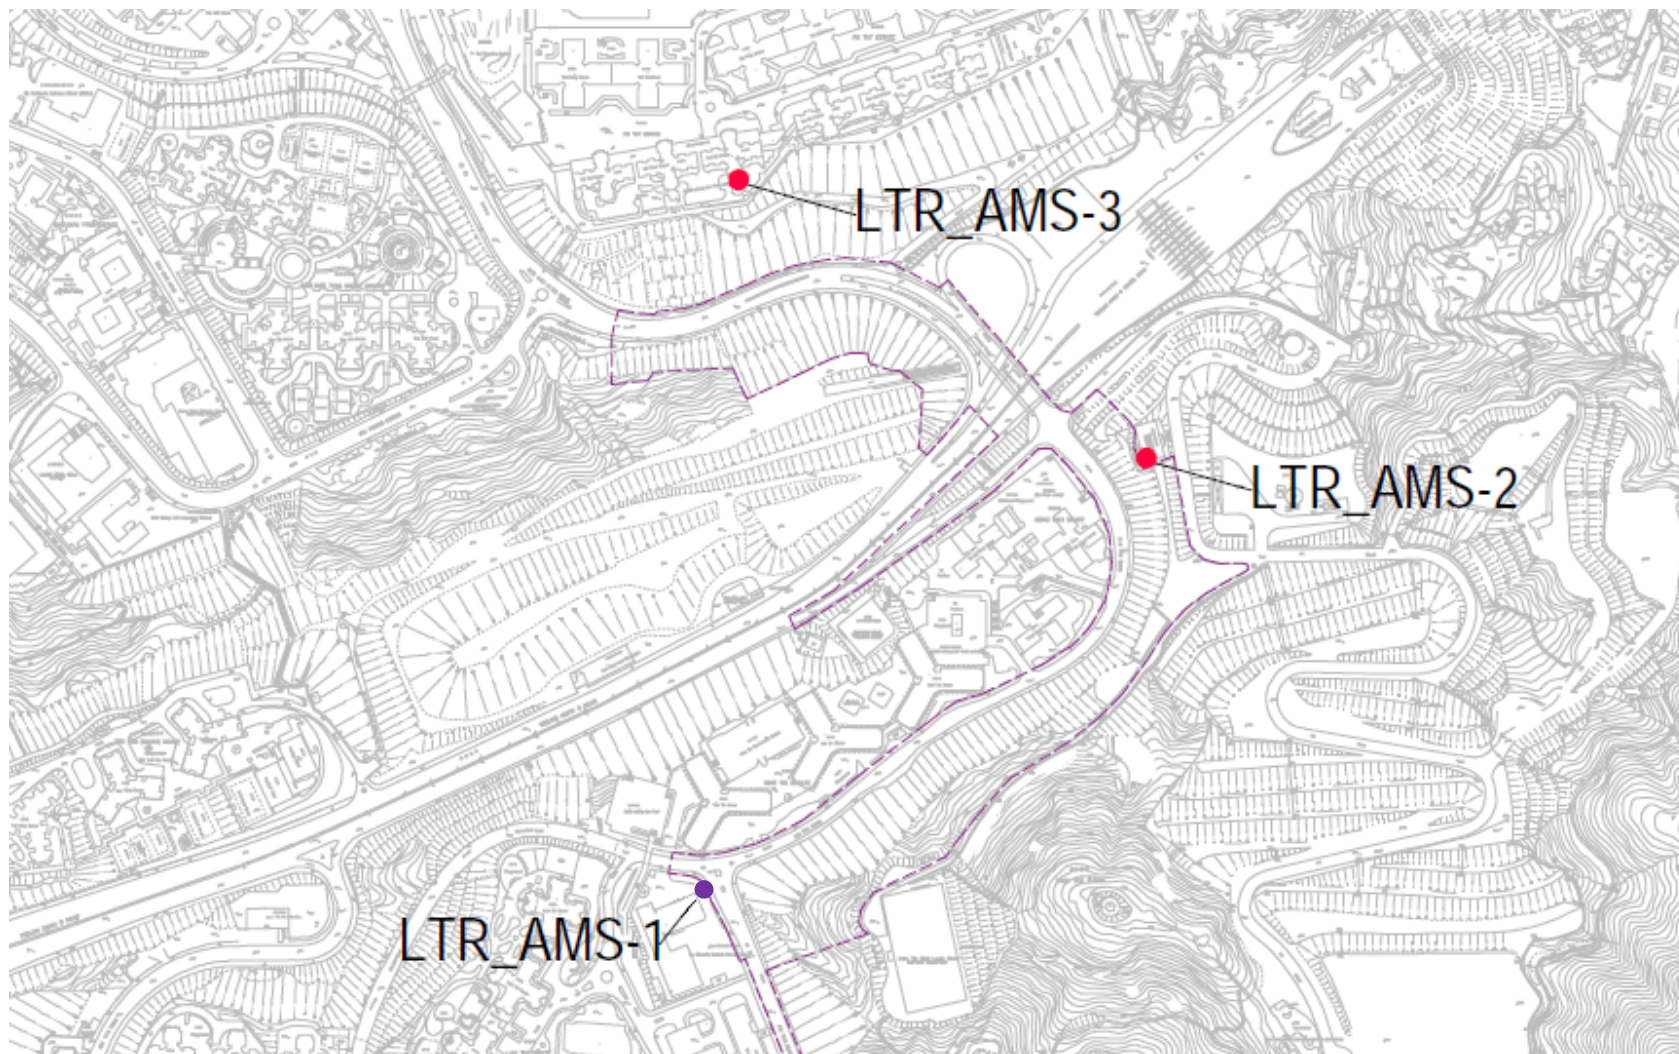
Figure 4.3
Location of Air Quality Monitoring Station
(for Road Improvement Work 1 & 2)

Monitoring Station ID	EIA ID	Location
NCWBR RIW		
NCWBR_AMS-1	ASLF-1	Shun Lee Fire Station
NCWBR_AMS-2	ASLE-21	Shun Lee Estate Lee Hang House
NCWBR_AMS-3	ASLD-10	Shun Lee Disciplined Services Quarters (Block 6)
NCWBR_AMS-4	AFNS-3	Sienna Garden
NCWBR_AMS-5	ASCC-05	Shun Chi Court Shun Fung House

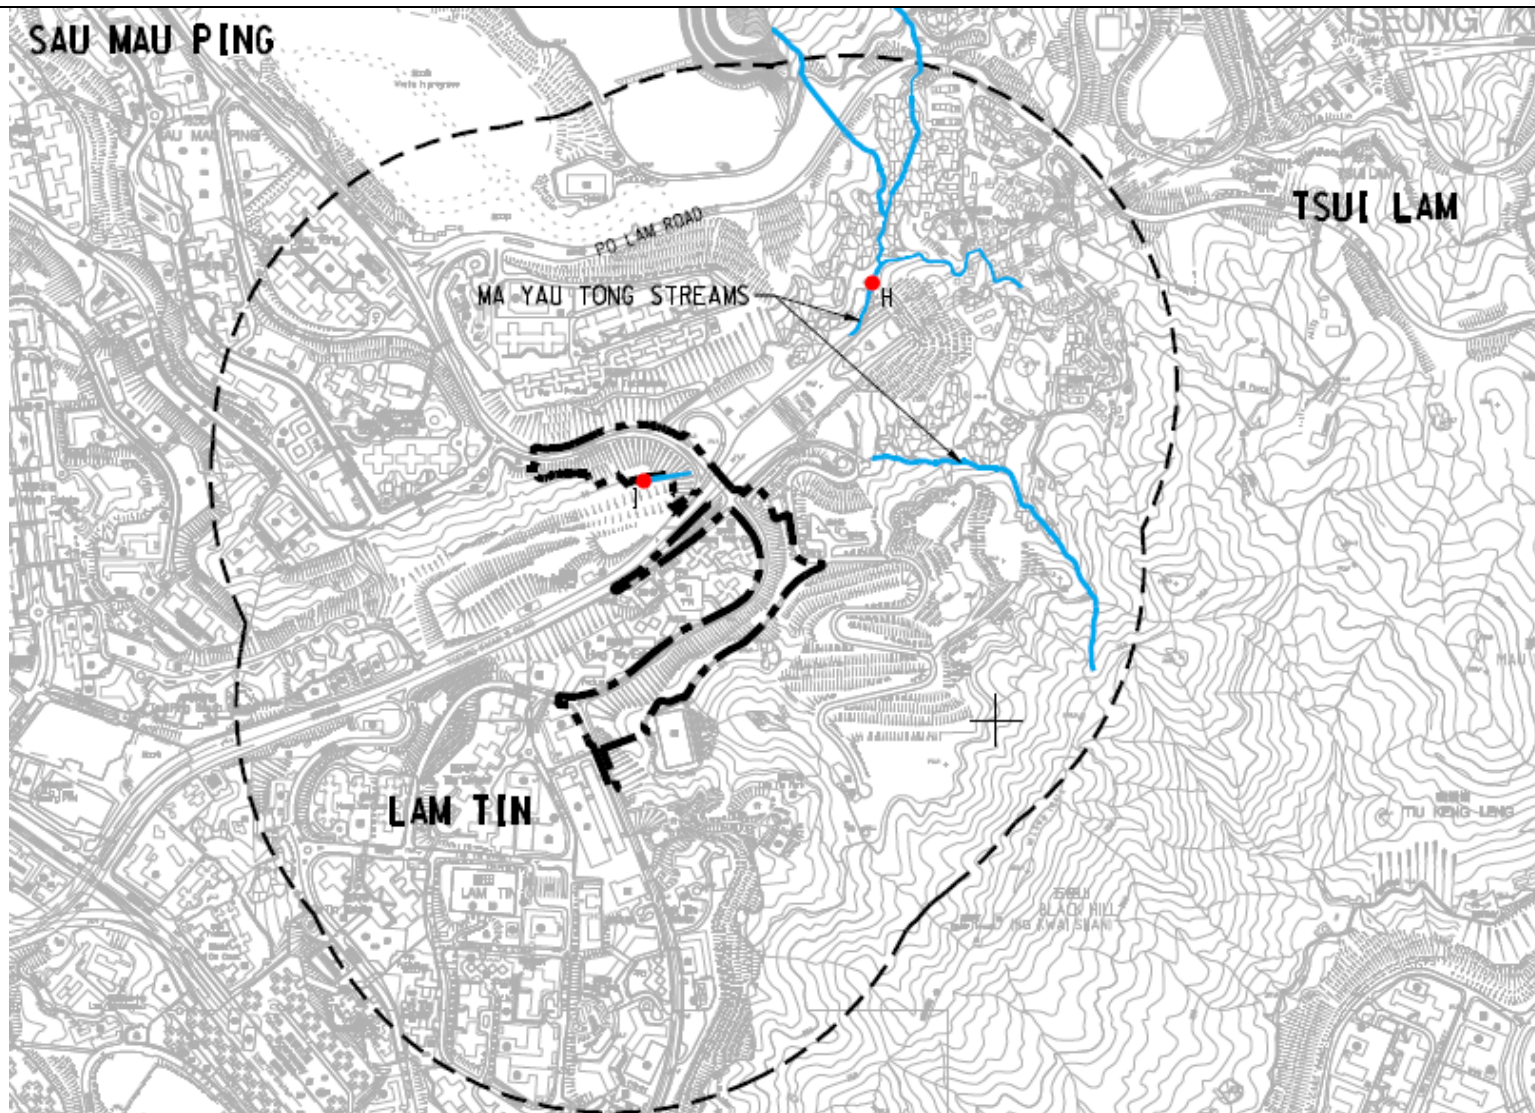
Figure 4.5
Location of Water Quality Monitoring Station
(for Road Improvement Work 1 & 2)

Inland Water	Stations	Description
Channelized nullah across the Project site	E	Upstream Control Station
	F	Downstream Impact Station
	AC1	Upstream Reference Station
	AC2	Upstream Reference Station
	AC3	Upstream Reference Station

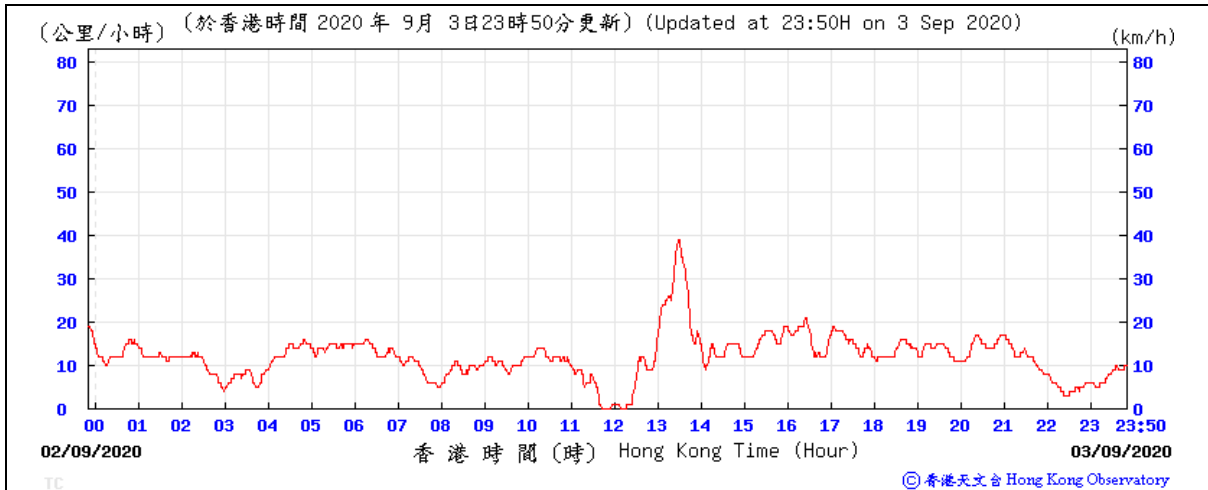
B. Wind Speed extracted from Tate's Cairn HKO Automatic Weather Station
