Agreement No. CE 60/2017 (EP)

Environmental Team for Tung Chung New Town Extension (East) - Design and Construction

Monthly Environmental Monitoring & Audit Report for December 2021

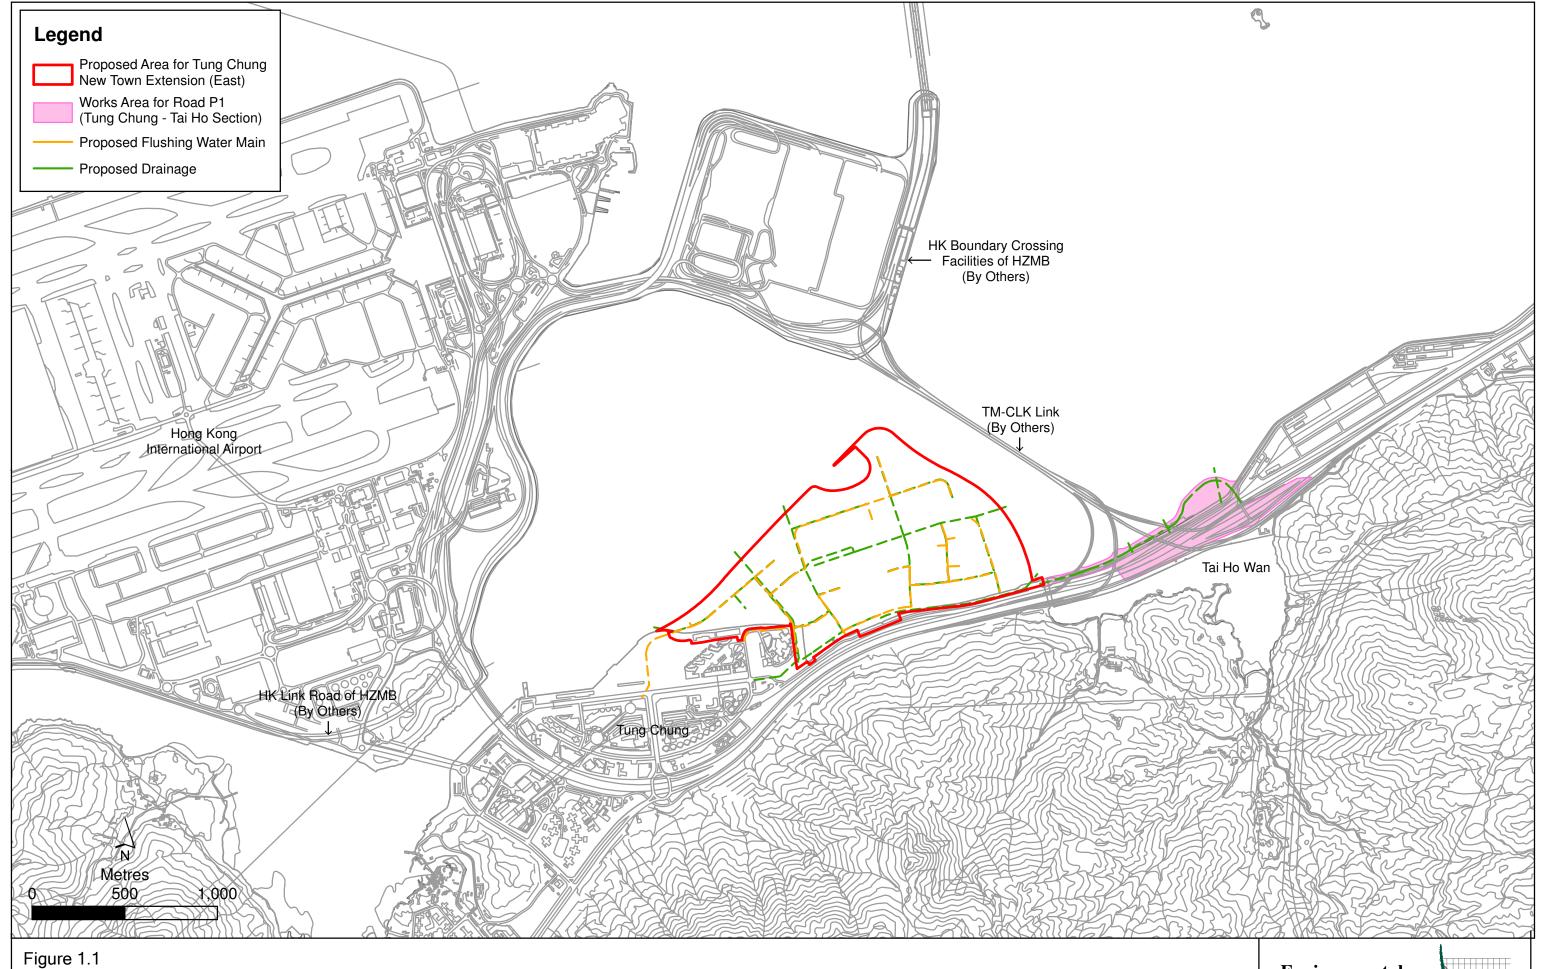
Location of Contract No. NL/2017/03 - Tung Chung New Town Extension - Reclamation and Advance Works (Contract 1)

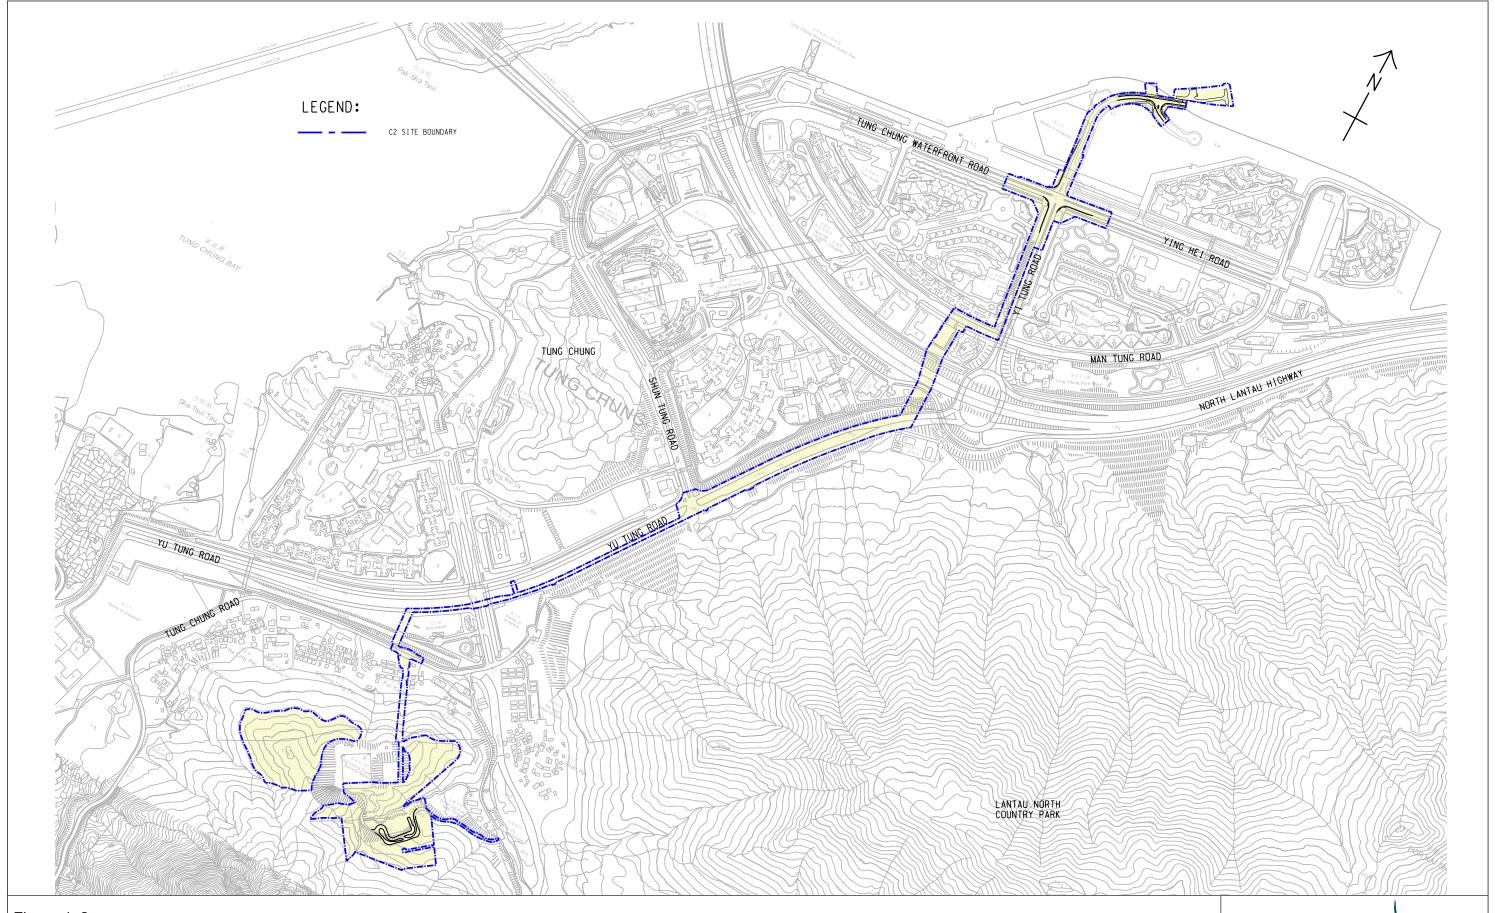
Figure 1.2 Location of Contract No. NL/2020/02 - Tung Chung New Town Extension – Salt Water Supply System (Contract 2)

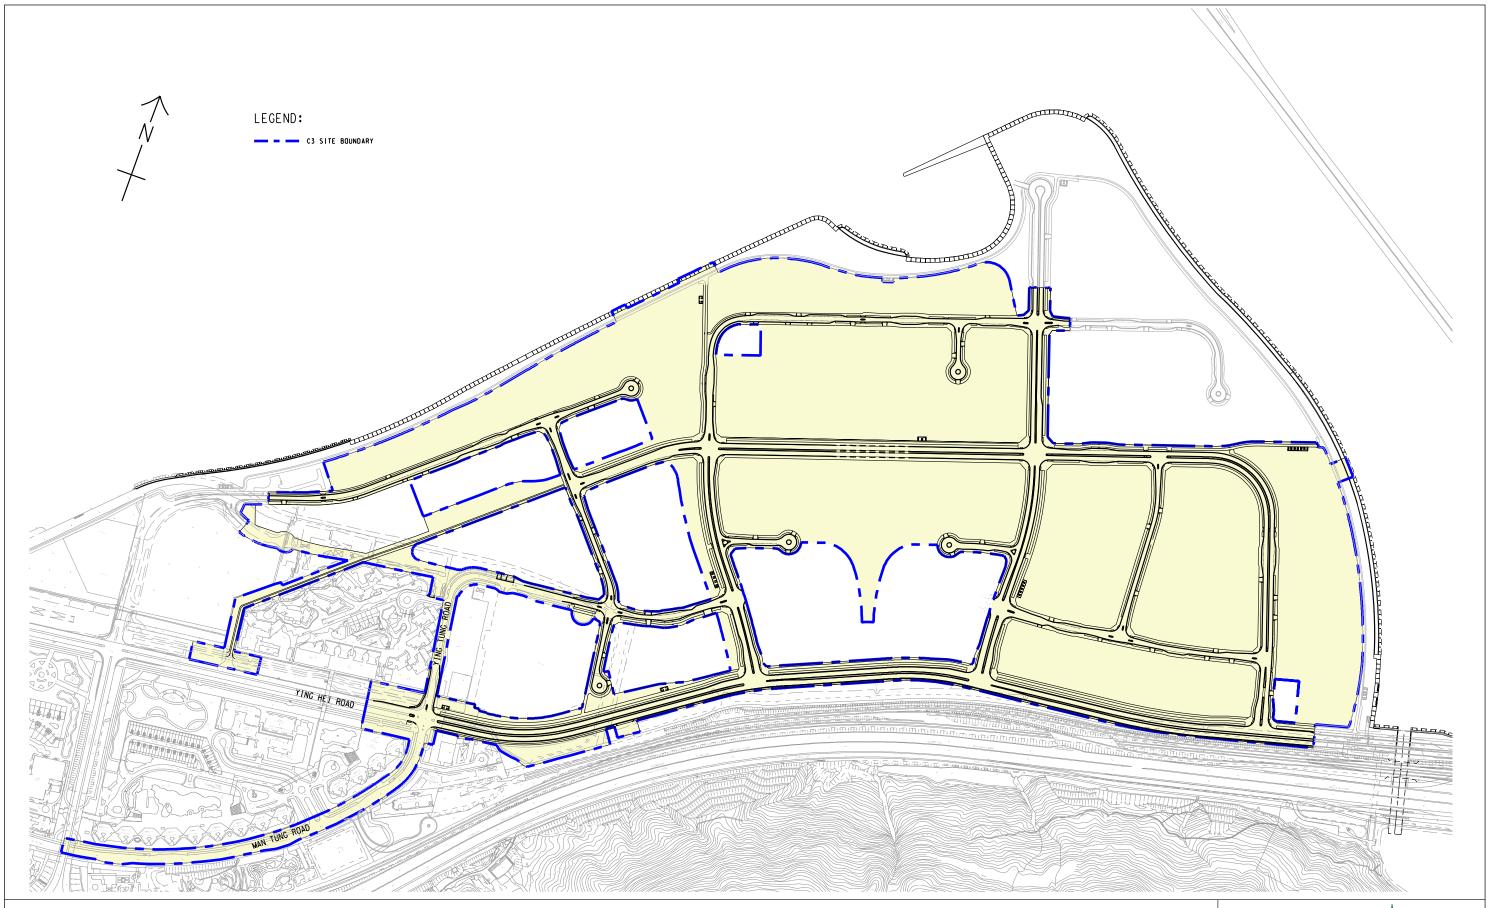
Figure 1.3 Location of Contract No. NL/2020/03 - Tung Chung New Town Extension – Major Infrastructure Works in Tung Chung East (Contract 3)

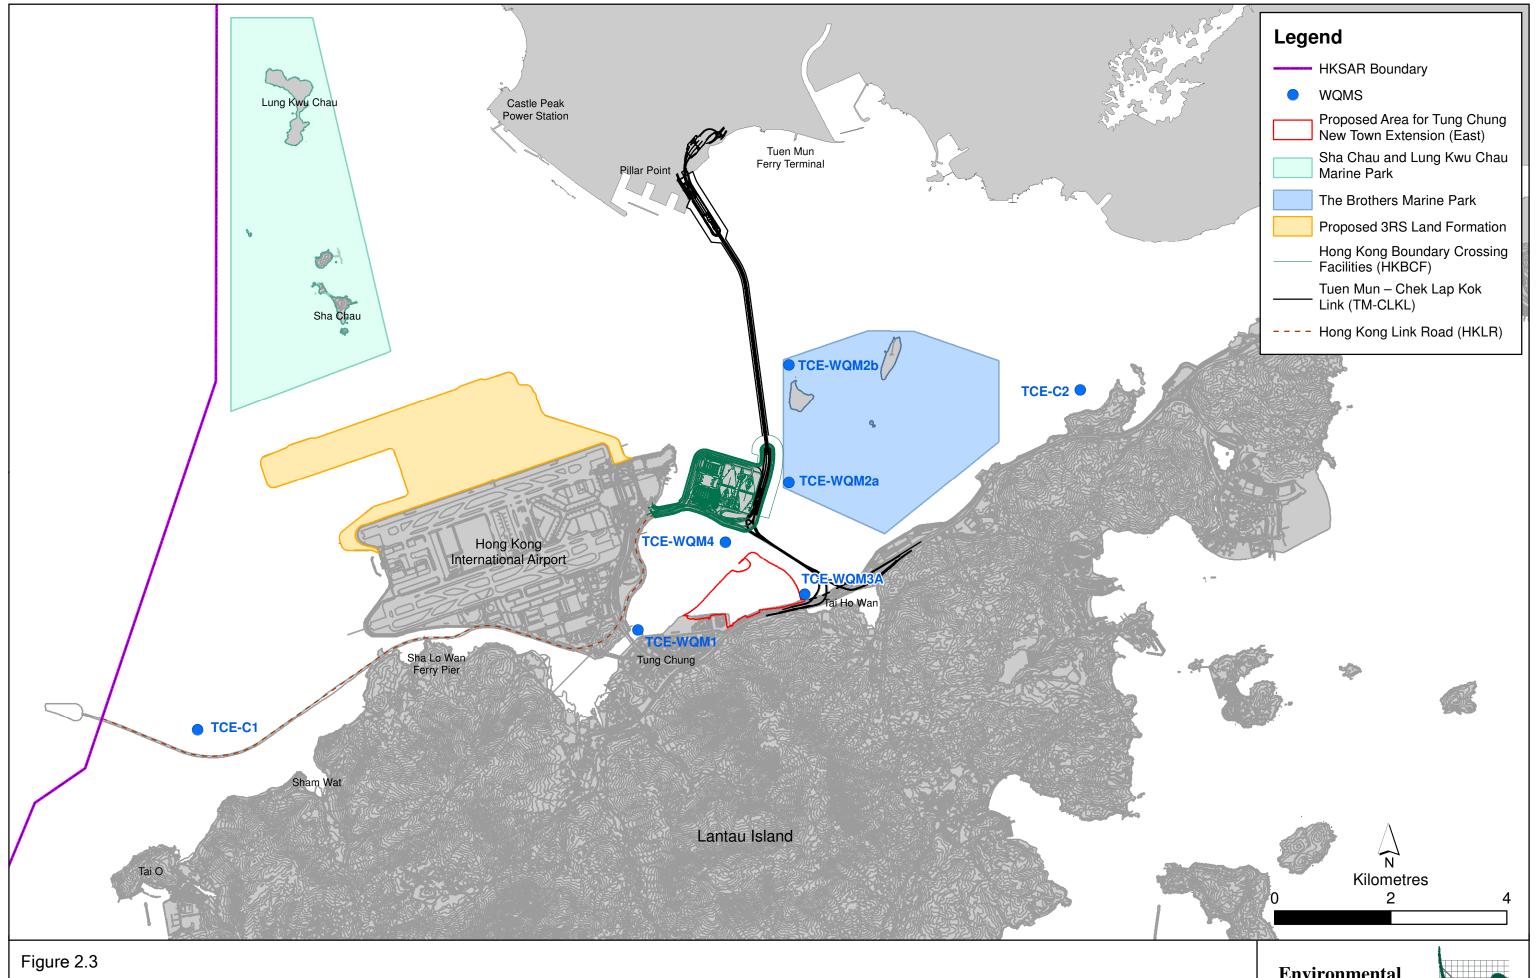
Water Quality Monitoring Locations

Impact water quality monitoring was carried out to ensure that any deterioration of water quality was detected, and that timely action was taken to rectify the situation. Impact water quality monitoring was undertaken three days per week since the commencement of marine works during the reporting period in accordance with the Updated EM&A Manual. Each impact water quality monitoring was scheduled such that the interval between two impact water quality monitoring was more than 36 hours to record representative water quality data throughout the week during the marine works.

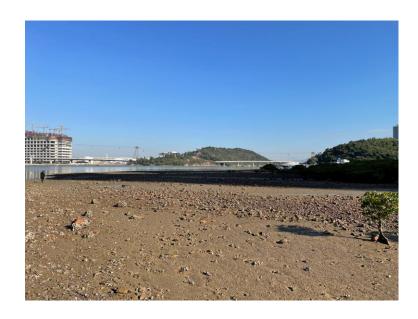
(a) Survey Location at TCB1

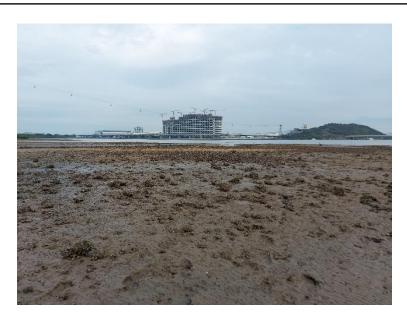
(b) Survey Location at TCB2

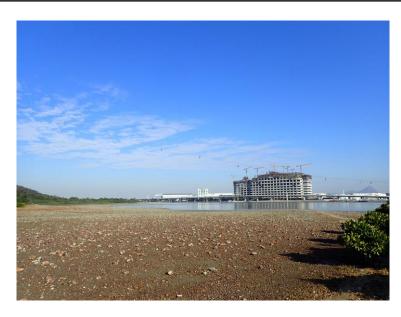
(c) Survey Location at TCB3

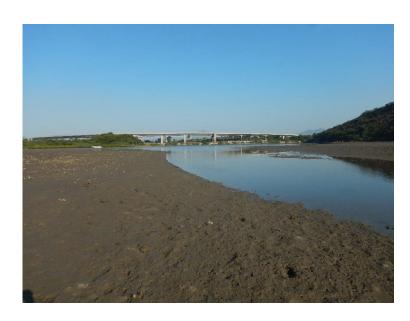
(d) Survey Location at THW

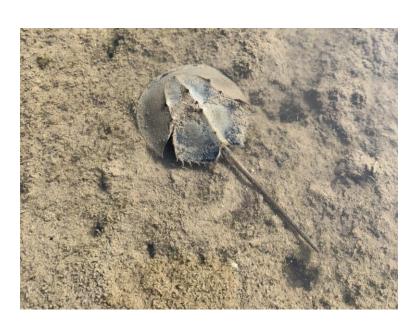
(e) Horseshoe crab *Tachypleus tridentatus* recorded at THW during the Qualitative Walk-through Survey
