Agreement No. CE 64/2020 (EP) Environmental Team for Tung Chung New Town Extension (West) – Design and Construction

Monthly Environmental Monitoring & Audit Report for September 2022

October 2022

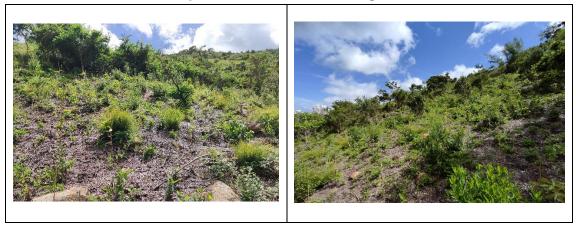
Table 7.6: Photos of the Compensation Woodland Planting

Compensation Woodland Planting was completed in May 2022. Monitoring for Compensation Woodland will be carried out after the confirmation of the monitoring proposal. Photos of the Compensation Woodland planting are shown in **Table 7.6**.
