Agreement No. CE 64/2020 (EP) Environmental Team for Tung Chung New Town Extension (West) – Design and Construction

Monthly Environmental Monitoring & Audit Report for October 2022

November 2022

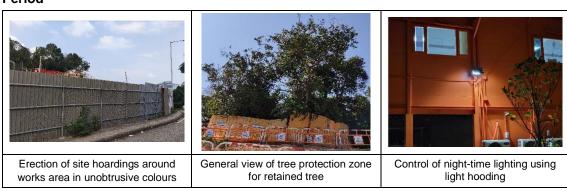
Table 7.3: Examples of Landscape and Visual Mitigation Measures in the Reporting Period

Landscape and Visual Mitigation Measures during Construction	Implementation Status	Relevant Contract(s) in the Reporting Period
MM1- Optimization of Construction Areas & Providing Temporary Landscape on Temporary Construction	The implementation of mitigation measures was checked by ET during weekly site inspection. Implementation of the measures by Contractors was observed.	All works contracts
MM2 - Minimize Topographical Changes		
MM3 - Preservation of Potentially Registerable OVTs, Rare and Protective Vegetation	Tree Protection Specifications were provided in the relevant Contract Specifications respectively for implementation by the Contractors under the Project.	All works contracts
	The Detailed Preservation and/or Translocation Plan for Plant Species of Conservation Importance was submitted under EP Condition 2.21 and accepted by EPD.	
	The Contractors' performance on the implementation of the tree maintenance and protection measures were observed and checked by the ET weekly during construction period.

Landscape and Visual Mitigation Measures during Construction	Implementation Status	Relevant Contract(s) in the Reporting Period
MM5 – Screen Hoarding	The implementation of mitigation measures was checked by ET during weekly site inspection. Implementation of the measures by Contractors was observed.	All works contracts
MM7 – Protection of Natural Rivers and Streams	The implementation of mitigation measures was checked by ET during weekly site inspection. Implementation of the measures by Contractors was observed.	Contract 6
MM8 - Preservation of Natural Coastline	The implementation of mitigation measures was checked by ET during weekly site inspection. Implementation of the measures by Contractors was observed.	Contract 5
MM18 - Landscaping on Slopes	Not applicable during the reporting period	Contract 5
MM19 - Landscape Treatment on Channelized Watercourses	Not applicable during the reporting period	Contract 6

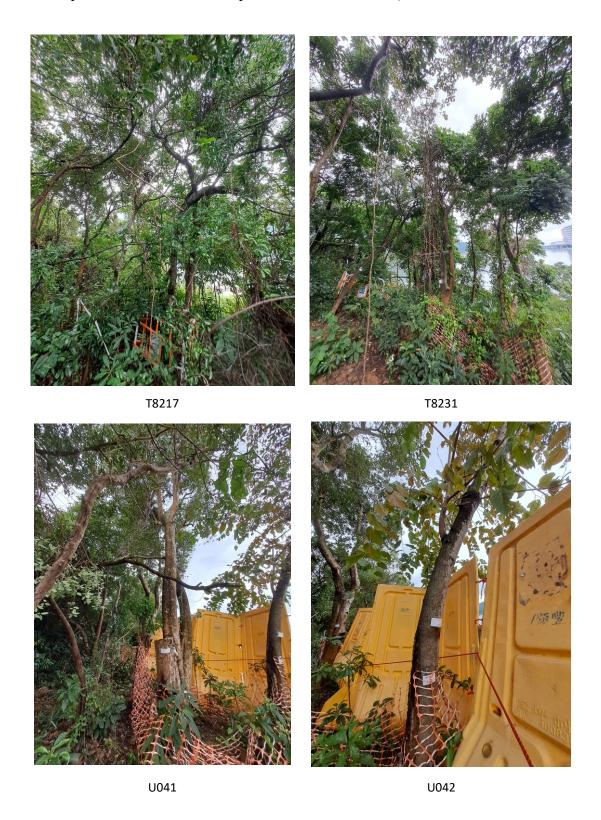
NL/2020/05 Photographic record (Monthly Monitoring Report for Preservation of Plant Species of Conservation Importance – October 2022)
