Agreement No. CE 64/2020 (EP) Environmental Team for Tung Chung New Town Extension (West) – Design and Construction

Monthly Environmental Monitoring & Audit Report for February 2023

March 2023

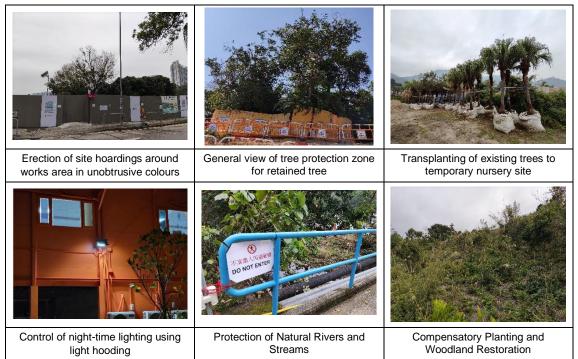
Table 7.3: Examples of Landscape and Visual Mitigation Measures in the Reporting Period

Landscape and Visual Mitigation Measures during Construction	Implementation Status	Relevant Contract(s) in the Reporting Period
MM5 – Screen Hoarding	The implementation of mitigation measures was checked by ET during weekly site inspection. Implementation of the measures by Contractors was observed.	All works contracts
MM7 – Protection of Natural Rivers and Streams	The implementation of mitigation measures was checked by ET during weekly site inspection. Implementation of the measures by Contractors was observed.	Contract 6
MM8 - Preservation of Natural Coastline	Implementation of the measures were carried out during the detailed design stage of the Project.	Contract 5
MM10 – Compensatory Planting	Not applicable during the reporting period	All works contracts
MM11 – Woodland Restoration	The implementation of mitigation measures was checked by ET during weekly site inspection. Implementation of the measures by Contractors was observed.	Contract 6

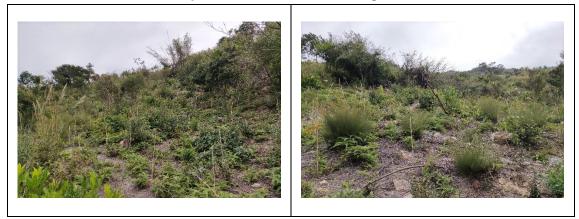
Table 7.6: Photos of the Compensation Woodland Planting

Compensation Woodland Planting was completed in May 2022. With the approval from EPD on the monitoring proposal in October 2022, the monitoring for Compensation Woodland was commenced in November 2022. Quarterly post-planting monitoring for the compensation woodland was ongoing. Photos of the Compensation Woodland planting are shown in **Table 7.6**.

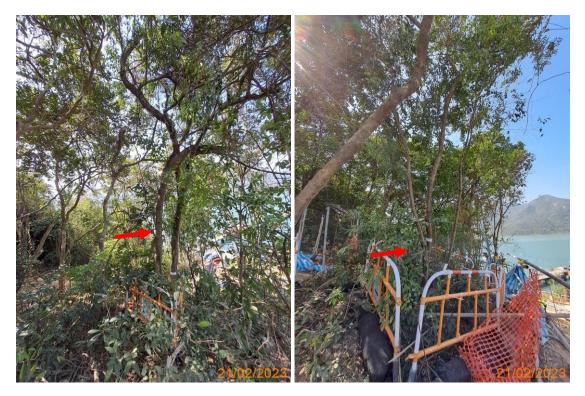
1: T8217

Monthly monitoring of the in-situ preserved plant species of conservation importance by the Qualified Botanist (QB) appointed under Contract 5 and Contract 6 respectively were implemented in the reporting period. No active termite was recorded at the individual of *Aquilaria sinensis* (Tree No. U043) under Contract 5. The condition of the concerned plant would be monitored by the QB appointed under Contract 5.

Tree protection zones for the *in-situ* preserved plant species of conservation importance were demarcated. No injuries and/or damages to the individuals of the *in-situ* preserved plant species of conservation importance were reported by the QB during the reporting period. Photographic record and tree schedule of the preserved plant species of conservation importance monitoring are provided in **Appendix J**.

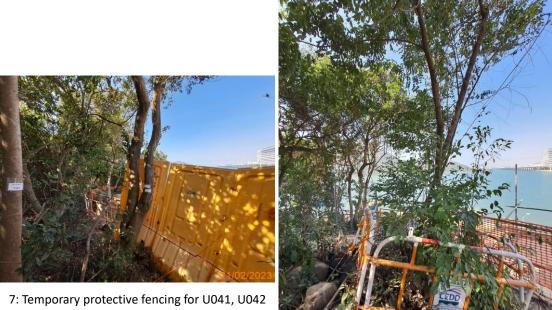
7: Temporary protective fencing for U041, U042 and U043 (2)

8: Protective fence sealed by sand bag
