**Contract No. SPW 09/2018
Environmental Team Baseline Surveys
for Sha Tin Cavern Sewage Treatment
Works**

**Detailed Vegetation Survey Report
(Version 8.1)**

**Detailed Vegetation Survey Report
(Conditions 2.13(i) and 2.14 of EP-533/2017)**

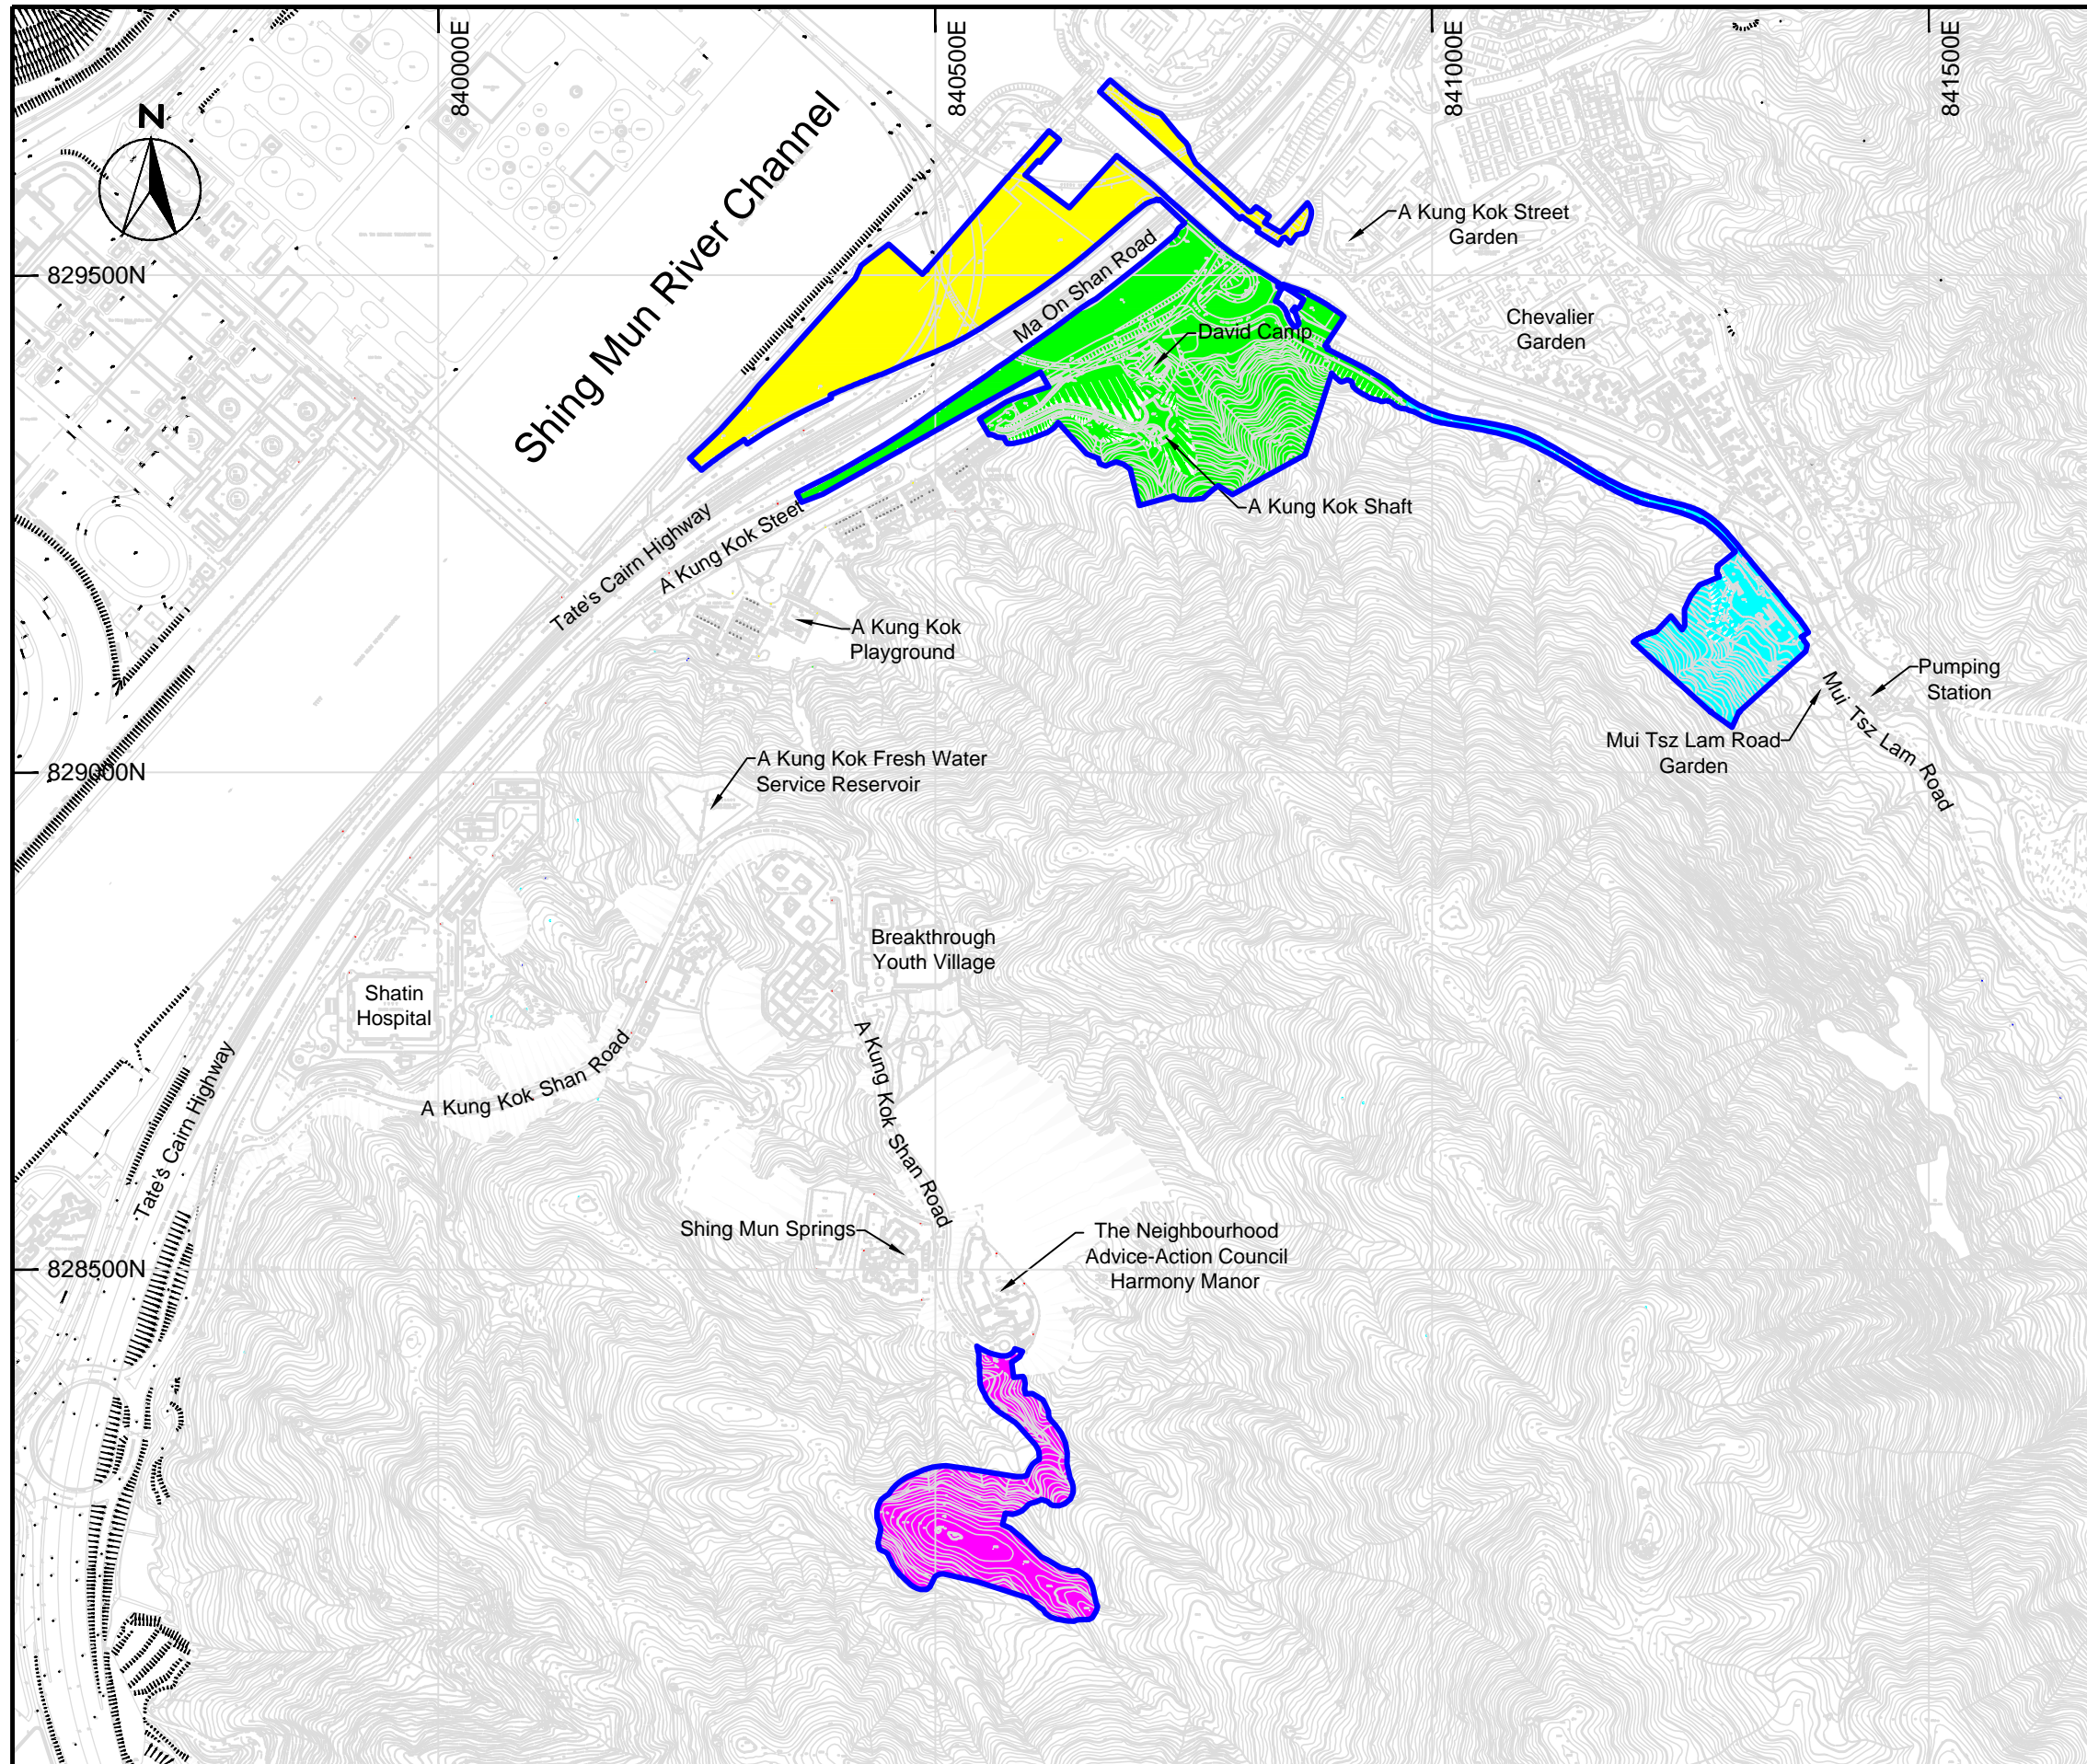
SCALE	1:7000 @ A3	DATE	MAY 2019
CHECK	BC	DRAWN	TL
JOB No.	IA18064	FIGURE No.	1a
		REV	1

2.1 The detailed vegetation project boundary required under the Project is shown in **Figure 1a**. With reference to Figure 8.05a and 8.05b of the EIA Report, seven flora species of conservation importance were found within or in the proximity to the project boundary (**Table 2-1**).

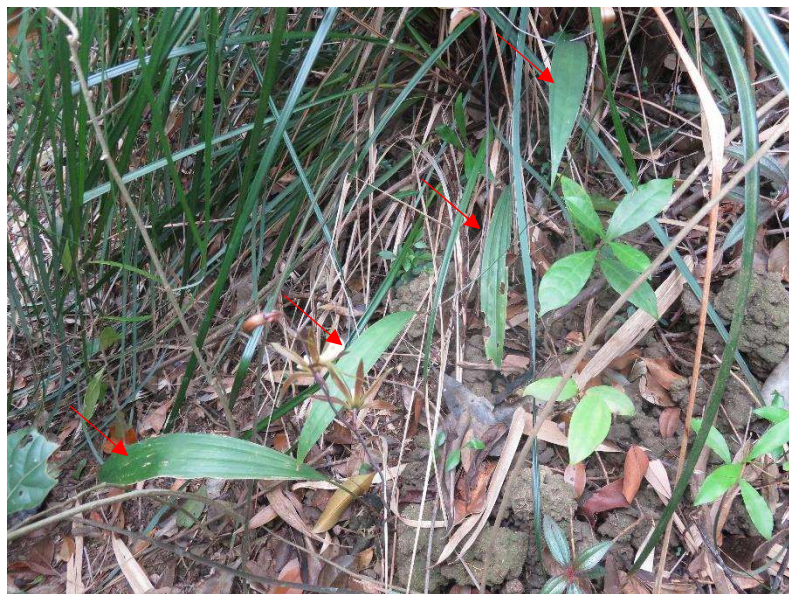
H0001 Purple Bulb Orchid *Ania hongkongensis*

- 3.8 Five individuals of *Ania hongkongensis* (in two clusters H0001 (4 nos.) and H0002 (1 no.)) grew on loose soil in secondary woodland.

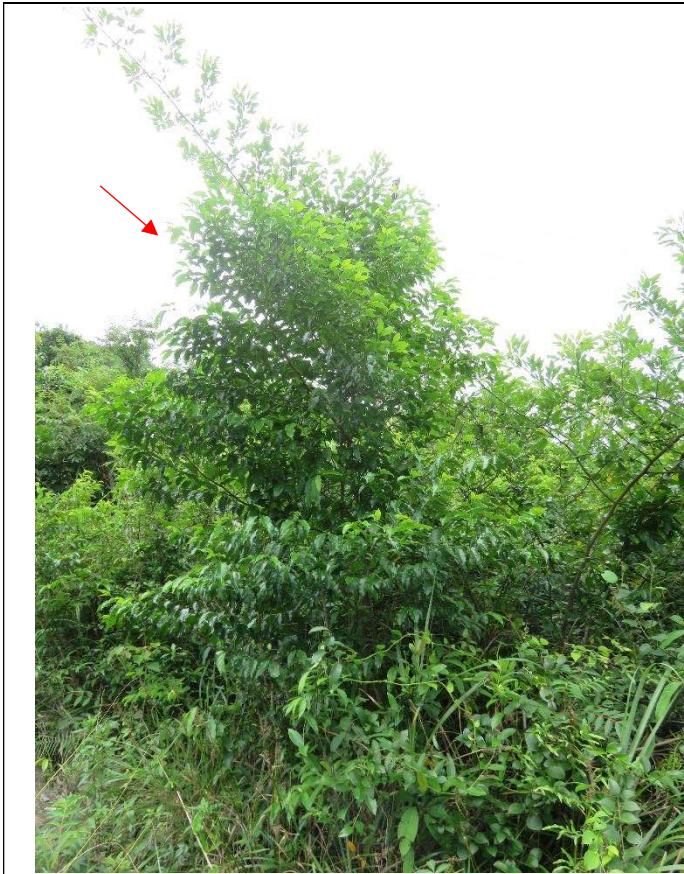
D0003 Butulang Canthium *Canthium dicoccum*

-
- 3.10 Four species of conservation importance were recorded, with *Diospyros vaccinioides* and *Gnetum luofuense* being the most abundant species.
- 3.11 *Diospyros vaccinioides* dominated in shrubland/woodland in the uphill. Individuals of height from 0 – 1m was the major portion (60%)
- 3.12 Due to the climbing nature of *Gnetum luofuense*, this species mostly clung on trees in shrubland/woodland. It is estimated to cover 15% of Site 2 area (~2,800m²).
- 3.13 Four patches of *Cibotium barometz* (E0001a (16 nos.), E0001b (2 nos.), E0002 (1 no.) and E0003 (2 nos.)) were found along two seasonal streams. Five individuals of *Canthium dicoccum* (D0003, D0004, D0006, D0008 and D0009) scattered in the shrubland/woodland.

- 4.6 Most *Canthium dicoccum* recorded are semi-mature trees over 7m tall. Young individuals are growing near rocks or concrete structure. These make formation of a good root ball difficult. For two individuals located within the works area in Site 2 (D0008 and D0009), the former has poor health condition while the latter has been uprooted. Although they would be affected by the construction works, they are unlikely to survive after transplantation and thus this option is not recommended.

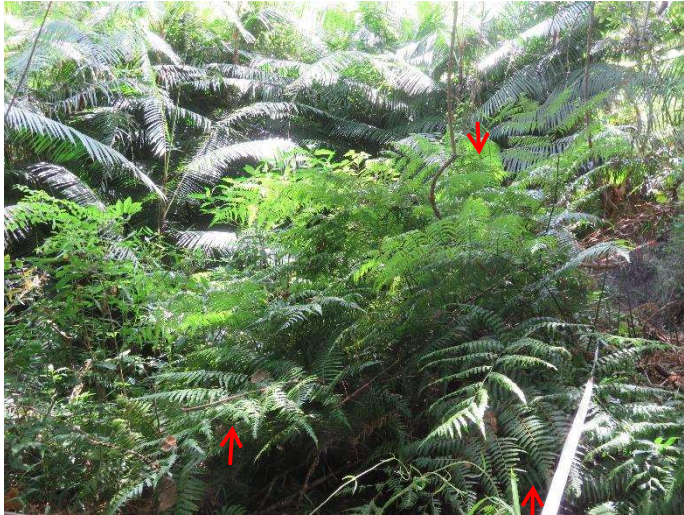
E0004 Lamb of Tartary *Cibotium barometz*

- 3.18 Four patches of *Cibotium barometz* (E0004 (7 nos.), E0005 (50 nos.), E0006 (1 no.) and E0007 (100 nos.)) were found along three flowing streams and its damp vicinity. One major patch of about 100 individuals (E0007) is located in the upstream section of the stream behind A Kung Kok Shaft. Another major patch of about 50 individuals (E0005) is located in the downstream section of the stream near Mui Tsz Lam Road. Both streams are characterised by steep topography and well-shaded environment.

- 4.14 *Cibotium barometz* grows in damp environment (such as stream and seeping rock). However, nearby suitable habitat within the project boundary (stream in the upper slope in Site 3) has been adopted as transplantation receptor site and thus compensation for the lost individuals would not be recommended.

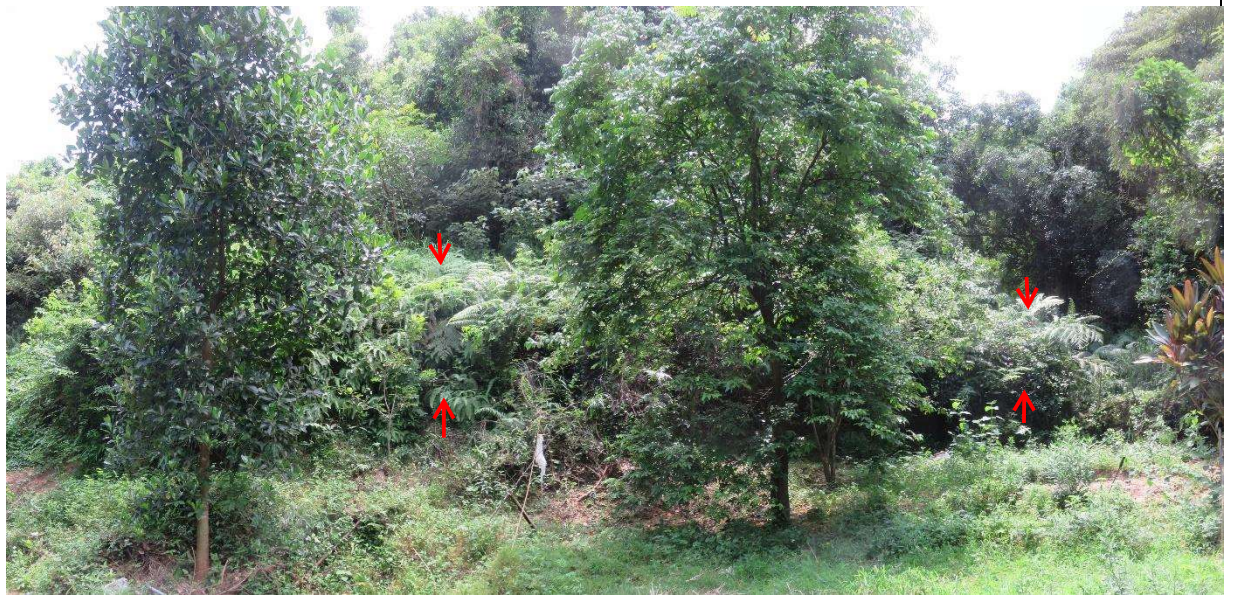
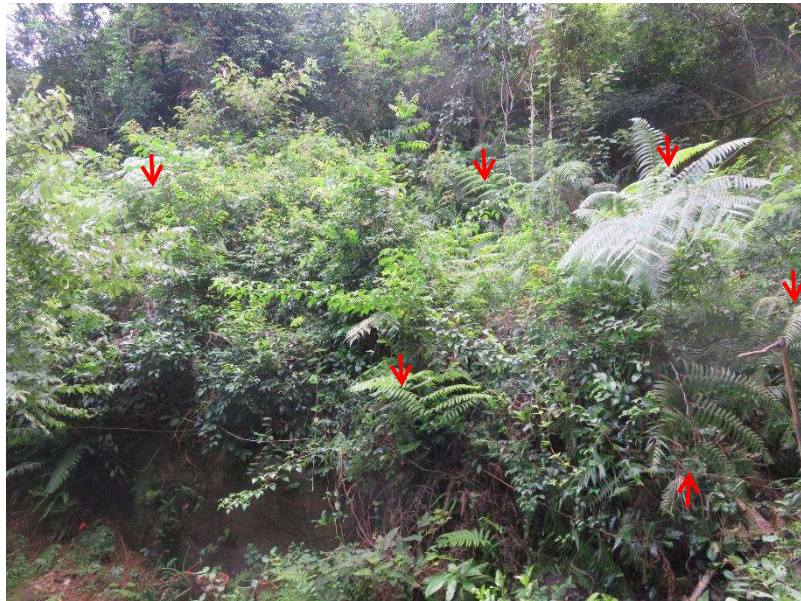
E0005 Lamb of Tartary *Cibotium barometz* (On slope behind the two trees)

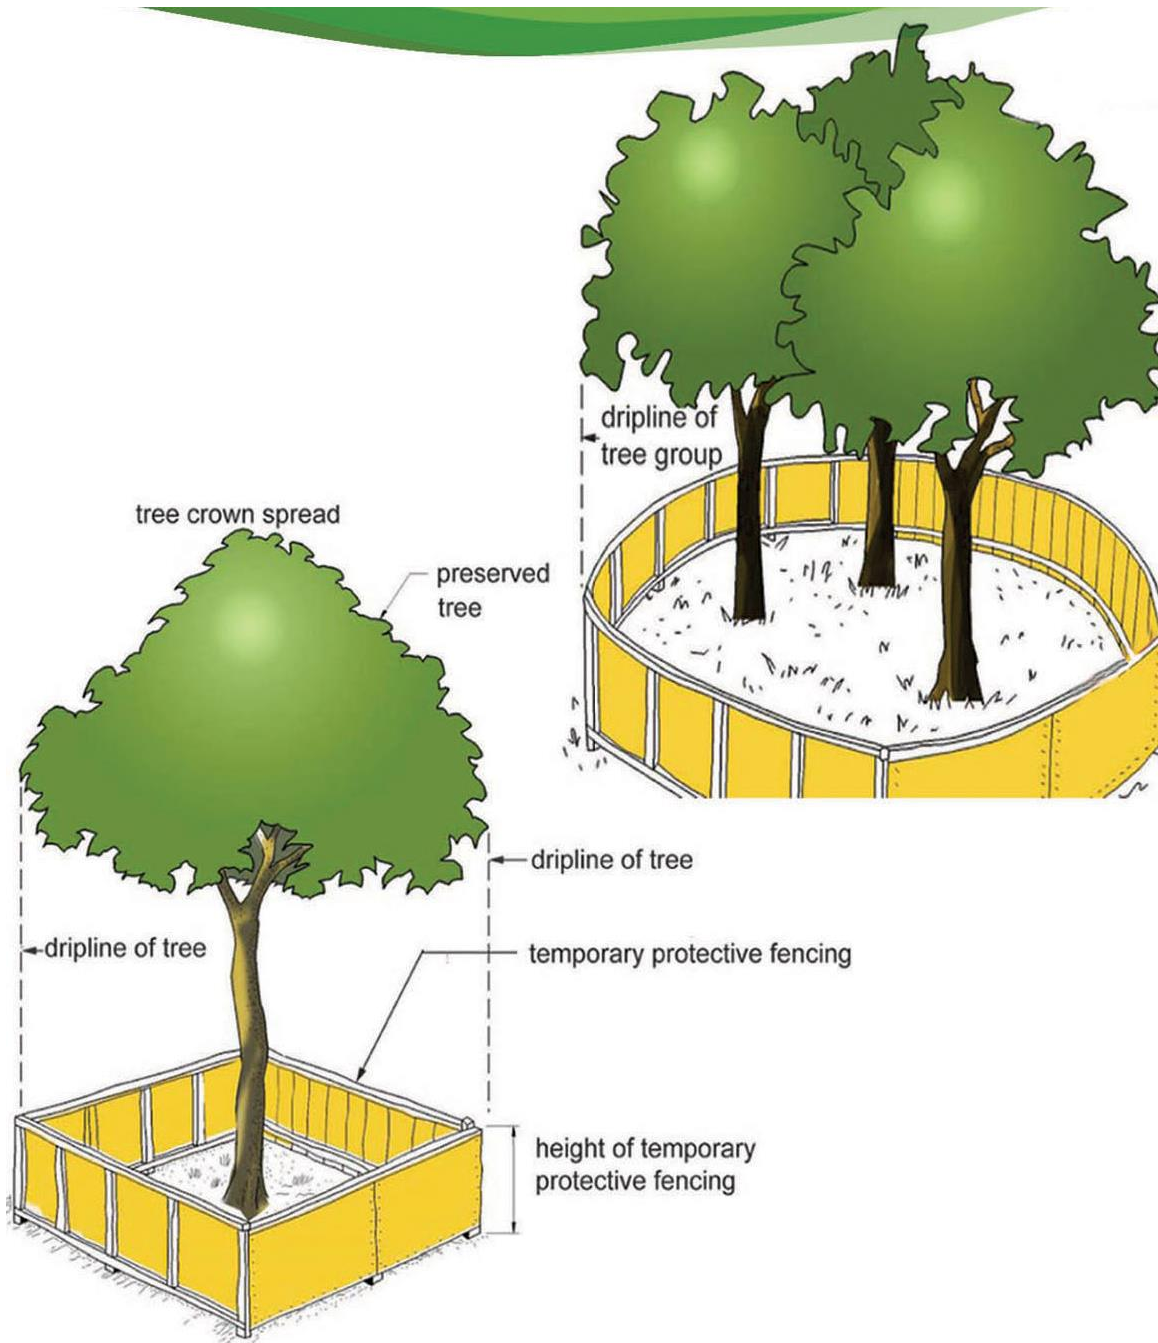
Appendix F – Typical Design of Tree Protection Zone

- Heavy equipment, supplies, ditches and underground utility lines should be placed outside the protection zone.
- Care should be taken to prevent trees/plants being damaged by mechanical equipment both during site clearance works and construction works.

- No soil, debris or construction materials should be deposited around and against the trunk of a tree/plant as this causes bark damage and compaction of the soil.
