**ENVIRONMENTAL TEAM FOR
RELOCATION OF SHA TIN SEWAGE TREATMENT
WORKS TO CAVERNS – SITE PREPARATION
AND ACCESS TUNNEL CONSTRUCTION**

UNDER ENVIRONMENTAL PERMIT NO. EP-533/2017

**MONTHLY ENVIRONMENTAL MONITORING & AUDIT
REPORT**

JUNE 2021

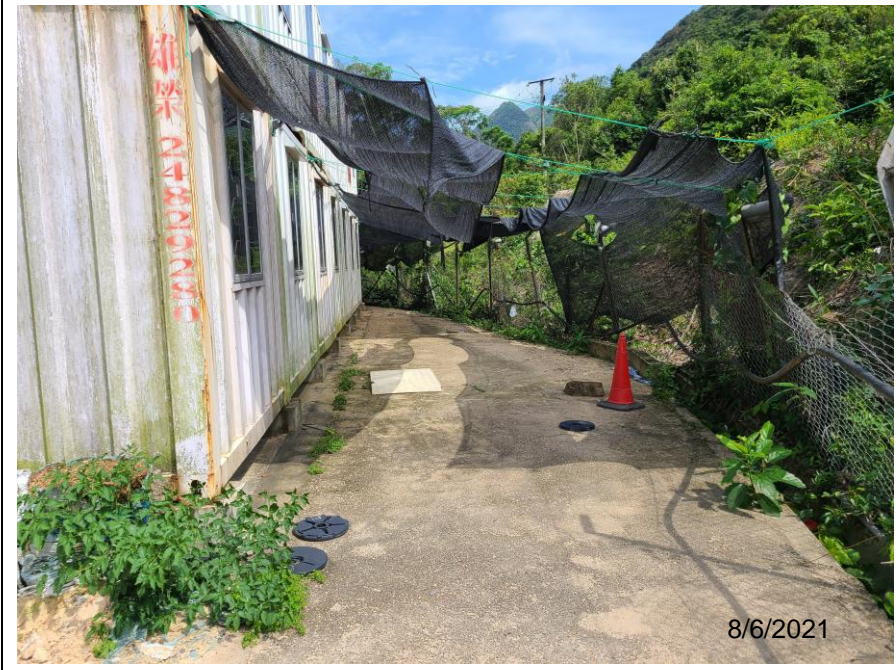
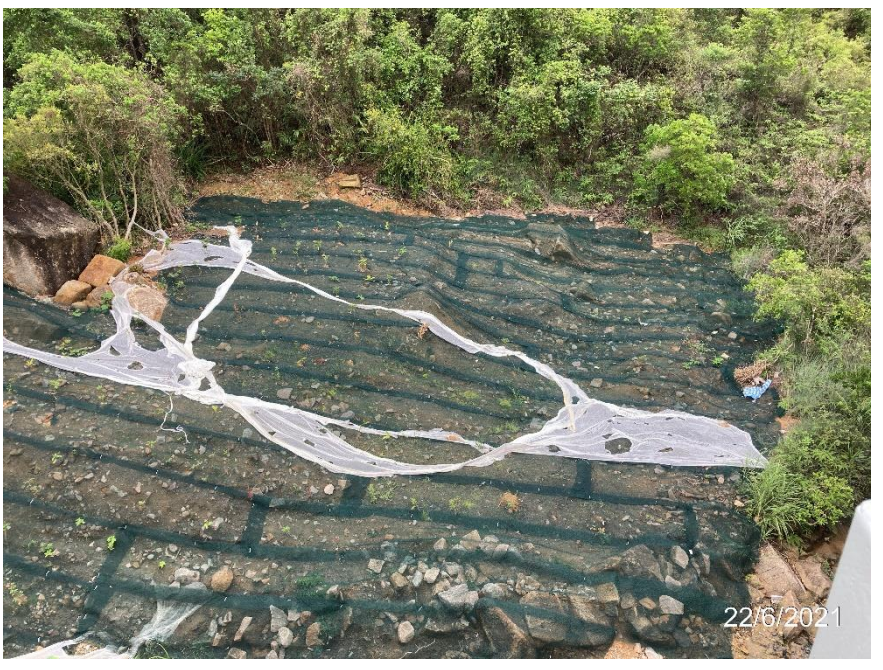
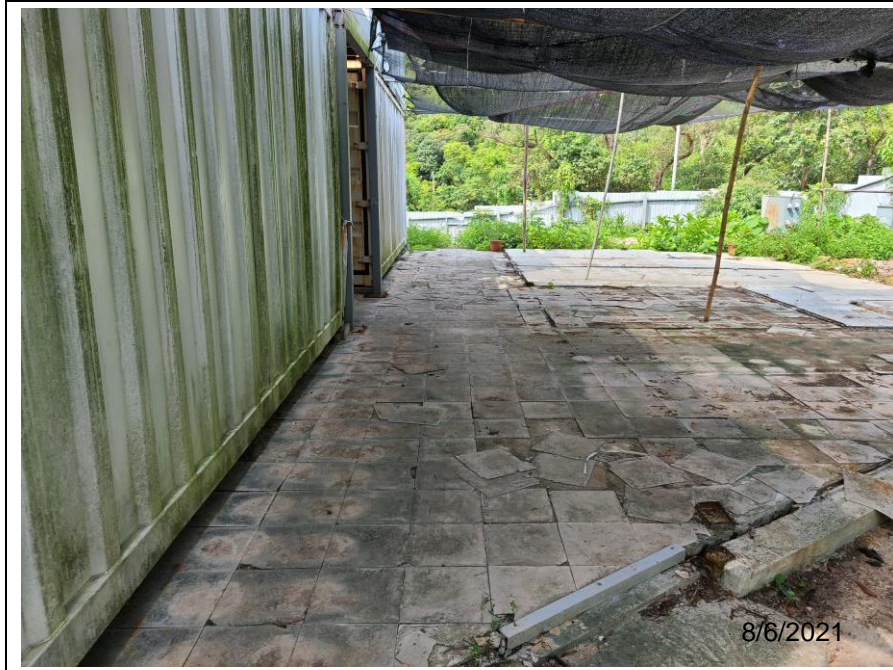
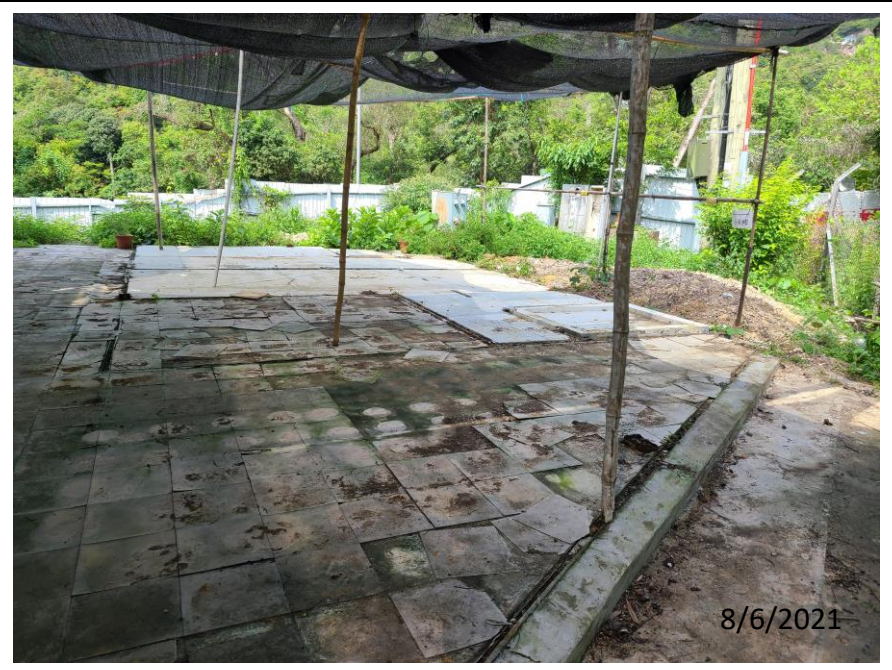
Plate 1. The 4 batches of *Diospyros vaccinioides* at the on-site nursery were transplanted to receptor site on 11st and 21st May 2021

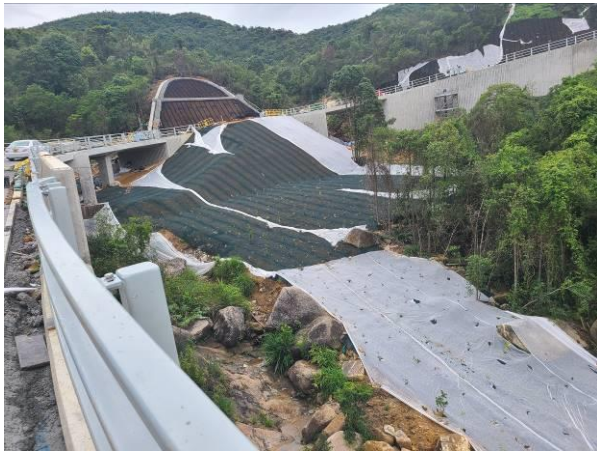
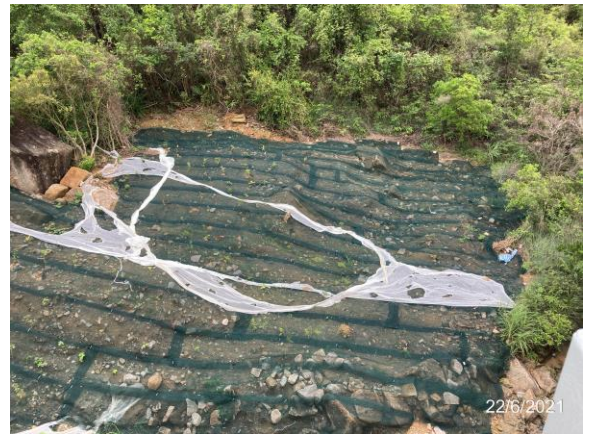
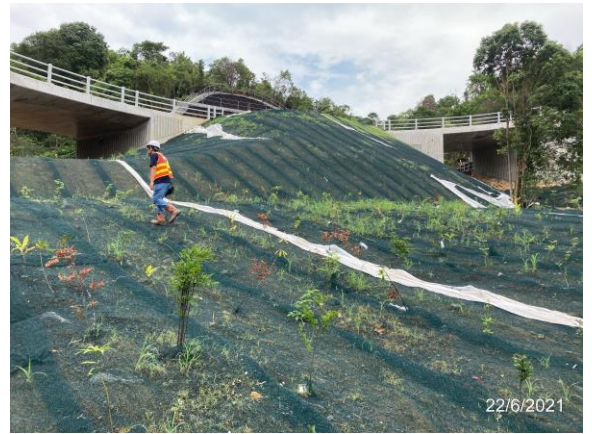
Post-transplantation monitoring at receptor site on 8 and 22 June 2021

The final findings of plant conditions of 1st batch, 2nd batch, 3rd batch and 4th batch were listed in **Table 2a, 2b, 2c, 2d** and illustrated in **Appendix 1** before transplantation to the receptor site on May 2021. Some seedlings were generally tiny (about 10cm in height) aiming at smaller root zone and better survival. However, some of them have yet developed sufficient leaves. Sign of leaf drop and dehydration has been observed, despite provision of shelter and irrigation (**Plate 1**). Although tiny new branch or leaf buds were observed, seedlings may struggle for survival against environmental stress.

Receptor site of *Diospyros vaccinioides*

According to environmental condition and location of the receptor sites/ nursery, watering frequency was recommended in daily practice for at least the first 3 months as the transplant time is in summer months with strong sunlight and high temperature; except the days with fog and rain. Water frequency may be reduced based on the plant condition after monitoring in the first 3 months.

In contrast, the Landscape Contractor was recommended to check all transplanted plants after heavy rains/ typhoon under safe condition, in order to carry out any stabilization/ maintenance work. Blocked drainage shall be cleared; excessive water shall be pumped or diverged from nursery ground; saturated soil shall be aerated.

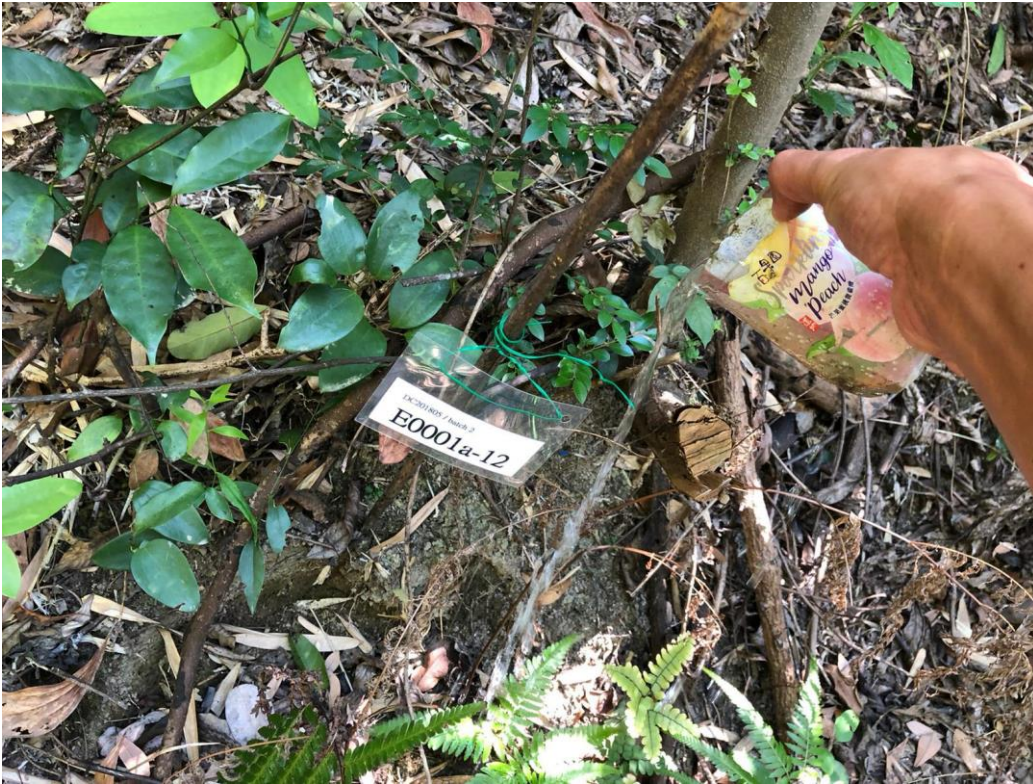
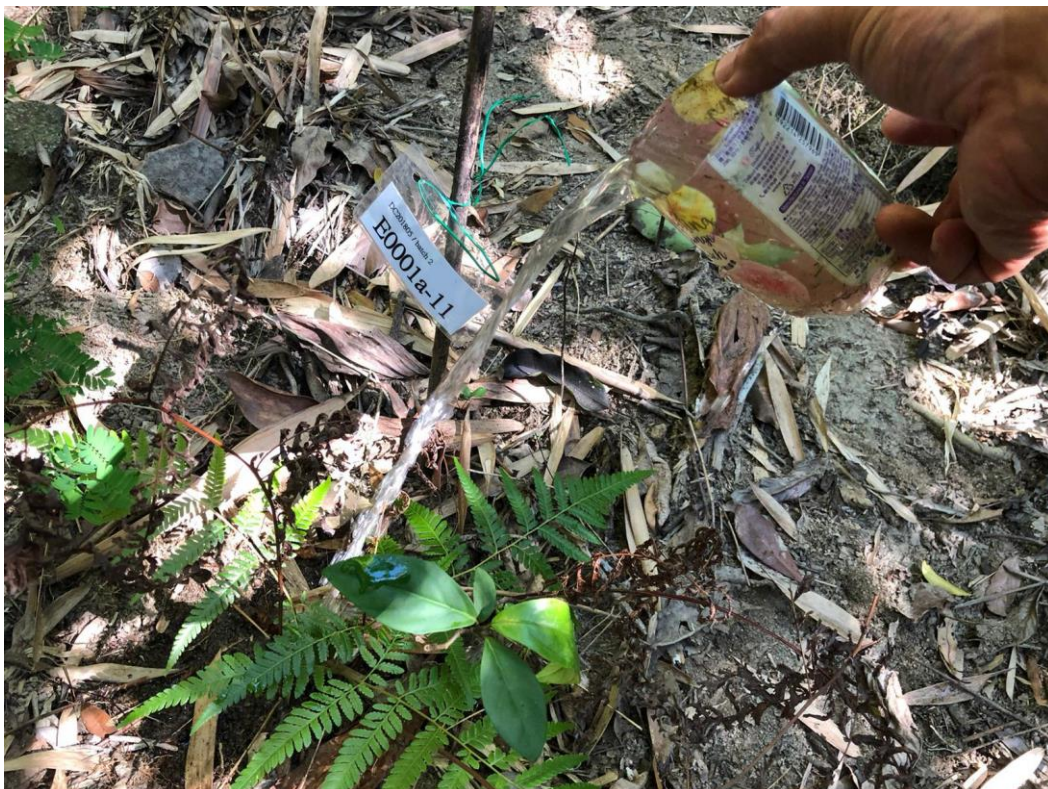
Post-transplantation monitoring at receptor site on 30 March 2021

Monitoring for 19 nos. of *Cibotium barometz* (E0001a-1 to E0001a-16, E0002-01, E0002-02 and E0003) were conducted on 22 June 2021 at a quarterly basis and the coming monitoring will be carried out in September 2021. Plant conditions were listed in **Table 3**, and corresponding photographic records were shown in **Appendix 2**.

Date of monitoring	No.	Form	Health condition	Structural condition	Amenity value	Remarks
June-21	E0001a-1	Poor	Poor	Poor	Poor	
	E0001a-2	Poor	Poor	Poor	Poor	
	E0001a-3	Poor	Poor	Poor	Poor	
	E0001a-4	Poor	Poor	Poor	Poor	
	E0001a-5	Poor	Poor	Poor	Poor	
	E0001a-6	Poor	Poor	Poor	Poor	
	E0001a-7	Poor	Poor	Poor	Poor	
	E0001a-8	Poor	Poor	Poor	Poor	
	E0001a-9	Poor	Poor	Poor	Poor	
	E0001a-10	Poor	Poor	Poor	Poor	
	E0001a-11	Poor	Poor	Poor	Poor	
	E0001a-12	Poor	Poor	Poor	Poor	
	E0001a-13	Poor	Poor	Poor	Poor	
	E0001a-14	Poor	Poor	Poor	Poor	
	E0001a-15	Poor	Poor	Poor	Poor	
	E0001a-16	Poor	Poor	Poor	Poor	
	E0002-01	Poor	Poor	Poor	Poor	
	E0002-02	Poor	Poor	Poor	Poor	
	E0003	Poor	Poor	Poor	Poor

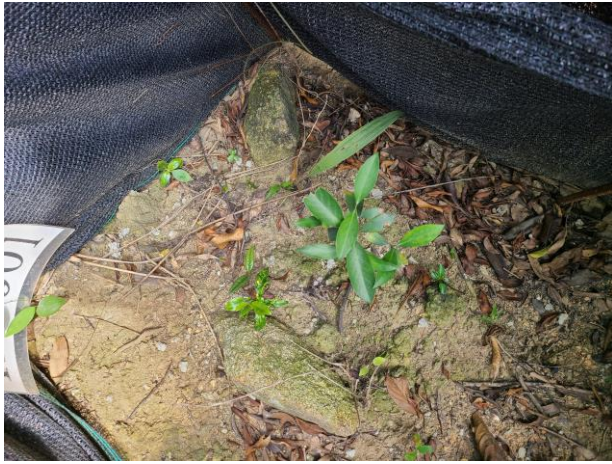
The patch of retained *Ania hongkongensis* (named as H0001) was observed in a fair condition during reporting period, with corresponding photos presented in **Appendix 3**. The protection zone of H0001 has been expanded due to additional individuals were observed. Landscape Contractor was reminded to carry out regular watering to the transplanted H0002.
