**CONTRACT NO. STW 01/2021**

**ENVIRONMENTAL TEAM FOR  
RELOCATION OF SHA TIN SEWAGE TREATMENT  
WORKS TO CAVERNS – SITE PREPARATION  
AND ACCESS TUNNEL CONSTRUCTION**

**MONTHLY ENVIRONMENTAL MONITORING & AUDIT  
REPORT**

**AUGUST 2021**

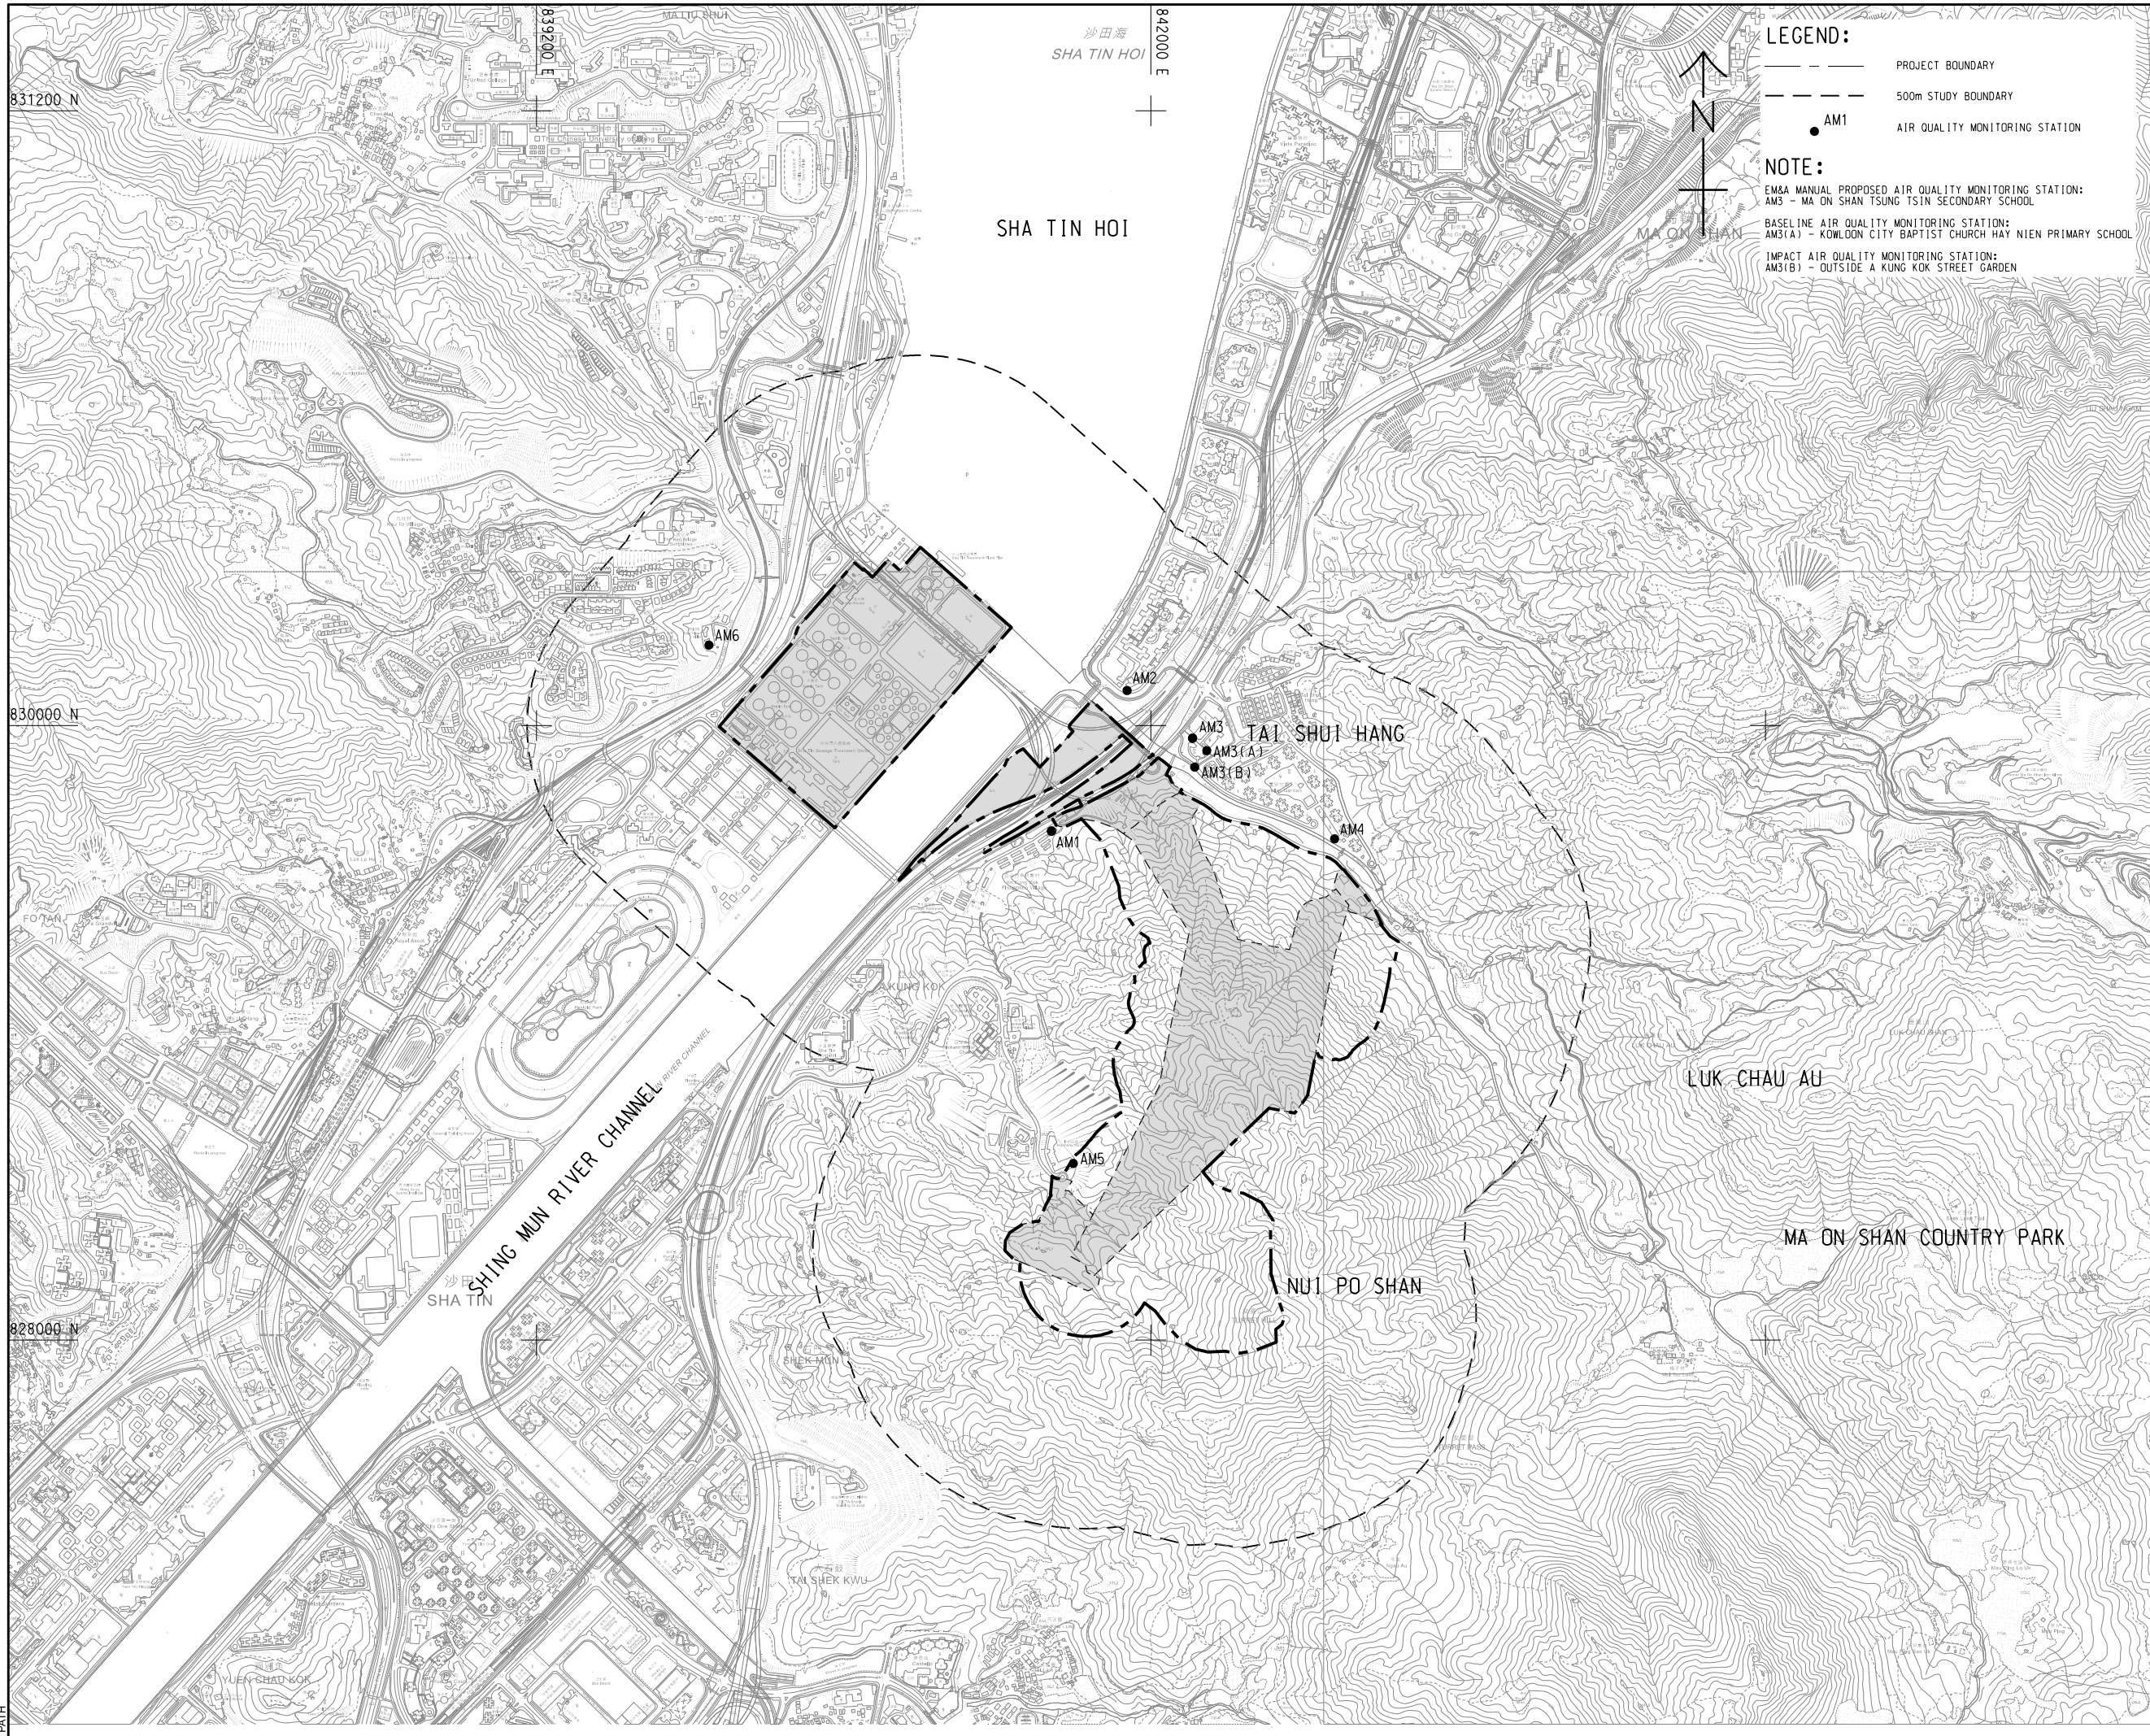
***Locations of Monitoring Stations***

**LEGEND:**  
 - - - - - PROJECT BOUNDARY  
 - - - - - 500m STUDY BOUNDARY  
 ● AM1 AIR QUALITY MONITORING STATION

**NOTE:**  
 EM&A MANUAL PROPOSED AIR QUALITY MONITORING STATION:  
 AM3 - MA ON SHAN TSUNG TSIN SECONDARY SCHOOL  
 BASELINE AIR QUALITY MONITORING STATION:  
 AM3(A) - KOWLOON CITY BAPTIST CHURCH HAY NIEN PRIMARY SCHOOL  
 IMPACT AIR QUALITY MONITORING STATION:  
 AM3(B) - OUTSIDE A KUNG KOK STREET GARDEN

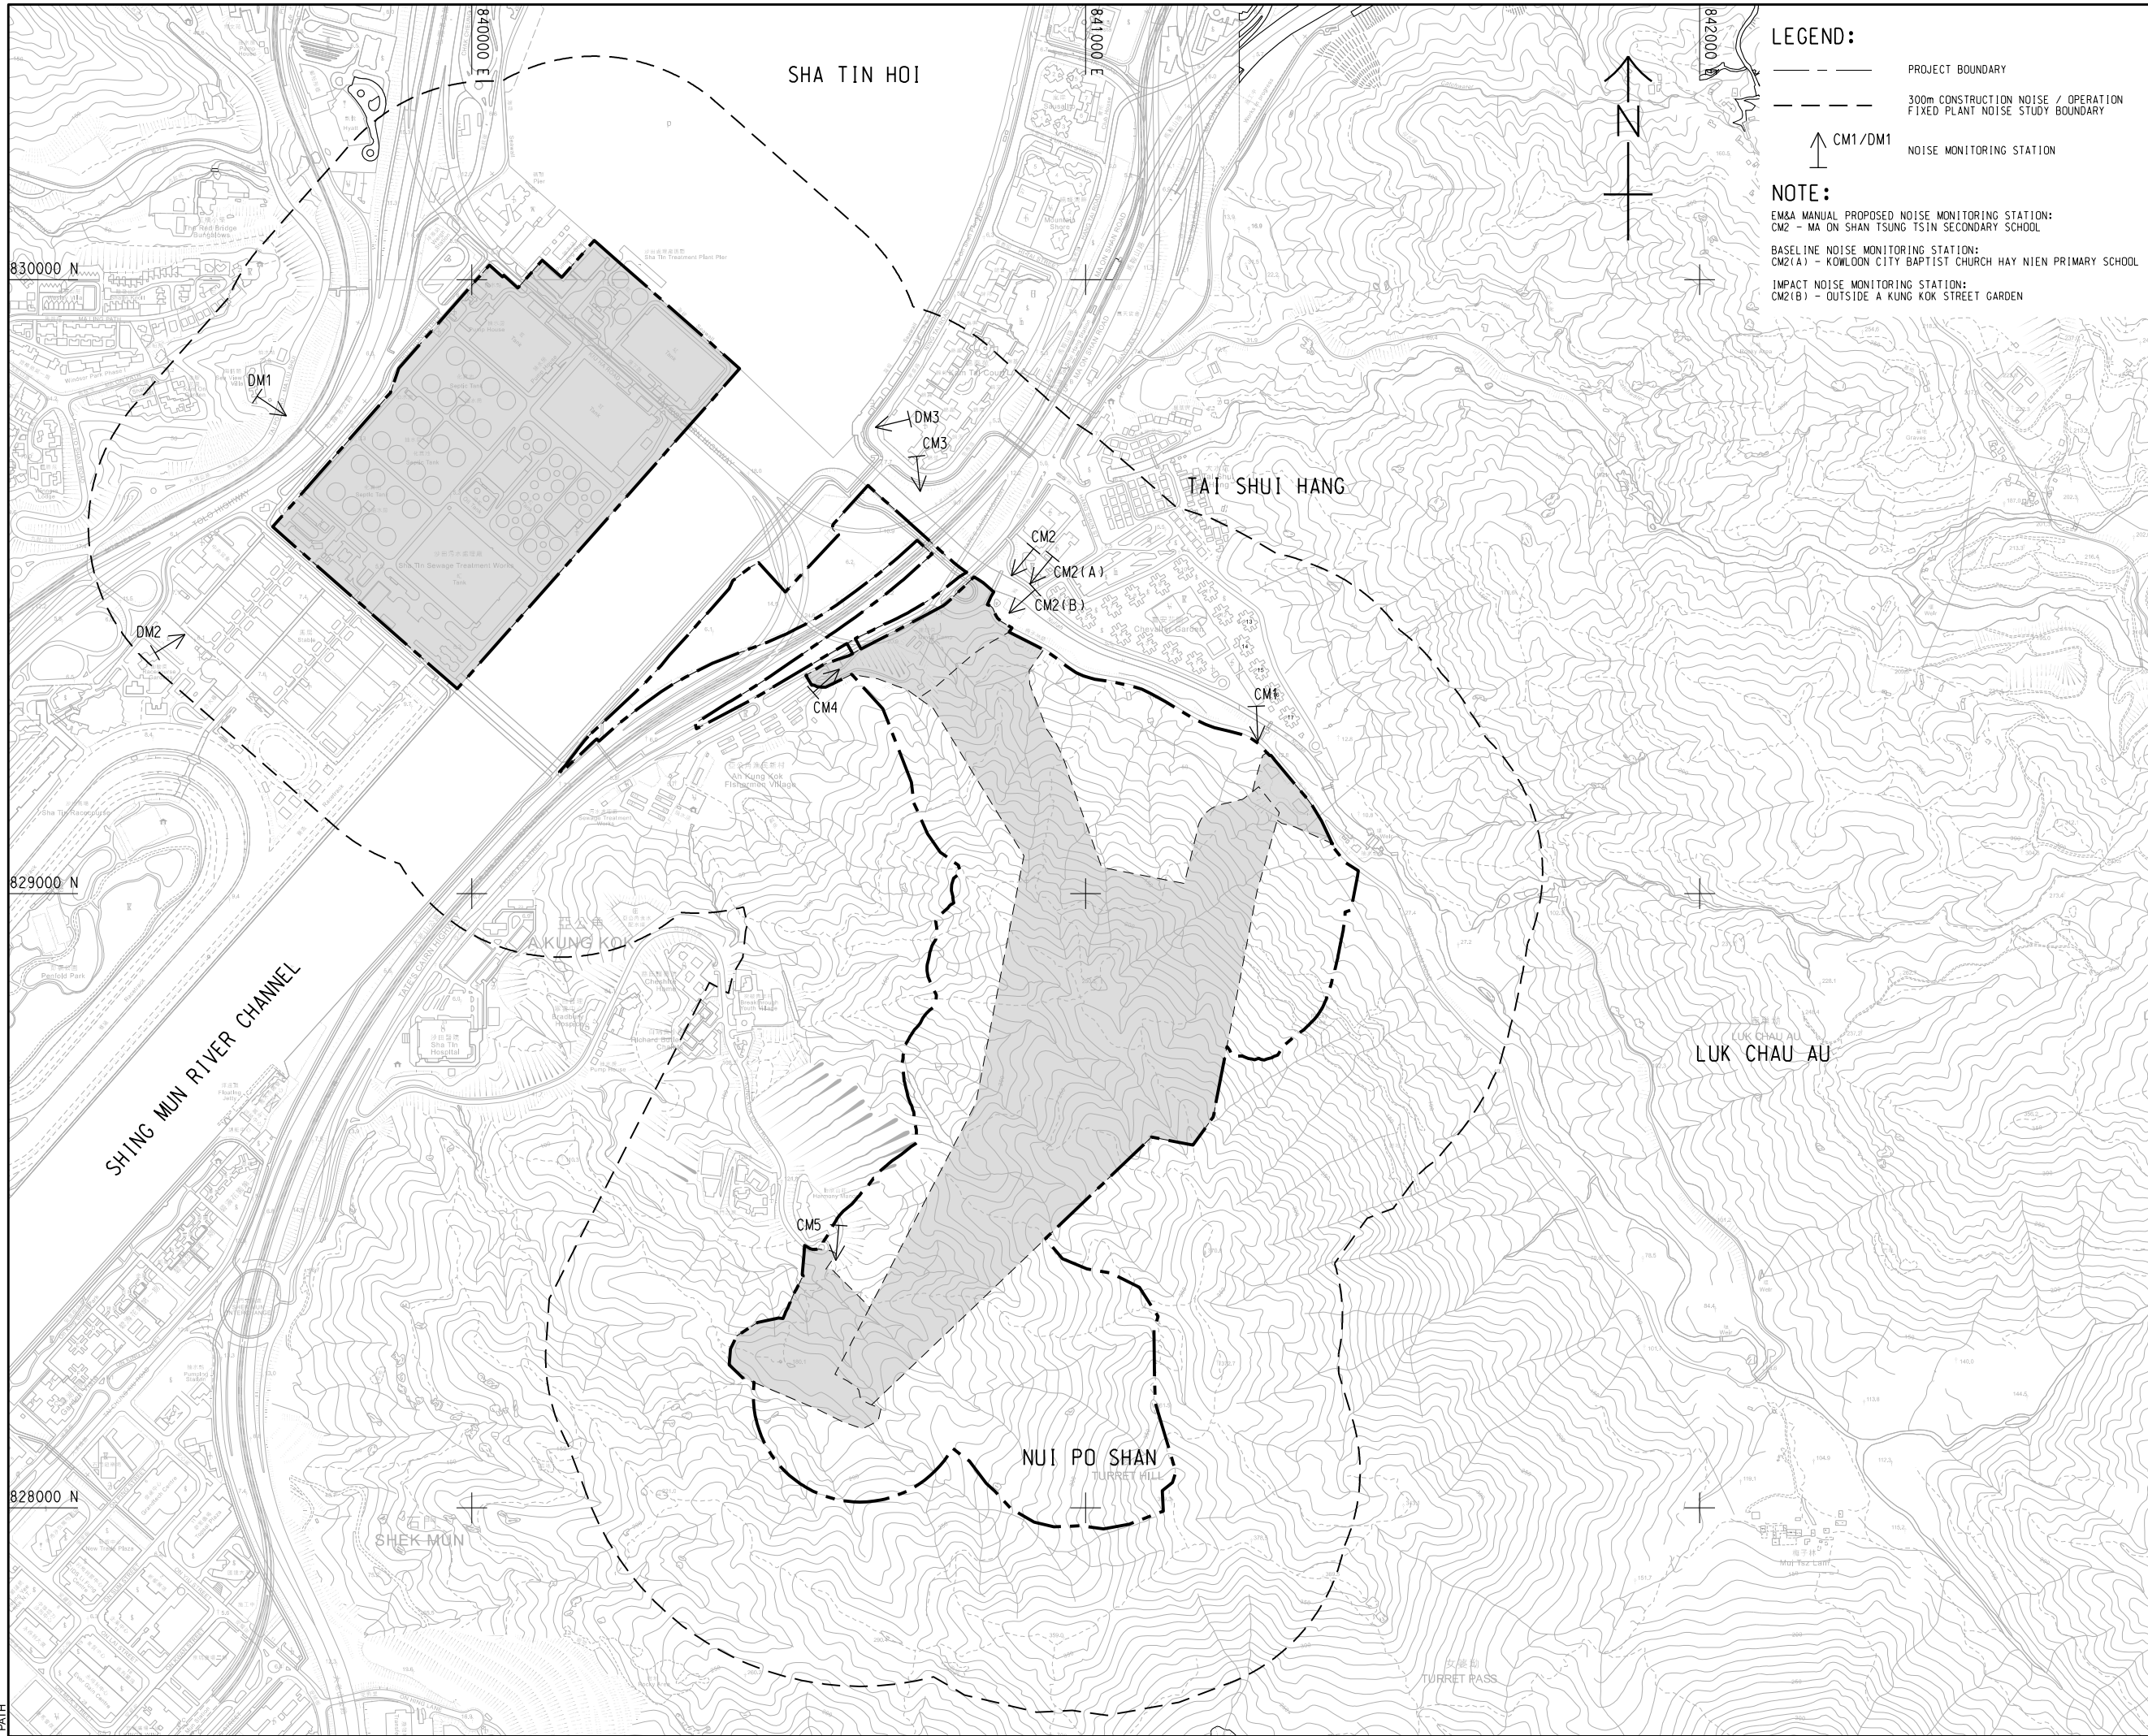
**LEGEND:**  
 - - - - - PROJECT BOUNDARY  
 . . . . . 300m CONSTRUCTION NOISE / OPERATION FIXED PLANT NOISE STUDY BOUNDARY  
 ↑ CM1/DM1 NOISE MONITORING STATION

**NOTE:**  
 EM&A MANUAL PROPOSED NOISE MONITORING STATION:  
 CM2 - MA ON SHAN TSUNG TSIN SECONDARY SCHOOL  
 BASELINE NOISE MONITORING STATION:  
 CM2(A) - KOWLOON CITY BAPTIST CHURCH HAY NIEN PRIMARY SCHOOL  
 IMPACT NOISE MONITORING STATION:  
 CM2(B) - OUTSIDE A KUNG KOK STREET GARDEN

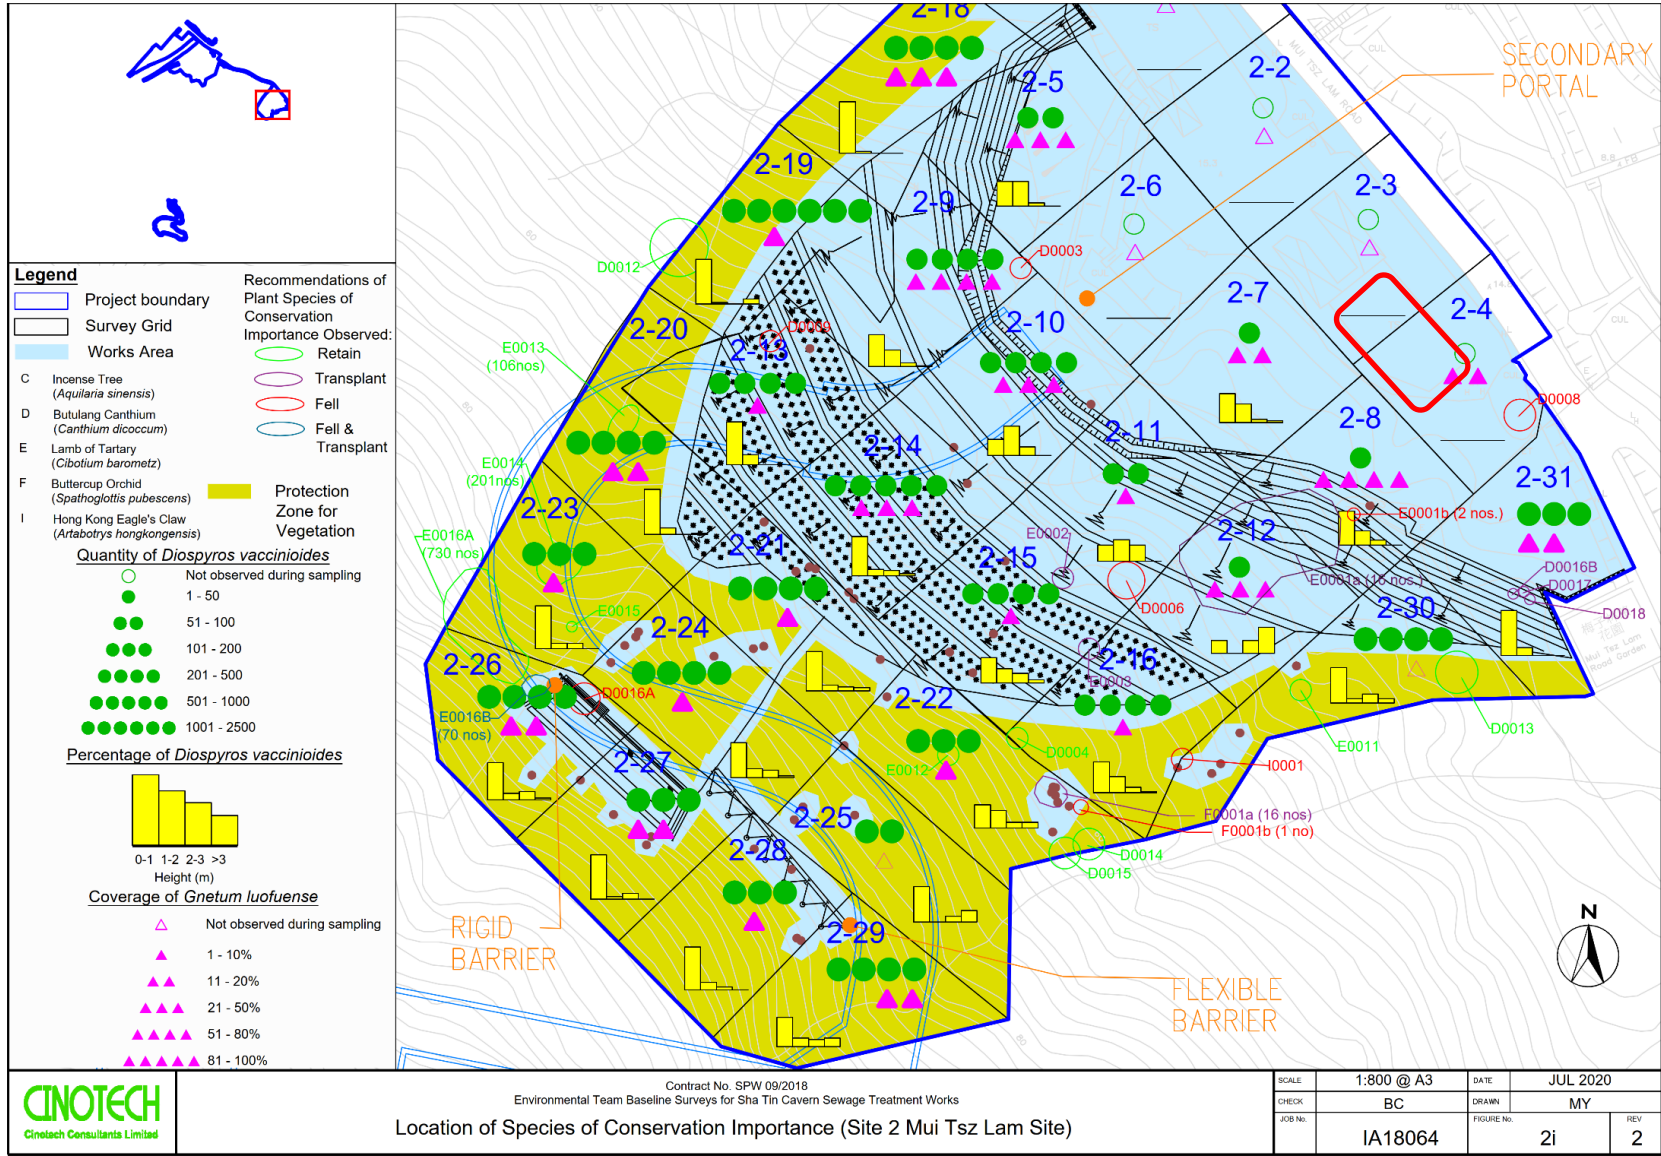
**Figure 2.** Original location of DV0269-DV0500 (3<sup>rd</sup> batch) and DV0501-DV0550 (4<sup>th</sup> batch) at Site 2. Nursery site highlighted in red frame for DV0229-DV0268 (1<sup>st</sup> batch), DV0001-DV0228 (2<sup>nd</sup> batch), DV0269-DV0500 (3<sup>rd</sup> batch) and DV0501-DV0550 (4<sup>th</sup> batch) at Site 2.

Post-transplantation monitoring for 530nos. of *Diospyros vaccinioides* (names as DV001-DV530) were conducted on 3, 20 Aug & 1 Sept 2021 at their corresponding receptor sites / nursery (**Figure 2**). During the bad weather condition, the schedule of the Post-transplantation monitoring on 31 Aug 2021 was re-scheduled to 1 Sept 2021.

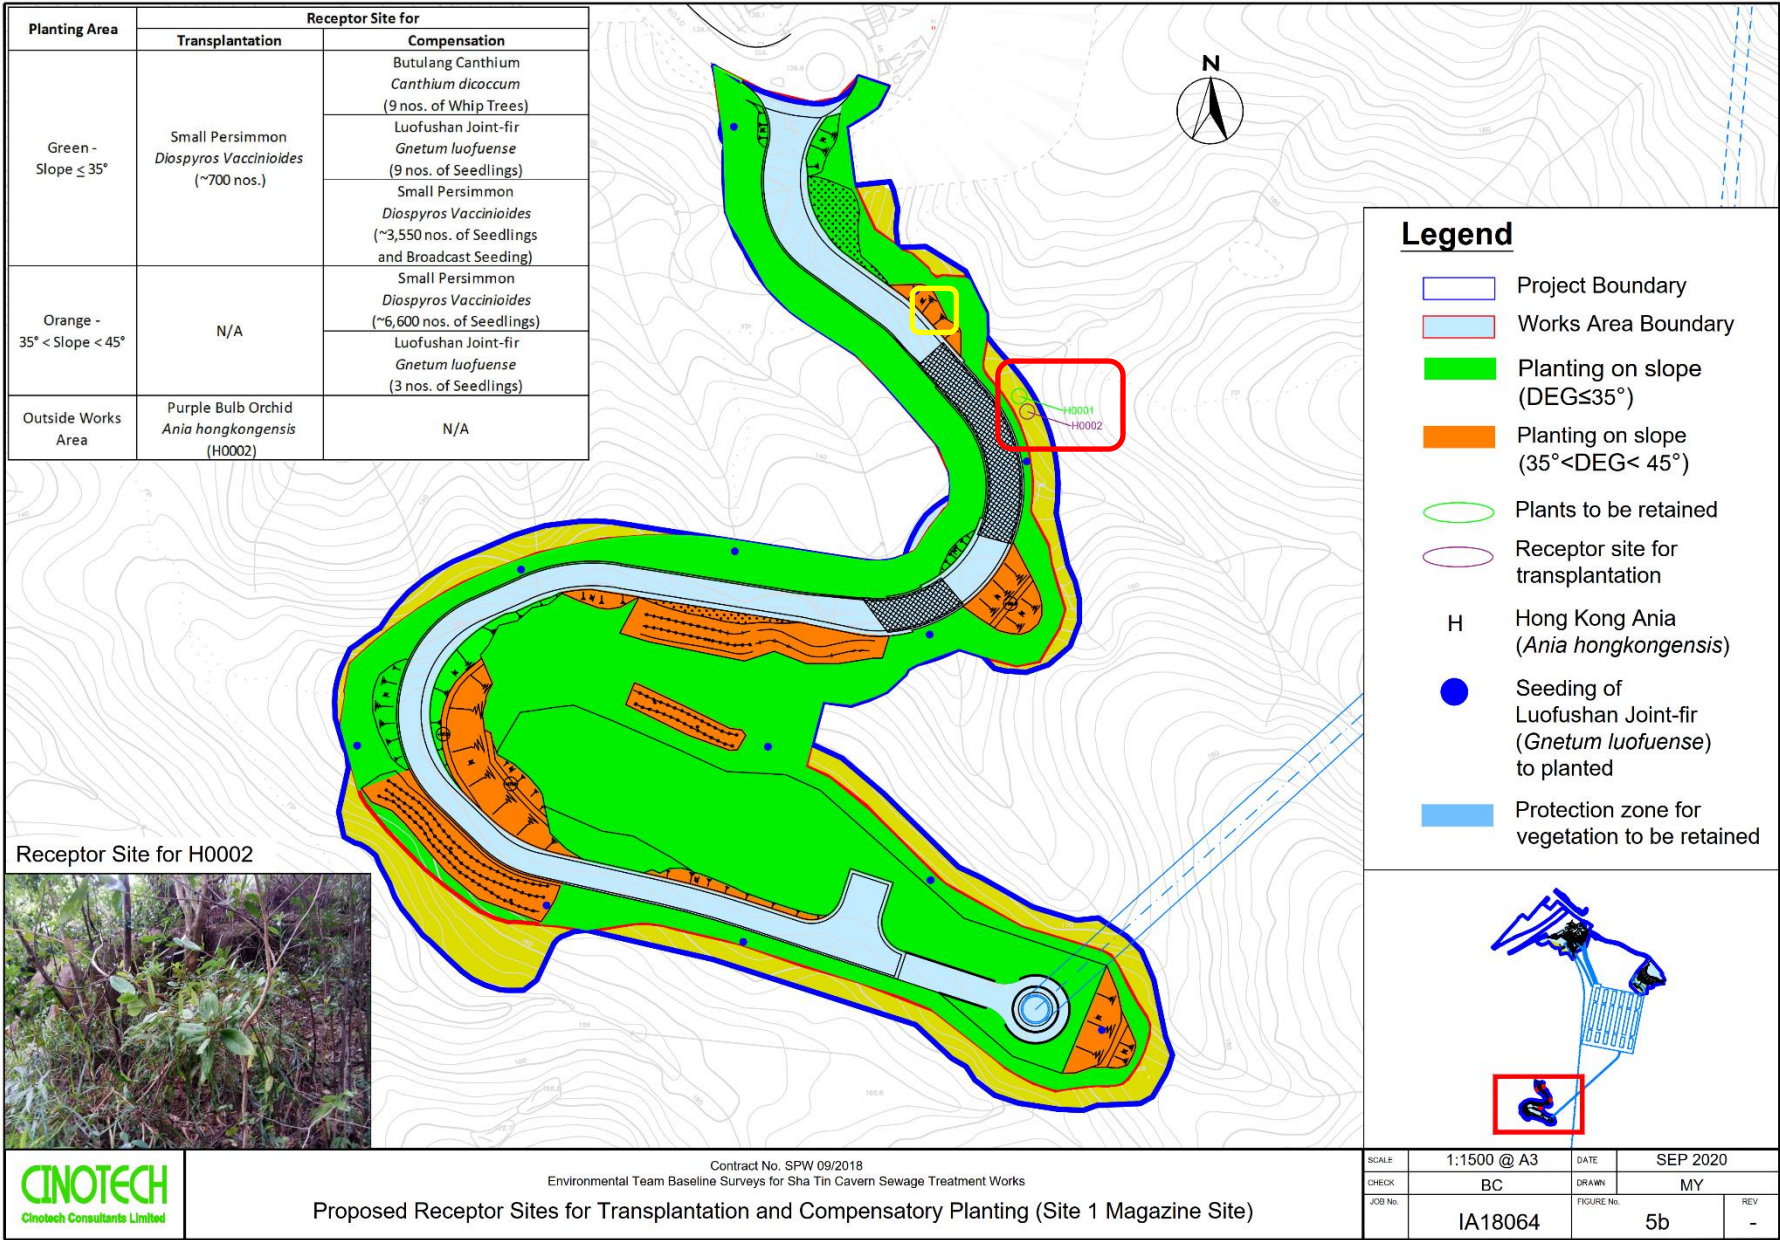
Figure 3. Original location of H0002 highlighted in yellow frame and its receptor site highlighted in red frame.

On 11<sup>st</sup> and 21<sup>st</sup> May 2021, 530nos. of *Diospyros vaccinioides* in the nursery has been transplanted to the receptor site – RMZ1 down hill side (green hatched area adjacent to the access road in **Figure 3**) at a spacing of 0.5m. The other 20nos. of *Diospyros vaccinioides* will be teansplanted until the slope is formed and stability. The first three months after transplantation (June to August 2021) will serve as an adaptation period for these newly transplanted individuals. Change in condition or survival rate is expected more fluctuating, especially as the hillside receptor site does not have any shelter and irrigation as the nursery set-up; while temperature and sunlight can be extreme in recent months.

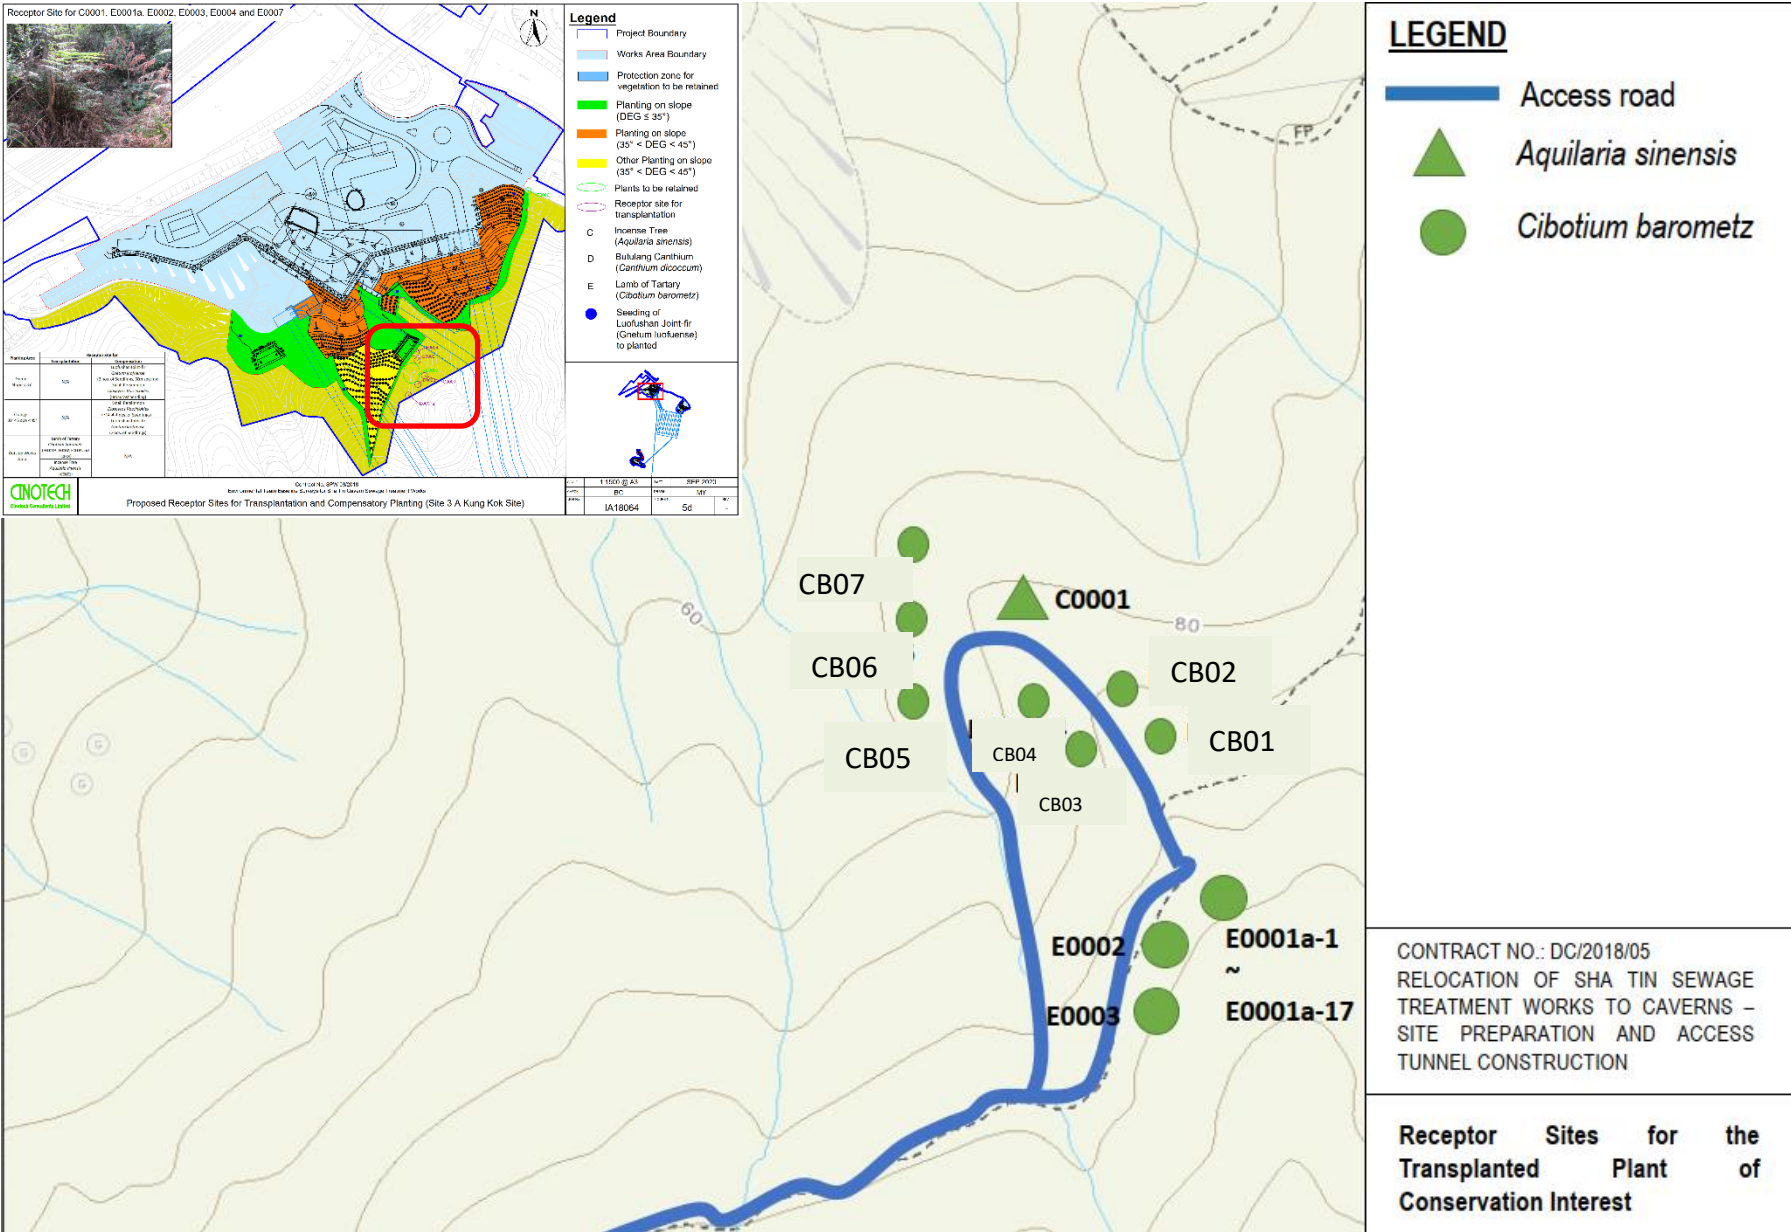
Figure 4. Receptor site for C0001 and E0001a-E0004, the area highlighted in red frame is enlarged.

Monitoring for the 19 nos. newly transplanted *Cibotium barometz* (grouped as E0001a-1 to a-16, E0002-01, E0002-02 and E0003) was conducted on 22 June 2021 at quarterly basis and the coming monitoring will be carried out in September 2021. (**Figure 4**).

Monitoring for 19 nos. of *Cibotium barometz* (E0001a-1 to E0001a-16, E0002-01, E0002-02 and E0003) were conducted on 22 June 2021 at a quarterly basis and the coming monitoring will be carried out in September 2021. Plant conditions were listed in **Table 2**, and corresponding photographic records were shown in **Appendix 2**.

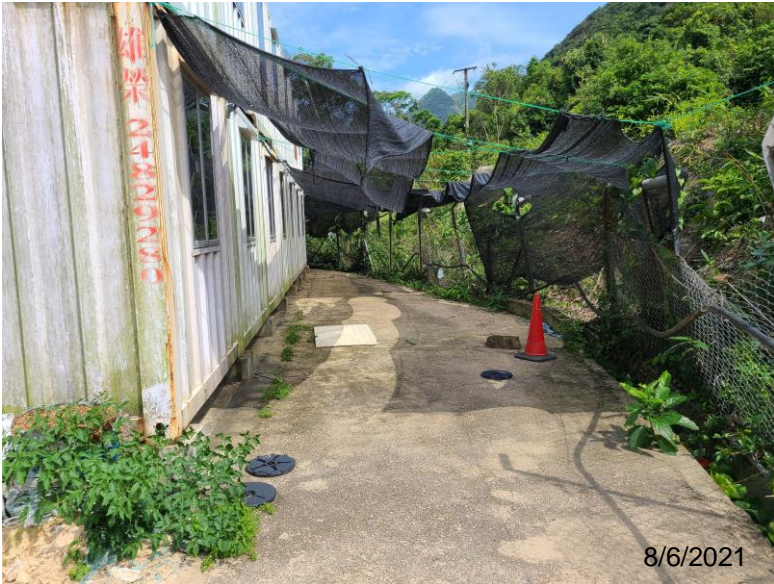
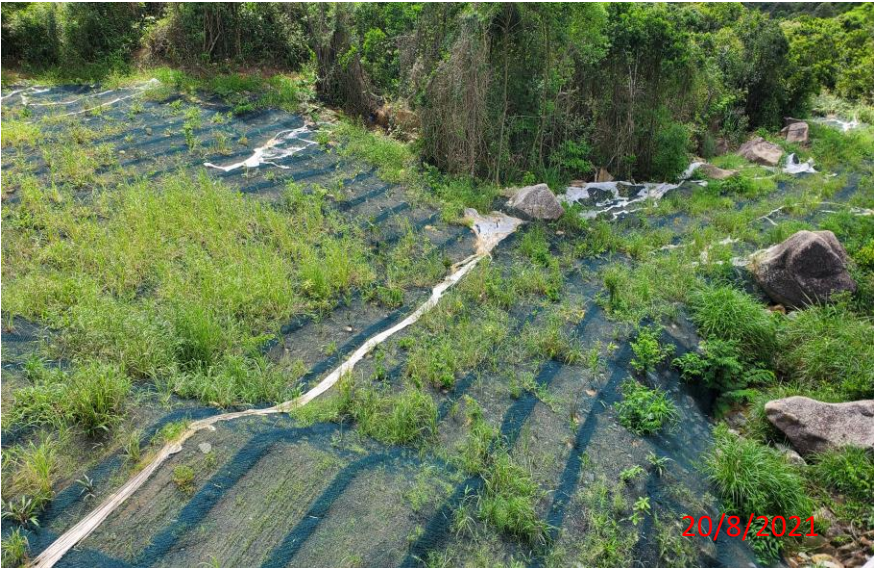
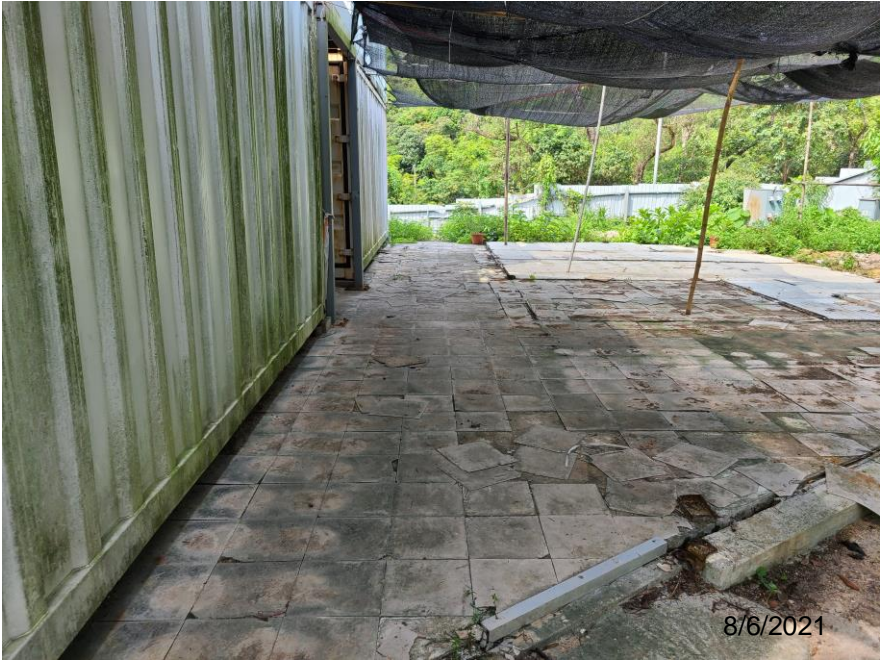
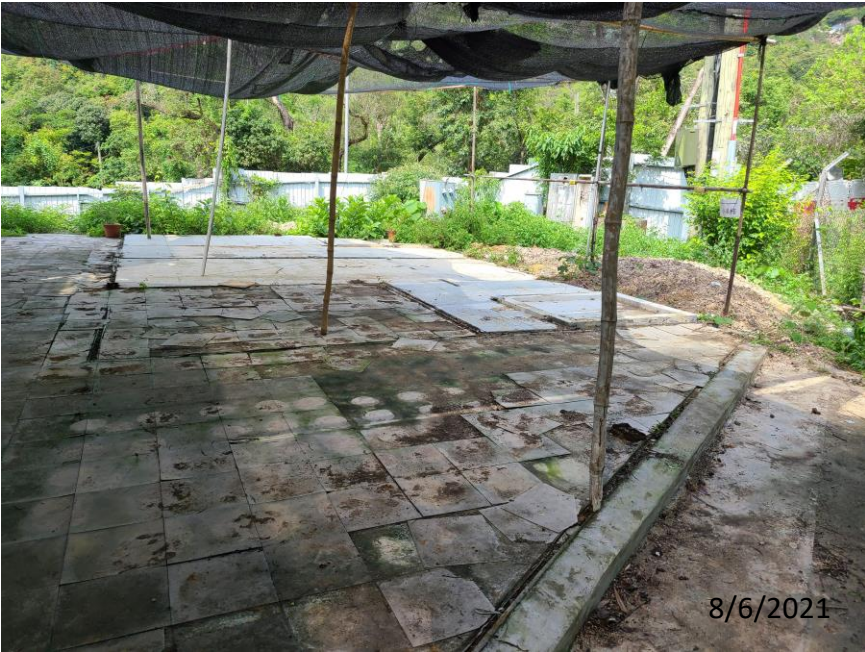
*Plate 1.* The 4 batches of *Diospyros vaccinioides* at the on-site nursery were transplanted to receptor site on 11<sup>st</sup> and 21<sup>st</sup> May 2021

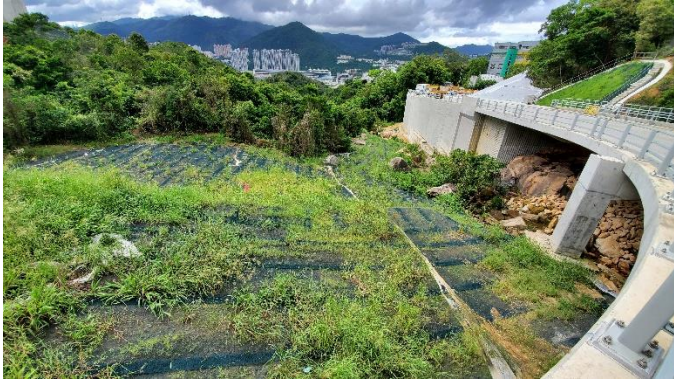
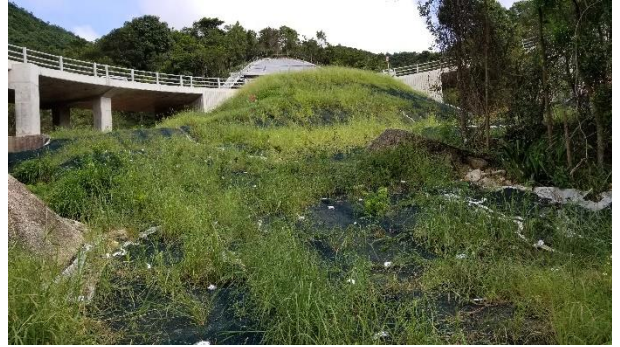
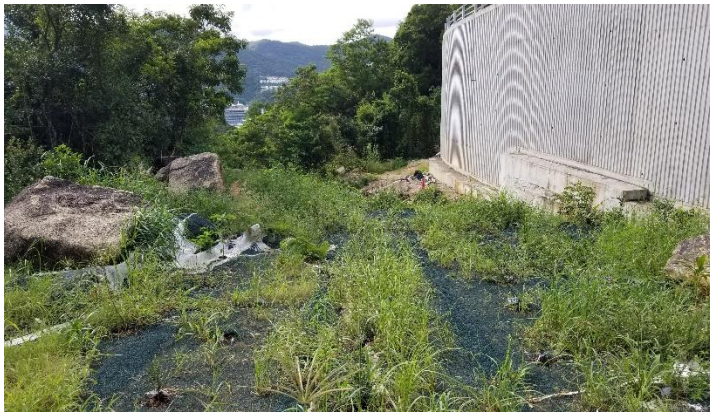
Post-transplantation monitoring at receptor site on 3 and 20 Aug and 1 sept 2021

Receptor site of *Diospyros vaccinioides*

After the adaptation period (June to August 2021), a total of 524 nos. of *Diospyros vaccinioides* (DV 001 – DV 0524) were retained in the receptor site– RMZ1 down hill side, while 6 nos. of *Diospyros vaccinioides* (DV0525-DV0530) were not found in receptor site during the monitoring on 1 September 2021. For the 6 nos. *Diospyros vaccinioides*, they're probably dead under influence of extreme weather condition (such as heavy rain or high temperature). All retained *Diospyros vaccinioides* were retagged and re-numbered. Plant conditions of *Diospyros vaccinioides* at the receptor site were listed in **Table 3** and illustrated in **Appendix 1**. Some seedlings were generally tiny (about 10cm in height) aiming at smaller root zone and better survival. However, some of them have yet developed sufficient leaves. Sign of leaf drop and dehydration has been observed. Although tiny new branch or leaf buds were observed, seedlings may struggle for survival against environmental stress.

According to environmental condition and location of the receptor sites/ nursery, watering frequency was recommended in daily practice for at least the first 3 months as the transplant time is in summer months with strong sunlight and high temperature; except the days with fog and rain. Water frequency may be reduced based on the plant condition after monitoring in the first 3 months.

In contrast, the Landscape Contractor was recommended to check all transplanted plants after heavy rains/ typhoon under safe condition, in order to carry out any stabilization/ maintenance work. Blocked drainage shall be cleared; excessive water shall be pumped or diverged from nursery ground; saturated soil shall be aerated.

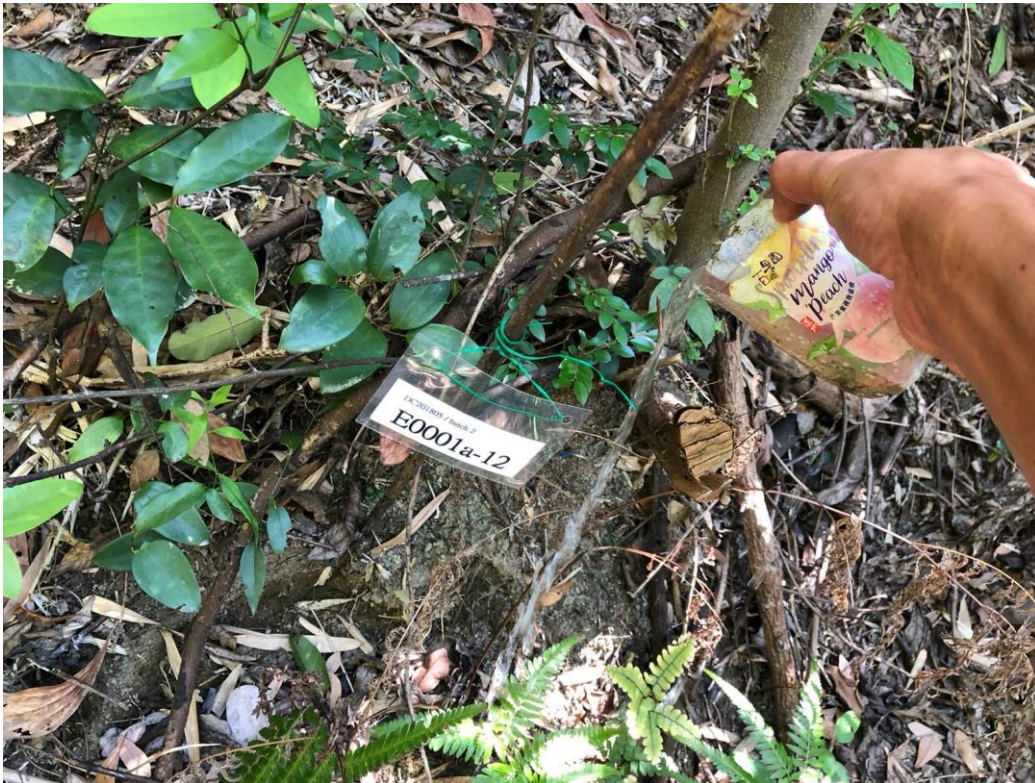
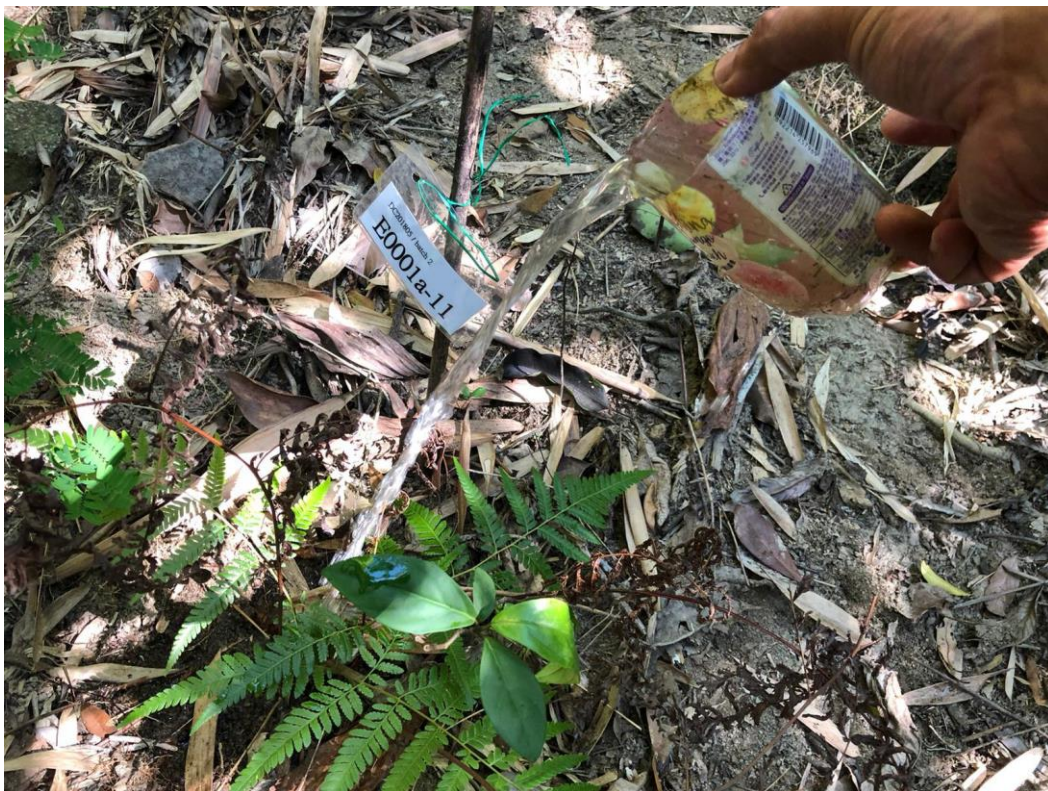
Post-transplantation monitoring at receptor site on June 2021

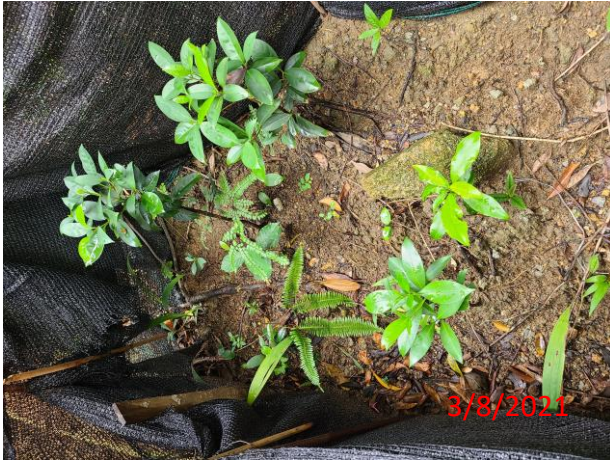
Bi-weekly ecological monitoring at Site 1 on 3 and 20 August 2021

The patch of retained *Ania hongkongensis* (named as H0001) was observed in a fair condition during reporting period, with corresponding photos presented in **Appendix 3**. The protection zone of H0001 has been expanded due to additional individuals were observed. Landscape Contractor was reminded to carry out regular watering to the transplanted H0002.
