**CONTRACT NO. STW 01/2021**

**ENVIRONMENTAL TEAM FOR  
RELOCATION OF SHA TIN SEWAGE TREATMENT  
WORKS TO CAVERNS – SITE PREPARATION  
AND ACCESS TUNNEL CONSTRUCTION**

**MONTHLY ENVIRONMENTAL MONITORING & AUDIT  
REPORT**

**AUGUST 2021**

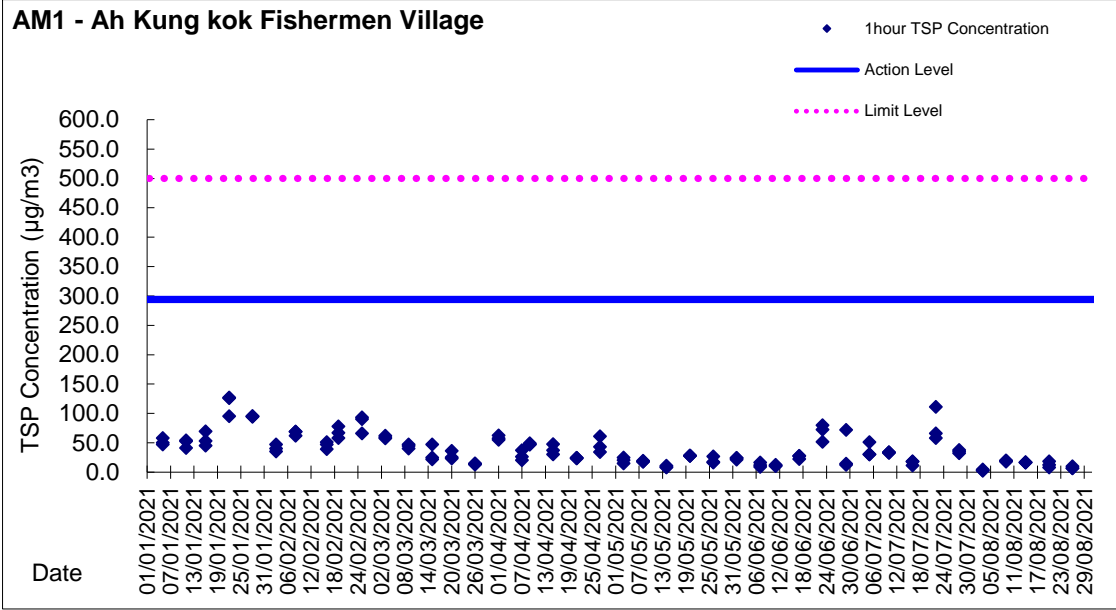
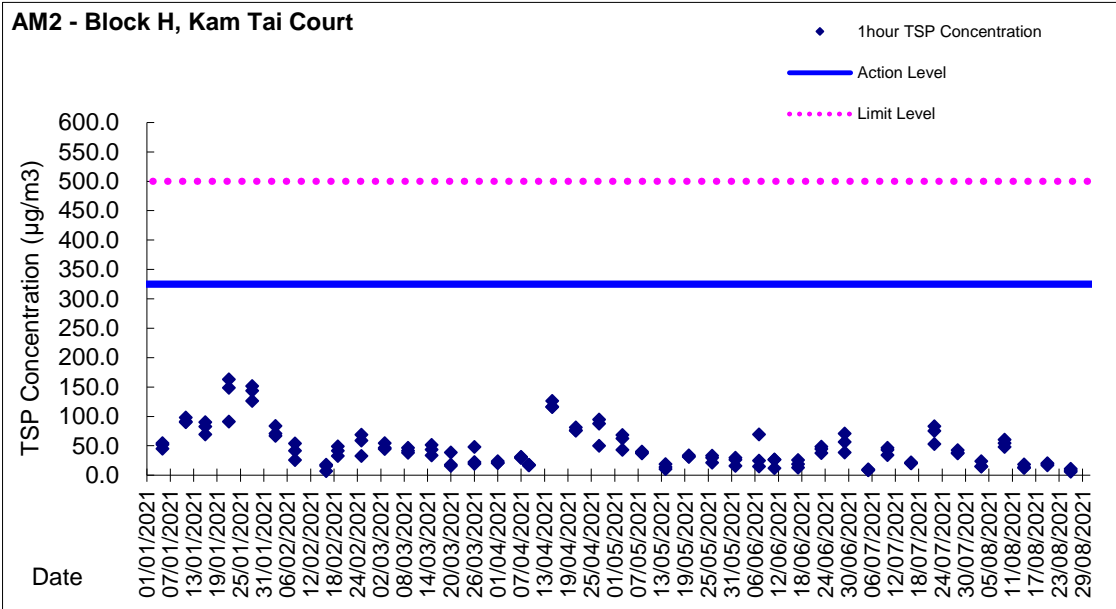
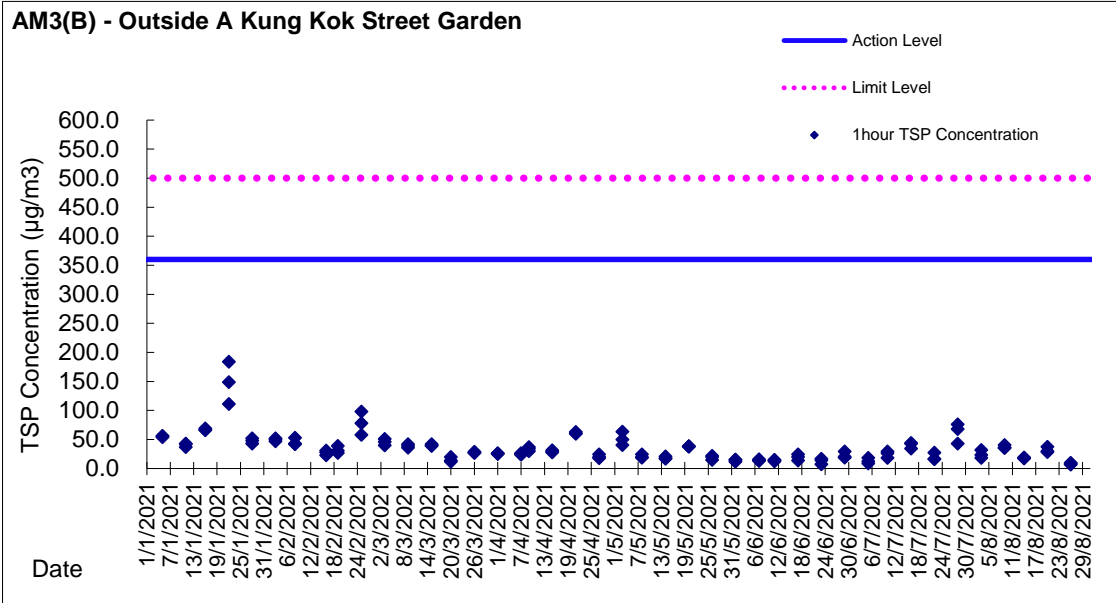
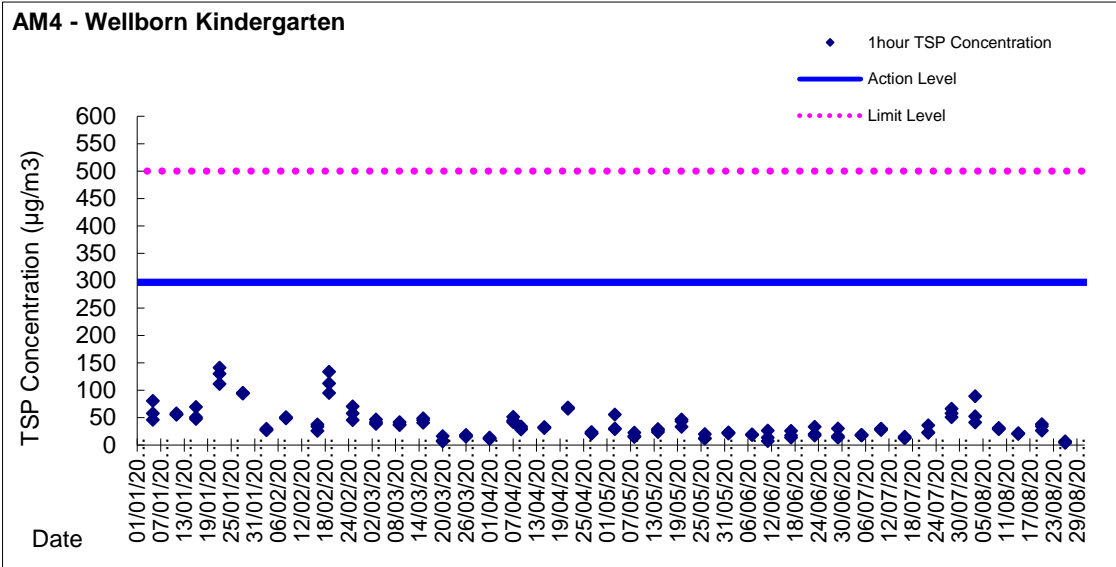
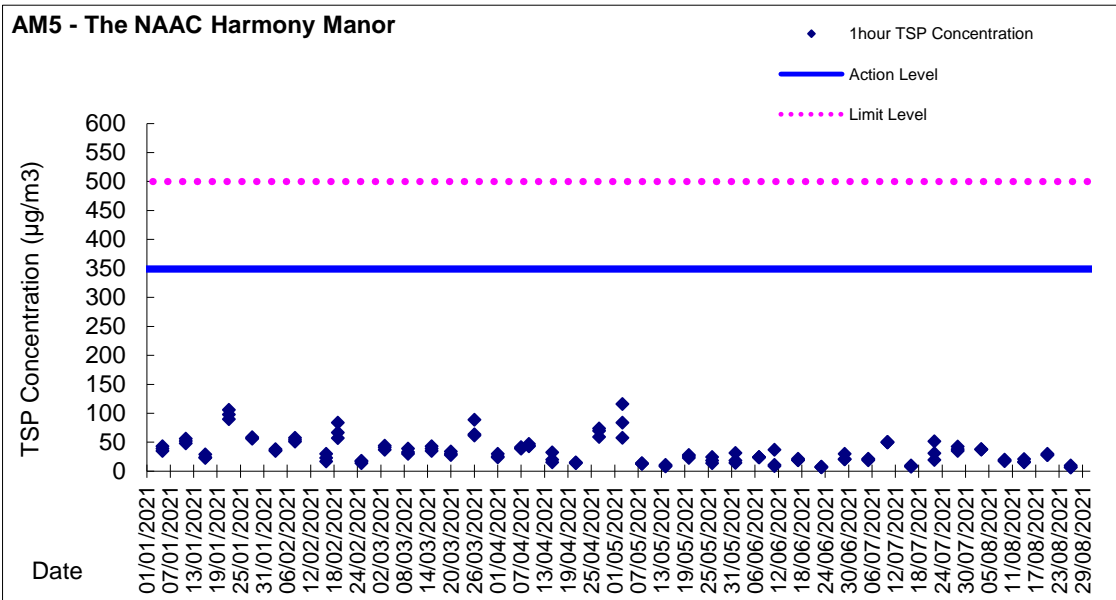
**Graphic Presentation of TSP Result**

Date	Weather Condition	Time	Mass Concentration ( $\mu\text{g}/\text{m}^3$ )
03-Aug-21	Fine	08:41	38
03-Aug-21	Fine	09:41	38
03-Aug-21	Fine	10:42	38
09-Aug-21	Fine	08:13	17
09-Aug-21	Fine	09:14	20
09-Aug-21	Fine	10:14	18
14-Aug-21	Fine	08:33	17
14-Aug-21	Fine	09:35	15
14-Aug-21	Fine	10:36	21
20-Aug-21	Fine	08:14	30
20-Aug-21	Fine	09:15	28
20-Aug-21	Fine	10:16	28
26-Aug-21	Fine	08:16	10
26-Aug-21	Fine	09:17	7
26-Aug-21	Fine	10:18	6

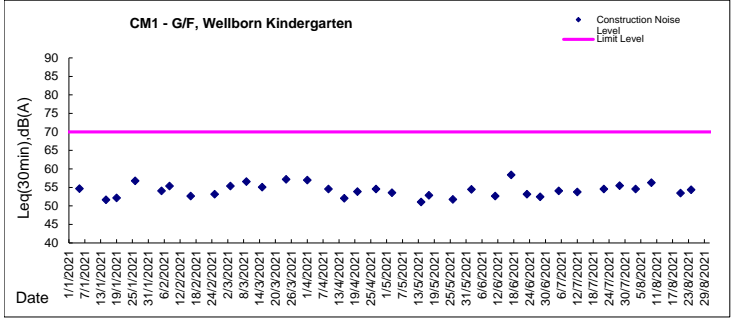
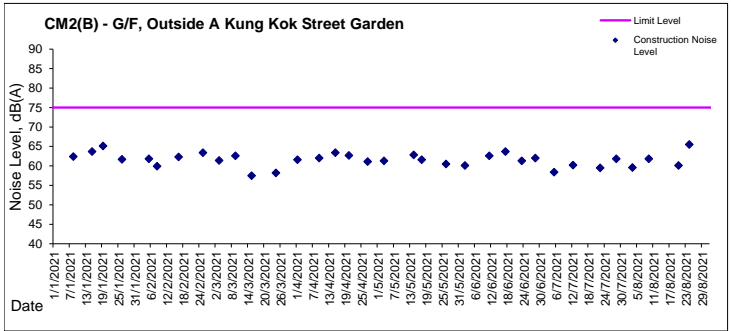
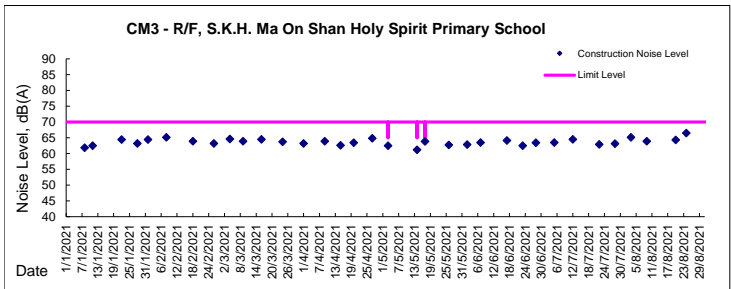
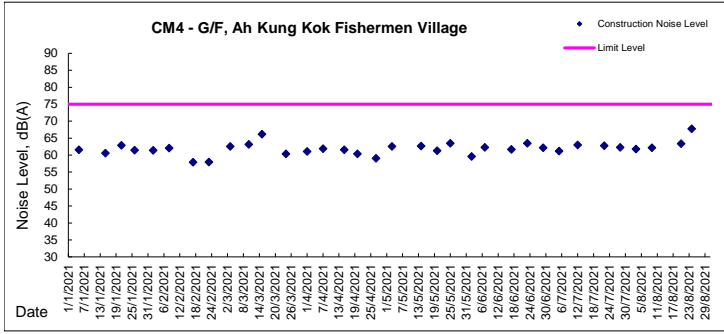
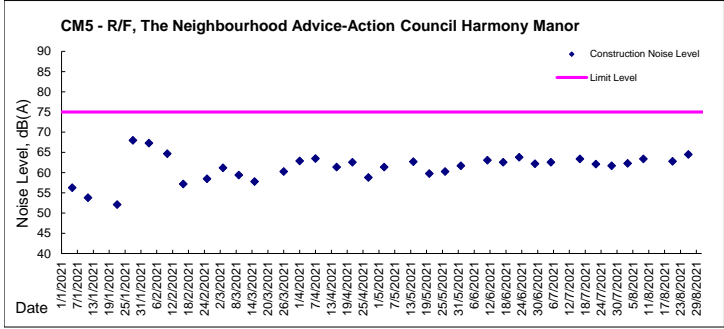
**Graphic Presentation of Noise Monitoring Result**

**Day Time (0700 - 1900hrs on normal weekdays)**
