**Contract No. SPW 09/2018
Environmental Team Baseline Surveys
for Sha Tin Cavern Sewage Treatment
Works**

**Protection and Transplantation Proposal
(Version 7.1)**

**Protection and Transplantation Proposal
(Conditions 2.13(ii) and 2.14 of EP-533/2017)**

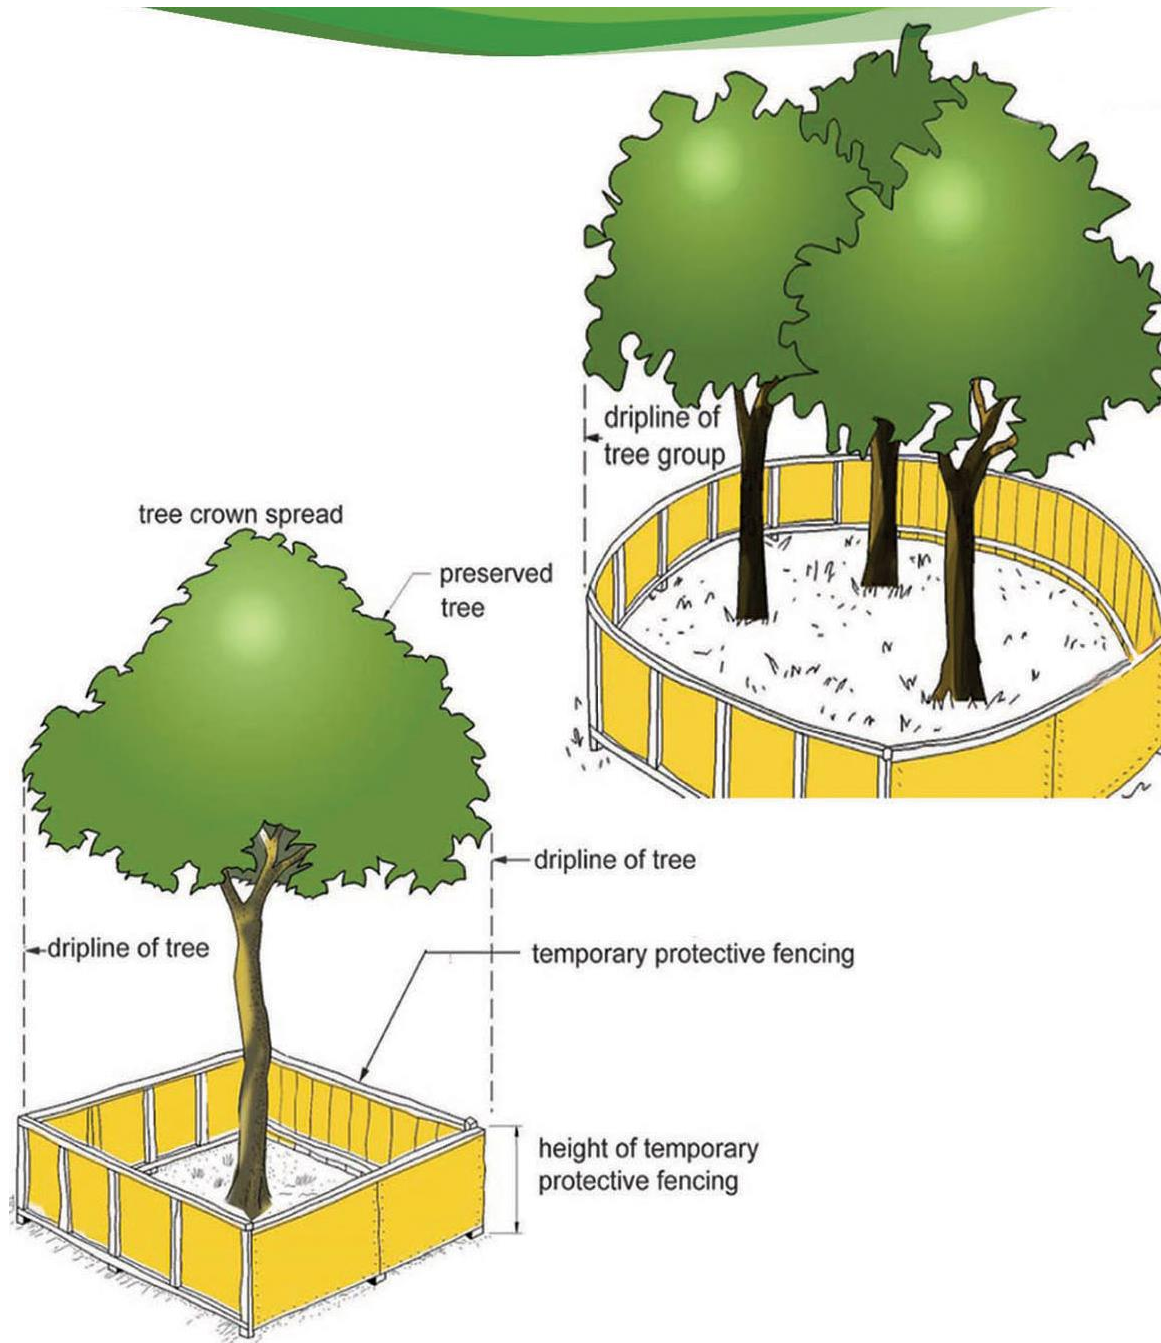
Appendix E – Typical Design of Tree Protection Zone

**APPENDIX E
TYPICAL DESIGN OF TREE
PROTECTON ZONE**

- As a general rule the majority of a tree's roots lies within an area just greater than the spread of its crown and are at a depth of approximately 600mm. This may be less on heavy soils and greater on drier soils. Therefore, the following precautions should be undertaken in order to prevent damage to the trunks, roots and crowns of trees during constructions.

- Heavy equipment, supplies, ditches and underground utility lines should be placed outside the protection zone.
 - Care should be taken to prevent trees/plants being damaged by mechanical equipment both during site clearance works and construction works.

- No soil, debris or construction materials should be deposited around and against the trunk of a tree/plant as this causes bark damage and compaction of the soil.
