# Drainage Services Department

**Contract No. SPW 09/2018  
Environmental Team Baseline Surveys  
for Sha Tin Cavern Sewage Treatment  
Works**

**Supplementary Contamination  
Assessment Plan  
(Version 3.1)**

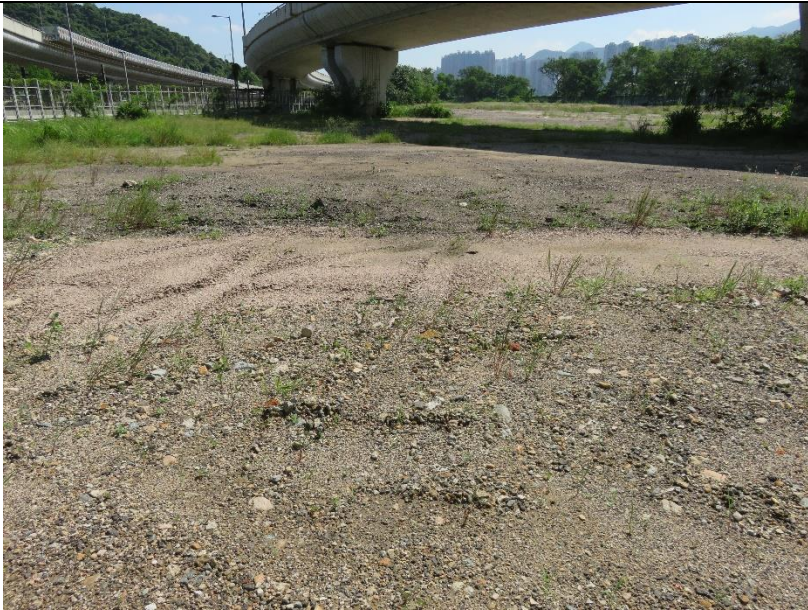
- 2.19 At the contamination hotspots identified in the EIA Stage, no sign of contamination (e.g. oil stain) was seen. Nevertheless, black stains were observed in the middle of the VDC. They were confirmed as non-aqueous phase liquid when flooded with water. Each stain was smaller than 1m<sup>2</sup>. The C&ED CAP did not report any oil stain. Also, C&ED clarified that no repairing/dismantling work was performed in the VDC and the DLO confirmed that no third party can enter the VDC after handing over and before the site inspection in July 2018 (**Appendix F**). Judging from the black colour, the stains are suspected to be engine oil, which might be left during site clearance after cessation of VDC operation. As no large scale oil stain was observed, the oil stains are believed to be localized leakage. The locations of the stains are shown in **Figure 2**.

Temporary storage of spent batteries identified in EIA Stage

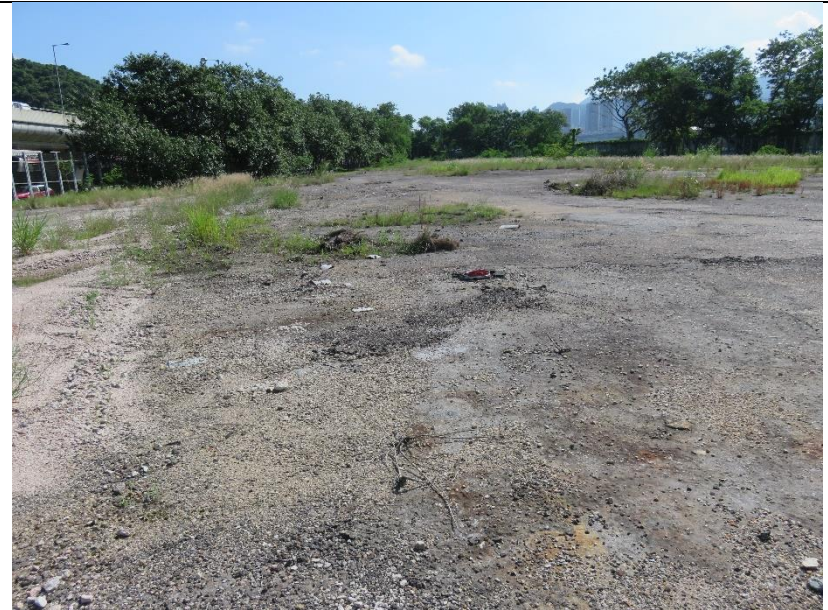
Storage area of siezed goods identified in EIA Stage

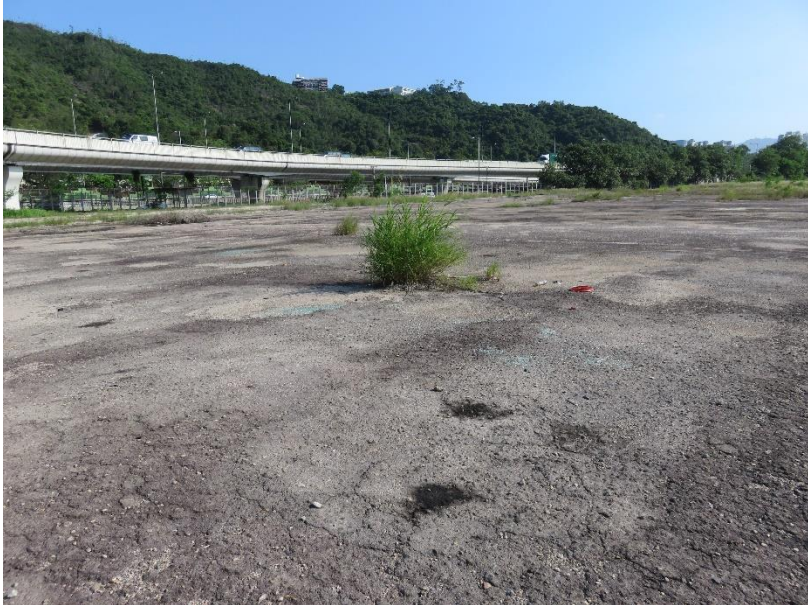
Engineer oil stain observed in recent walkover

- 3.4 According to the *Practice Guide for Investigation and Remediation of Contaminated Land*, simplified site investigation at the potential hotspot can be carried out for very small scale operation. The stains are suspected to be leaked engine oil left during site clearance after cessation of VDC when there is no long term vehicle storage. Therefore, no large scale contamination is expected and sampling at the hotspot is proposed. A total of 2 sampling locations (S1 & S2) are proposed as shown in **Figure 2**.

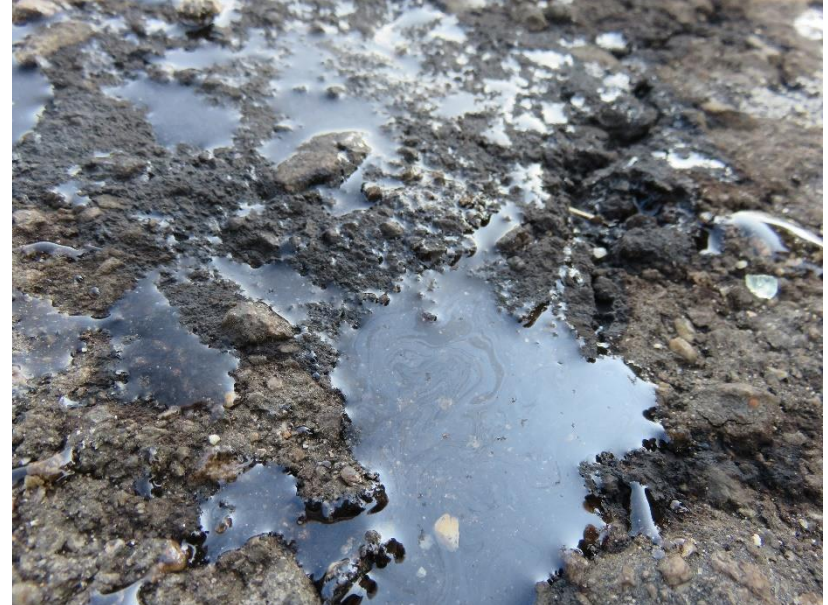
Non-aqueous phase liquid in oil stain

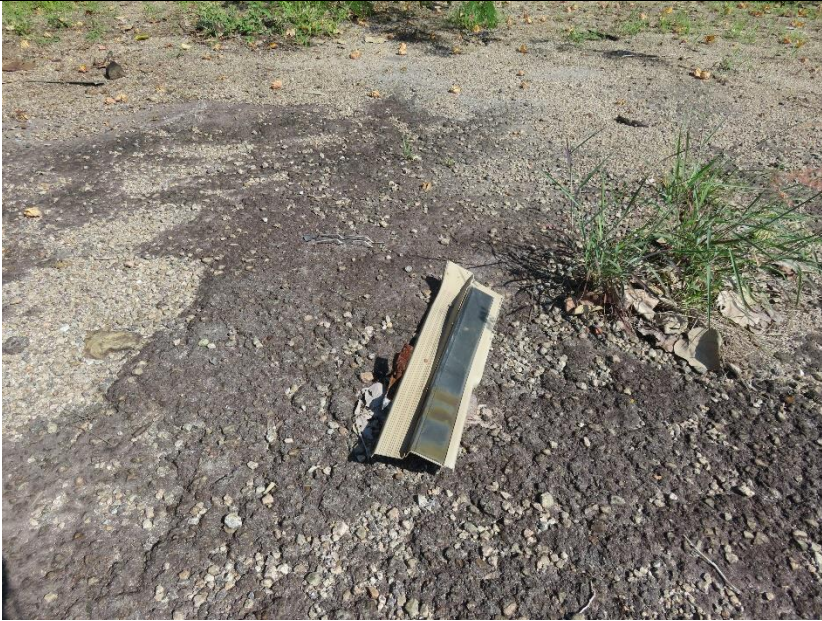
- 2.17 The vacant portion of the VDC was cleared of cars, trucks and containers observed in the aerial photos. However, pieces of car parts such as broken windshield, car door, exhaust pipe were occasionally found in the northwestern part of the VDC site. As confirmed by C&ED with written statement as shown in **Appendix F**, the VDC only stored vehicles with no repairing or dismantling works. Also, the District Lands Office confirmed that no access to the site by third parties were made after C&ED handed over the site and before site inspection in July 2018 (**Appendix F**). Therefore, no vehicle repairing/dismantling activity was conducted during and after operation of the VDC. It is surmised that the car parts may be accidentally broken up during vehicle removal for site clearance.

Broken Car Door

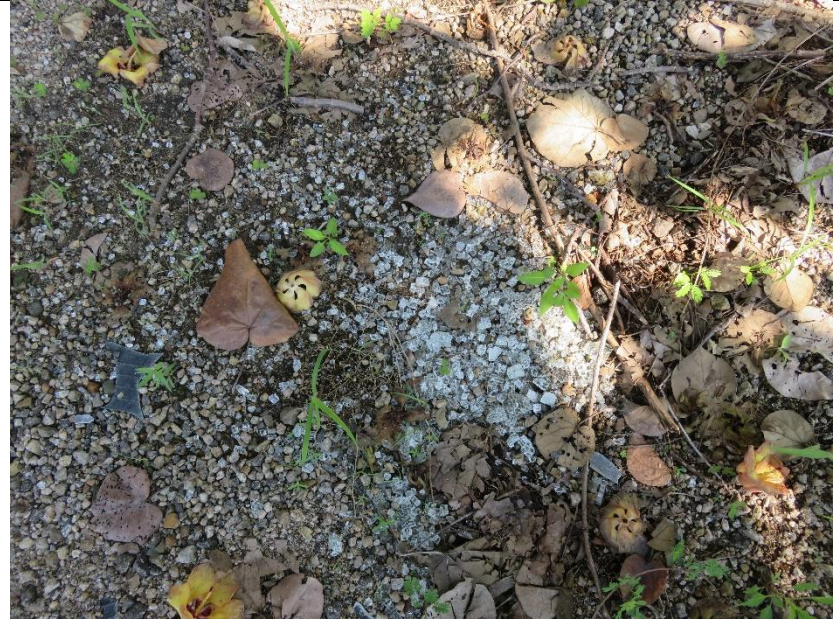
Broken Windshield

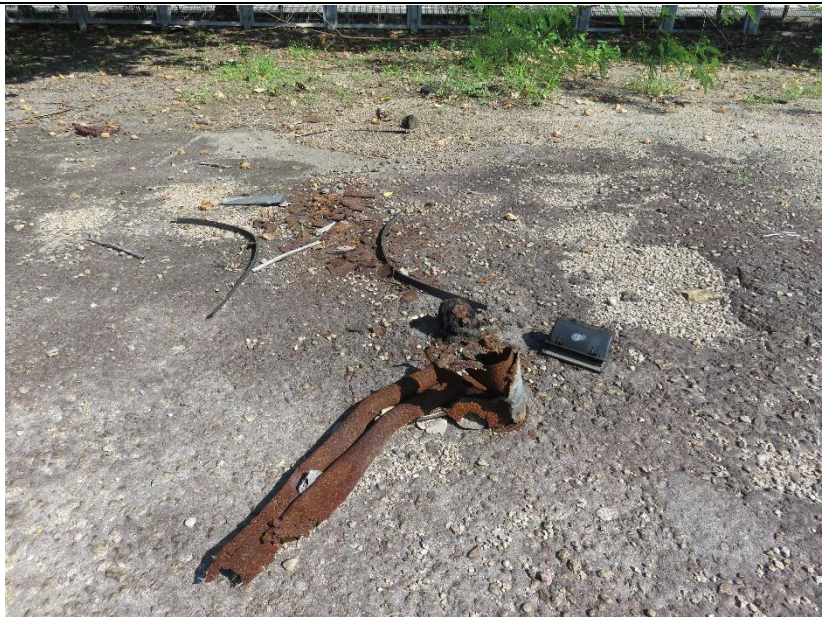
Broken Exhaust Pipe

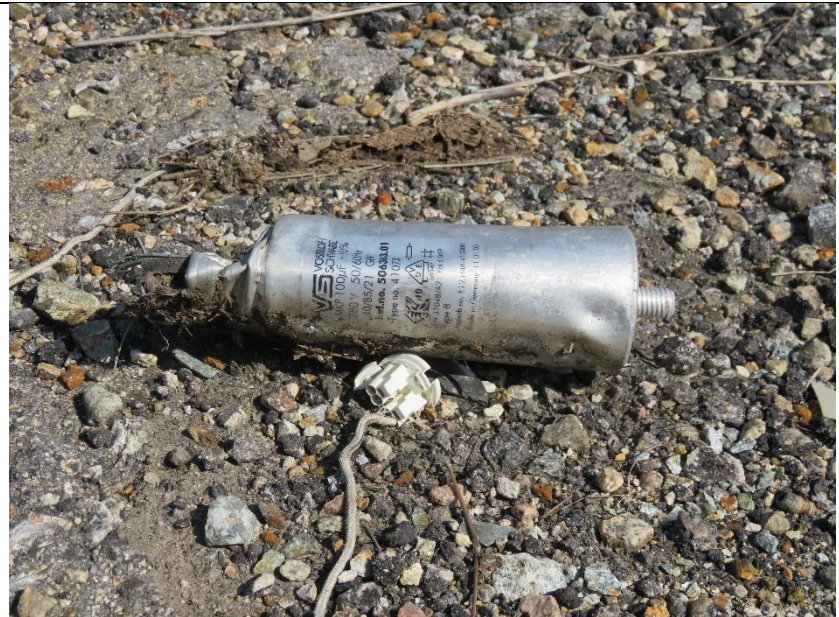
Broken Ignitor

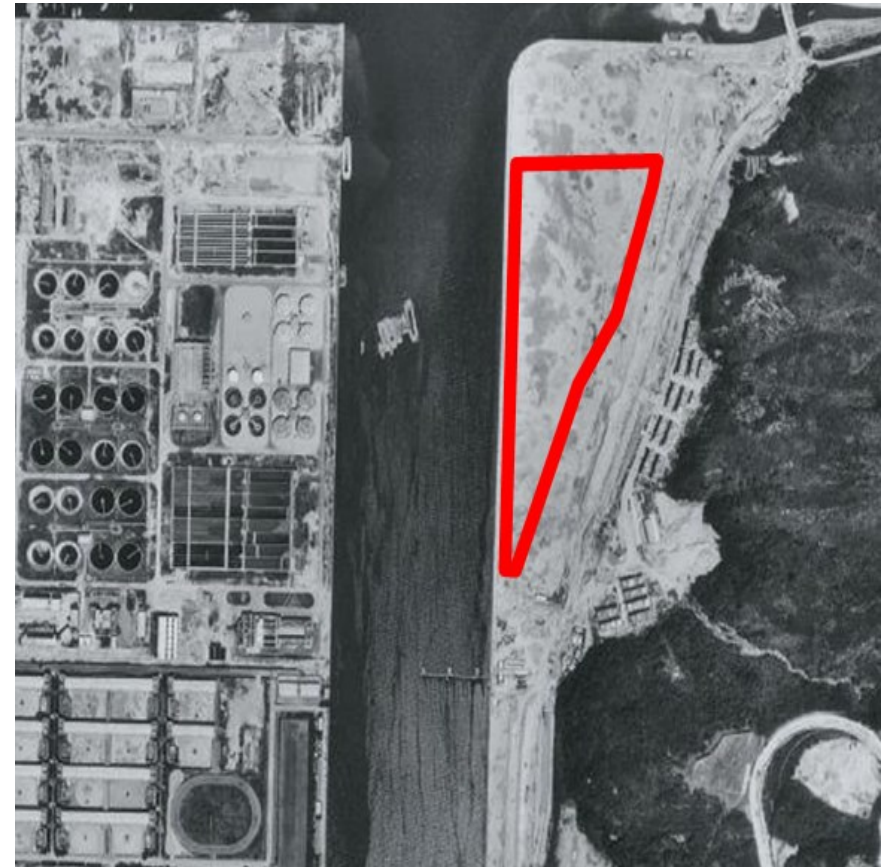
Year 1985 (ref: A02413, height: 4,000ft) – Reclamation of the Tai Shui Hang area has been complete. Construction for the Tate's Cairn Highway Bridge was in the early stages with no infrastructures erected.

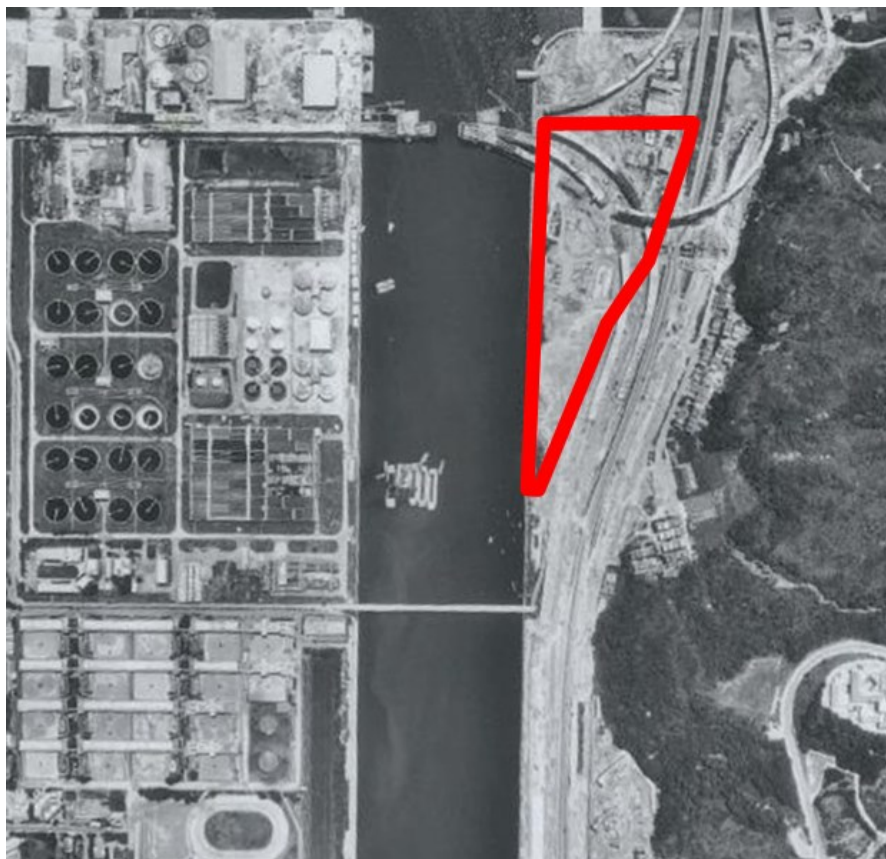
Year 1990 (ref: A21212, height: 4,000) – Tate's Cairn Highway Bridge was under construction. The areas for the proposed work were partly vacant and partly occupied by material storage.

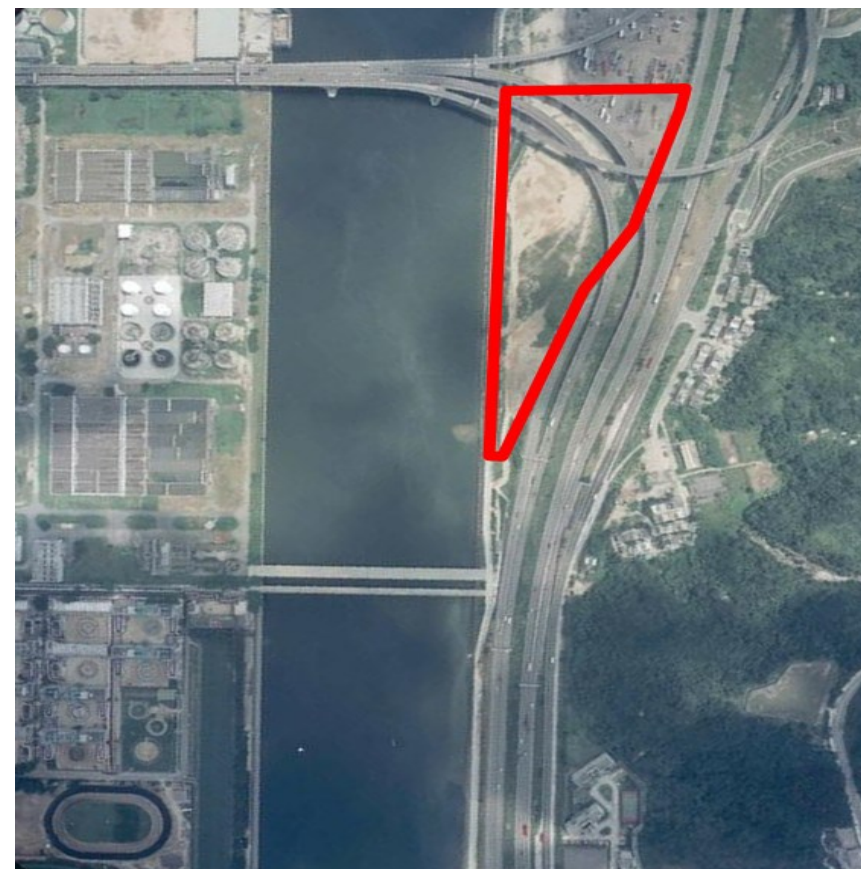
Year 1995 (ref: CN 10812, height: 2,500ft) – Construction of Tate's Cairn Highway Bridge was completed. The north eastern end of the Shatin VDC area was occupied by containers and vehicles.

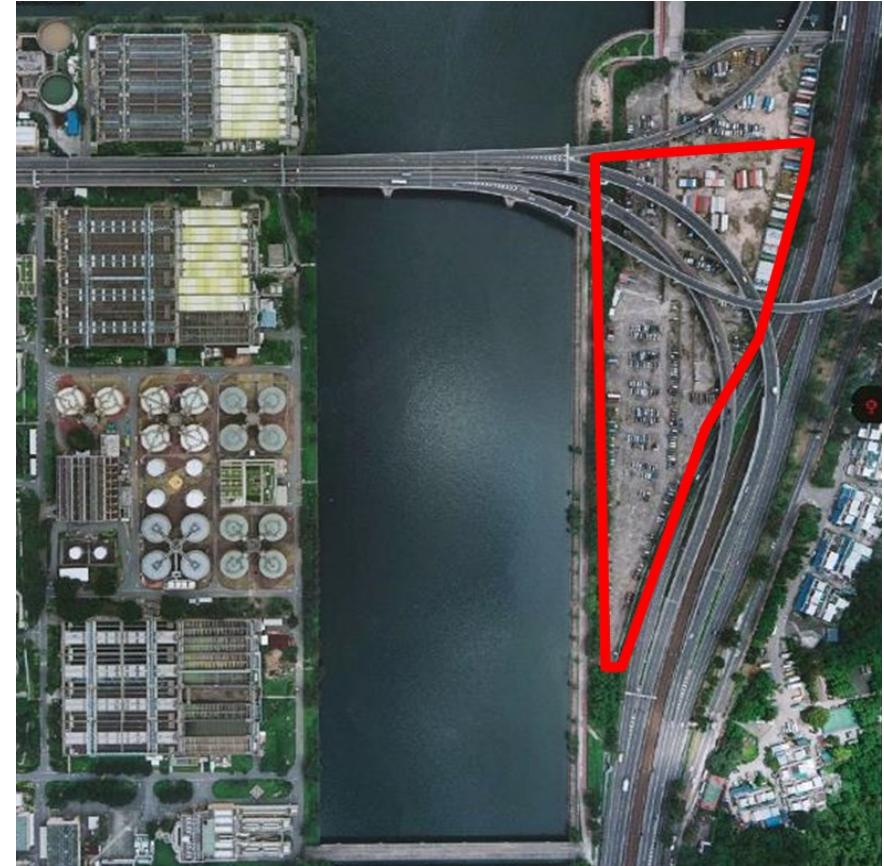
Year 2013 (ref: CW103602, height: 2,000ft) – Overview of the C&ED Shatin VDC. No significant changes have been made to the land use since commencement of operation.
