**JOB No.: TCS00881/18 & TCS00944/18**

**SITE FORMATION AND ASSOCIATED INFRASTRUCTURAL  
WORKS FOR DEVELOPMENT OF COLUMBARIUM,  
CREMATORIUM AND RELATED FACILITIES AT SANDY  
RIDGE CEMETERY**

**MONTHLY ENVIRONMENTAL MONITORING AND AUDIT  
REPORT (NO.61) – AUGUST 2023**

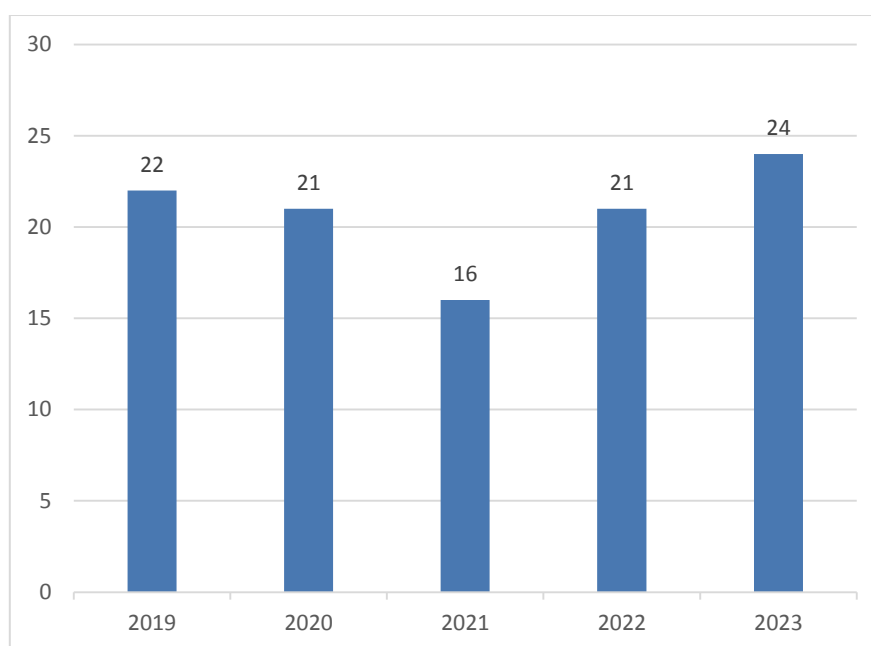
Figure 1: Bar chart showing the total species richness within site boundary from 2019 to 2023  
(Actual quantity annotated at the top of each bar)

- 5.1 Total abundance and species richness in August over years were compared to show the trends. Figures 1 and 2 indicate the total species richness and total abundance within the site boundary respectively.

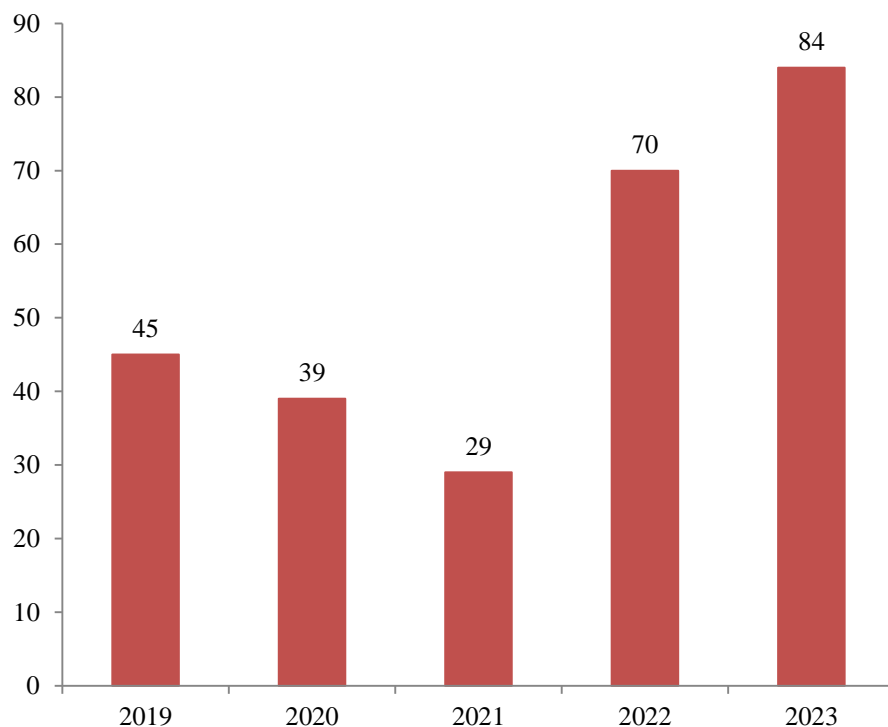
Figure 2: Bar chart showing the total abundance within site boundary from 2019 to 2023  
 (Actual quantity annotated at the top of each bar)

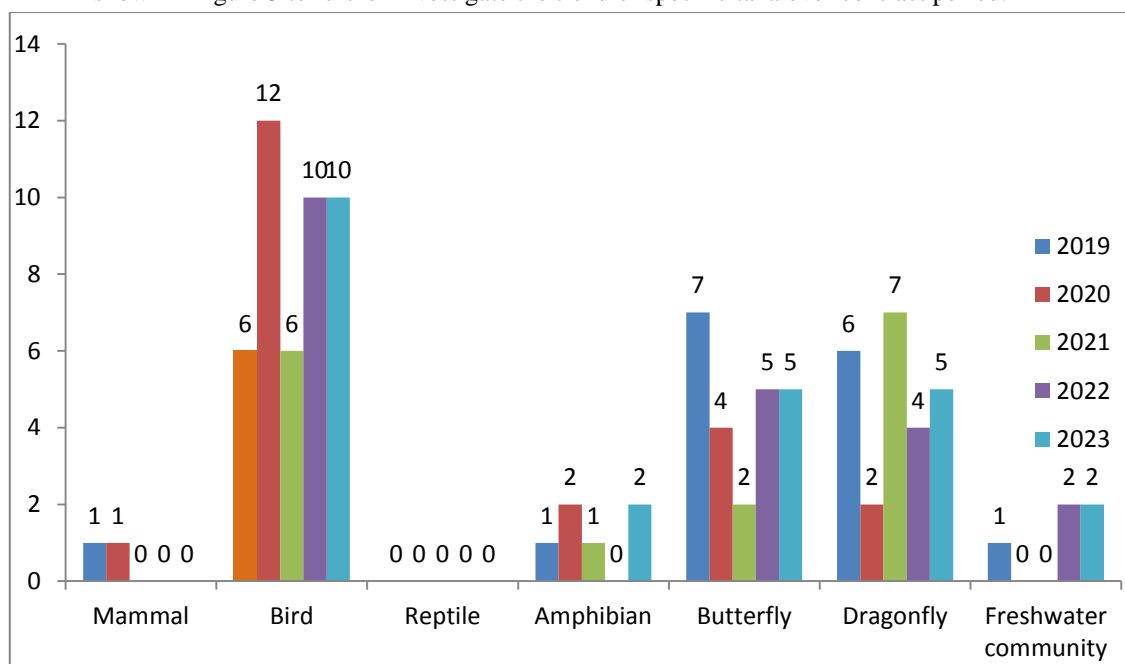
Figure 3: Bar chart showing the species richness within site boundary by taxa from 2019 to 2023  
 (Actual quantity annotated at the top of each bar)

5.2 As results in section 4 were categorized by taxa, a detailed breakdown of each taxon is shown in figure 3 to further investigate the trend of specific taxa over contract period.

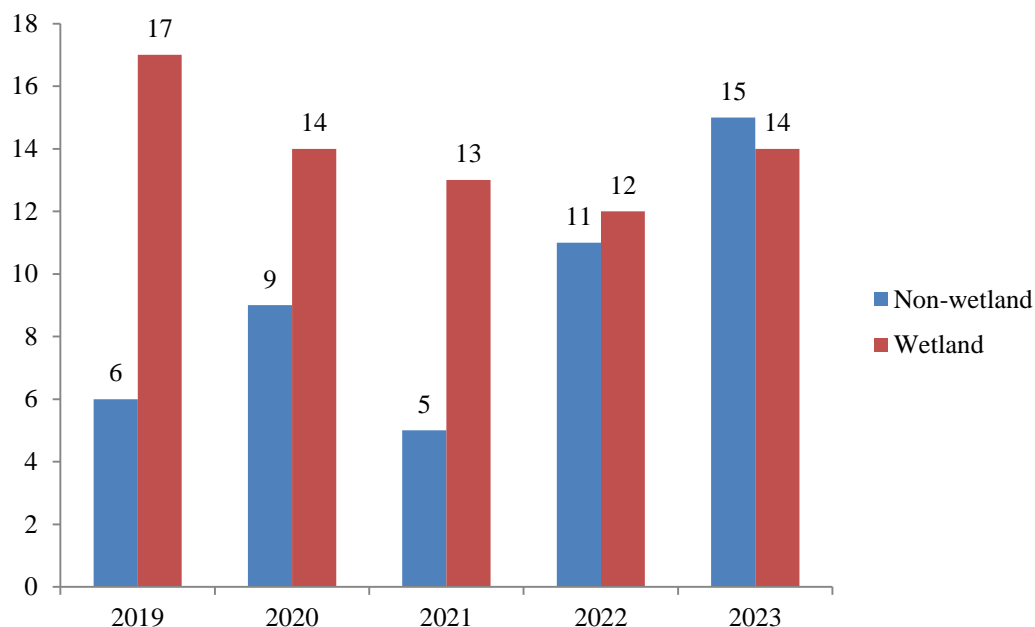
Figure 4: Bar chart showing the species richness based on habitat type from 2019 to 2023  
 (Actual quantity annotated at the top of each bar)

5.4 After analysing survey results in August from 2019 to 2023, stable number of species richness and a significant increase in the abundance for Wetland and Non-wetland habitat are recorded in August 2023. This could be benefited by some positive factors such as the major construction works were completed and most of the PME has been removed from site. Besides, compensation planting works have been conducted in early Jan 2023. Therefore, disturbance to fauna species from construction works have been largely minimised. In addition, woodland compensation and grassland reinstatement would be implemented in the second and third quarter of 2023. Hence, the habitat of fauna species would be gradually recovered and expectation of increase in the species richness and abundance for wetland habitat is high.

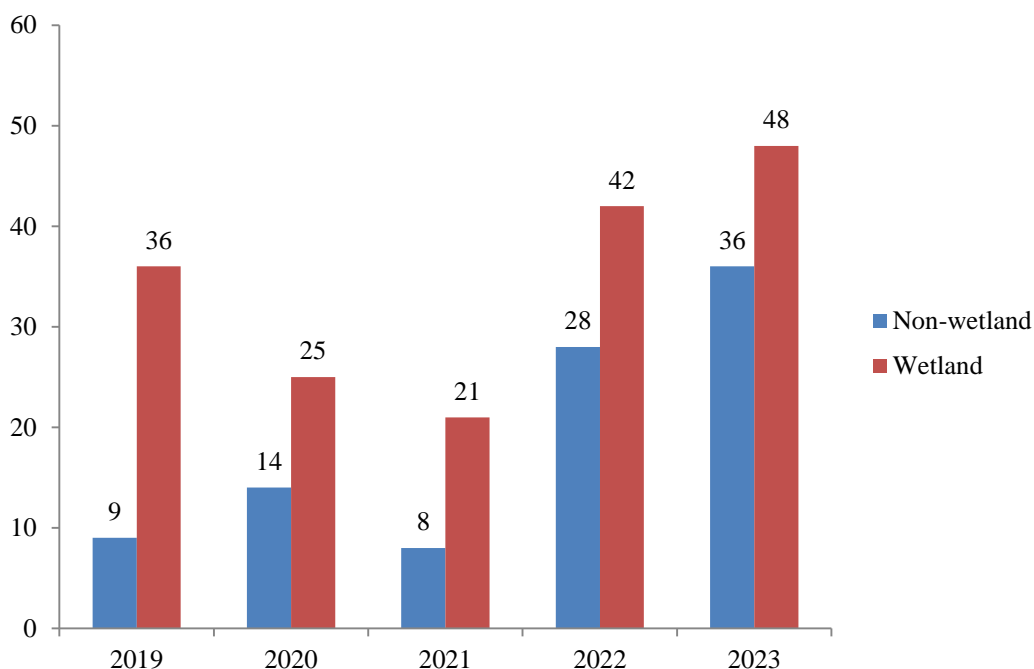
Figure 5: Bar chart showing the abundance based on habitat type from 2019 to 2023  
 (Actual quantity annotated at the top of each bar)

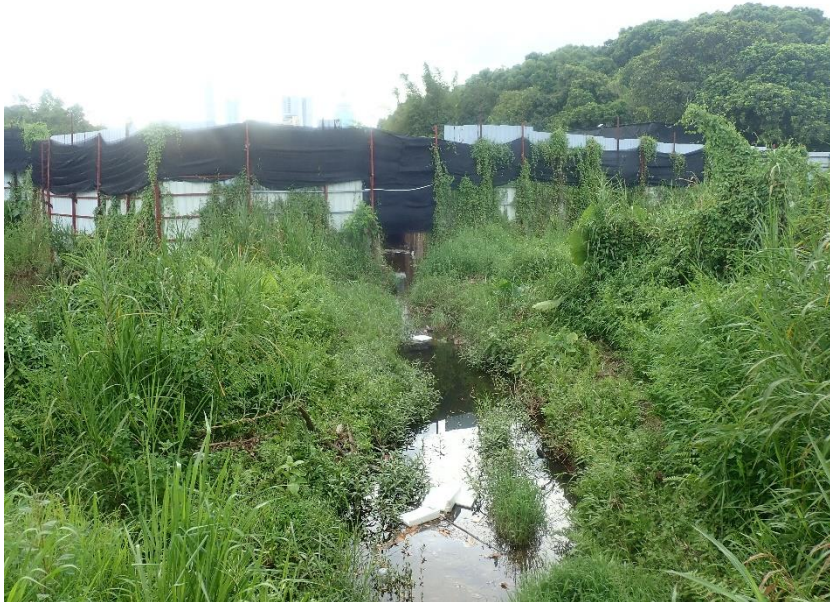
**Picture 1**

Watercourse in monitoring area.

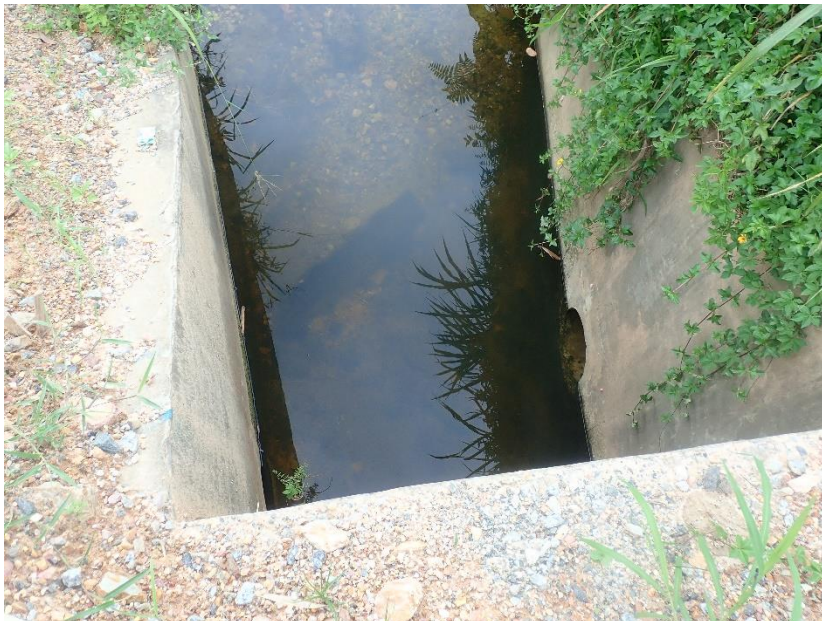
**Picture 2**

Watercourse in monitoring area.

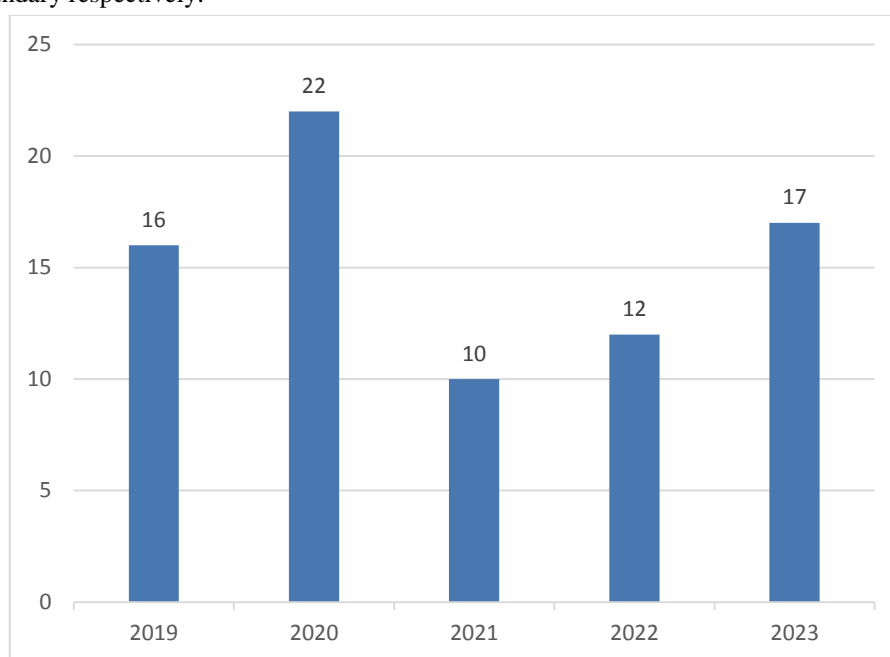
Figure 1: Bar chart showing the total species richness within site boundary from 2019 to 2023 (Actual quantity annotated at the top of each bar)

5.1 Total abundance and species richness in August over years were compared to show the trends. Figures 1 and 2 indicate total species richness and total abundance within the site boundary respectively.

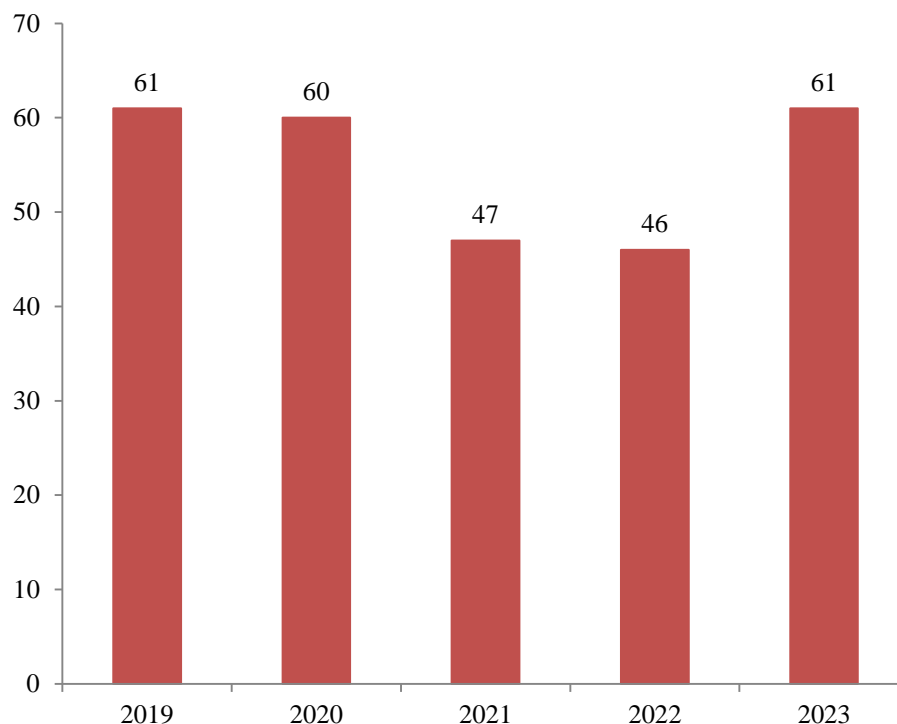
Figure 2: Bar chart showing the total abundance within site boundary from 2019 to 2023  
 (Actual quantity annotated at the top of each bar)

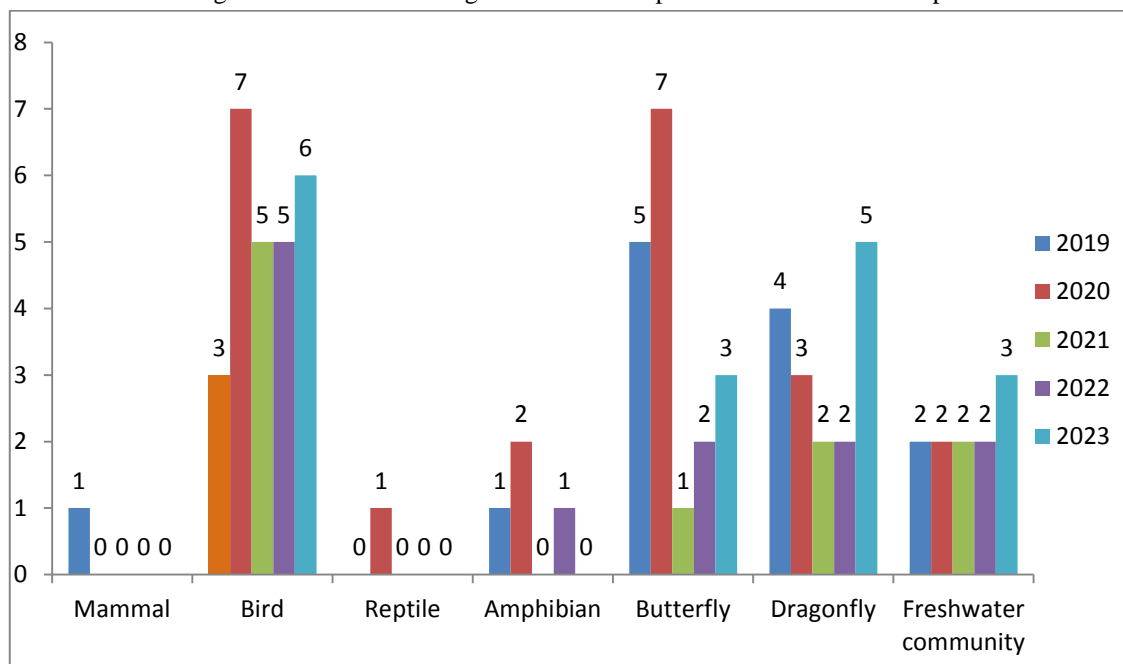
Figure 3: Bar chart showing the species richness within site boundary by taxa from 2019 to 2023  
 (Actual quantity annotated at the top of each bar)

5.2 As results in section 4 were categorized by taxa, a detailed breakdown of each taxon is shown in figure 3 to further investigate the trend of specific taxa over contract period.

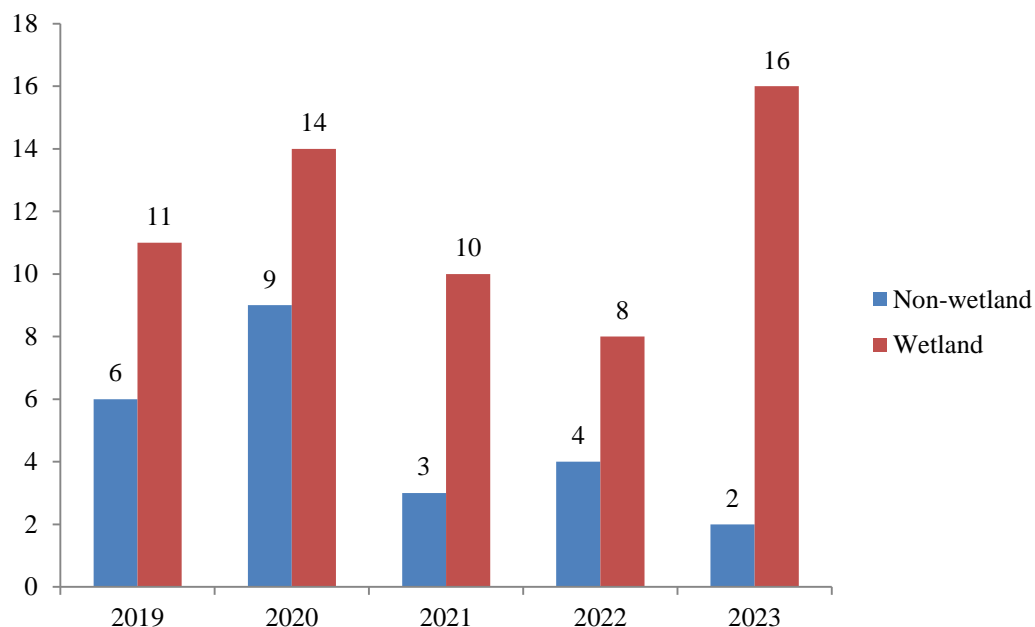
Figure 4: bar chart showing the species richness based on habitat type from 2019 to 2023  
 (Actual quantity annotated at the top of each bar)

- 5.4 After analysing survey results in August from 2019 to 2023, records in species richness and abundance for wetland and non-wetland habitats are unstable, this may due to natural fluctuation. According to the recent on-site observation, there are new built workshops by others situated on both sides of Lin Ma Hang Road so the disturbance to fauna species from construction works could be increased. Due to the cause was not related to this project, remedial action to remove or reduce source of disturbance is limited.

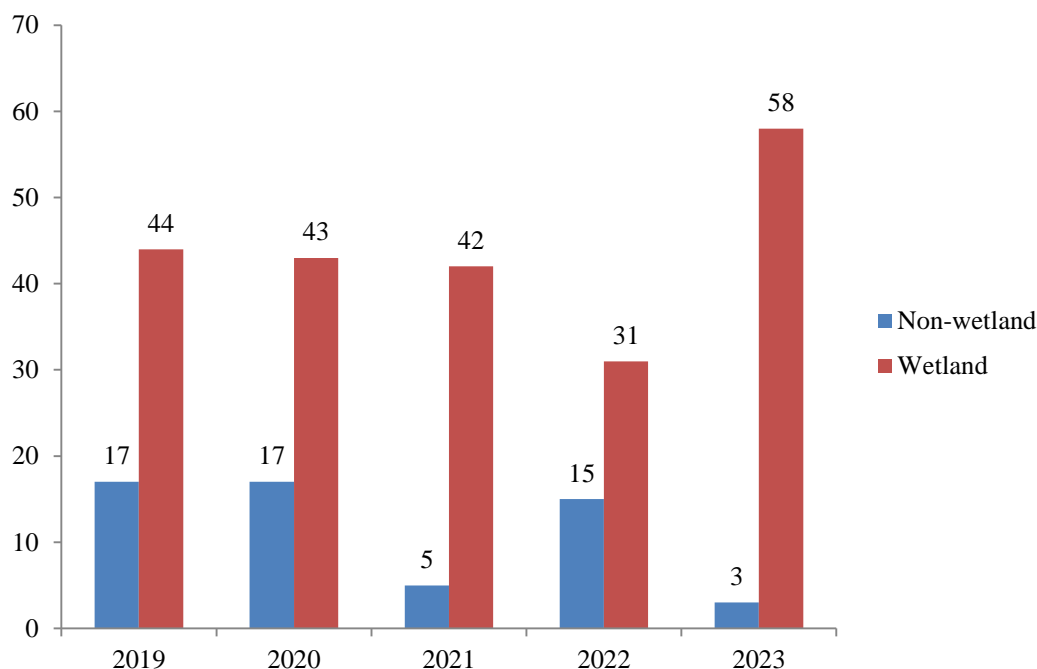
Figure 5: bar chart showing the abundance based on habitat type from 2019 to 2023  
 (Actual quantity annotated at the top of each bar)

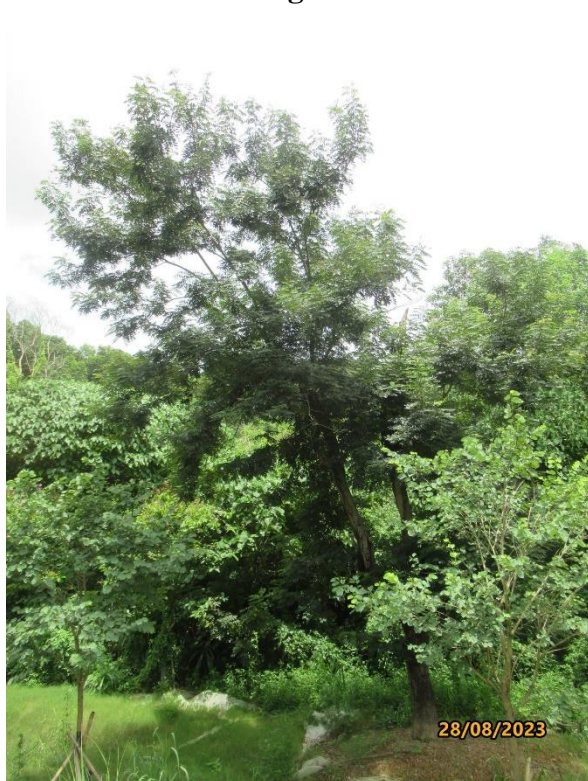
**Fig E.**

Transplanted tree (T-2465)

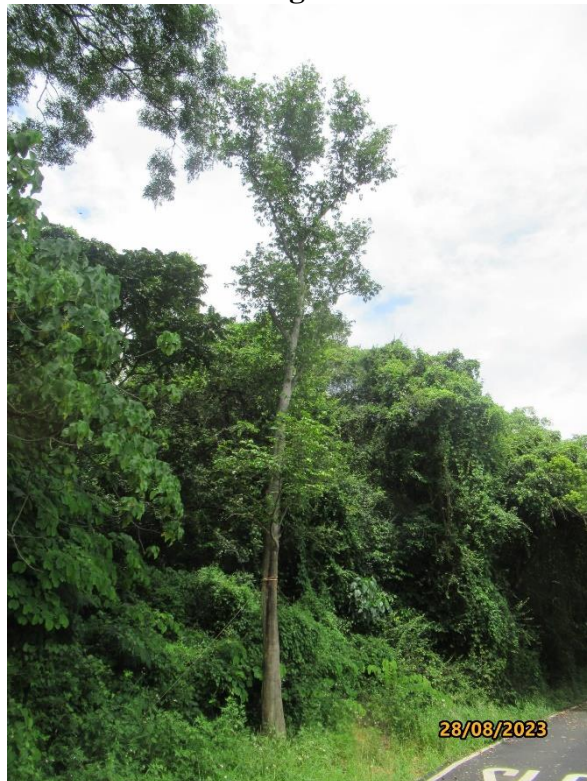
**Fig F.**

Transplanted tree (T-2928)
