香港電燈有限公司  
The Hongkong Electric Co., Ltd.

**ENVIRONMENTAL PERMIT NO. EP-535/2017**

**IMPROVEMENT DREDGING FOR  
LAMMA POWER STATION NAVIGATION CHANNEL**

Report Title Quarterly EM&A Report (February to April 2020)

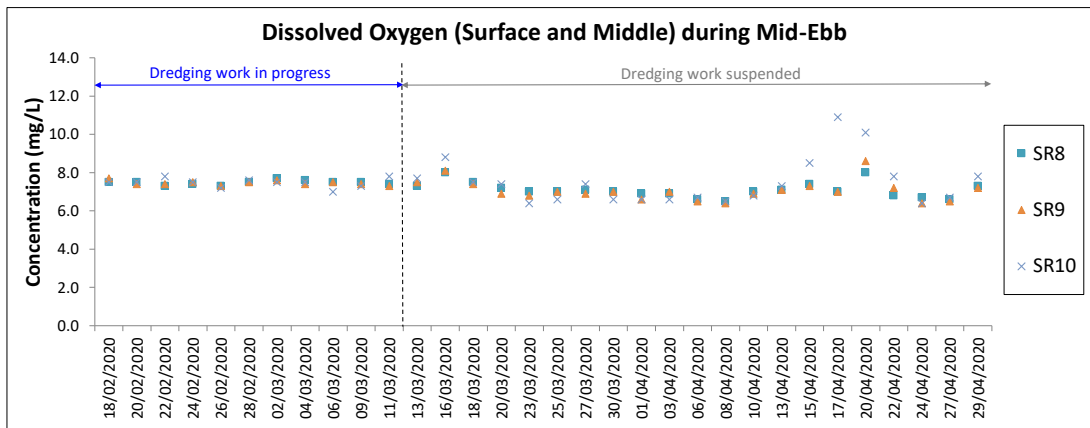
## **A. Graphical Presentations of Water Quality Monitoring Results**

1. General weather condition during monitoring ranged from sunny to rainy, with sea condition ranged from calm to rough. Detailed meteorological conditions can be referred to the corresponding Monthly Water Quality Monitoring Reports.
2. As specified in the Updated EM&A Manual, SR2 and SR3 were monitored during bathing season only (March to October inclusive).
